Hydrologic Summary: IT'S BEEN A YEAR

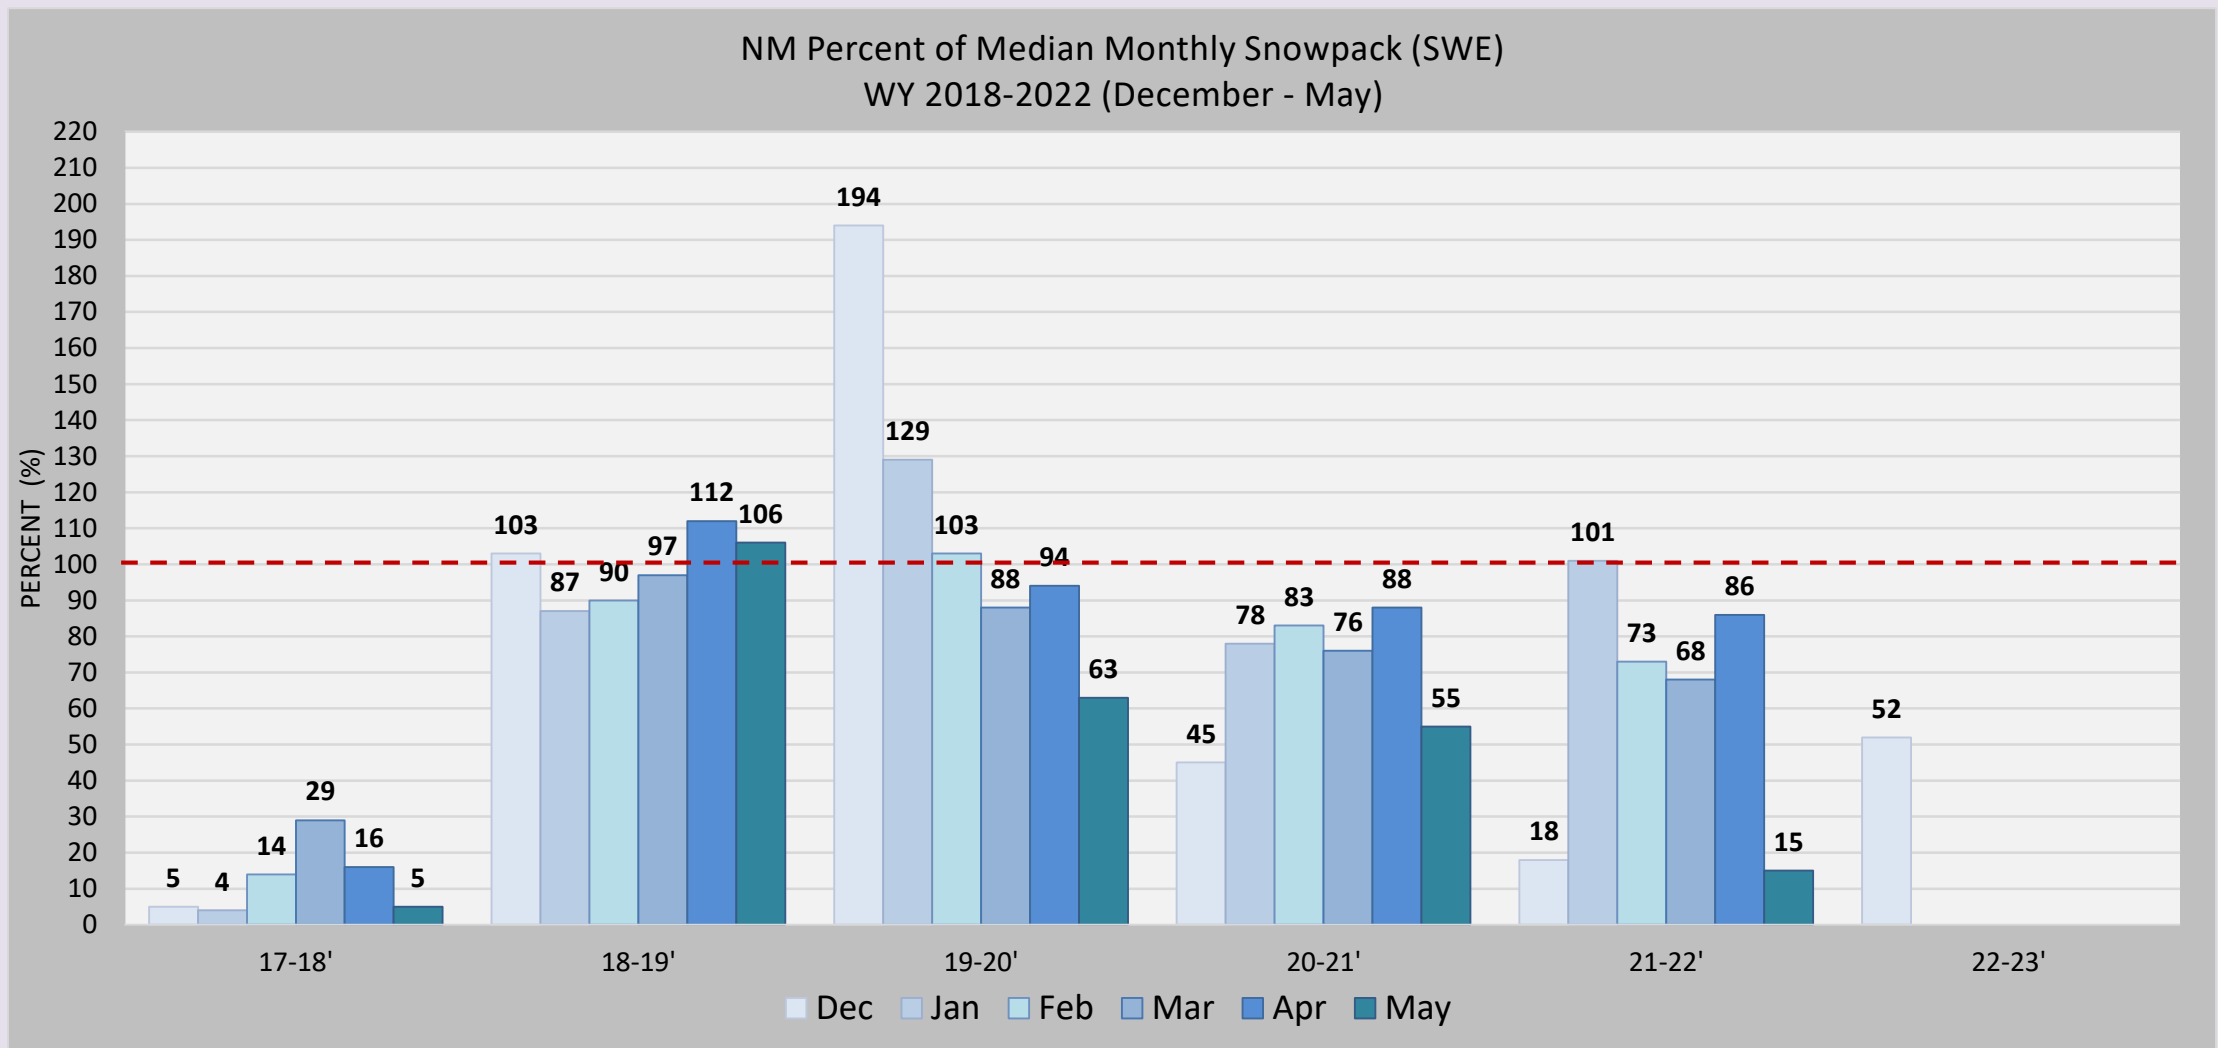
The chart above is the same as slide five but for 2018 to 2022. The 2017-2018 season was practically snow-free. The following 2018-2019 season made a big comeback with close to median snowpack through the entire season. 2019-2020 started out great then trailed off by late spring. 2020-2021 was fair followed by more struggles in 2021-2022. The 2022-2023 season is already off to a poor start. At this point, notable reservoir recovery will require several back-to-back years with robust snowfall.

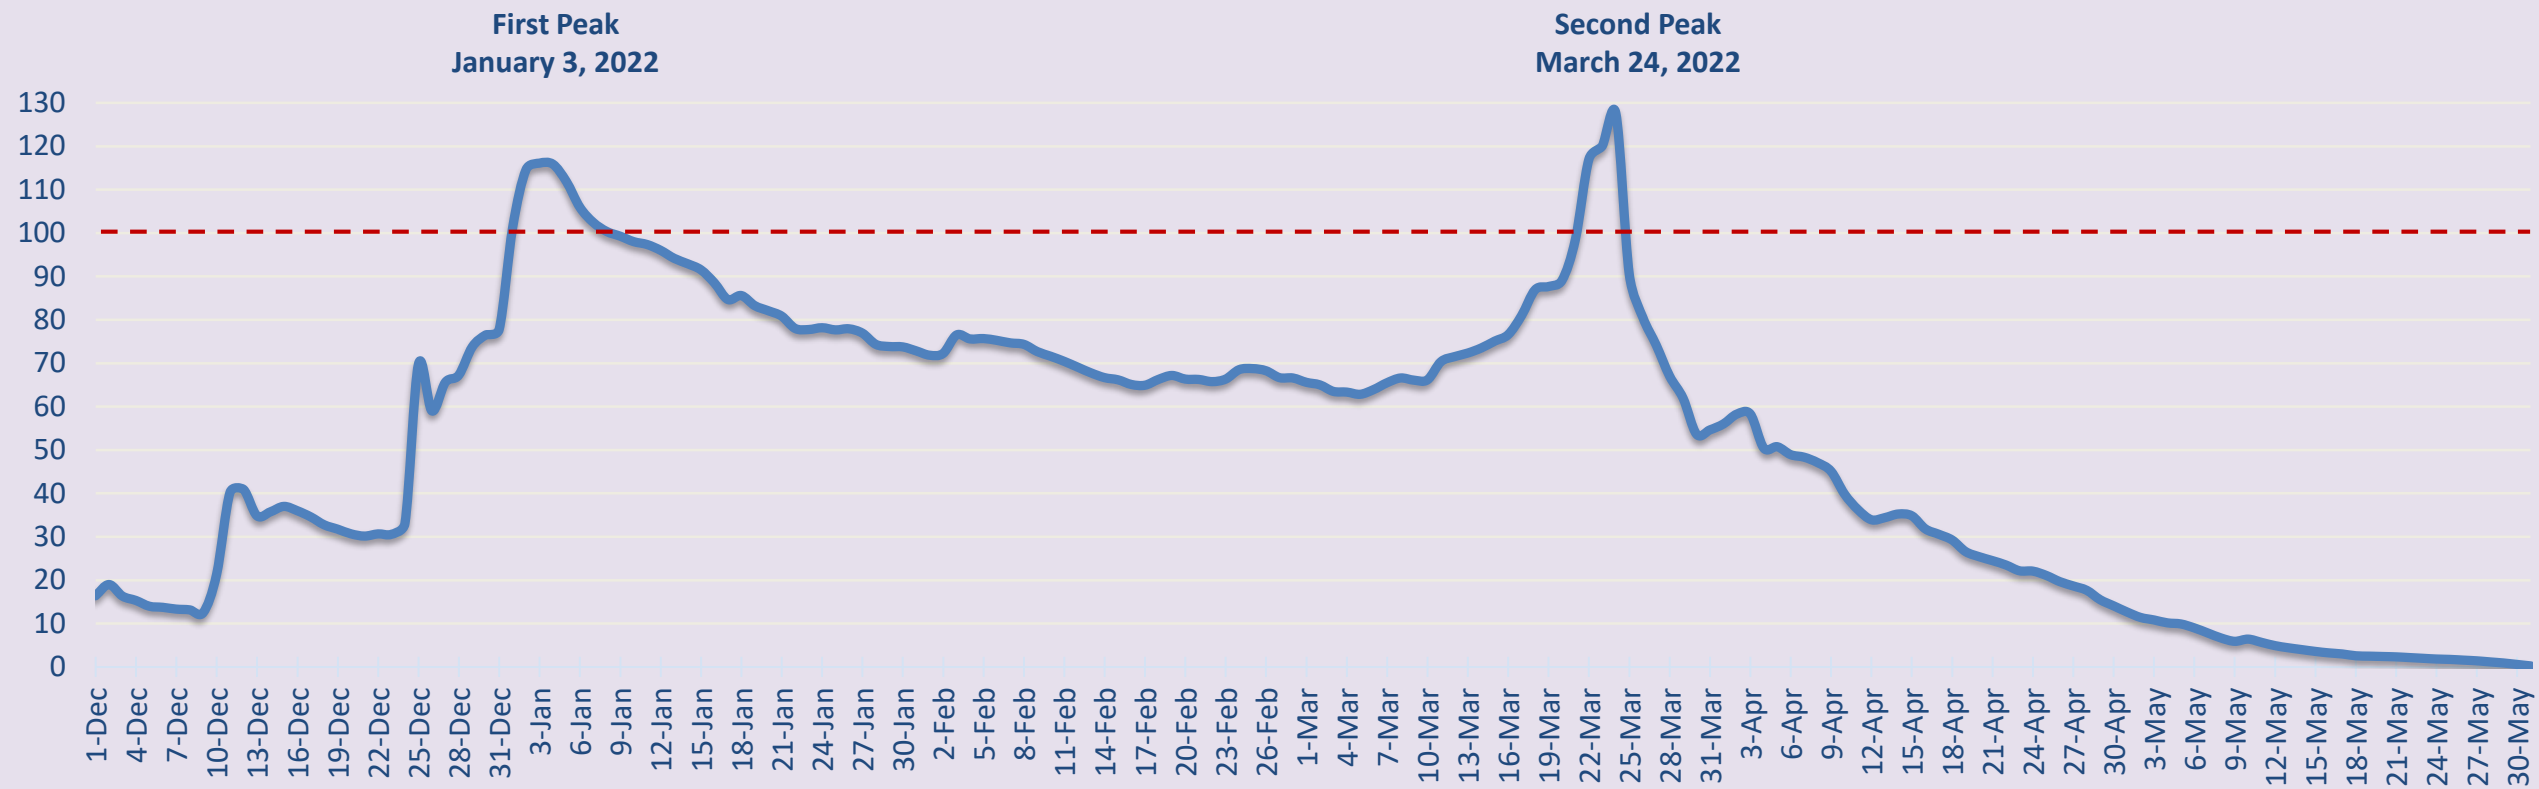
The 2021-2022 seasonal snowpack for New Mexico experienced an initial peak on January 3, 2022 after several robust storm systems crossed the region in December. A quieter weather pattern through January and February led to a slow decline in snowpack with statewide percent of median falling to near 60% through early March. A brief return to active winter weather in mid March created a second peak on March 24, 2022. The initial and secondary peaks were notably higher than the median but did not persist long enough to support healthy runoff. Snowpack was decimated during April and May with exceptionally dry and warm conditions prevailing over the region.

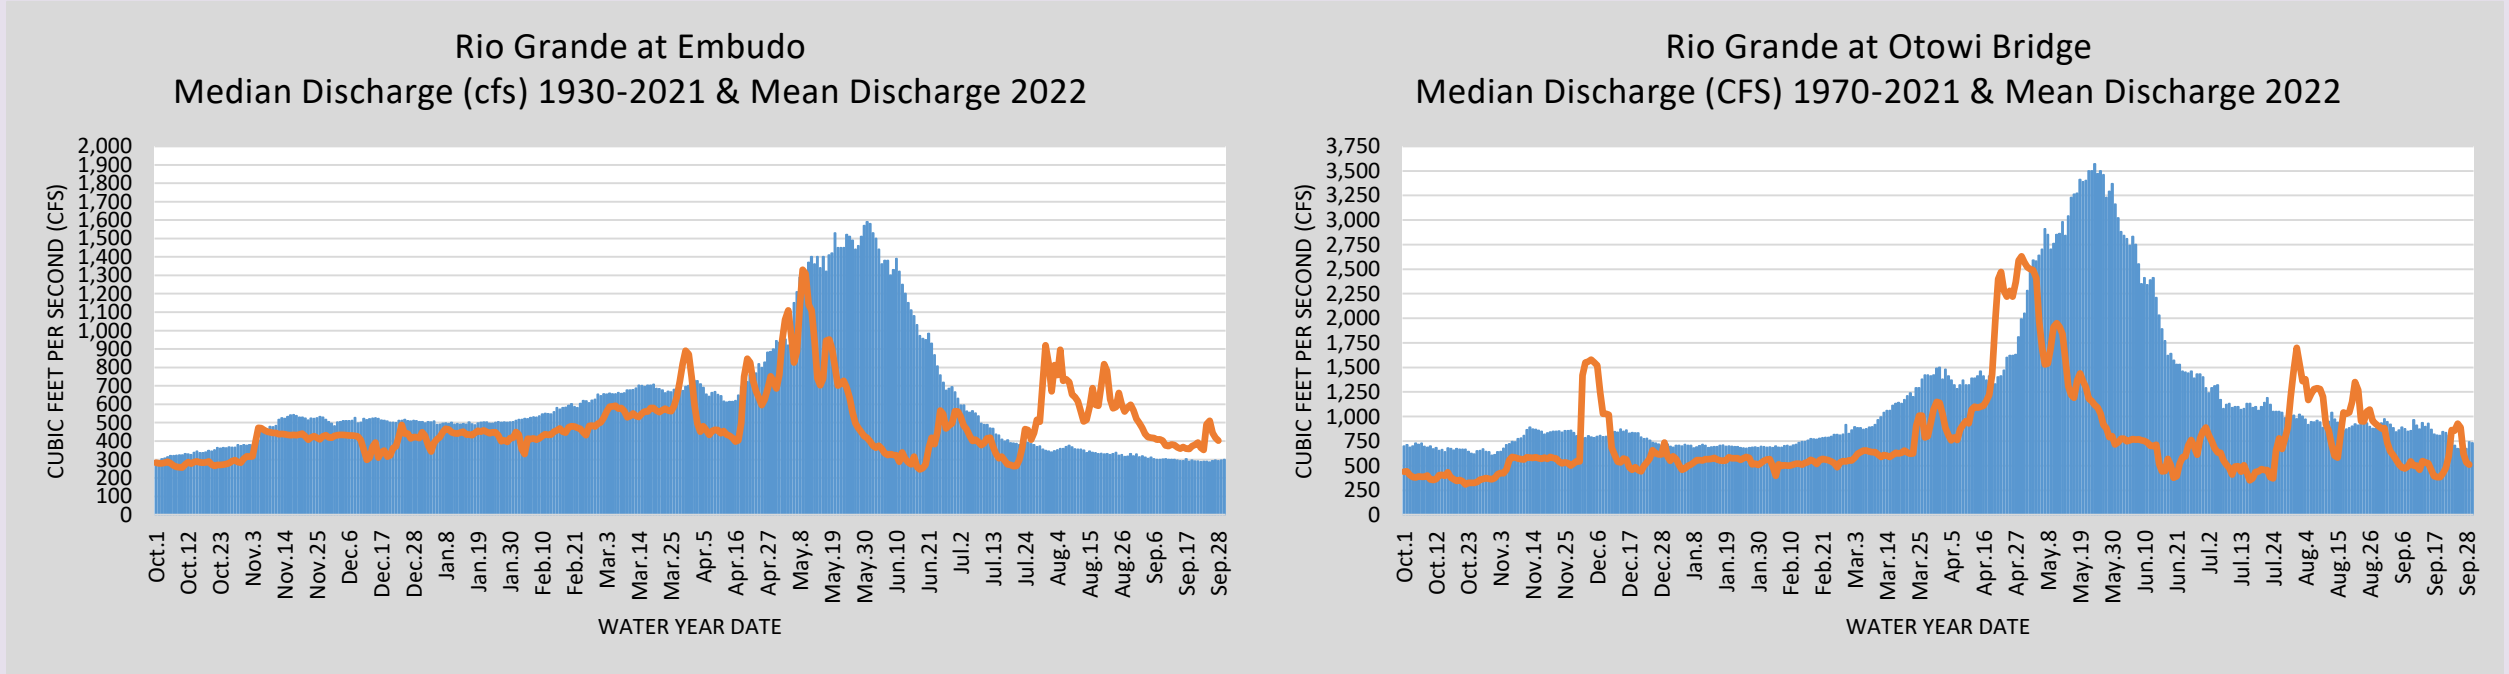
The charts below shows the median daily discharge (shaded blue) at select river gages compared to the 2022 discharge (orange line). The area under the curve is analogous to the overall volume of water passing by the gage throughout the season. A “skinnier” discharge curve like 2022 indicated a much lower volume of water passed by the gage compared to the long-term median. A secondary peak was observed at several gage locations in late July during the heart of the active 2022 monsoon season. The Pecos River runoff during the summer of 2022 far outpaced the lackluster runoff from the spring season. (It is worth noting to pay special attention to the scale of the vertical axis on each chart as the peak discharge varies considerably between the various stations shown on slides 23 and 24.)

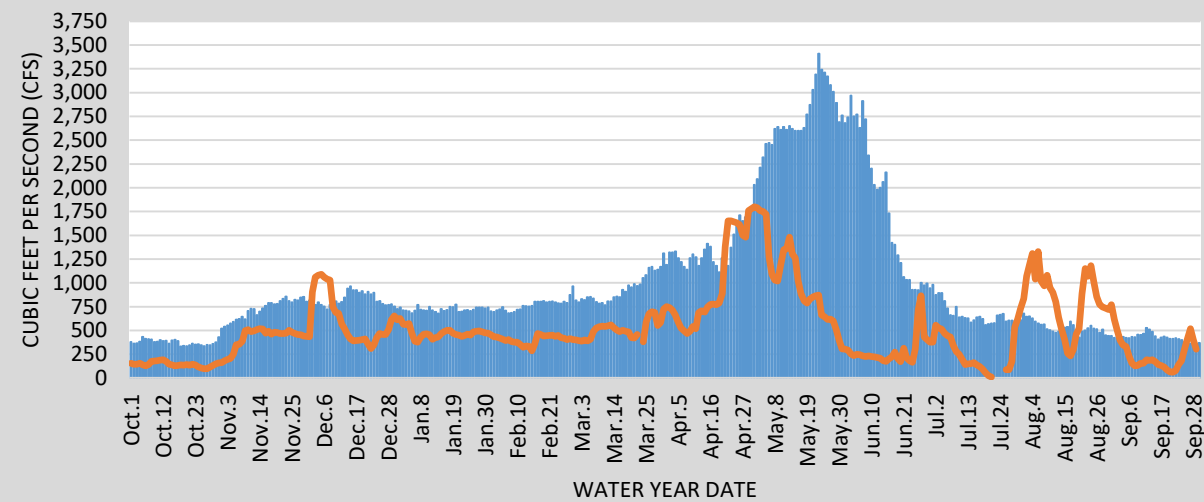
Rio Grande at Albuquerque
Median Discharge (cfs) 1973-2021 & Mean Discharge 2022

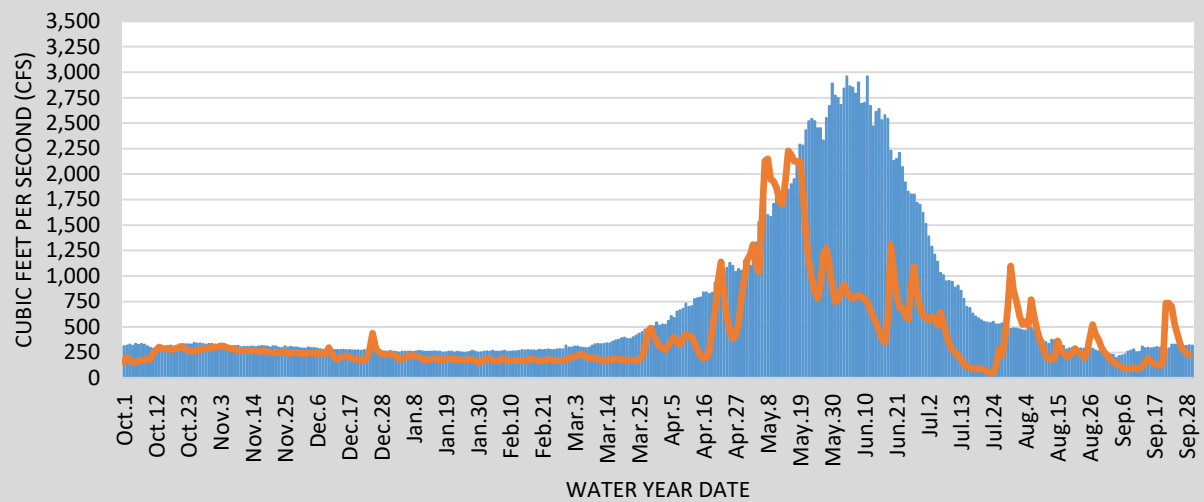
Animas River at Farmington
Median Discharge (CFS) 1913-2020 & Mean Discharge 2022

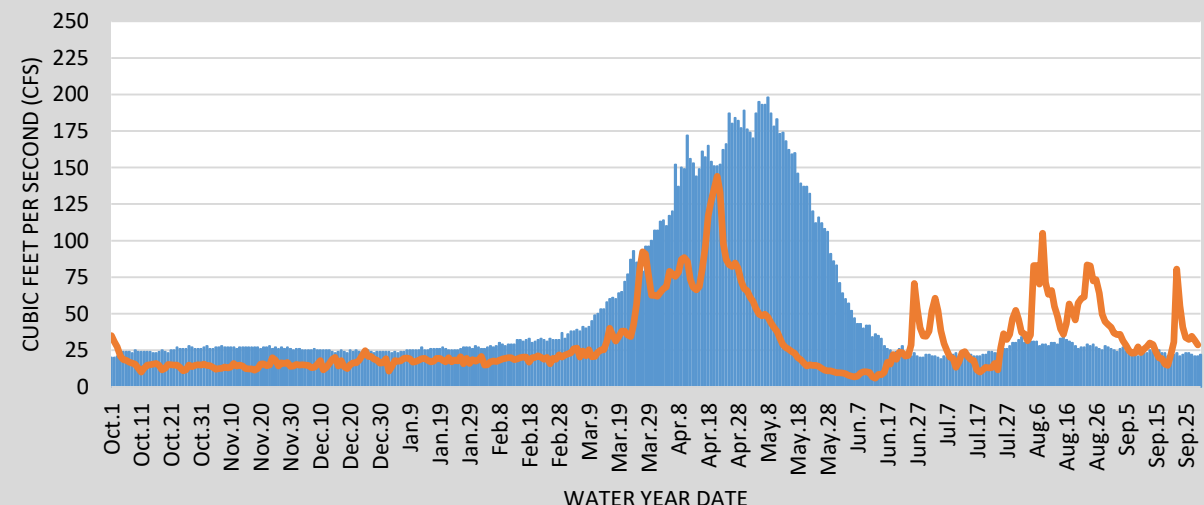
Jemez River near Jemez
Median Discharge (cfs) 1953-2021 & Mean Discharge 2022

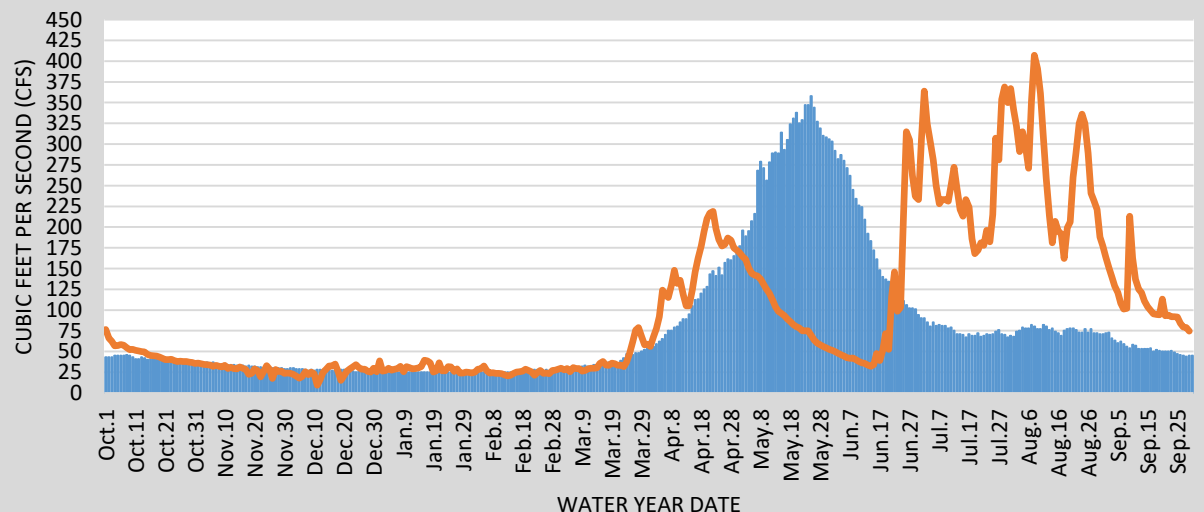
Pecos River near Pecos
Median Discharge (cfs) 1919-2021 & Mean Discharge 2022
