## THREE TORNADOES CONFIRMED FROM MARCH 31, 2017

...EF2 [TORNADO](#) CONFIRMED IN CHESAPEAKE / VIRGINIA BEACH...

...EF1 [TORNADO](#) CONFIRMED SOUTHEAST OF DOWNTOWN SUFFOLK VA...

...EF1 [TORNADO](#) CONFIRMED NEAR POWELLSVILLE IN BERTIE COUNTY [NC](#)...

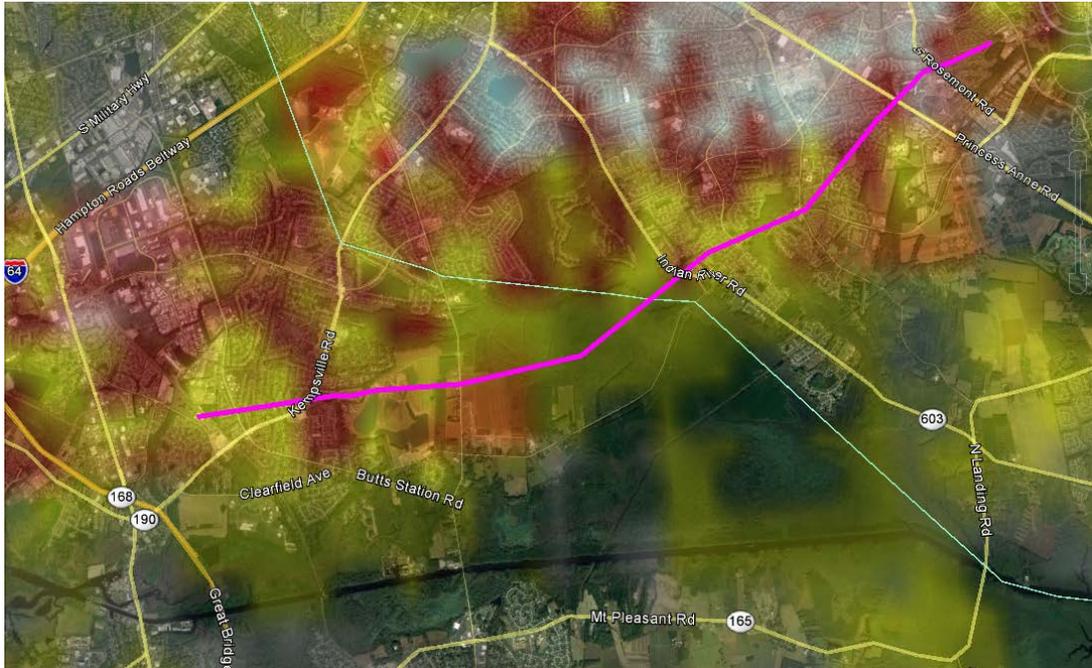
Confirmed EF-1 to EF-2 tornado track (pink) combined with rotational track data from the NEXRAD radar.
