Wolf Creek Flood May 23rd – 25th 2007

Introduction:

This is a report on the new record flooding that occurred along the Wolf Creek in Ochiltree and Lipscomb Counties. The objectives of this report are: 1) Give a brief synoptic overview of what caused the heavy rain event. 2). Chronicle the events that occurred in the Wolf Creek watershed from Ochiltree County downstream through Lipscomb County. 3) Compare this flood event with the flood event of 1996.

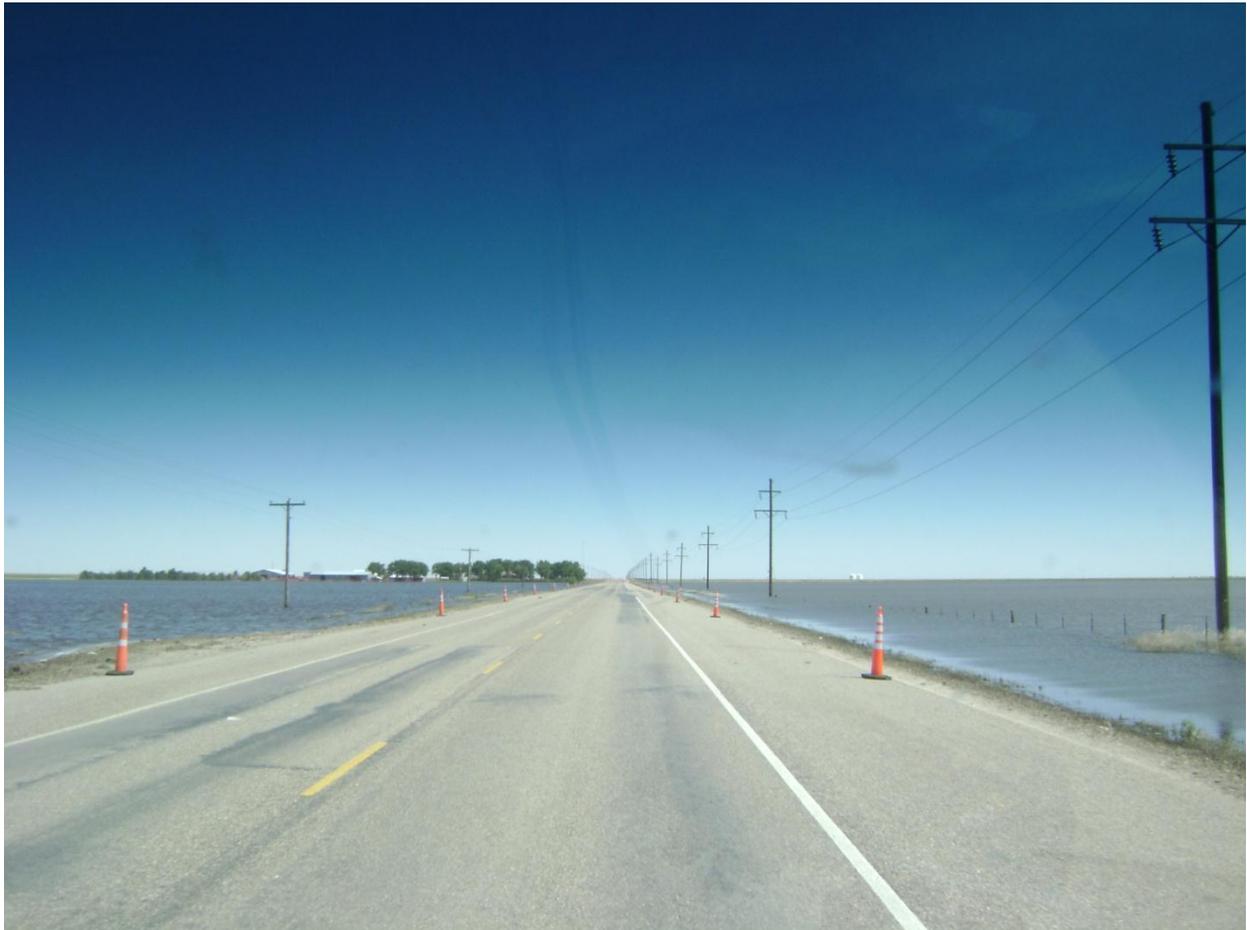
State highway 70 about 15 miles south of Perryton had water covering it.

Two playa lakes merged over Highway 70, closing this road for about 2 weeks.

State highway 70 about 15 miles south of Perryton

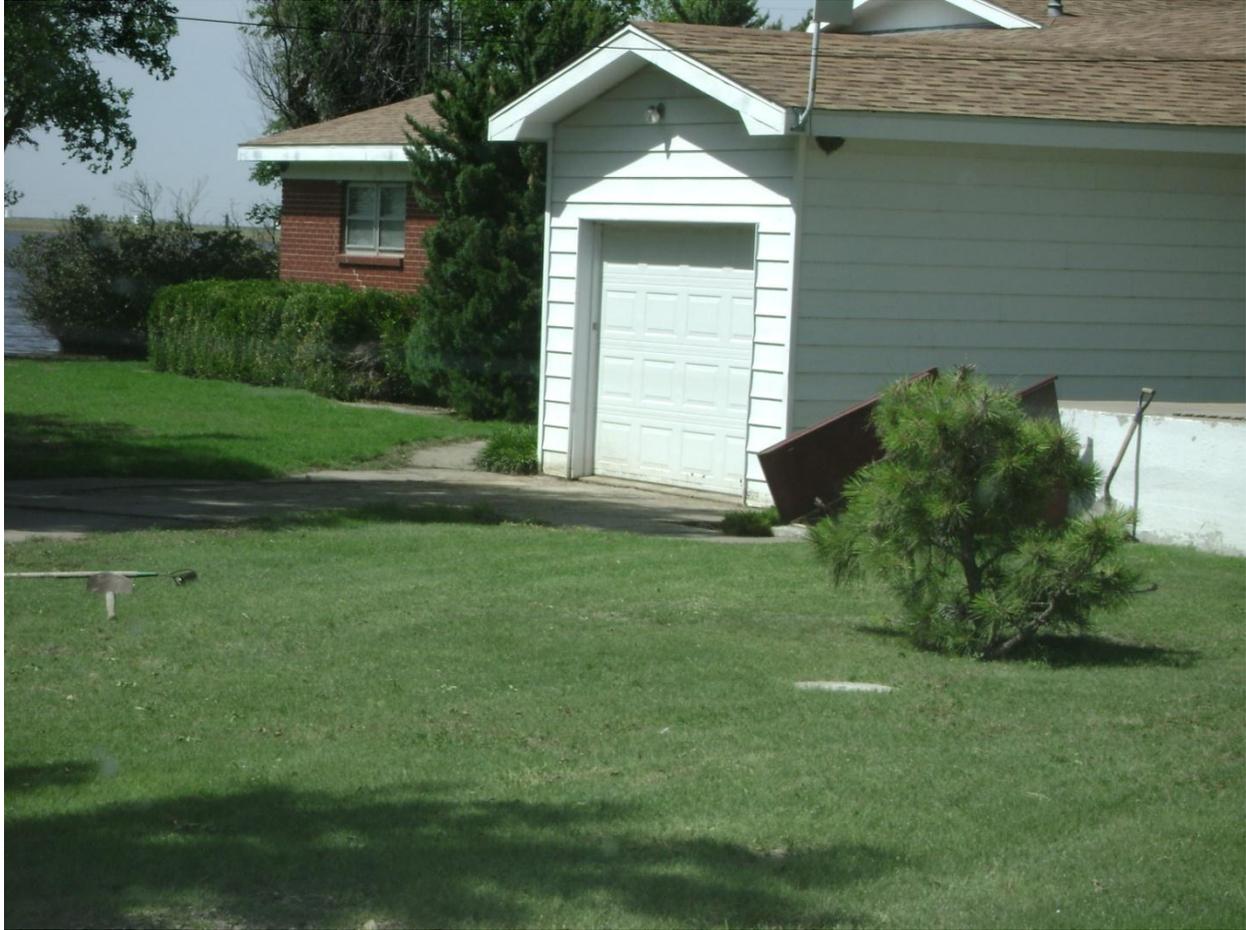
High water mark on garage about one half of a foot up on the door. This farm is located on the north side of the playa lake on the west side of Texas State highway 70 about 15 miles south of Perryton.

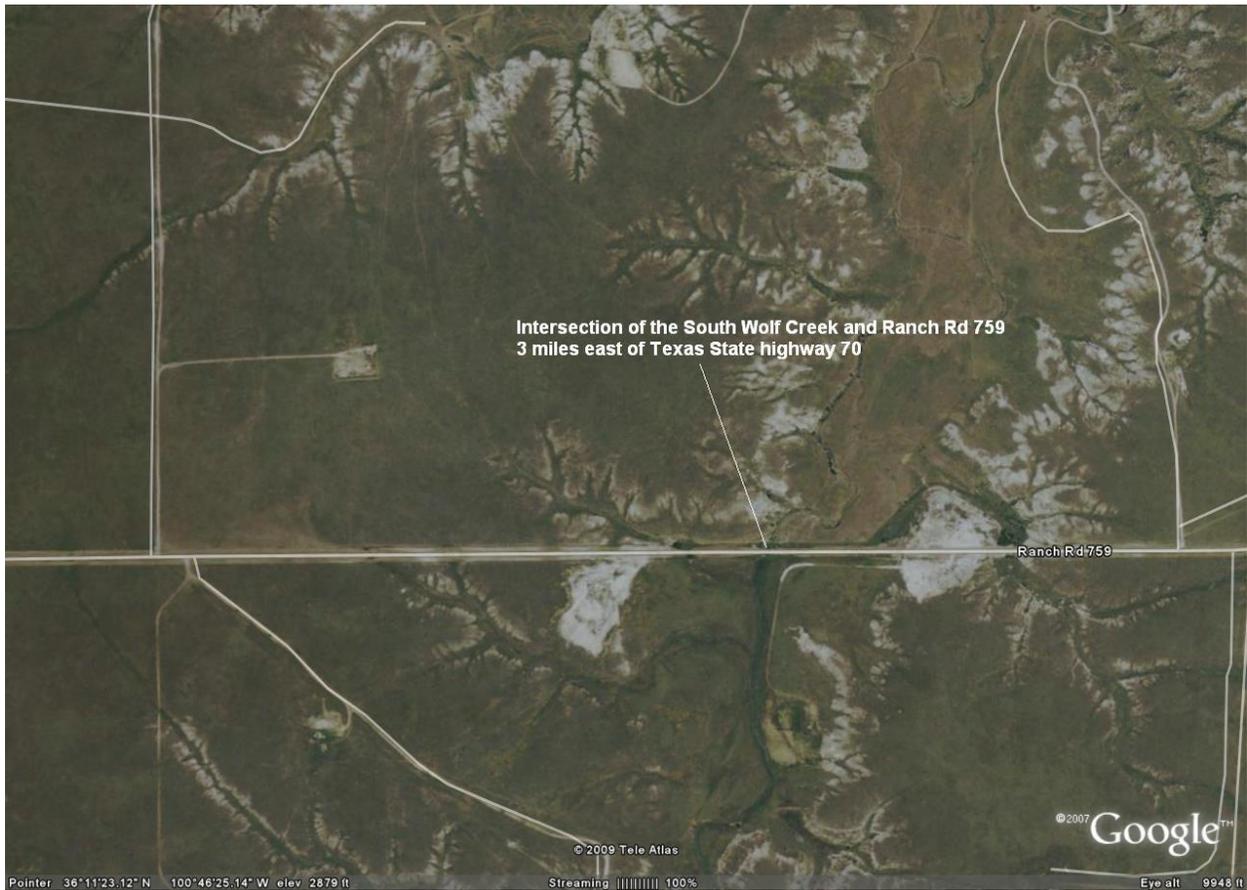
About 4 feet of water was flowing over F.M. road 759 at the south fork of the Wolf Creek, 3 miles east of State Highway 70. The flooding eroded part of F.M. road 759 and it dug out a huge hole on the north side of the road. Dirt was also eroded from around the culverts under the road.

F.M. road 759 at the south fork of the Wolf Creek, 3 miles east of State Highway 70

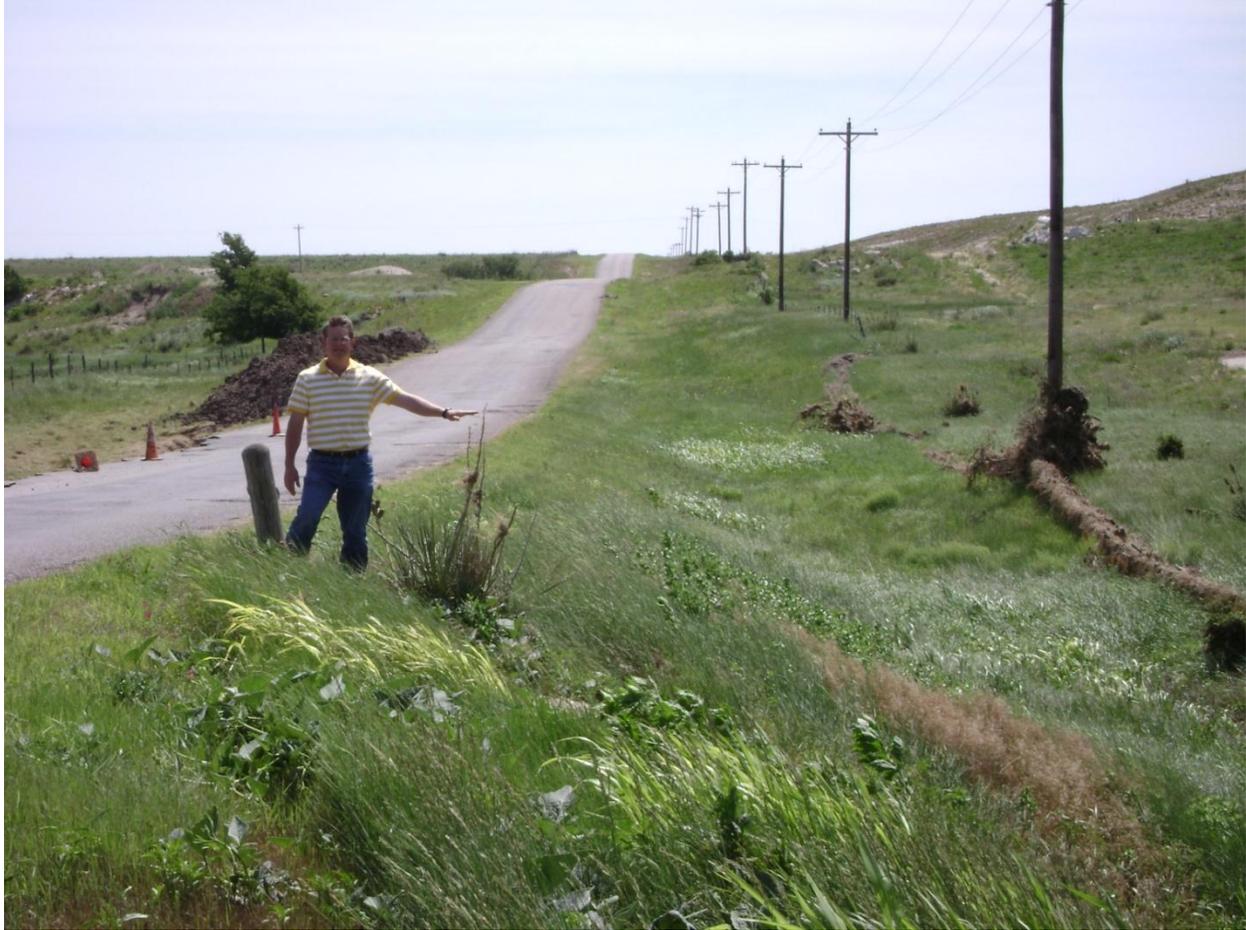
Mr. John Lipe (SH LUB) showing the high water mark on F.M. road 759 at the south fork of the Wolf Creek, 3 miles east of State Highway 70.

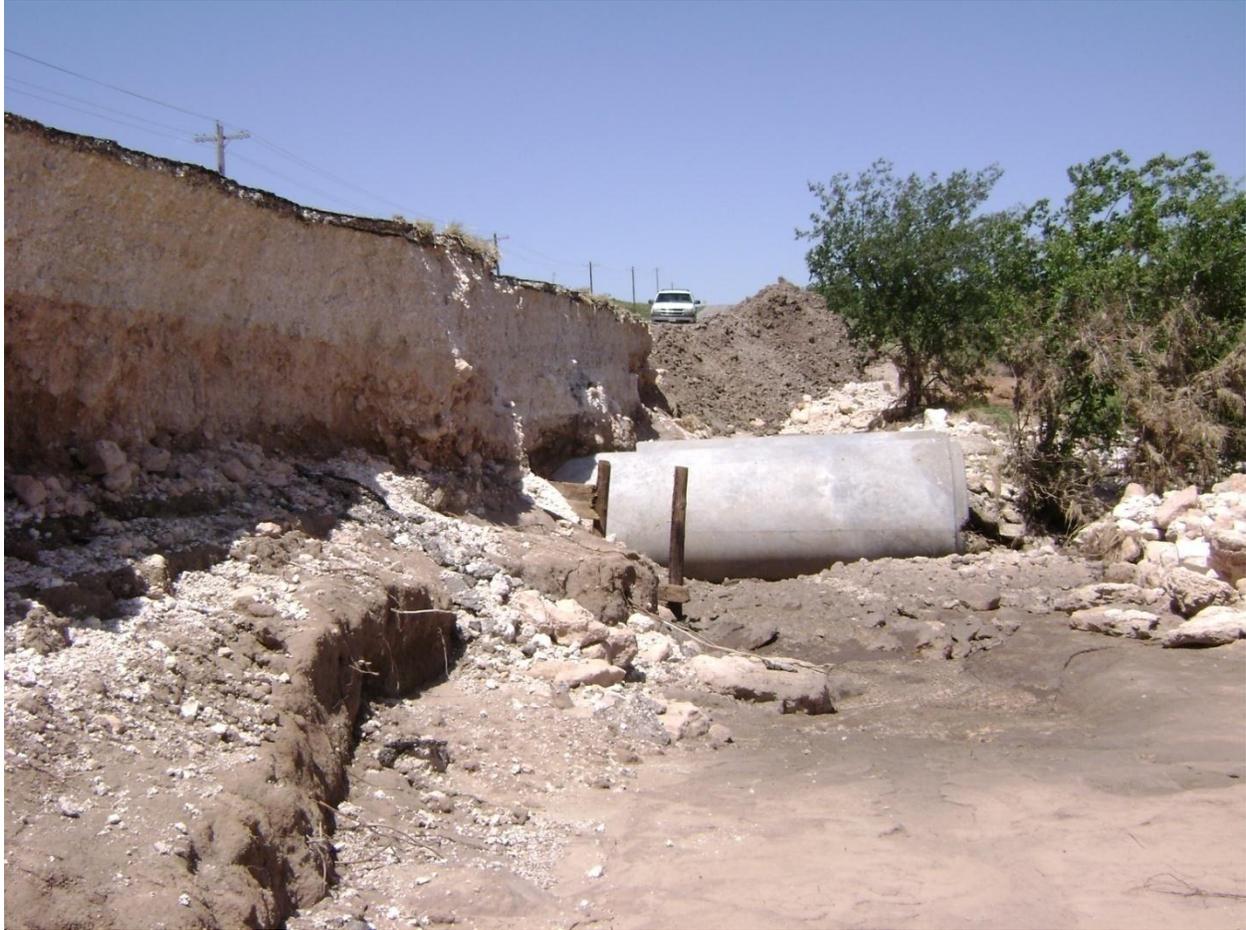
Water washed out the downstream side of F.M. road 759 at the south fork of the Wolf Creek, 3 miles east of State Highway 70.

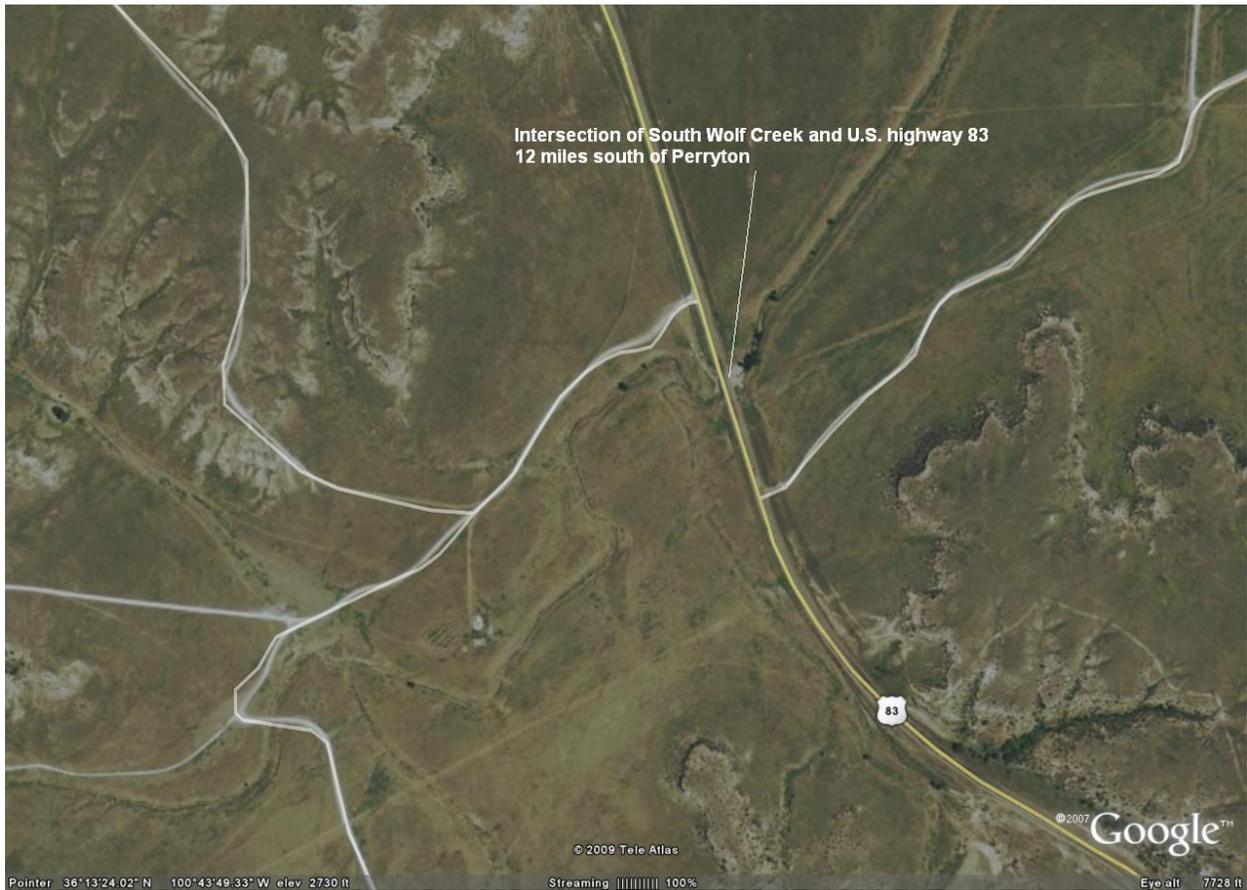
5 feet of water was flowing over U.S. Highway 83 at the south fork of the Wolf Creek, 12 miles south of Perryton. U.S. Highway 83 was closed for over 15 hours due to water flowing over it and then for debris clean up and repair once the water receded. The water eroded about 3 feet of silt and sand from under the highway 83 bridge.

U.S. Highway 83 at the south fork of the Wolf Creek, 12 miles south of Perryton.

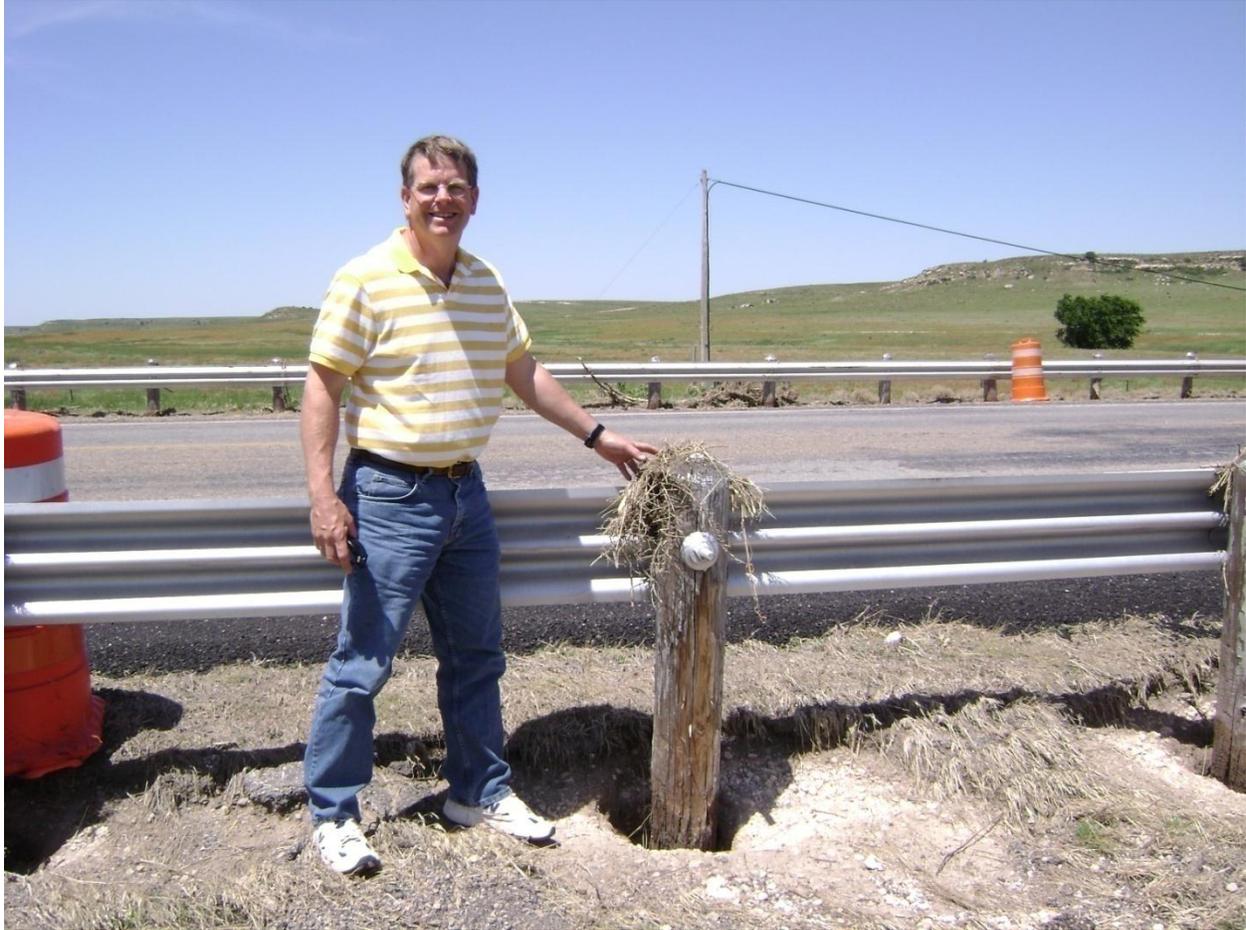
Mr. John Lipe (SH LUB) showing the high water mark where U.S. Highway 83 crosses the south fork of the Wolf Creek, 12 miles south of Perryton.

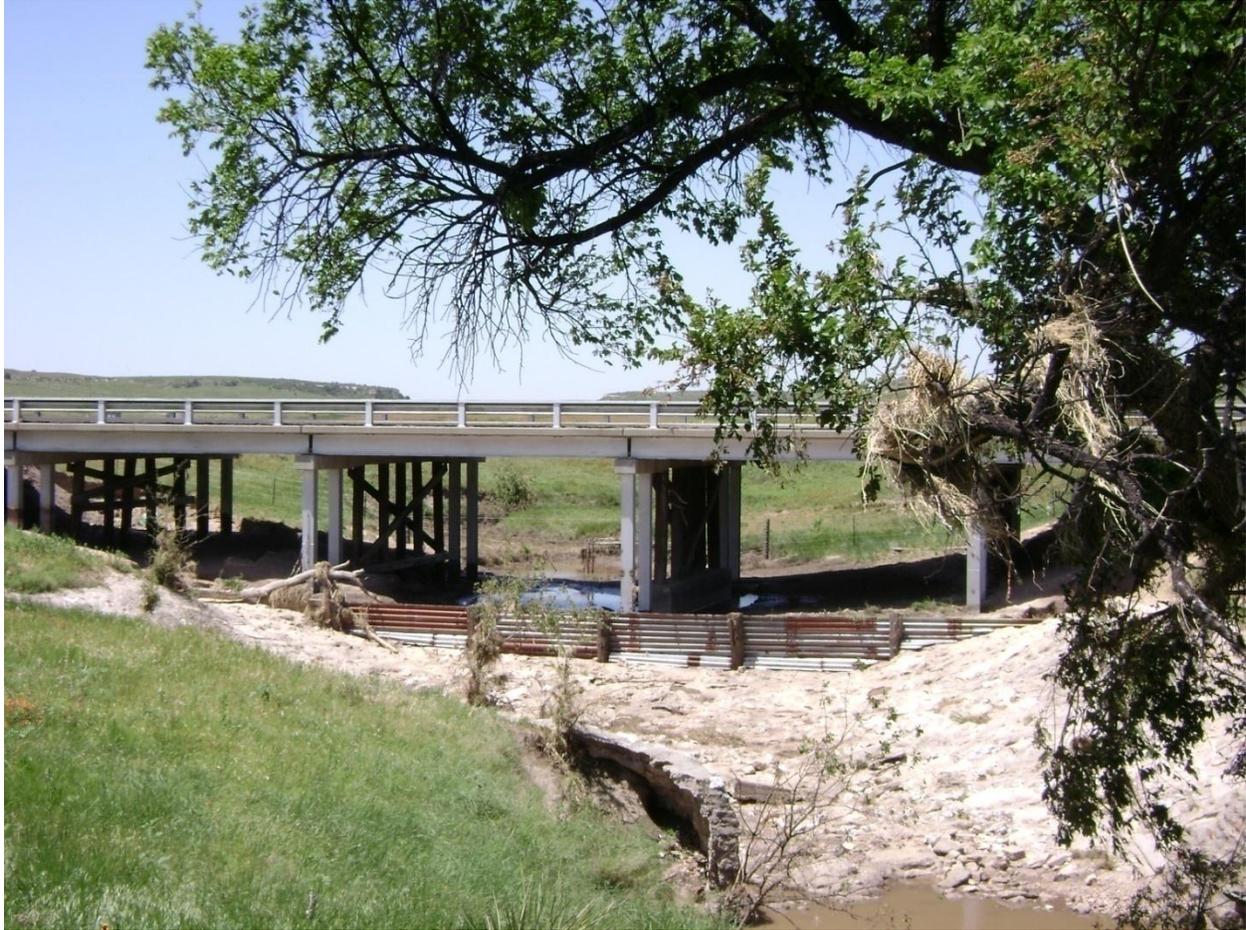
U.S. Highway 83 bridge at the south fork of the Wolf Creek, 12 miles south of Perryton (looking upstream (west)).

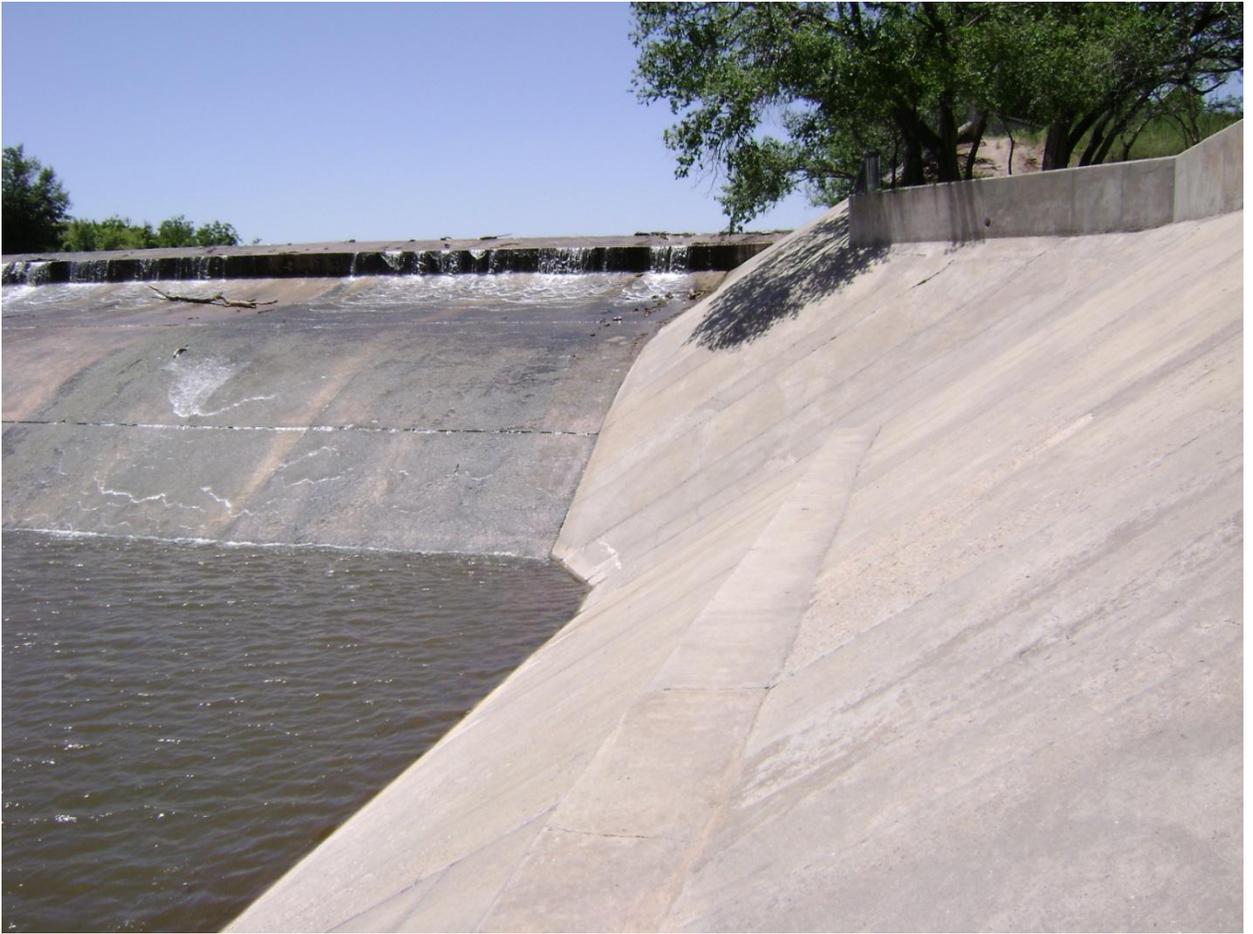
Water began going over the spillway at Lake Fryer at 9:00 pm on the 23rd. The flood crested around 3:00 am on the 24th with an estimated 11 feet of water going over the spillway. Water reached the top of the concrete structure on either side of the spillway. Water was 2 feet above the ledge that runs parallel to the creek on the concrete wall that forms the sides of the spillway below the outlet from the lake. This ledge is located on the north side of the spillway structure.

Below the spillway at Lake Fryer at Wolf Creek Park.

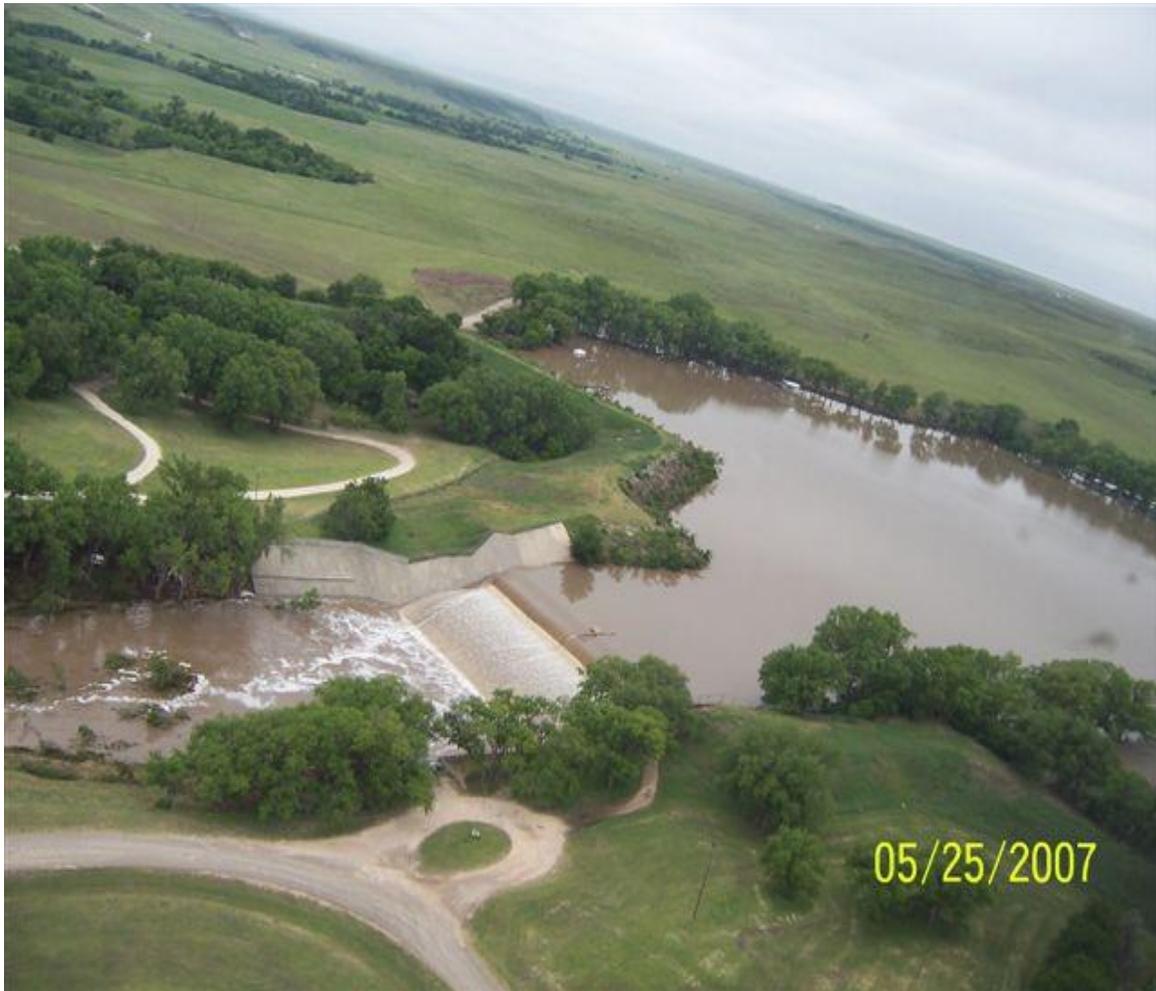
Following a post storm survey, it appeared that water almost went all the way around the dam both on the north and south sides. Flood waters also reached the floor of the bath house just to the north of the spillway.

Aerial view of Lake Fryer at Wolf Creek Park in Ochiltree County. Photo courtesy of Ochiltree county Sheriff.

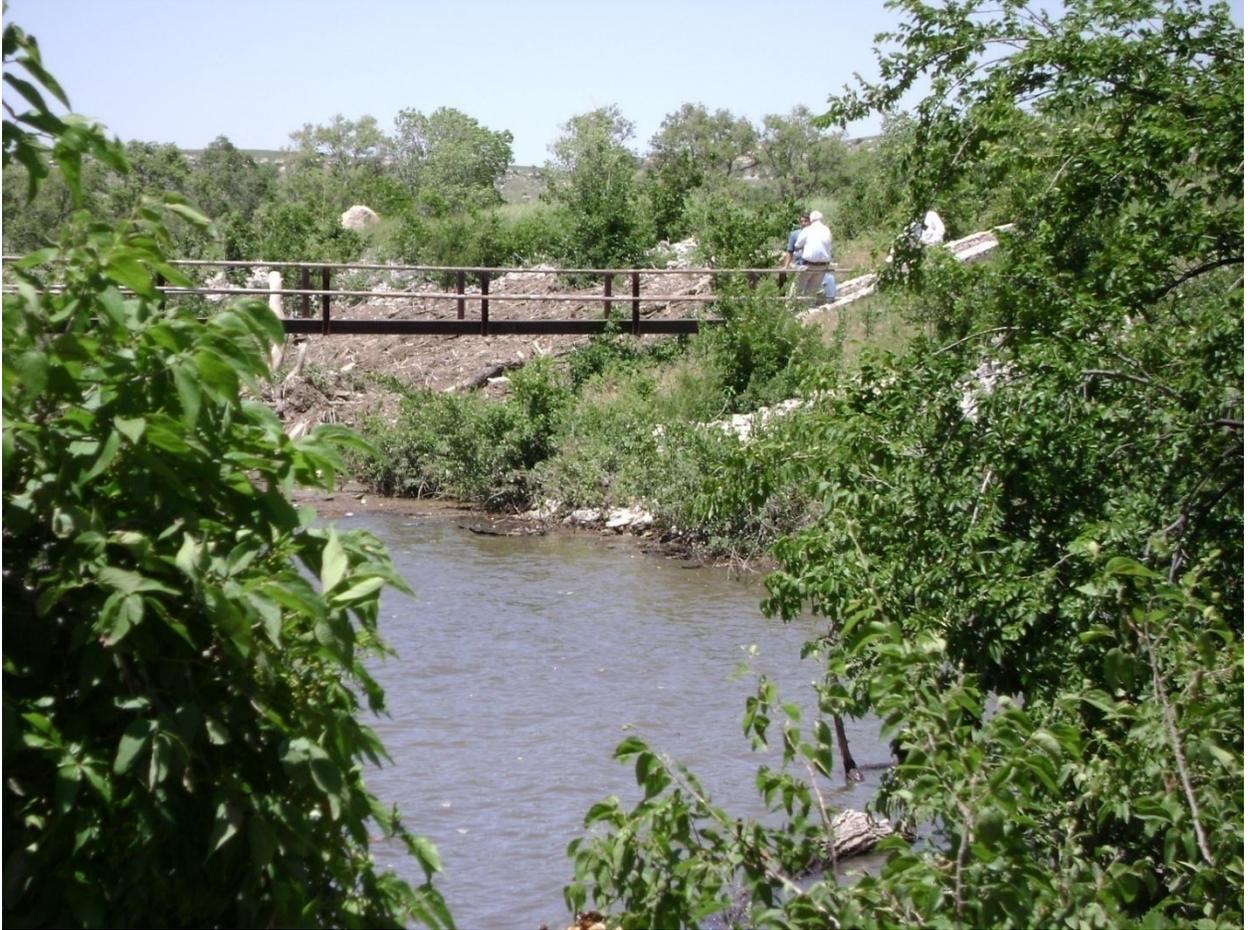
Bridge out to the intake structure at Lake Fryer at Wolf Creek Park.

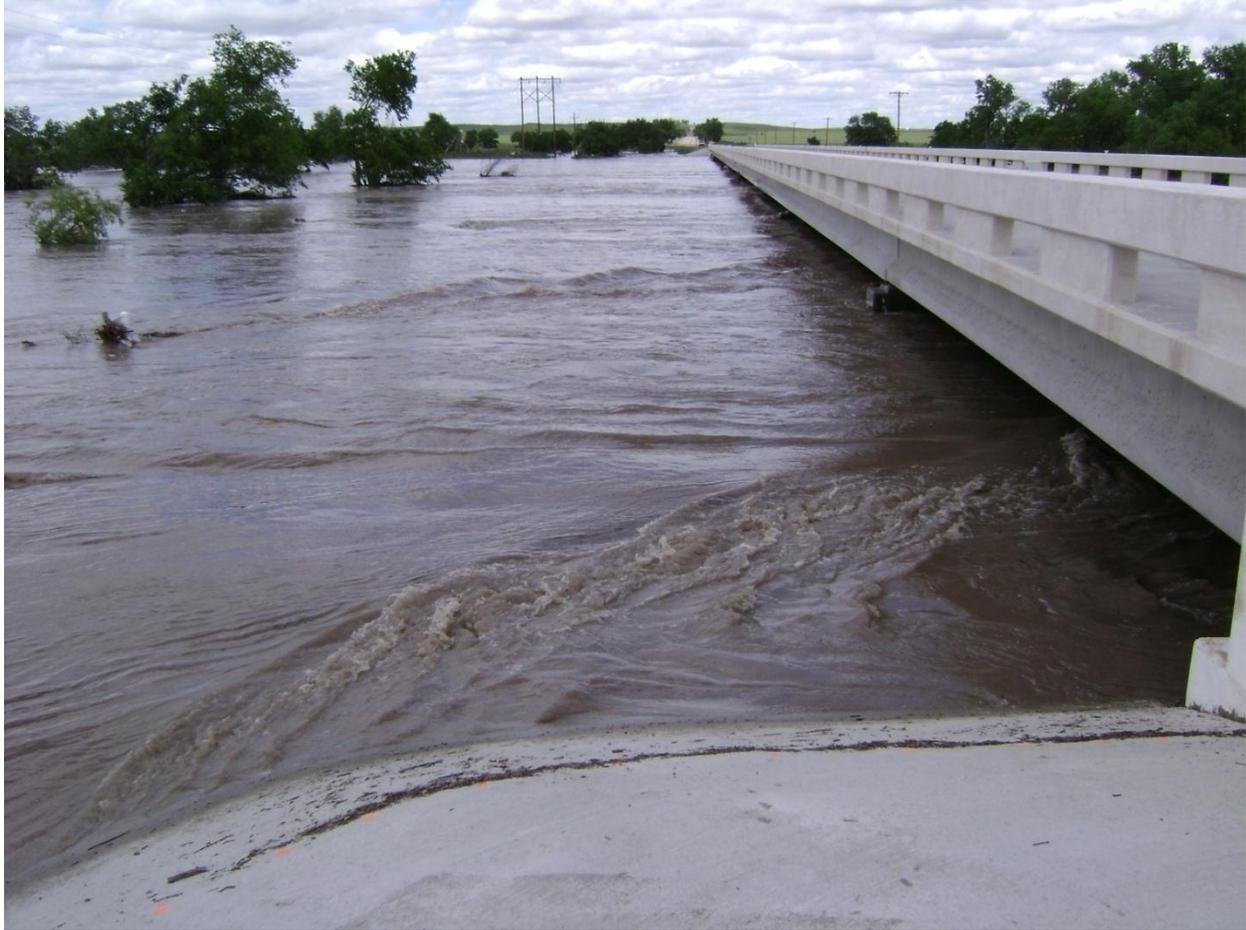
Water made it to the bottom of the bridge deck (hwy 305), but never crossed the bridge at Lipscomb.

Wolf Creek at the Texas State highway 305 bridge at Lipscomb. Looking north along the upstream side of the bridge. Note the high water mark on the bridge abutment.

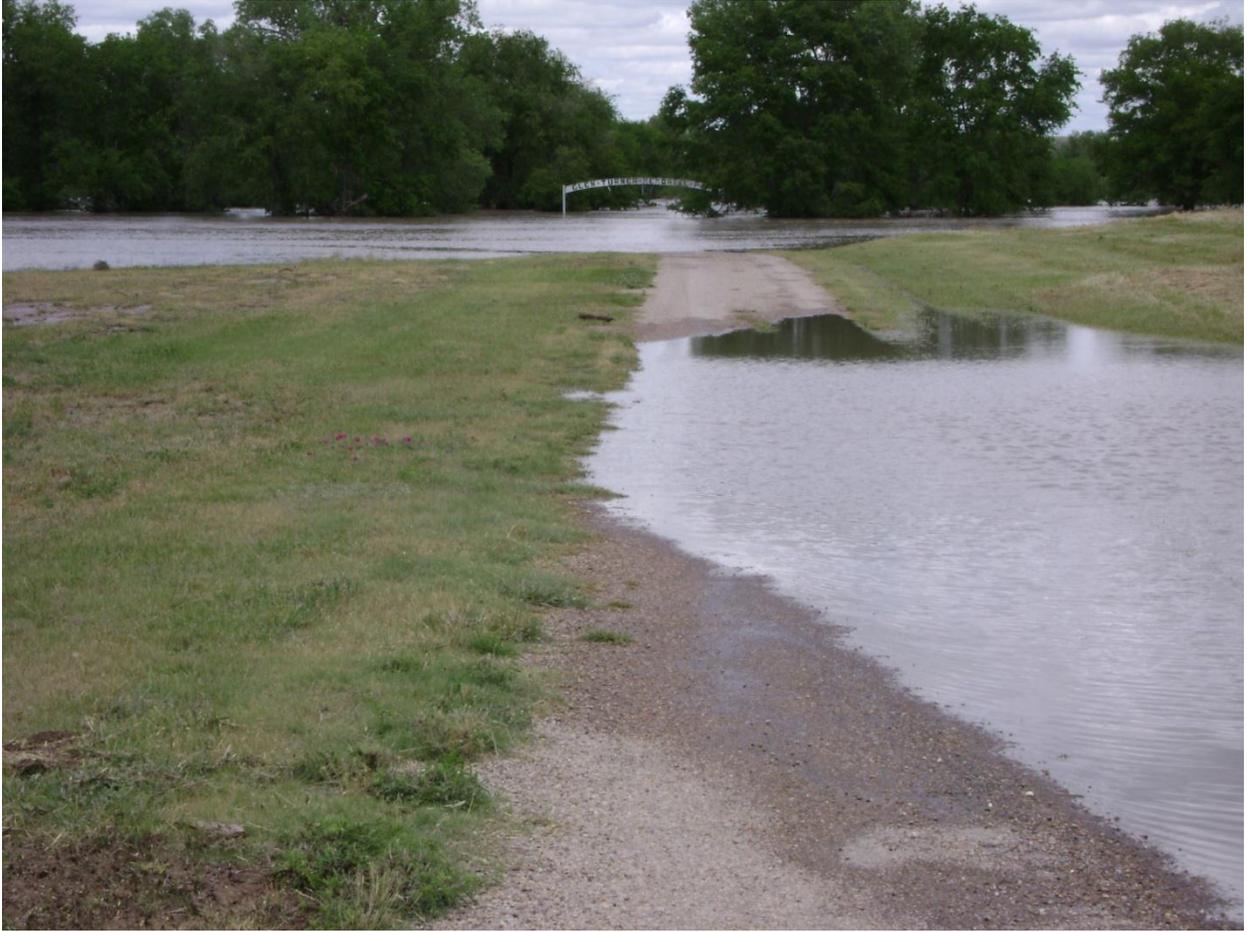
Glen Turner Memorial Park had 5 to 6 feet of water covering it during the peak of the flood. A few homes on the northeast side and a few miles east of Lipscomb had water surrounding them. It is unclear if any of these homes sustained damage. Water was

Glen Turner Memorial Park on the northeast edge of Lipscomb, TX.

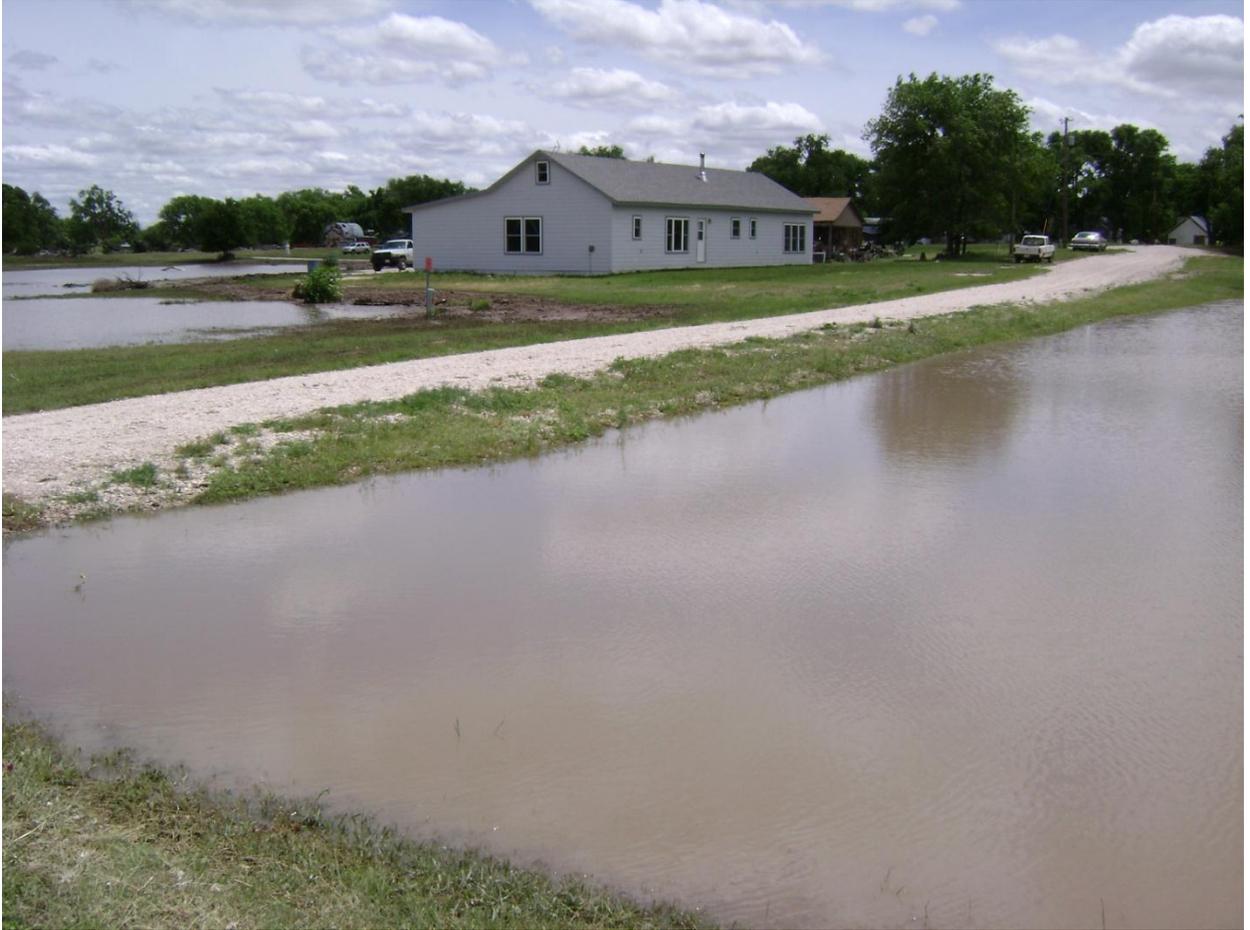
The water got up to within 3 feet of a blue home just to the southwest of Glen Turner Memorial Park.

Blue home in northeast Lipscomb, TX.

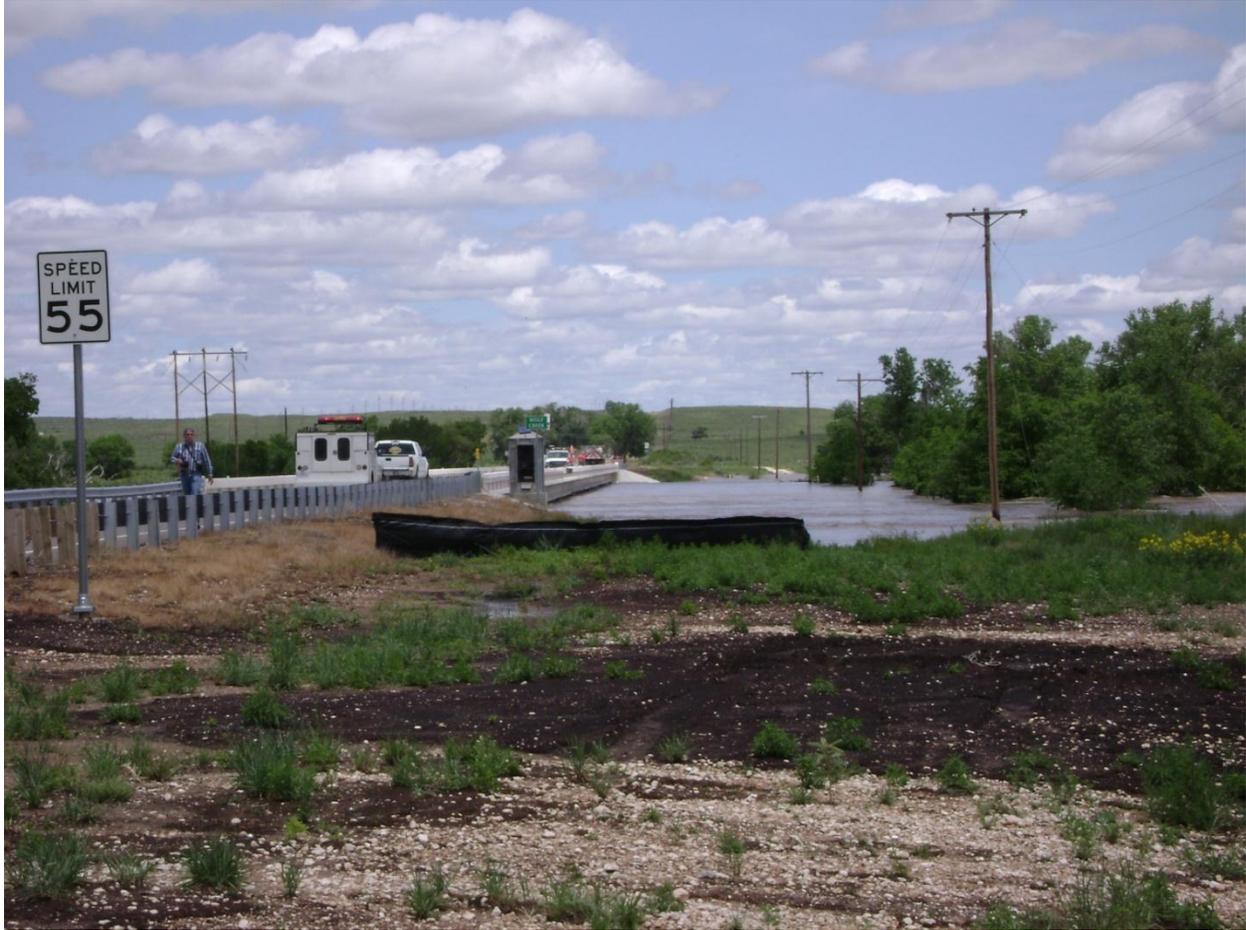
The creek was about $\frac{1}{4}$ of a mile wide at Lipscomb. The bridge across the creek is about 300 yards long. Water was confined under the bridge, but the creek spread out both upstream and downstream of the bridge.

Wolf Creek at Texas State highway 305 at Lipscomb, TX (looking north at the downstream side of bridge).
