End of 2006 Open Water Season  
 August Flooding in Southcentral Alaska  
**Anchorage HSA Report**  
 Cordova Flood Assessment  
**Fairbanks HSA Report**  
 New River Observers in Northwest Alaska  
 Richardson Highway Hit Hard by Flooding  
**Special Reports**  
 Extratropical Storms in Alaska  
 High Water Level Reference Levels  
**Back Page**  
 Start of Ice Thickness Measurements  
 Welcome New Observers

**Alaska - Pacific  
 River Forecast Center**  
 6930 Sand Lake Road  
 Anchorage, Alaska 99502-1845  
<http://aprfc.arh.noaa.gov>  
 800-847-1739

## August Flooding in Southcentral Alaska

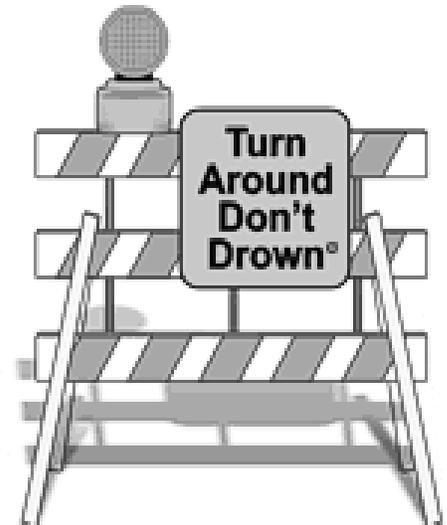
the area. At least two houses were washed away, and an estimated 300 homes were flooded. Eleven homes were evacuated by dive teams in boats and rafts. Road washouts and closures or deteriorated road conditions were reported on bridges over Moose Creek and Montana Creek and numerous roads in the communities of Willow, Houston, Wasilla, Trappers Creek, and Talkeetna. At least 16 bridges in Mat-Su Borough required repair or safety inspections before being used. Additional small lows moved across southcentral Alaska during the next several days. These kept stream levels high and prolonged the flooding in many areas. The Governor of Alaska issued a disaster declaration for the flooded areas. (See maps of impacted areas at left).

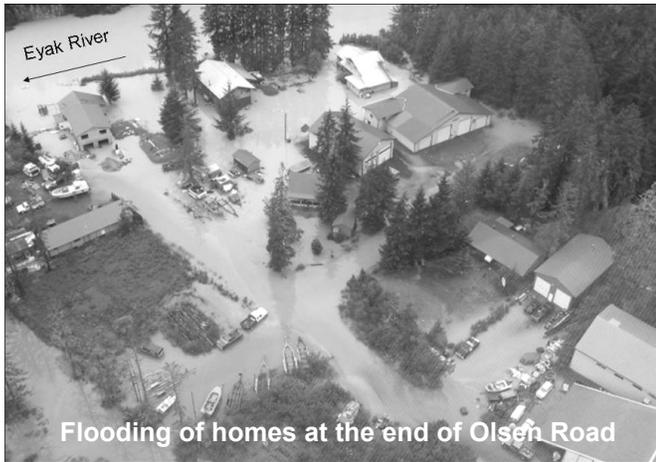
Flooding of homes at the end of Olsen Road

Eric and Scott spoke with town officials and residents about the flood's impacts in and around Eyak Lake and Eyak River. Many residences on the lake and along the river had their basements and crawlspaces flooded, as the water levels were over the river banks and a couple of feet above the lake's normal level. Flooding along the lake shore led to portions of Power Creek Road to wash out because of high lake levels and waves, and caused the municipal airport to close since its runways were underwater. Many locals observed that although the flooding was fairly severe, water levels were not as high as they were during the 1981 flood event. By the 24<sup>th</sup> the waters had receded and flooding was confined to yards and no structures were underwater.

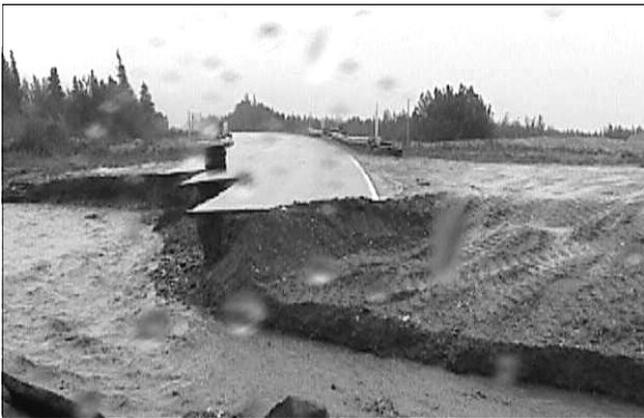
Several heavy rain events in the Alaska Range over the summer resulted in some significant flooding along the Richardson Highway. Over a three day period in mid-June, between 4 to 7 inches of rain fell from Delta Junction to Paxson. Flash flooding of small streams spread debris over the road and completely washed it out in several locations. More rain a few days later brought streams to bankfull again and pushed more water across the highway. More heavy rain in August resulted in another round of flooding and mudslides along the highway.

Richardson Hwy washed out south of Delta Junction

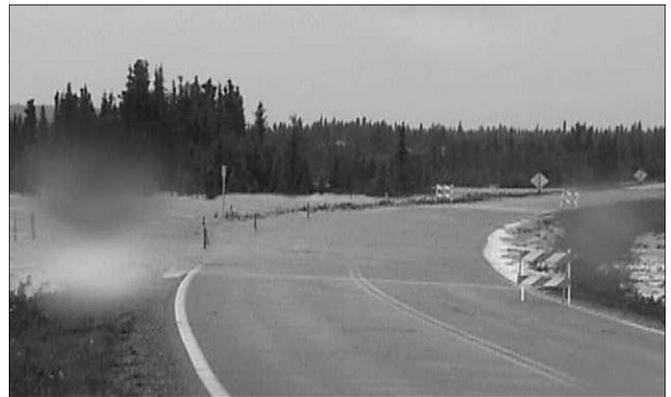
Water flows over the Richardson Hwy at Donnelly Creek State Recreation Site

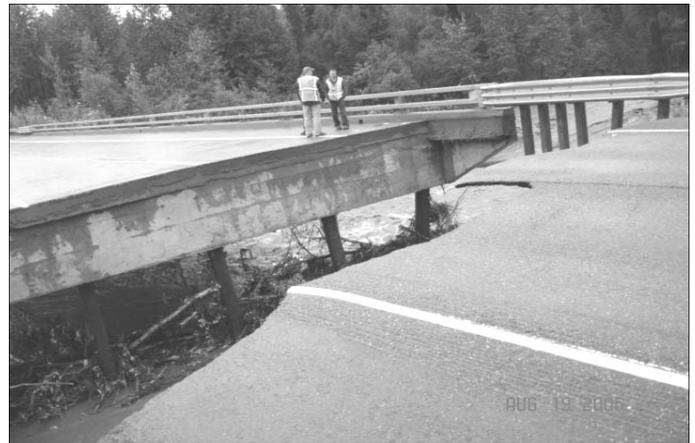
Washed out approach to bridge over  
Troublesome Creek  
on the Parks Hwy  
August 2006

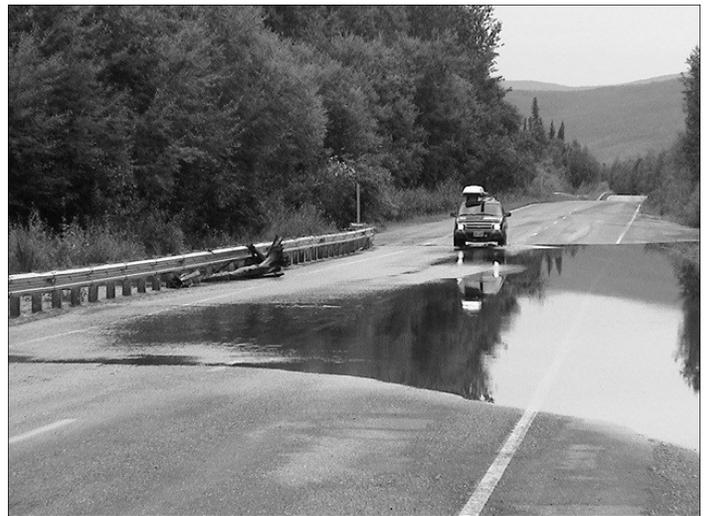
**Minor Flooding** is defined to have minimal or no property damage, but possibly some public threat. In remote areas with few specific impacts, floods with 5-10 year recurrence interval would be assumed to be causing minor flooding on streams in the area. Examples of conditions that would be considered minor flooding include:

Minor flooding at Mile 31 of Chena Hot Springs Road in Fairbanks August 2003

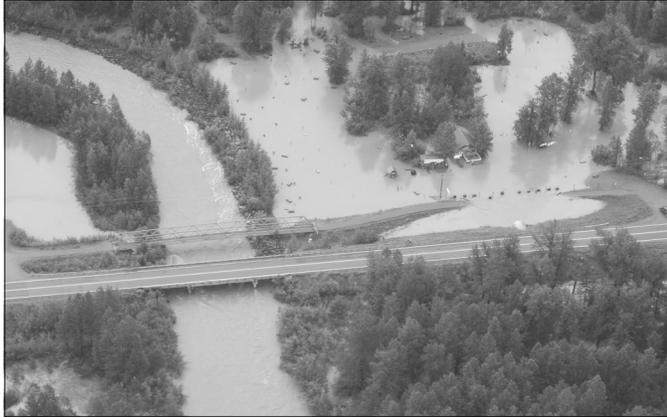
**Moderate Flooding** is defined to have some inundation of structures and roads near the stream. Some evacuations of people and/or transfer of property to higher elevations may be necessary. In remote areas with few specific impacts, floods with 15-40 year recurrence interval would be assumed to be causing moderate flooding on streams in the area. Examples of conditions that would be considered moderate flooding include:

Water inundates the Montana Creek Campground located off the Parks Highway - an example of moderate flooding August 2006

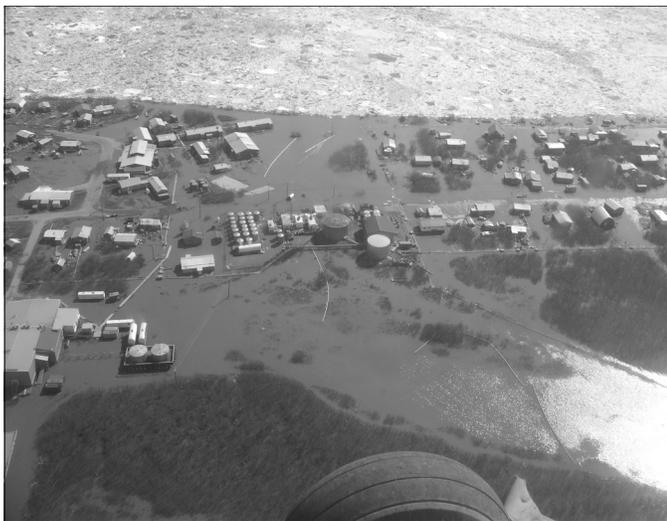
Moderate flooding in the village of Emmonak on the Yukon River May 2006

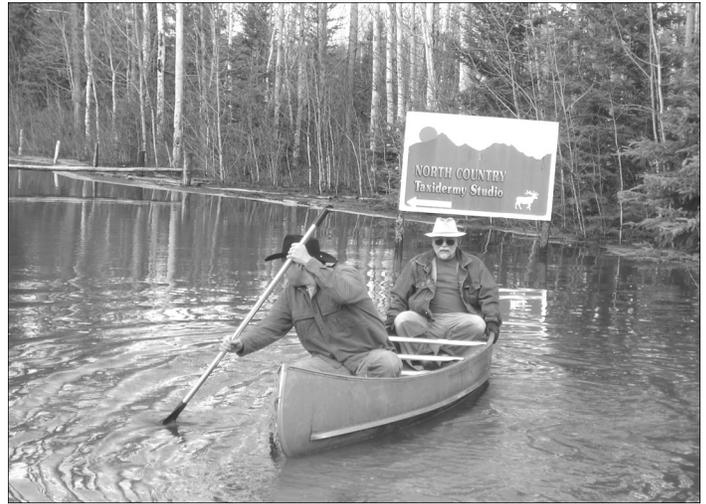
For several days, Delta residents traveled by canoe in order to reach their homes May 2004

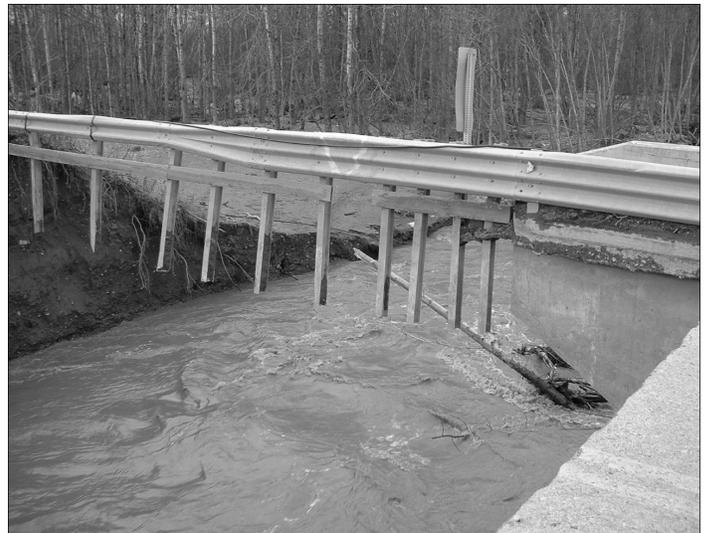
**Major Flooding** is defined to have extensive inundation of structures and roads. Significant evacuations of people and/or transfer of property to higher elevations are necessary. In remote areas with few specific impacts, floods with 50-100 year recurrence interval would be assumed to be causing major flooding on streams in the area. Examples of conditions that would be considered major flooding include:

Bridge washed out over Deep Creek due to heavy rains October 2002

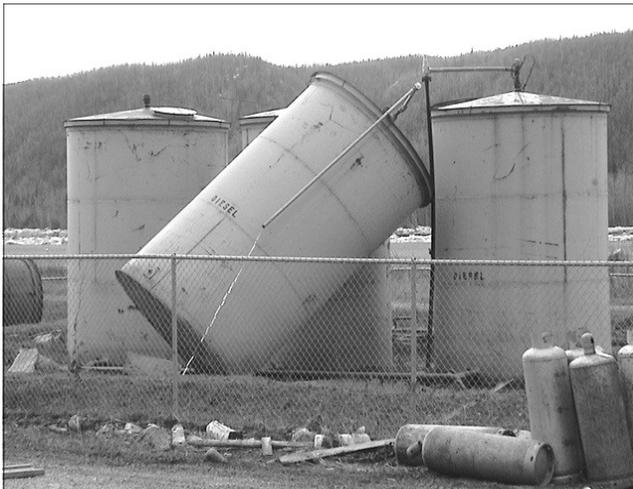
Fuel tank topples due to breakup related flooding in the village of Hughes on the Koyukuk River  
May 2003

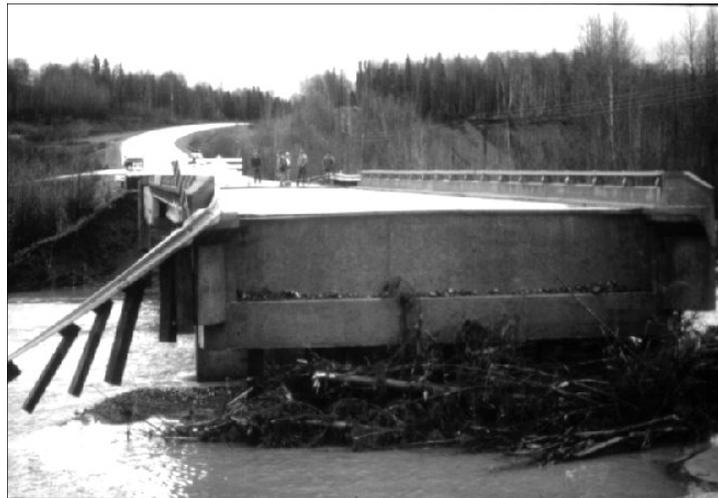
The approach to the bridge over Montana Creek on the Parks Highway washed out  
October 1986
