# Kuigmek: one who watches the river

December, 2018

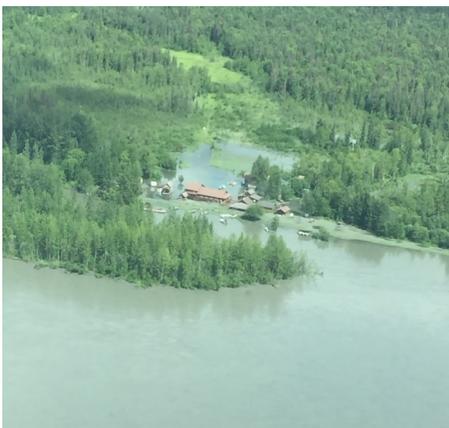
Figure 3: 2018 flooding on Yentna near Lake Creek. Photo credit: Don Bolton, NWS

Consistent heavy rain led to high water on the Yentna and Skwentna Rivers in mid-June, with flooding in some locations. The picture here is flooding at a fishing lodge on the Yentna River near Lake Creek. The headwaters of the Skwentna and Yentna Rivers begin in the southwestern Alaska Range, and are known as the Yentna River after they come together. The Yentna joins the Susitna River just before it empties into Cook Inlet. There are quite a few lodges in the area where Lake Creek meets the Yentna because the clarity of Lake Creek's water makes it ideal for fishing. The downside to the river proximity for these lodges is their vulnerability to flooding. The Skwentna area also has a number of individual homes and recreational cabins, but we had few reports of impacts to buildings up on the Skwentna. Some local aircraft landing strips were inundated and a layer of silt was left behind. Thanks to our observers out there (Cyndie Abbot and Steve Childs) and everyone who called in to report impacts. The Yentna gage was the third most looked at gage on our website this summer.

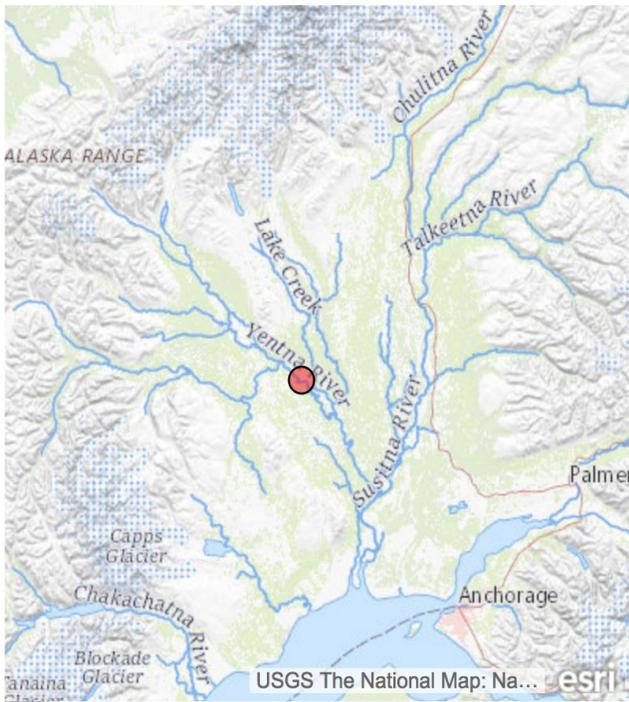
Figure 4: location of slope gage on the Yentna River near Lake Creek. National Weather Service at [weather.gov/apr/c](http://weather.gov/apr/c)

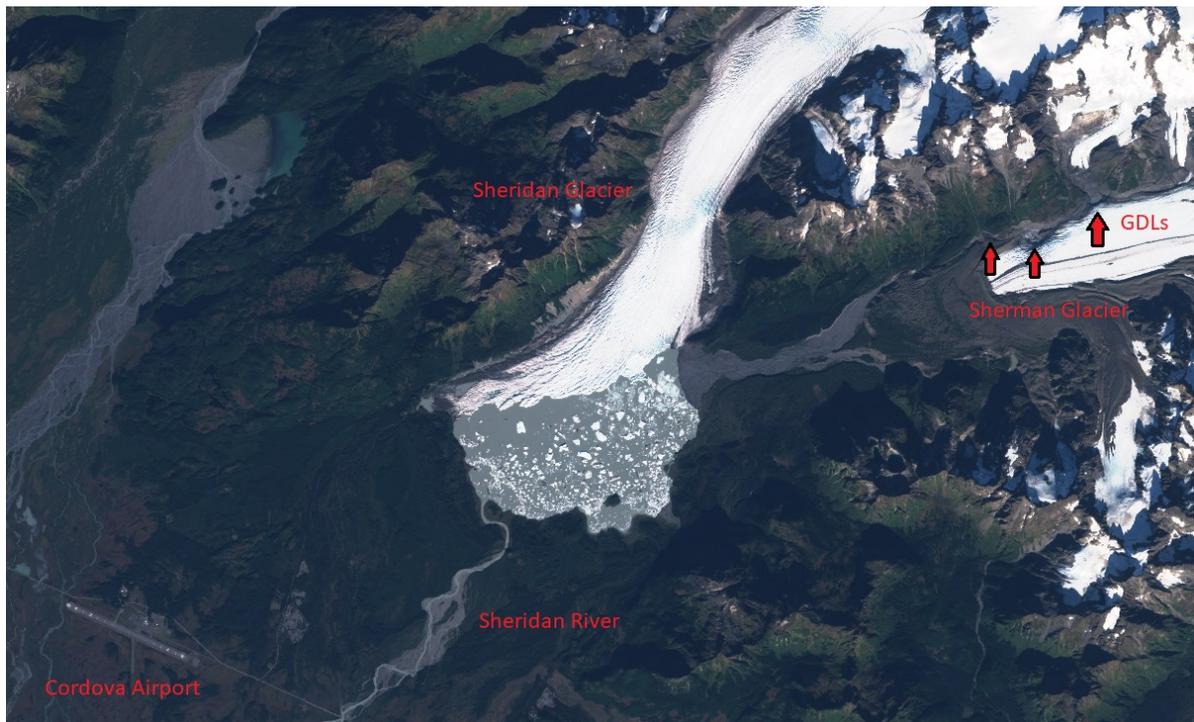
Figure 5: Sentinel-2 multi-spectral satellite imagery shows a series of glacial dammed lakes on Sherman Glacier. When one of these lakes lets go, the water ends up in the Sheridan River near Cordova.

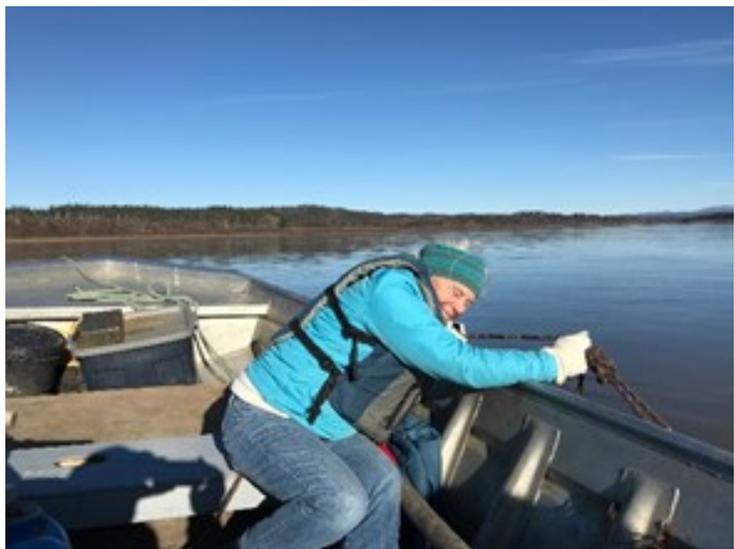
*Figure 8: NWS Service Hydrologist Karen Endres making a river discharge measurement from a boat. Photo credit: Eric Holloway.*

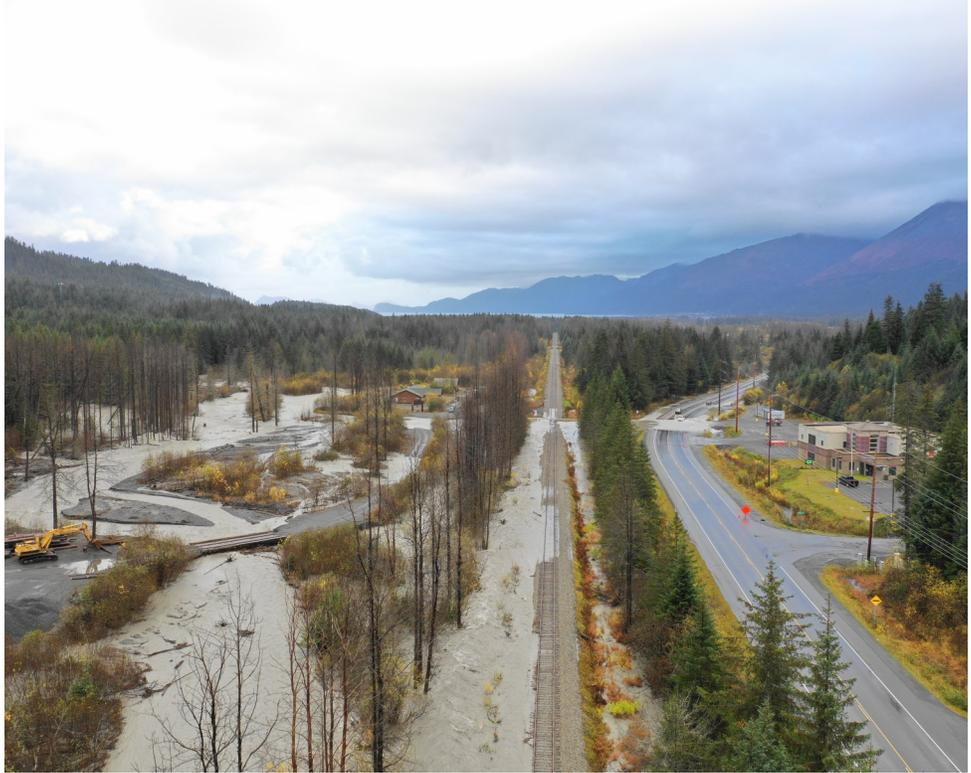
*Figure 10: heavy equipment is helping preserve this bridge near Seward by removing gravel from the streambed as it's washed down by heavy rain. Photo courtesy of Alaska DOT&PF.*

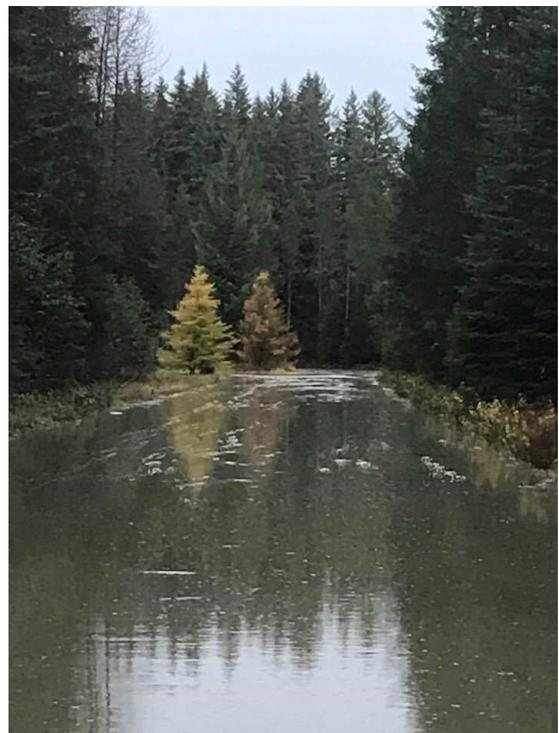
*Figure 12: October, 2018 flooding of Wilson Rd and Rink Creek area in Gustavus, AK. Photo: NWS Spotter Deb Woodruff*
