Mike Castillo, Alfredo Vega, Barry S. Goldsmith, and Jeral Estupinan
NOAA/National Weather Service Brownsville, TX

Abstract

Anatomy of a controlled flood

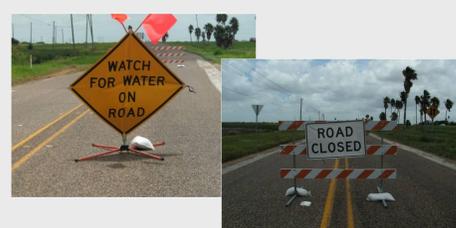
Many Roads were Closed in Hidalgo and Cameron Counties Due to Water in the Floodways

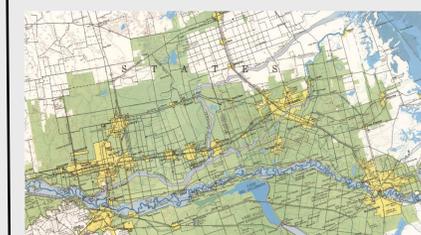
Diversion Floodways on the U.S. Side of the Rio Grande

Farther downstream, the Lower Rio Grande Valley Flood Control Project, including the Anzalduas Diversion Dam and the series of floodways (spillways) on both sides of the United States and Mexico border were activated. This includes the Banker Floodway, the Main Floodway, the North Floodway and the Arroyo Colorado in the United States. During the latter half of July and into early August 2010, the floodways were generally at half capacity, meaning water levels were several feet high but sufficiently below the height of the levee system. Visual and measured levels generally ranged from 1.2 to 2.4 meters across the system, which begins at Anzalduas and stretches east to just south of McAllen and Pharr toward Progresso Lakes, then curves northward between Weslaco and Mercedes (after a split with the Arroyo Colorado), then turns east at La Villa before entering extreme northern Cameron County, and passes between Combes and Sebastian before entering rural southern Willacy County.
