<b>NWS Form E-5</b> (04-2006) (PRES. BY NWS Instruction 10-924)	<b>U.S. DEPARTMENT OF COMMERCE</b> <b>NATIONAL OCEANIC AND ATMOSPHERIC ADMINISTRATION</b> <b>NATIONAL WEATHER SERVICE</b>	HYDROLOGIC SERVICE AREA (HSA) Burlington VT
		REPORT FOR: MONTH            YEAR November        2017
<b>MONTHLY REPORT OF HYDROLOGIC CONDITIONS</b>		SIGNATURE /s/ John M. Goff, METEOROLOGIST WFO BTV
TO: Hydrologic Information Center, W/OS31 NOAA's National Weather Service 1325 East West Highway Silver Spring, MD 20910-3283		DATE December 10, 2017

**Significant River Crests  
November 2017  
WFO Burlington VT**

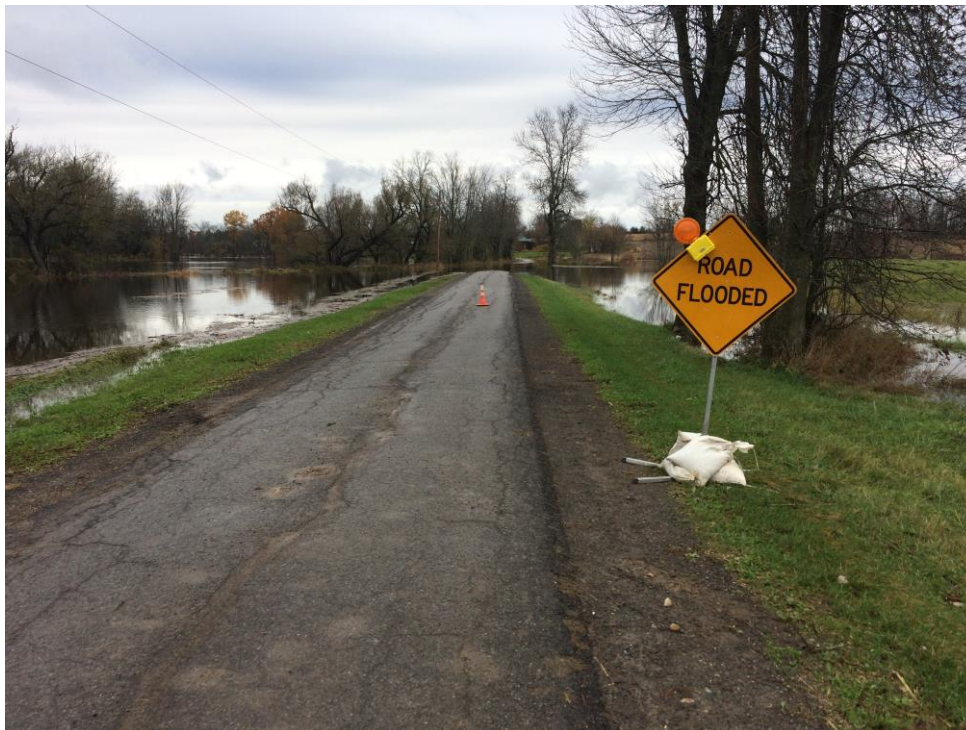
November 2017 was a rather uneventful month across the Burlington, VT HSA with weak systems and their accompanying frontal boundaries producing mainly light precipitation every few days. Temperatures averaged on a whole near normal for the 30-day period. By the end of the month negative precipitation departures from 1 to 3 inches were observed across most watersheds from the Adirondacks eastward, with slightly higher, near normal values across the St. Lawrence Valley (Figure 2). Despite the relative dryness, no large-scale water resource issues occurred as plentiful summer rainfall allowed soil moisture levels to remain on par with normal mid-Autumn values. Despite the drier than normal conditions, flooding was observed along the Oswegatchie River in St. Lawrence County from the 2<sup>nd</sup> through the 4<sup>th</sup> as heavier flows from prior heavy rainfall in late October slowly fed toward the St. Lawrence River. A Flood Warning was issued on the evening of the 1<sup>st</sup> with follow-up statements continuing for several days. Flooding was generally minor and mainly confined to a few secondary roads and lowland fields (Figures 3 and 4). Other than this one case, no other flooding occurred during the month.

Figure 3: River Road along the Oswegatchie River in Rensselaer Falls, NY on 3 November, 2017.

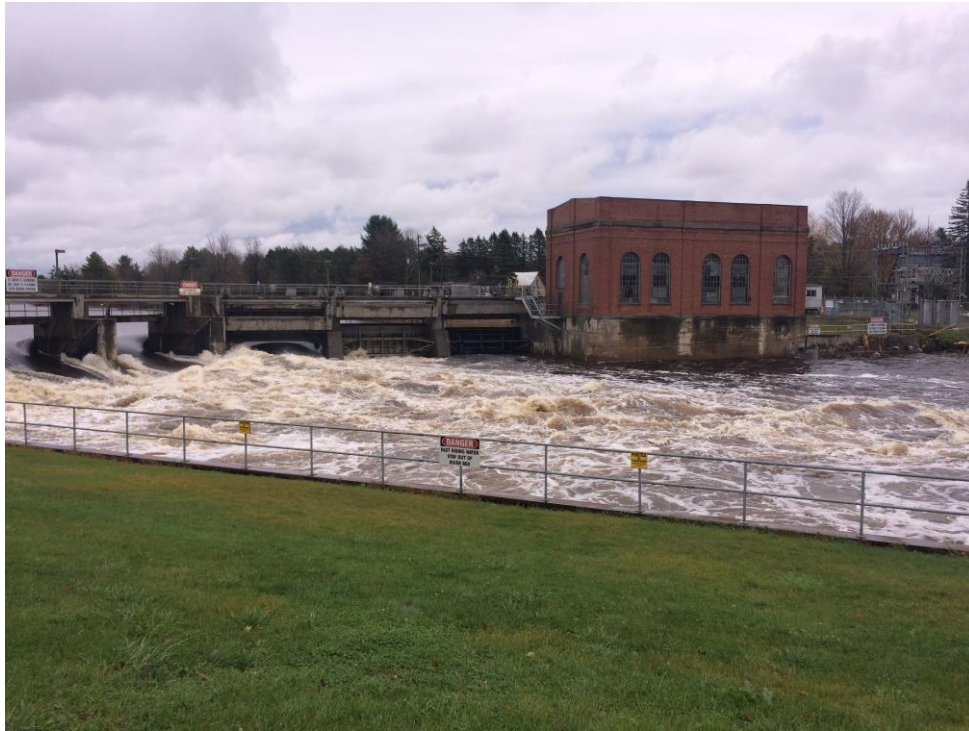
**Figure 4: Hydro Dam on the Oswegatchie River in Heuvelton, NY on 3 November, 2017.**

<b>Location</b>	<b>ID</b>	<b>Date</b>	<b>Time (UTC)</b>	<b>Crest Stage (ft)</b>	<b>Flood Stage (ft)</b>
OSWEGATCHIE RIVER @ HEUVELTON, NY	HEUN6	11/03/17	1315	7.93	7.5
