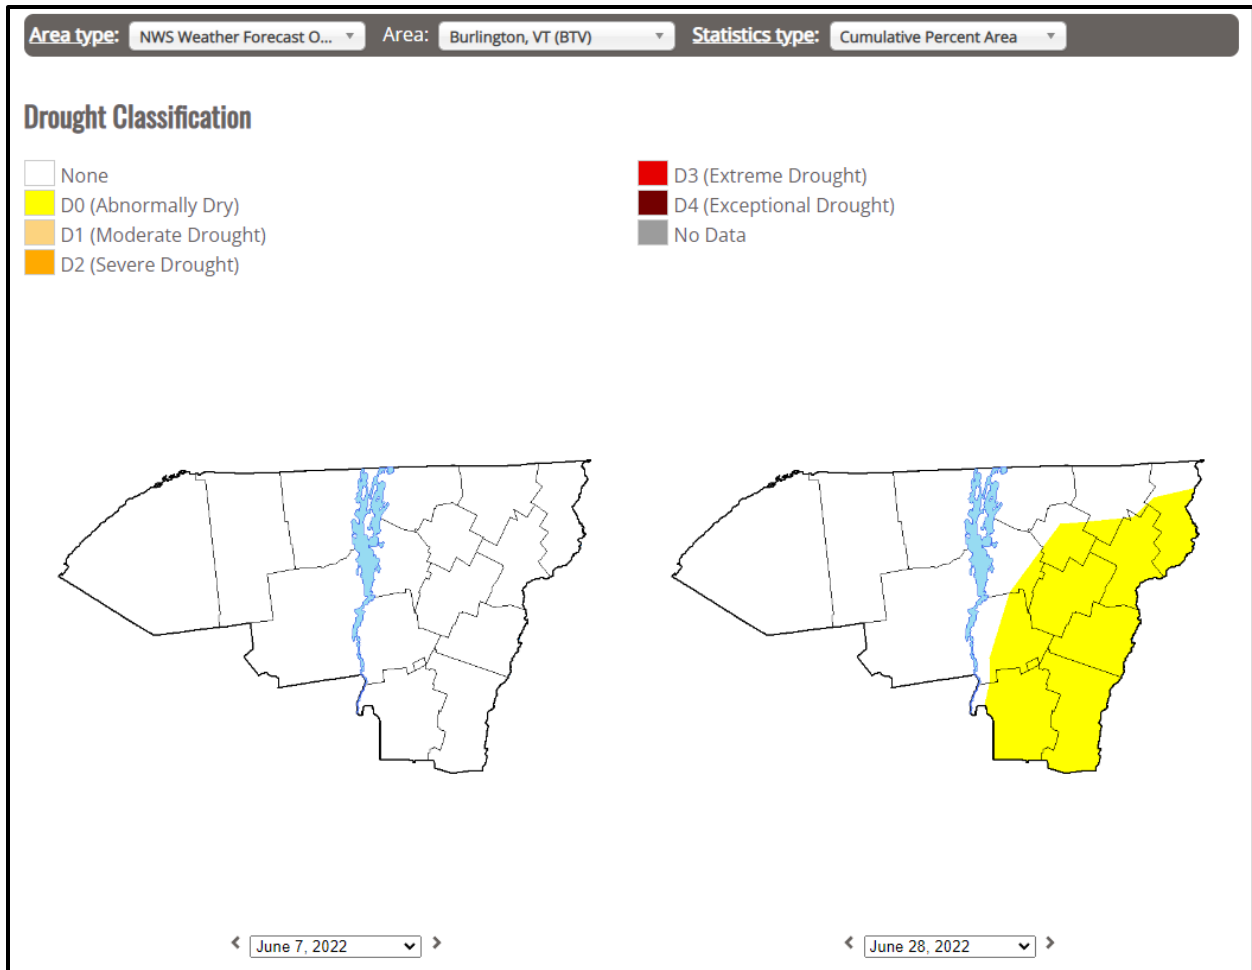
Figure 1: Comparison of U.S. Drought Monitor maps from June 7, 2022 (left) and June 28, 2022 (right). A return of extended periods of dryness throughout the 30 day period fostered a reintroduction of abnormally dry conditions (USDM category D0) to much of eastern Vermont by months end.

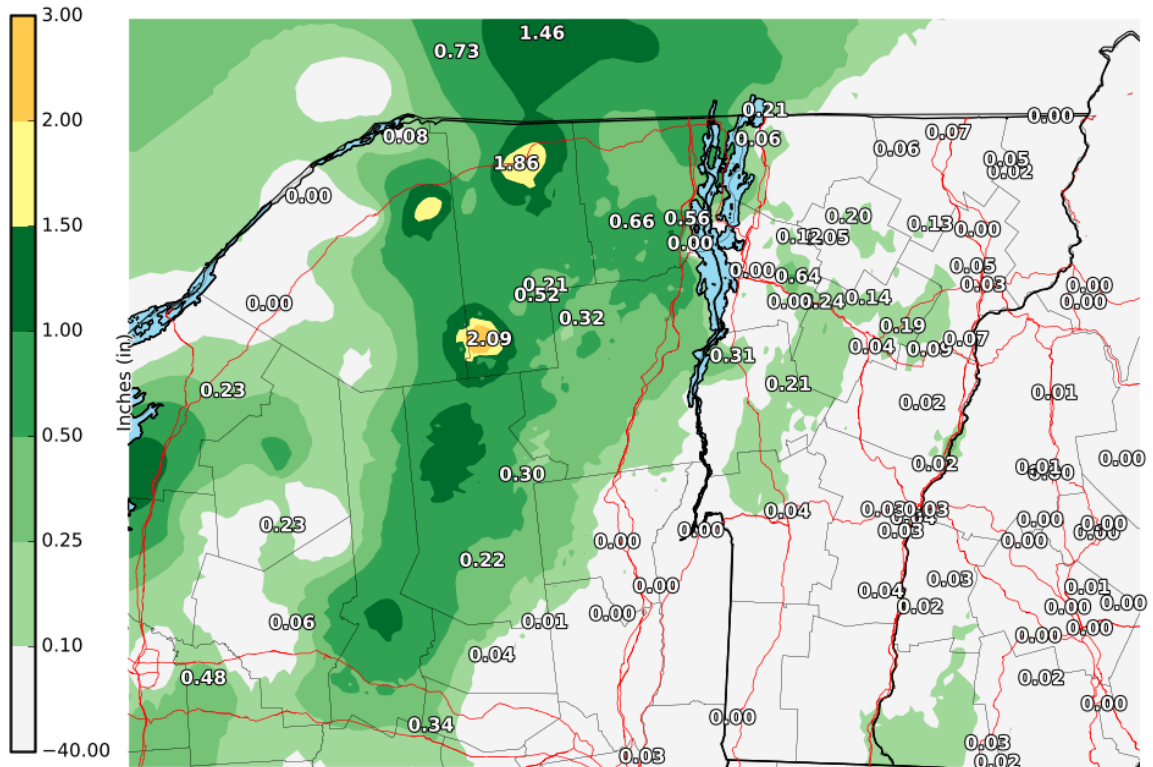
24-hr Precipitation Totals

Valid: 7 AM Wed Jun 22, 2022 to 7 AM Thu Jun 23, 2022

Figure 2: 24-hour rainfall ending at 7:00 AM local time on June 23, 2022. Beneficial rains fell across the NWS Burlington HSA during this period. A few spots experienced heavier rainfall, including portions of northeastern St. Lawrence County, NY where reports of flooding were received.

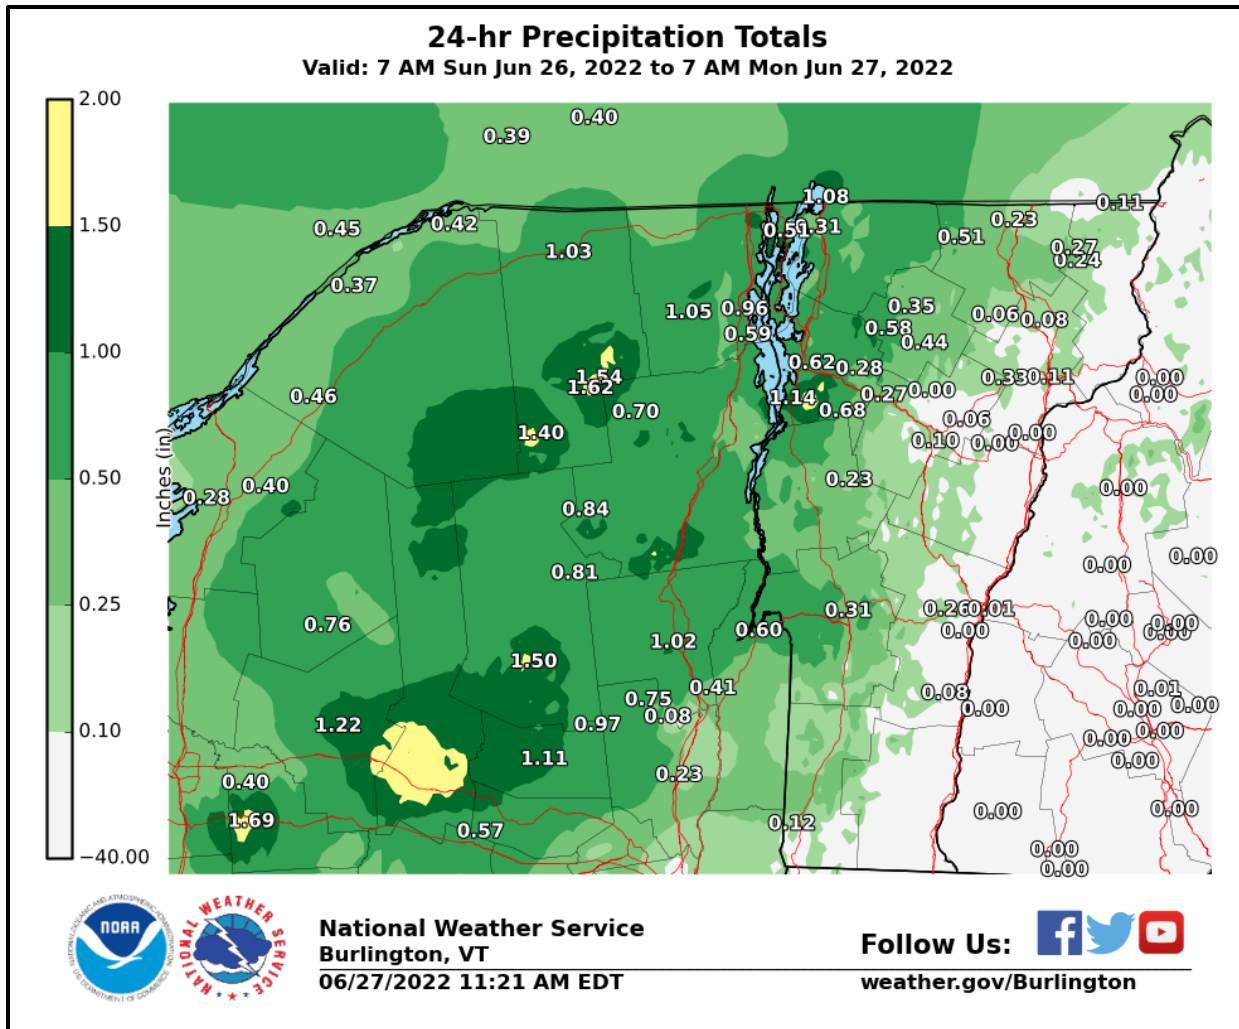
Figure 4: 24-hour rainfall ending 7:00 AM local time on June 27, 2022. Note the moderate to locally heavy swath of precipitation observed in a band across the northern Adirondack Mountains of New York during this period. Fortunately, no flooding was observed with this event.
