NWS Form E-5 (04-2006) (PRES. BY NWS Instruction 10-924)	U.S. DEPARTMENT OF COMMERCE NATIONAL OCEANIC AND ATMOSPHERIC ADMINISTRATION NATIONAL WEATHER SERVICE	HYDROLOGIC SERVICE AREA (HSA) Burlington VT
MONTHLY REPORT OF HYDROLOGIC CONDITIONS		REPORT FOR: MONTH YEAR July 2023
TO: Hydrologic Information Center, W/OS31 NOAA's National Weather Service 1325 East West Highway Silver Spring, MD 20910-3283		SIGNATURE /s/ John Goff, Senior Service Hydrologist DATE August 22, 2023

Overview

Devastating Vermont flash flooding of July 9-11, 2023

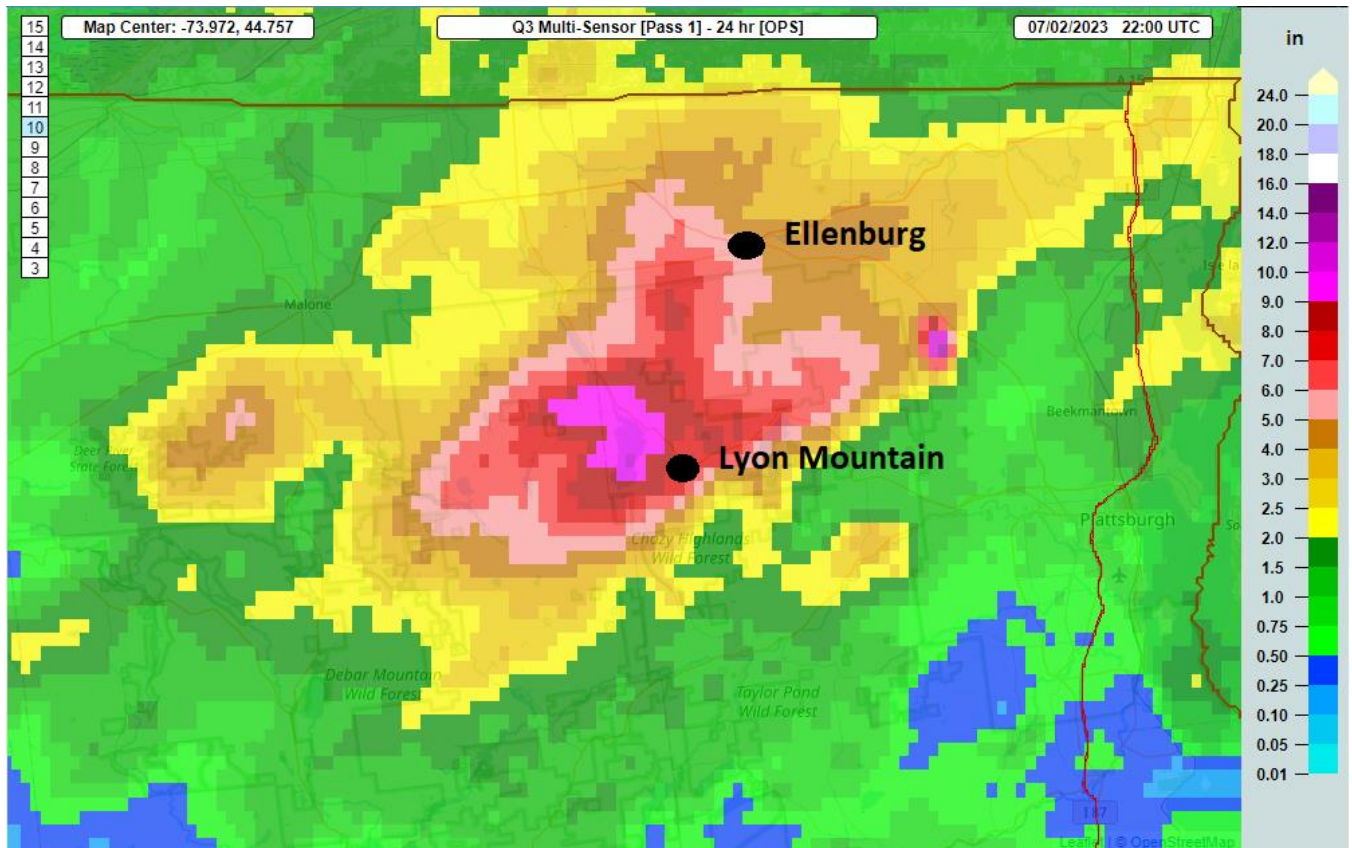
Figure 1: Multi-Radar/Multi-Sensor (MRMS) rainfall estimates in the Ellenburg/Lyon Mountain, NY area on July 2, 2023. Believable rainfall amounts of 5 to 8 inches occurred in this area leading to severe flash flooding.

The first system of significance occurred during the morning and afternoon hours of July 2 when rounds of training thunderstorms affected portions of Clinton County, NY in the towns of Ellenburg and Lyon Mountain. Two bursts of torrential rainfall occurred, the first occurring in the early morning hours after which another round developed in the early afternoon. Believable rainfall estimates between 5 and 8 inches occurred in this area including the New York Mesonet site at Ellenburg which recorded an impressive 5.21 inches (Fig. 1). This led to severe flash flooding with Clinton County Emergency Management reporting over 20 road washouts and several homes damaged. Perhaps the most severe flash flooding occurred in the Blue Haven Campground in Ellenburg, NY where rapid rises on the North Branch of the Great Chazy River led to evacuations of over 200 people during the early morning hours of the 2nd. The fast flowing water reached depths of up to 5 feet in this location leading to severe damage. Several campers were destroyed, but the quick action of the property owners and other campers to alert people resulted in no loss of life with only one injury reported (Figs. 2 and 3). The following day, NWS Burlington, VT performed an onsite flood damage assessment survey of the affected area.

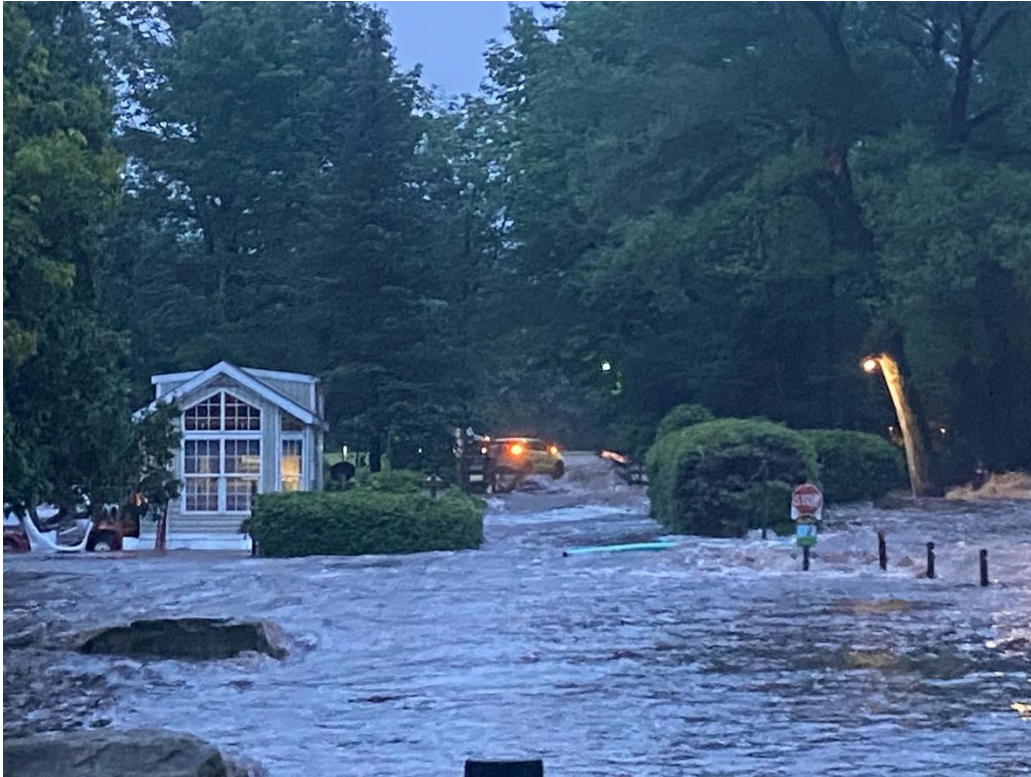
Figure 2: Flood waters rage through the Blue Haven Campground in Ellenburg, NY on the morning of July 2, 2023. Photo courtesy Clinton Co., NY Emergency Management.

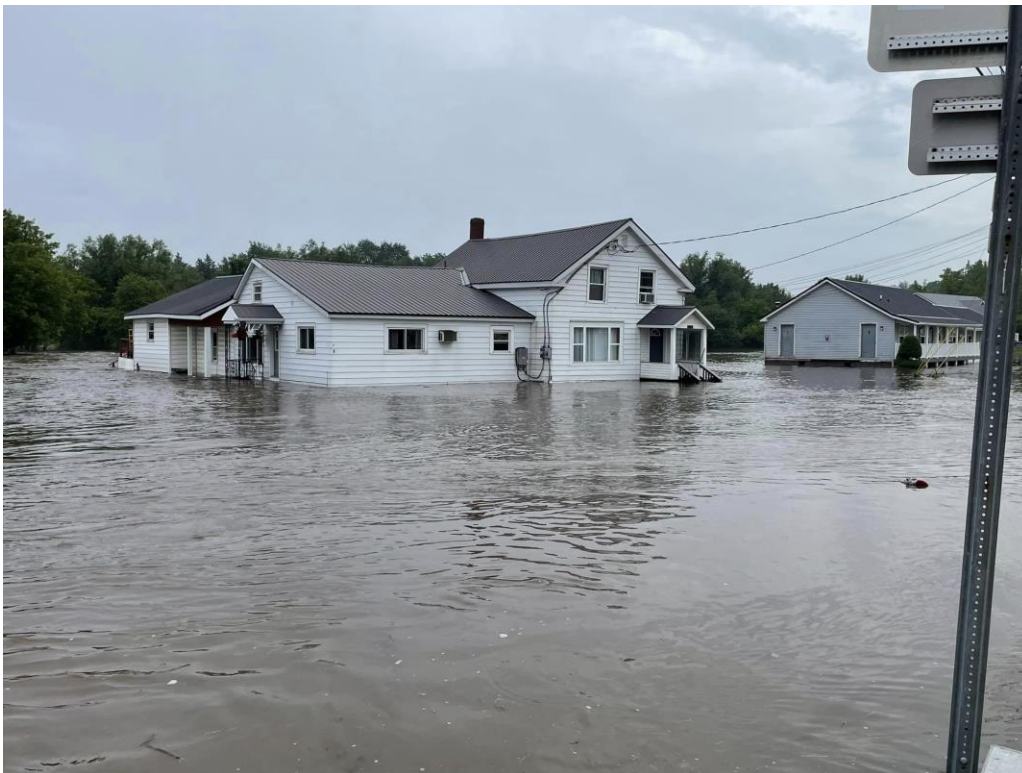
Figure 3: A home is surrounded by flood waters during the morning of July 2, 2023. Photo courtesy Clinton Co., NY Emergency Management.

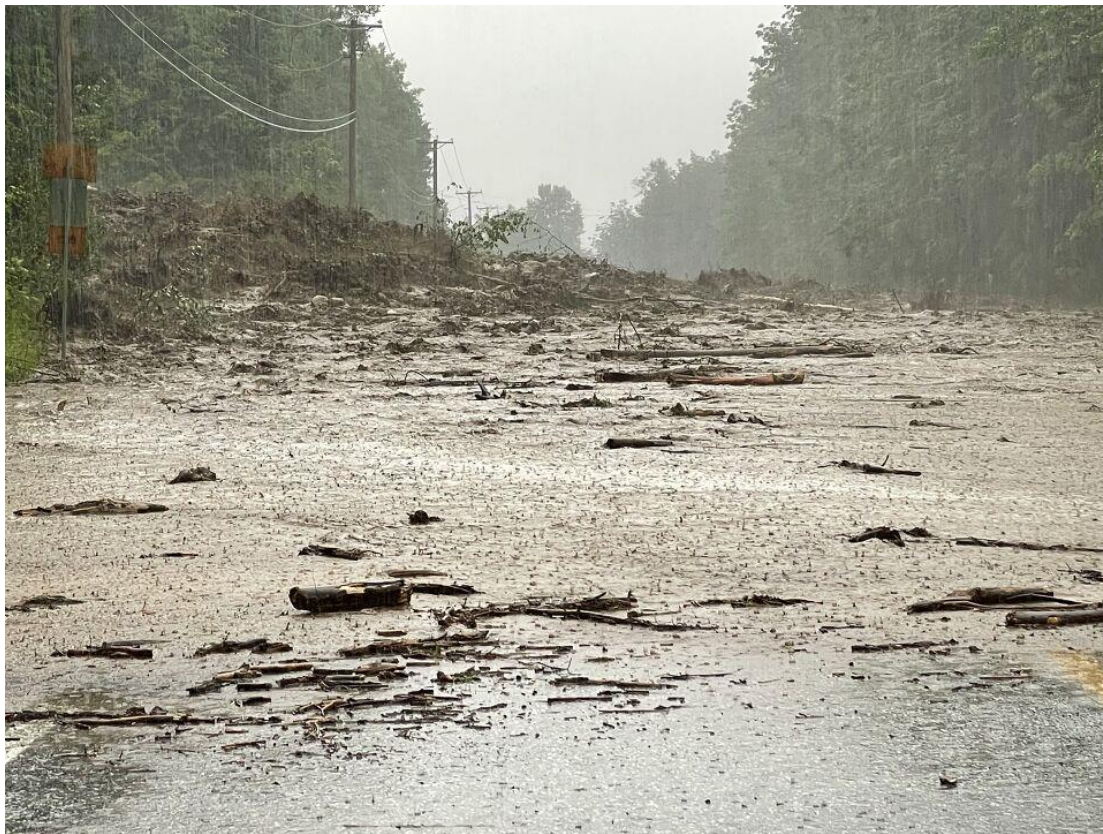
Figure 5: A close-up view of a landslide blocking U.S. Route 4 in Killington, VT during the early evening of July 7, 2023. Up to 5 inches of rain fell in this area leading to areas of significant to severe flash flooding. Photo courtesy public.

On July 7, another round of showers and thunderstorms with torrential rainfall affected portions of Vermont and northeastern New York. While not all areas received heavy rainfall, some spots experienced excessive amounts on the order of 3 to 5 inches. This led to additional areas of flash flooding which in some cases was severe. The hardest hit areas were 1) Clinton County, NY in the town of Altona and 2) in the towns of Killington and Bridgewater in southern Vermont (Fig. 4). Scattered to numerous road washouts occurred during the afternoon and evening hours with perhaps the most notable event being a large landslide which blocked U.S. Route 4 in the town of Killington (Fig. 5).

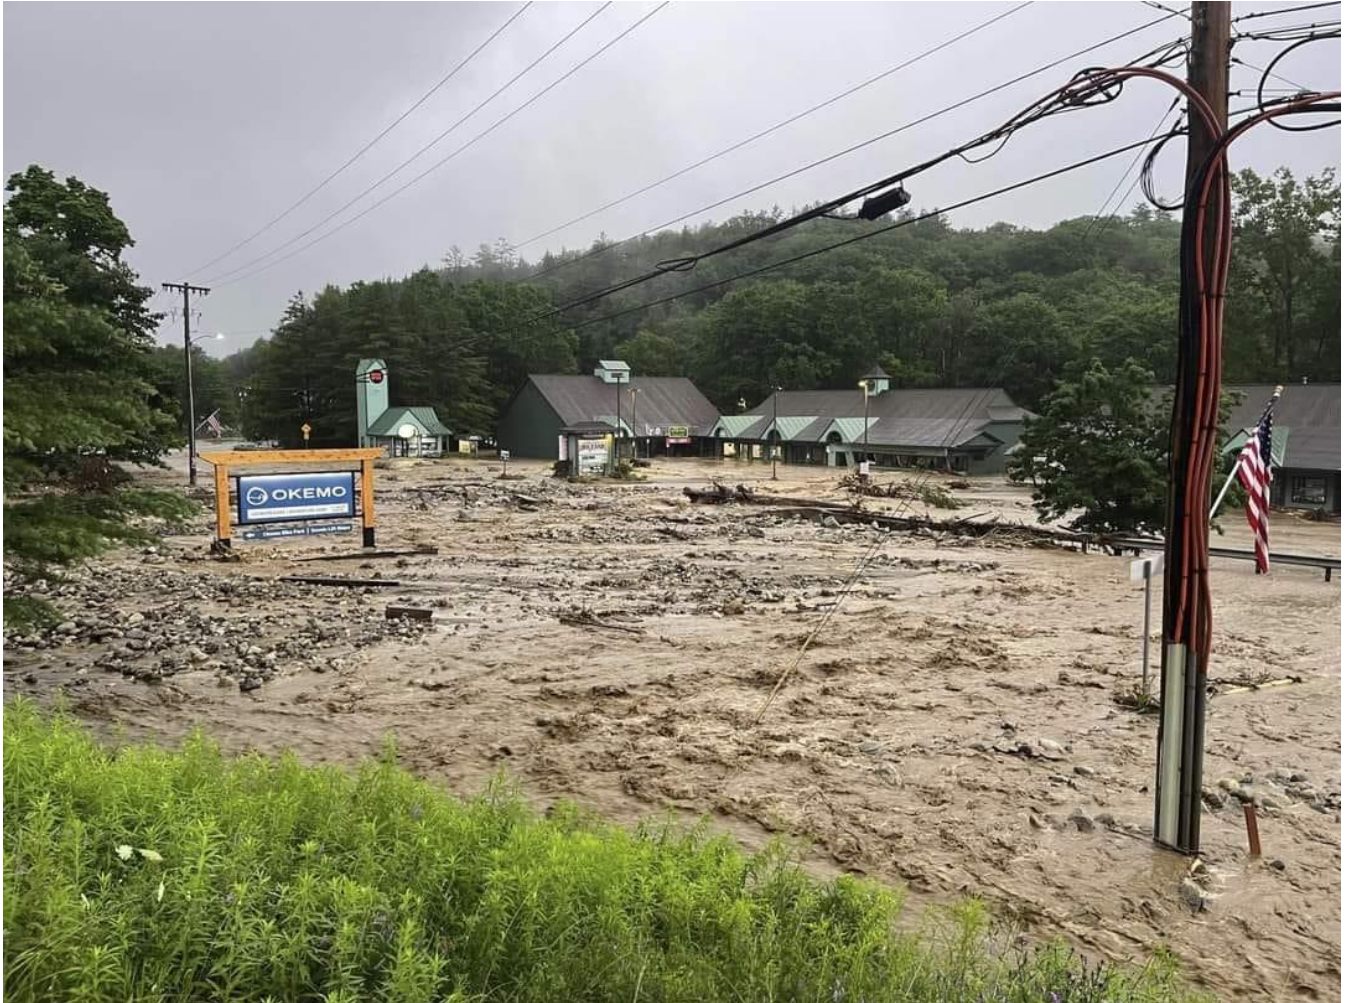
Figure 8: Severe flash flooding seen in Ludlow, VT on the morning of July 10, 2023. Photo courtesy public.

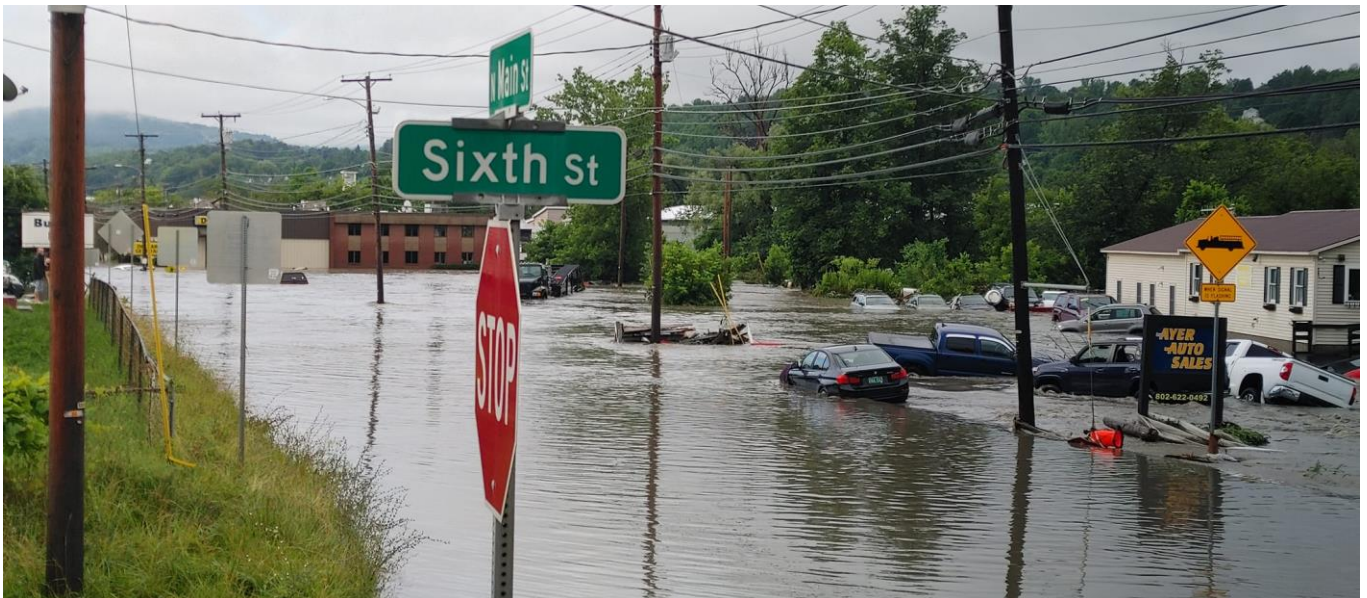
Figure 9: Flash flood waters inundate vehicles and businesses along U.S. Route 302 in Barre, VT on July 10, 2023. Photo courtesy public.

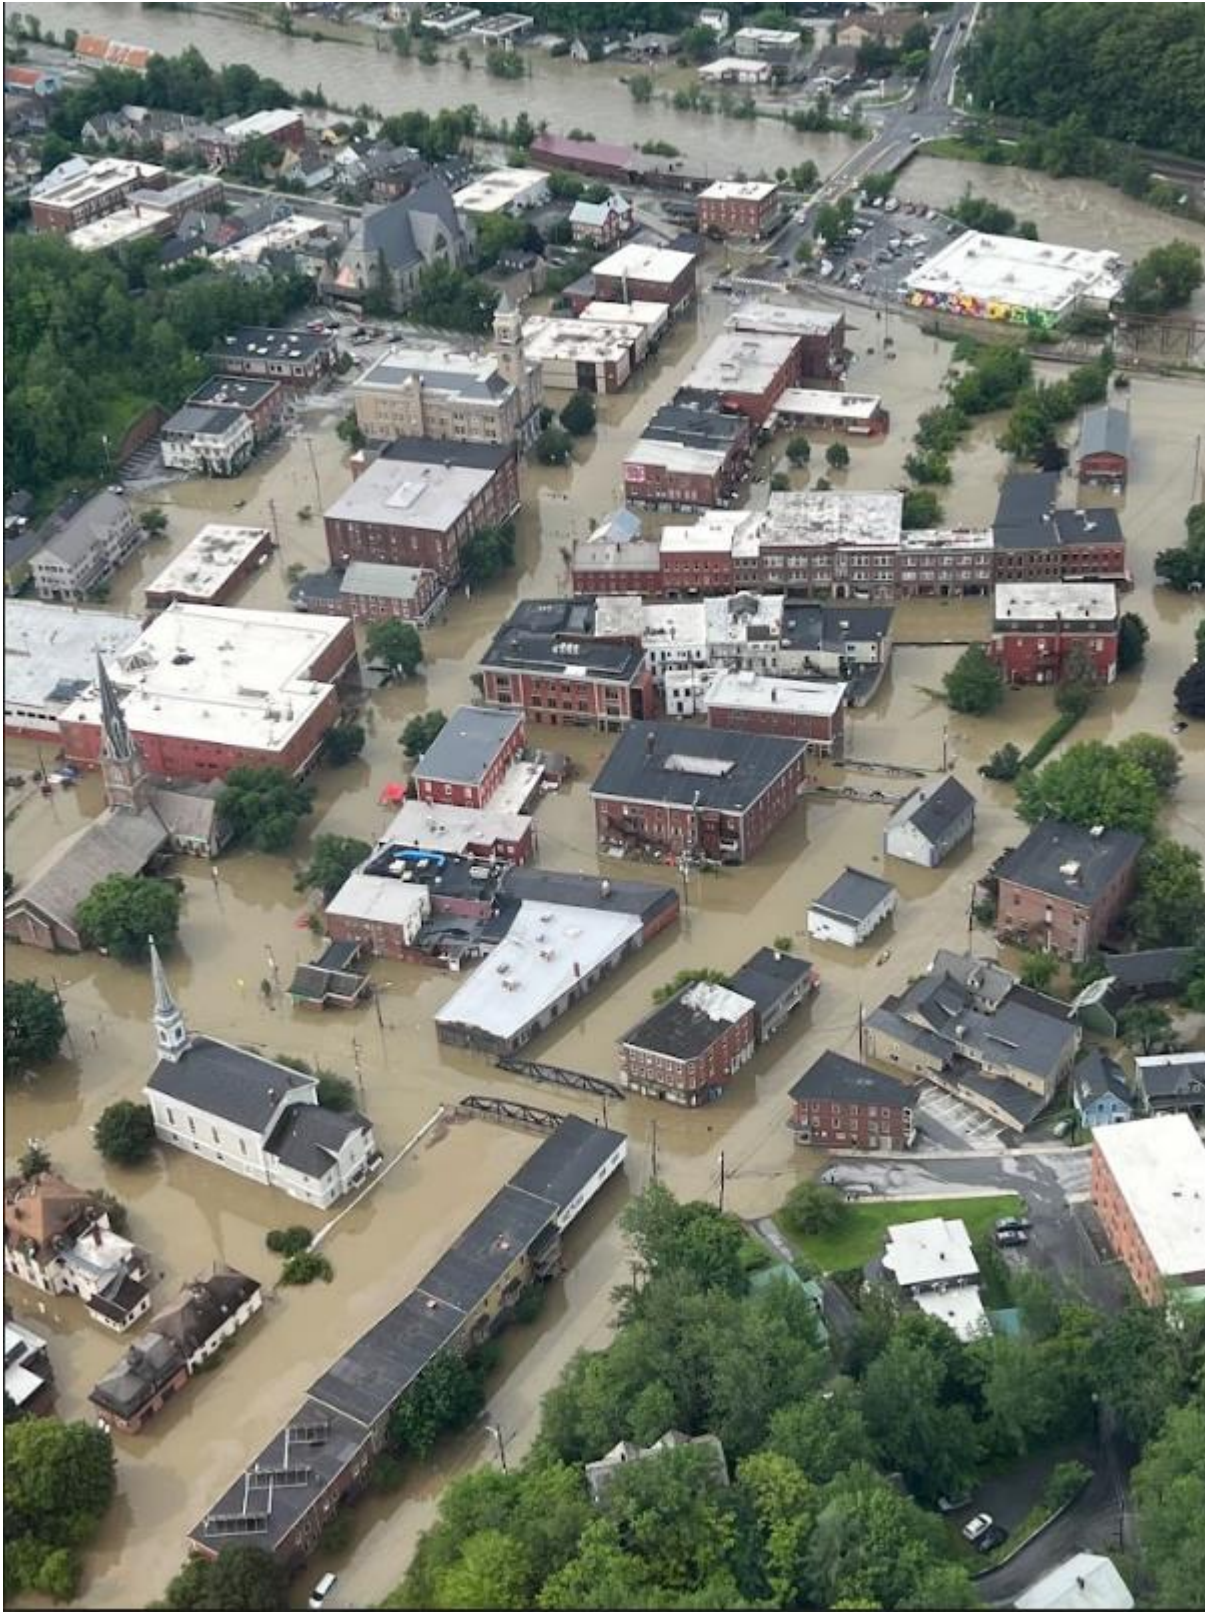
Figure 10: The City of Montpelier is inundated by Winooski R. flood waters on July 11, 2023. The river reached its highest crest in nearly 100 years, severely damaging the central business district of the city. Photo courtesy the U. of Vermont.

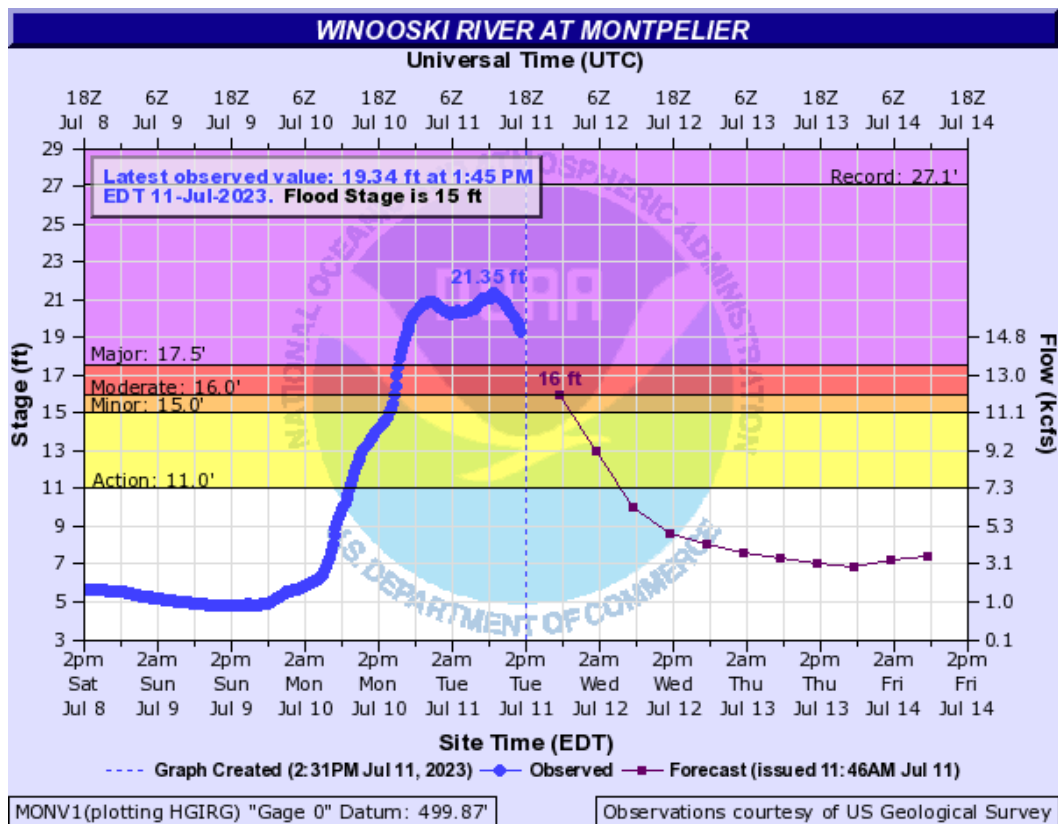
Figure 11: Hydrograph plot from the river gauge on the Winooski R. at Montpelier, VT showing major flood levels on July 10-11, 2023.

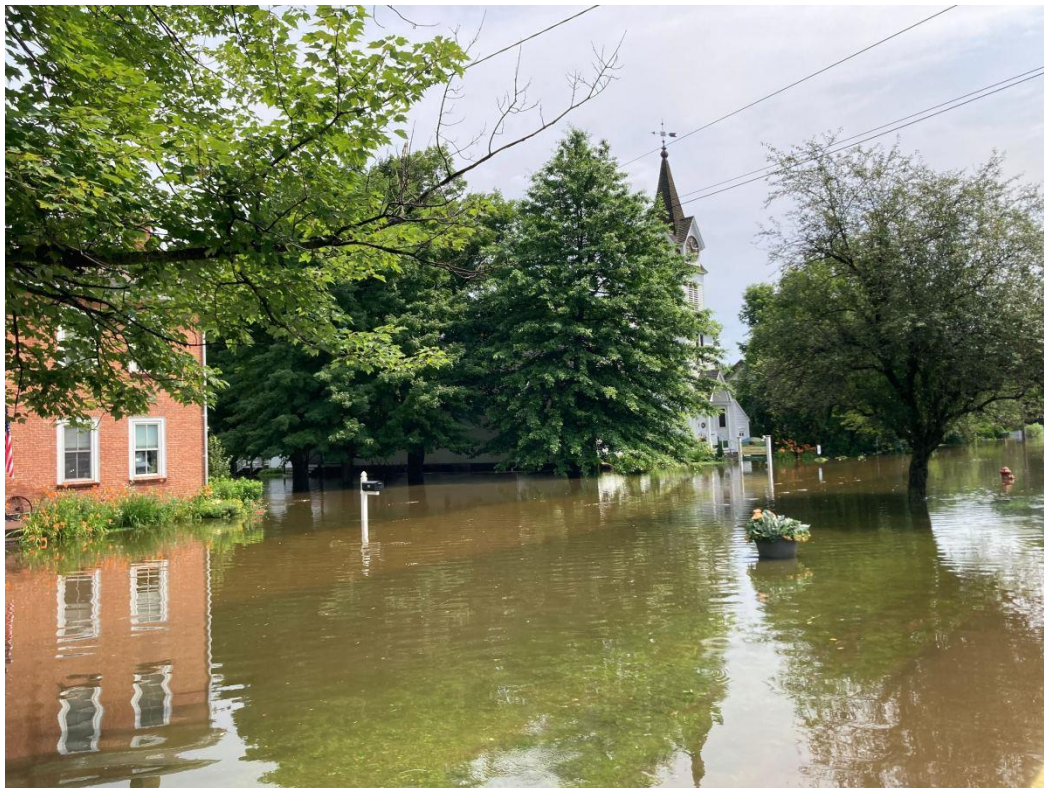
Figure 12: Major flooding affects the town of Cambridge, VT on the morning of July 11, 2023. Photo courtesy public.

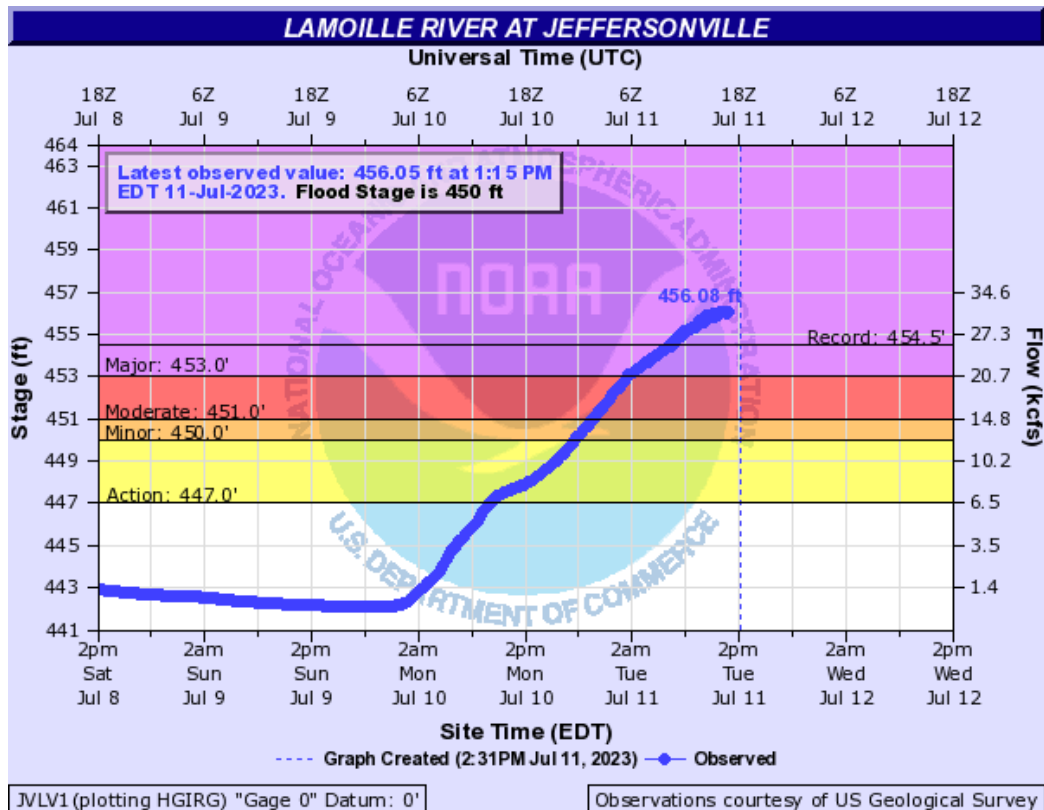
Figure 13: Hydrograph plot from the river gauge on the Lamoille R. at Jeffersonville, VT showing record flood levels on July 11, 2023. Severe flooding affected both Jeffersonville and Cambridge, VT during this time.

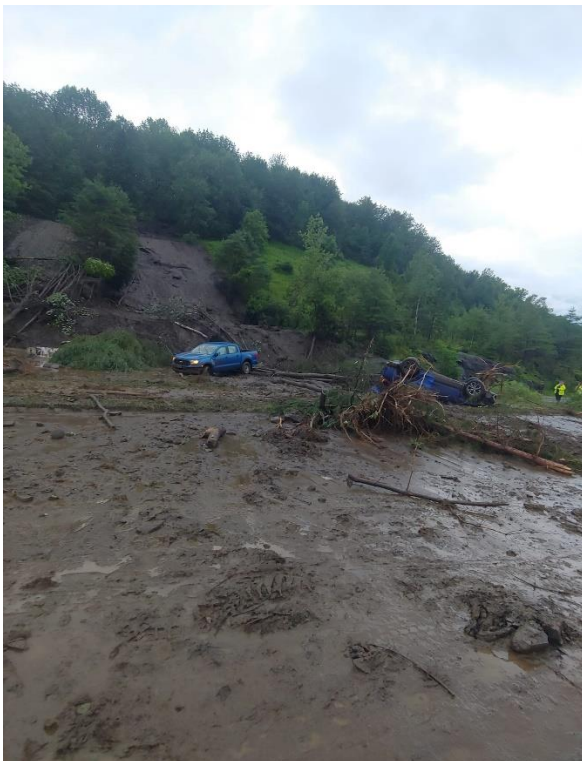
Figure 14: A landslide on State Route 62 in Barre, VT on July 10, 2023. Amazingly, the occupants of the two vehicles were uninjured. Photo courtesy public.

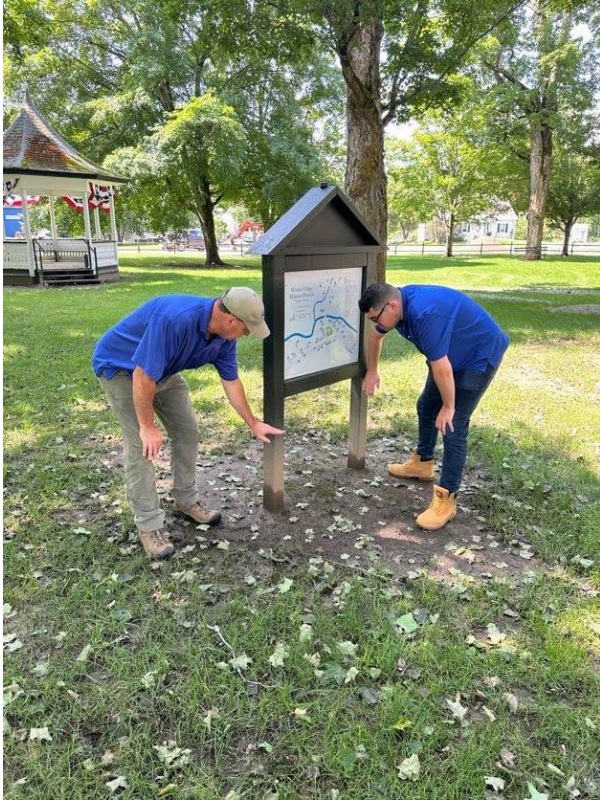
Figure 15: John Goff (Senior Service Hydrologist at NWS Burlington) and NWS Pathways student Evan Belkin (NWS Northeast River Forecast Ctr.) survey a high water mark in Weston, VT on July 18, 2023. Photo courtesy Emily Stephan.

This was the most severe flash flood/flood event in the state since Tropical Storm Irene 12 years prior in August 2011. During this time, repeated rounds of slow moving showers and storms, some with torrential rainfall affected much of the Green Mountain State. Multi-day totals averaged from 3 to 9 inches in this area with daily rainfall records set in several locations (Fig. 6). As a result, severe to catastrophic damage occurred in many locations, most notably in the City of Barre, VT, and in the towns of Weston, Ludlow and Plymouth just to name a few. In these and scattered other areas, the flooding was much worse than in Irene. In others, it wasn't quite as devastating but considerable to severe nonetheless (Figs. 7-9). In addition to flash flooding, severe river flooding also occurred along stretches of the Ottauquechee, Otter Creek, Winooski and Lamoille Rivers. The level on the Winooski River at Montpelier reached its second highest crest on record, eclipsed only by the Great Flood of 1927. This led to devastating flooding in the city with large swaths of the downtown district inundated by as much as 5 feet of water (Figs. 10-11). Record, or near record crests were also observed along the Lamoille R., especially in the Johnson and Cambridge, VT area where significant flood damage occurred (Figs. 12-13). Another unfortunate result of the torrential rainfall totals was numerous slope failures and landslides that occurred across the state during and in the week after this terrible event. Several of these damaged roads and in some cases, damaged or completely destroyed homes. To date, over 50 landslides have been reported to Vermont's Agency of Natural Resources (Fig. 14). The NWS in Burlington, with support from other NWS office and regional support staff, coordinated a multi-day flood damage assessment survey in the days following this event. This work led to proper archival documentation and improved flood forecast services for several communities (Fig. 15).
