Figure 1: May 2025 monthly precipitation across the NWS Burlington, VT HSA. Rainfall amounts were quite variable, with St. Lawrence County receiving about 2 inches of precipitation, while southern Vermont saw amounts up to 9 inches.

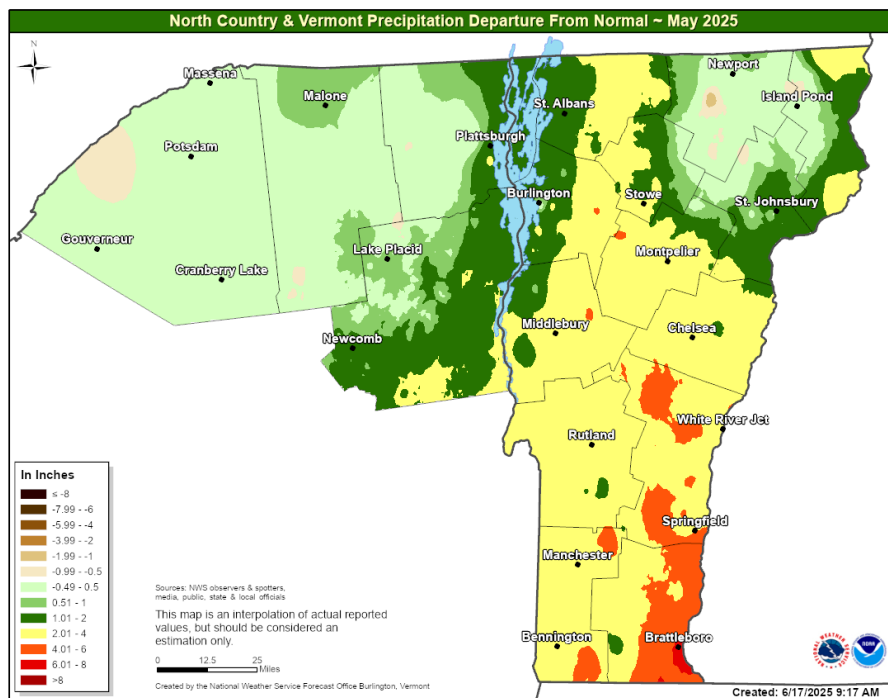
Figure 2: May 2025 monthly precipitation departures from normal across the NWS Burlington, VT HSA. On average, near normal amounts were observed across much of northern New York with positive departures of up to 4 inches occurring in portions of southern Vermont.

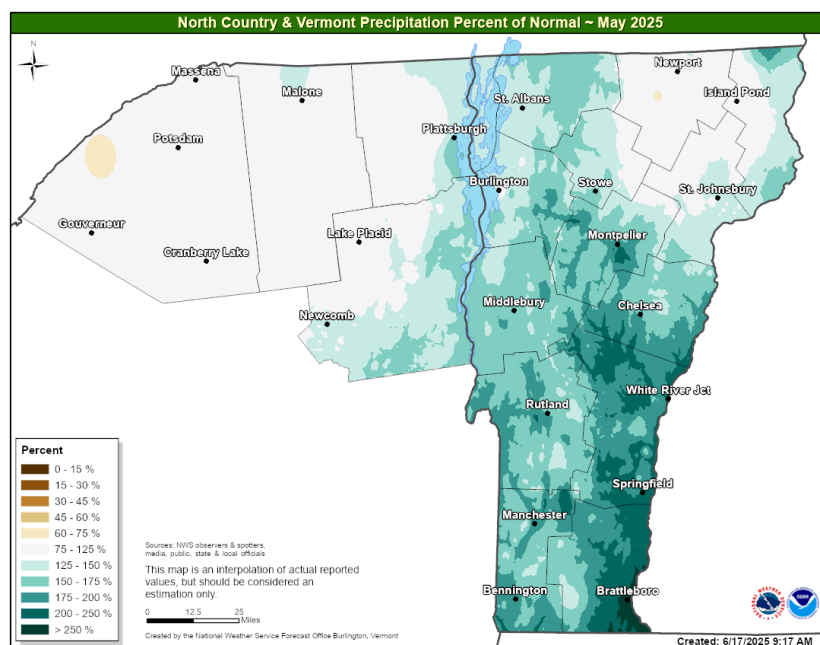
Figure 3: May 2025 monthly precipitation percent of normal across the NWS Burlington, VT HSA. Much of Vermont received over 100% of normal precipitation, with some locations nearing 200% of normal.

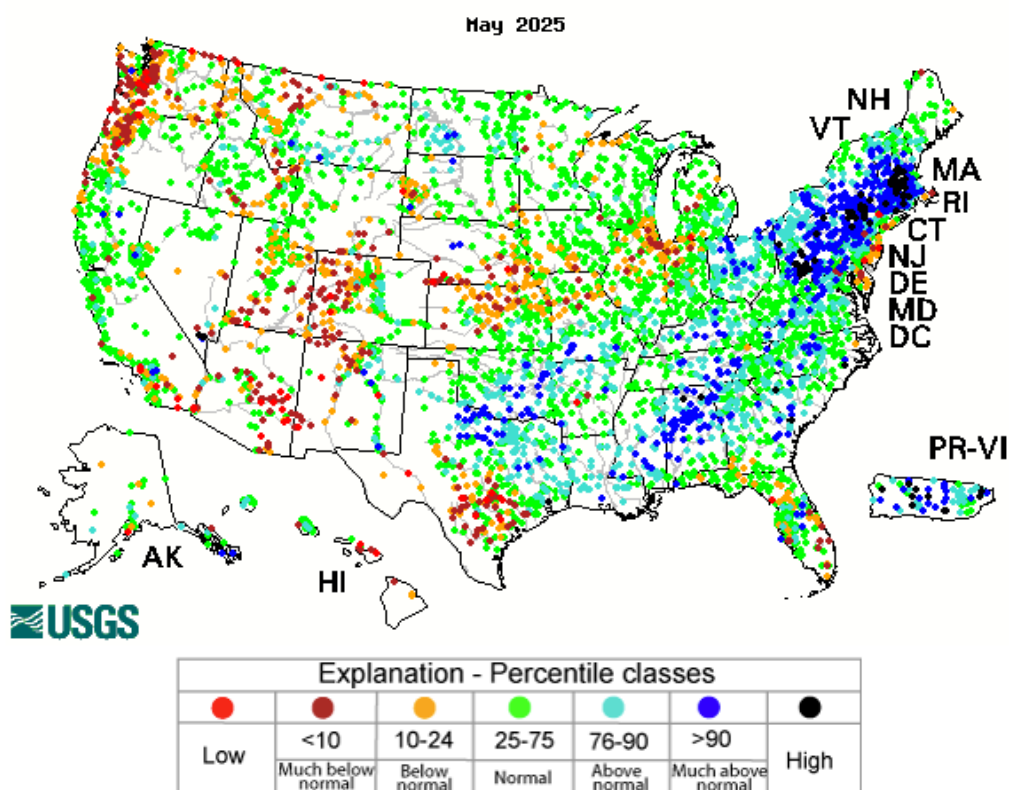
Figure 4: May 2025 monthly streamflow compared to historical streamflow for the month of May. The map above shows near normal streamflow across much of northern New York, but portions of Vermont were much above normal.

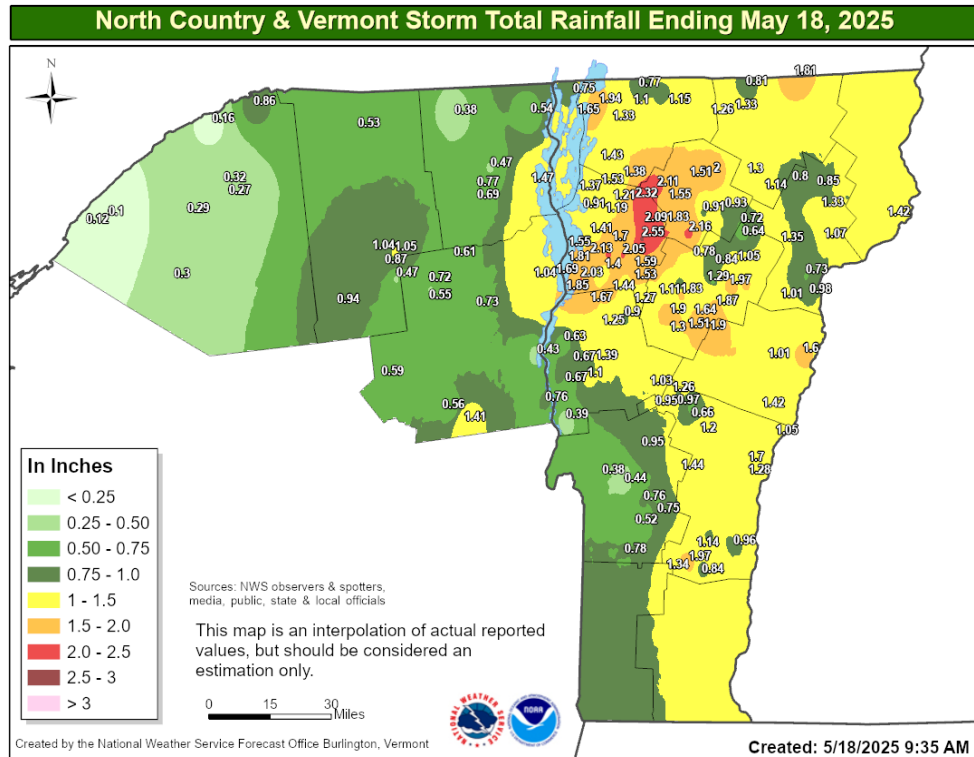
Figure 5: Storm total precipitation across the Burlington, VT HSA from May 17th, ending at 8 AM EDT on May 18th.

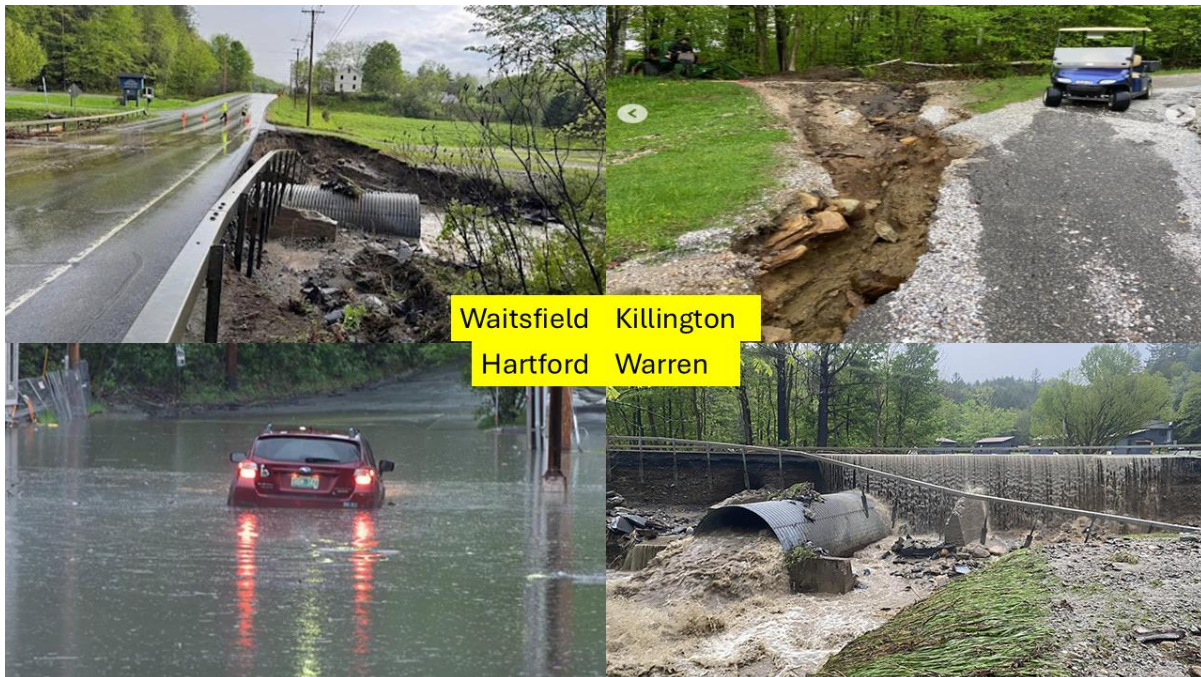
Figure 6: A 4-panel image showing flooding and flood damage in the Vermont communities of Waitsfield, Killington, Hartford, and Warren. Photos courtesy of local media outlets and Killington Mountain Resort.

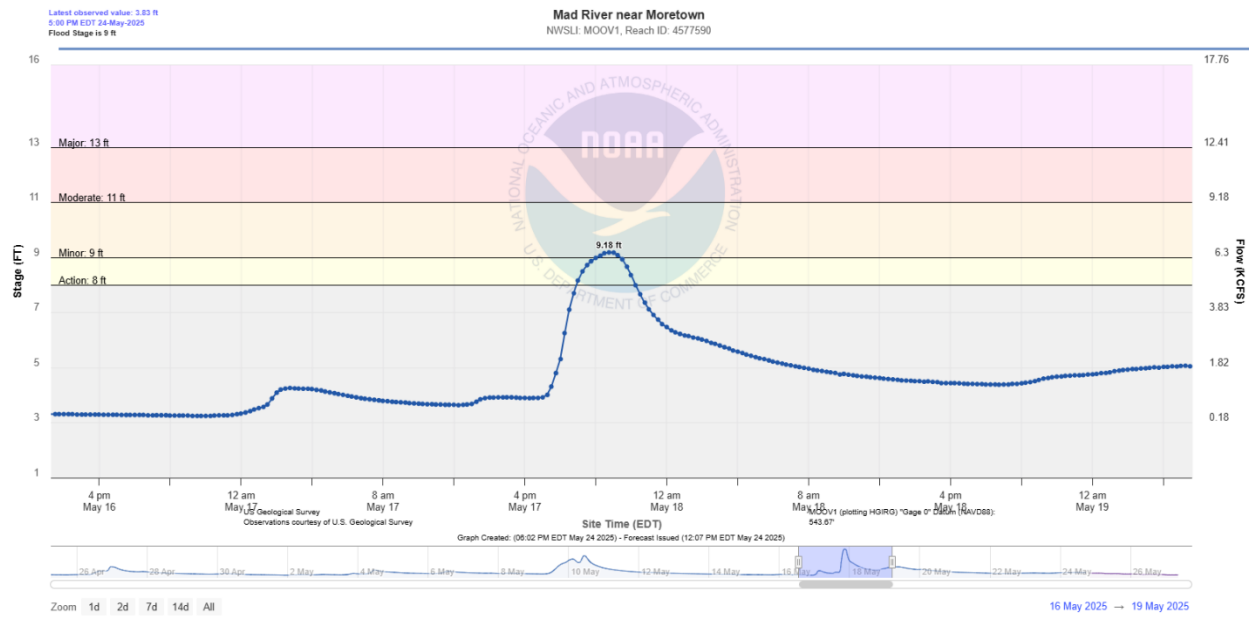
Figure 7: Hydrograph for the Mad River near Moretown, VT which briefly reached minor flood stage during the May 17th severe thunderstorm and flooding event.
