The Great Vermont Flood of 1927, November 3-4

The flood of November 3-4, 1927, stands as the greatest natural disaster in Vermont history. Devastation occurred throughout the state, with 1,285 bridges lost, countless homes and buildings destroyed, and hundreds of miles of roads and railroad tracks swept away. The flood waters claimed 84 lives, including that of the Vermont Lieutenant Governor at the time, S. Hollister Jackson. An account of the flooding across the state written by Luther B. Johnson, editor of the *Randolph Herald*, was published in 1928. His account was republished in 1996 by Greenhills Books. The following information is from that book and *The Vermont Weather Book*, by David Ludlum.

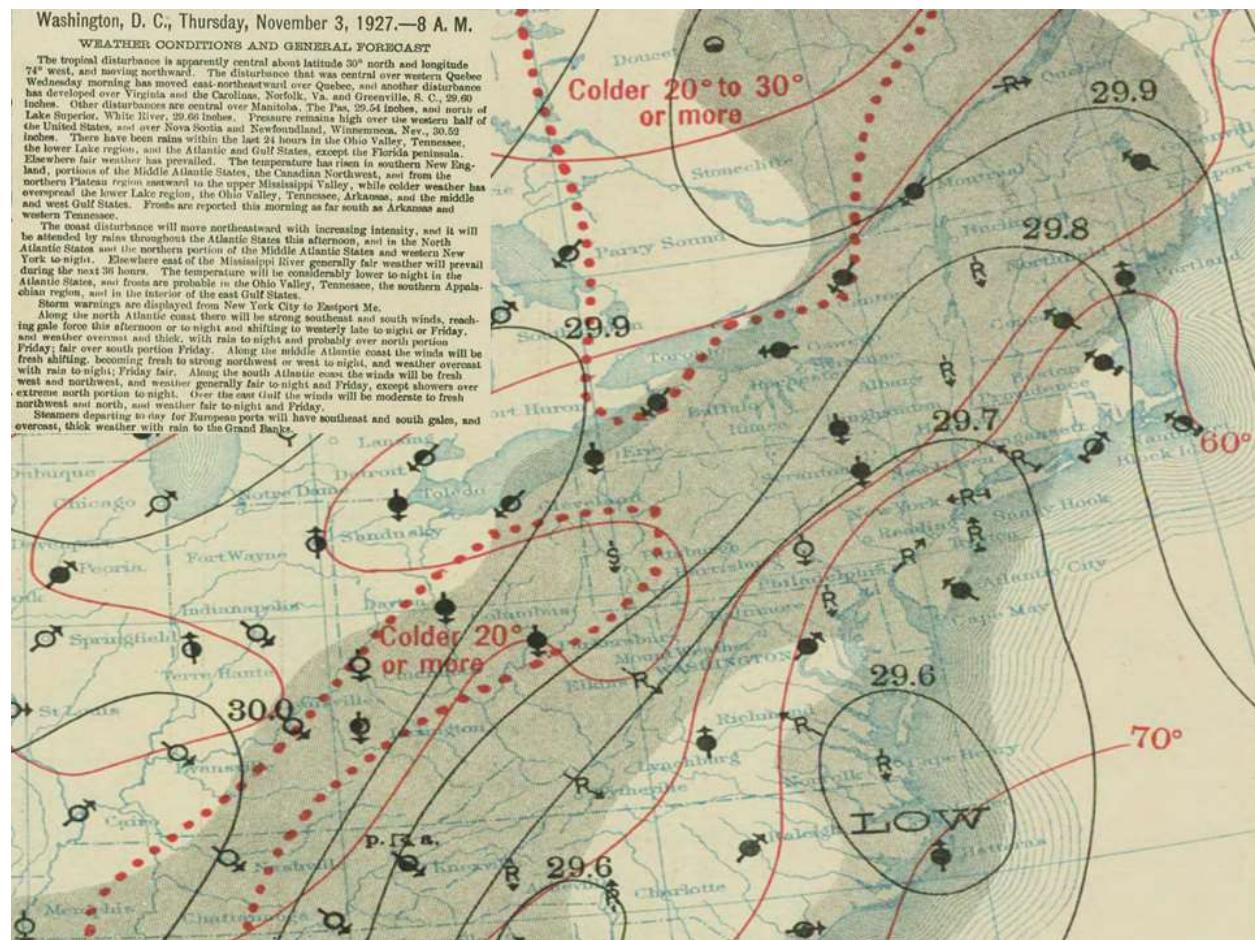
Figure 1: Weather Map Thu Nov 3, 1927 8 am

Rain began on the evening of November 2, as a cold front moved into the area from the west. Rainfall continued through the night with light amounts being recorded by the morning of the 3rd [Figure 1]. Rainfall intensity increased during the morning of the 3rd as a low pressure center moved up along the Northeast coast. This low had copious moisture associated with the remnants of a former tropical storm [Figure 2]. As the low moved up the coast, a strong southeast flow developed. This moisture-laden air was forced to rise as it encountered the Green Mountains, resulting in torrential downpours along and east of the Green Mountains. Rainfall amounts at the Weather Bureau station in Northfield totaled 1.65 inches from 4 am to 11 am on the 3rd, with 4.24 inches falling from 11 am to 8 pm. The total from late evening of the 2nd to late morning on the 4th was 8.71 inches [Table 1].

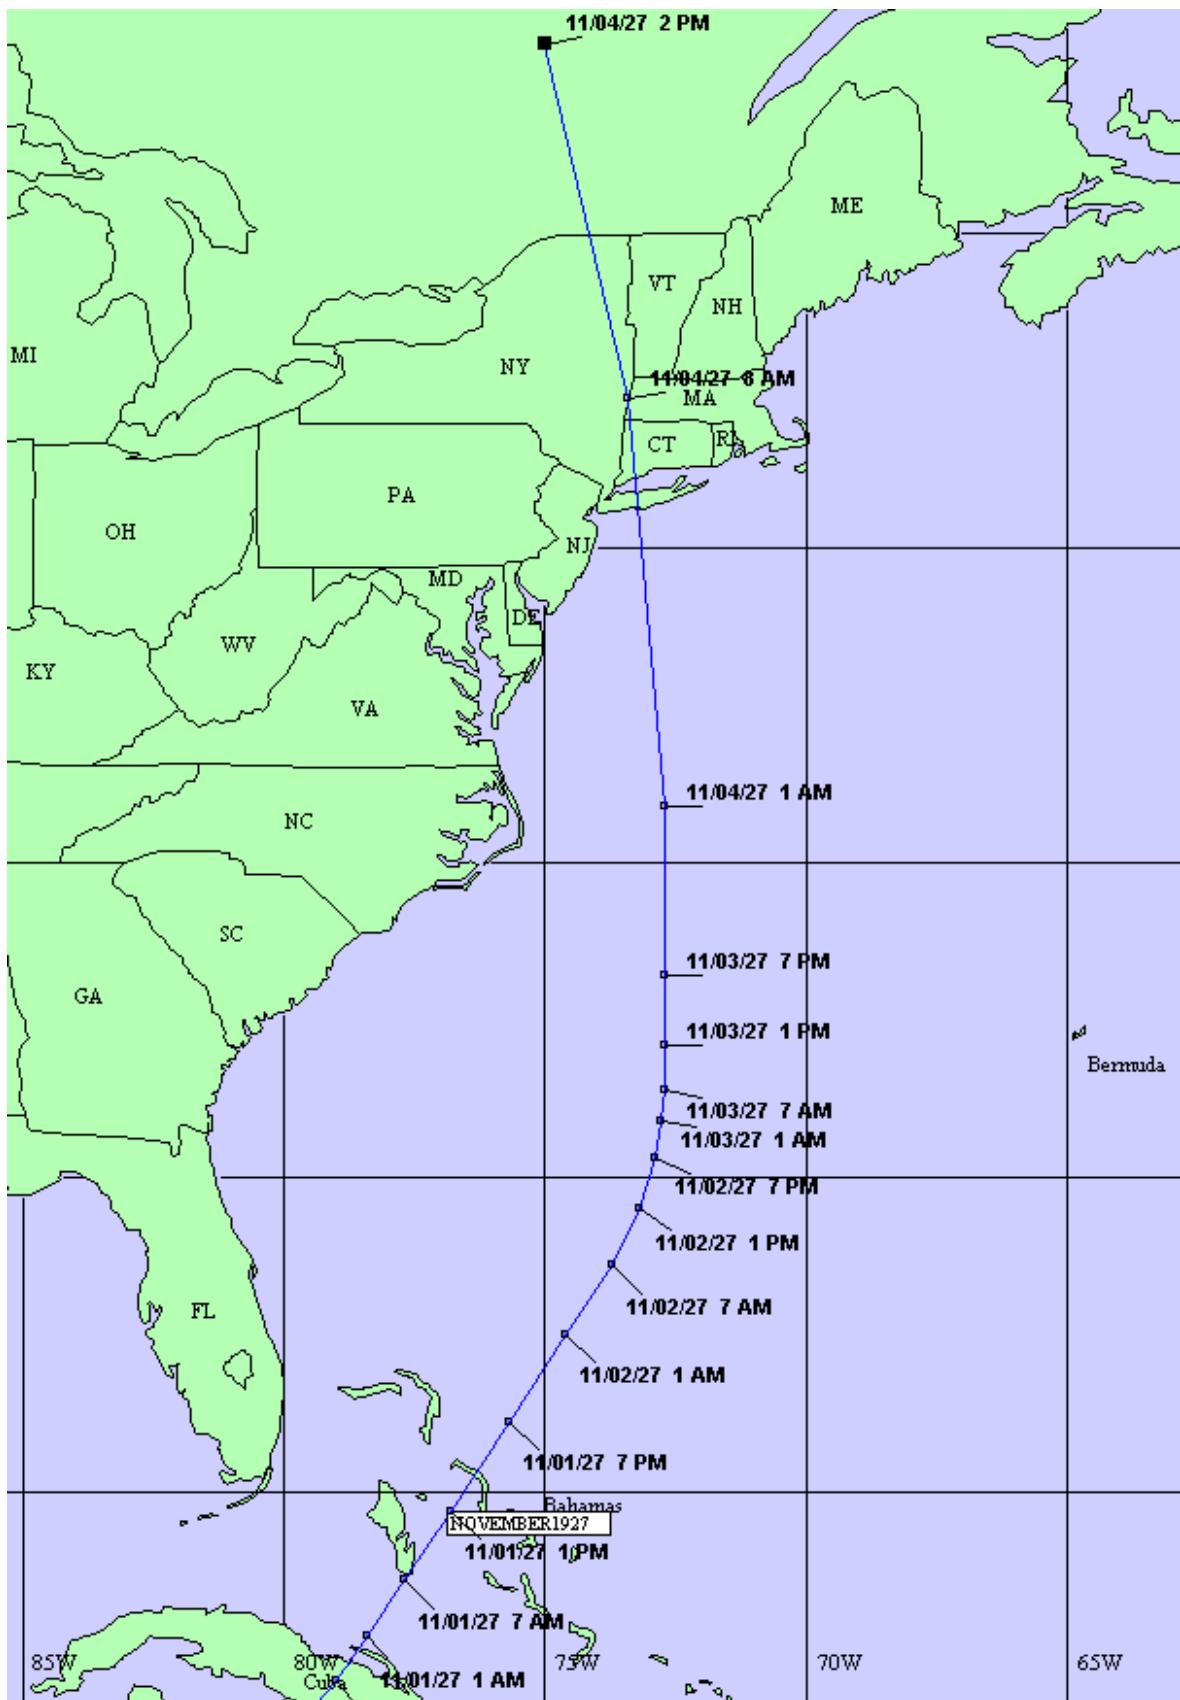
Figure 2: Track of tropical system November 1927

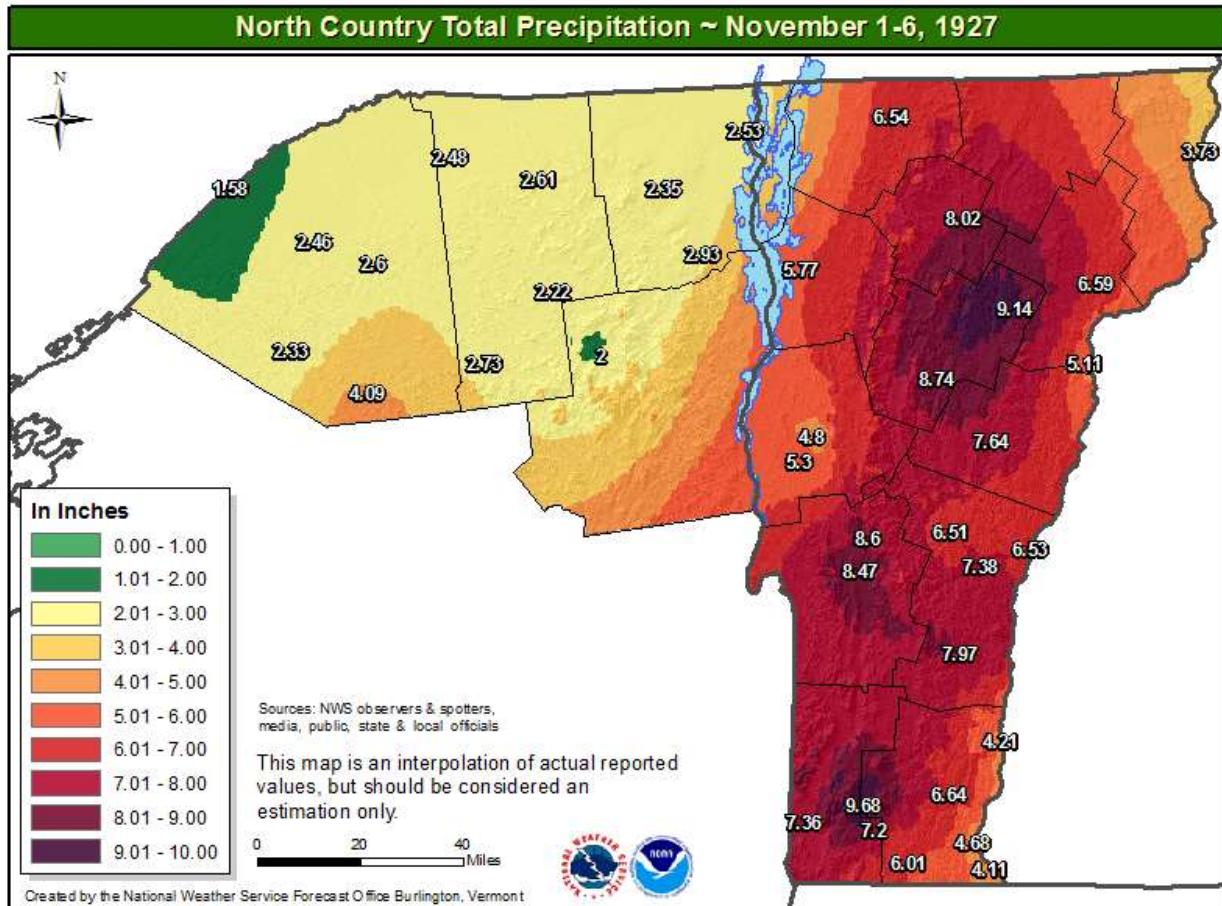
Figure 3: Total precipitation recorded from Nov 1-6, 1927

Devastation was distributed fairly evenly across the state, but the hardest hit area was most likely the Winooski Valley, where the majority of the population lived [Figure 3]. As a result of the statewide devastation caused by the flood, the U.S. Army Corps of Engineers built 3 flood retention reservoirs and accompanying dams in the Winooski River basin at East Barre, Wrightsville and Waterbury to try to mitigate the effects of further flooding. In 1949 the Union Village Reservoir and dam on the Ompompanoosuc River was completed. By the early 1960s, four other reservoirs/dams were completed in the Connecticut River basin. These were built on the Ottaquechee River at North Hartland, the Black River at North Springfield, and the West River at Ball Mountain (Jamaica) and Townshend. The historic flooding of Tropical Storm Irene brought additional devastation to the state in

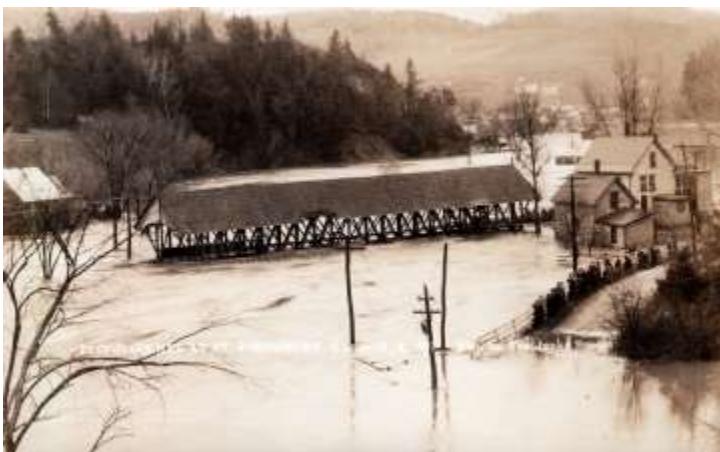
Covered bridge floating down river in St. Johnsbury, VT

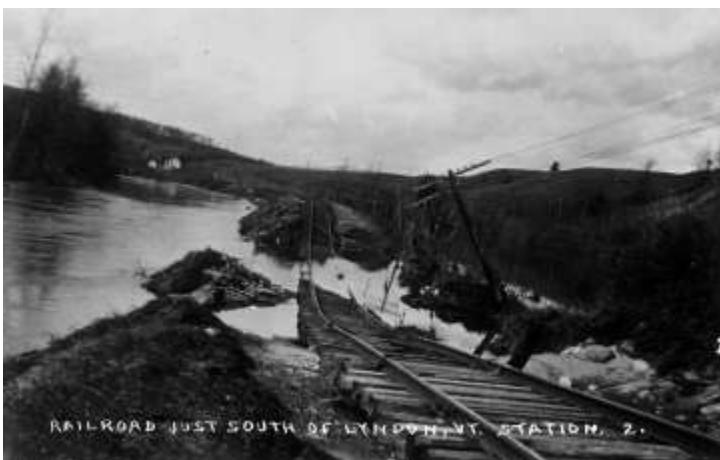
Destroyed railroad tracks Lyndon, VT
