Montgomery Flash Flood of July 15, 1997

In the early morning hours of Tuesday, July 15, 1997, a flash flood of historic proportion struck Montgomery in northern Vermont. Although much of northern and central Vermont, including Orleans, Essex, Lamoille, and Caledonia counties, was affected by heavy rains and flash flooding that day, Franklin County and the town of Montgomery in particular were the hardest hit. By the time the flood waters receded, \$8 million in damage had been done across Franklin County, with the total damage across Vermont reaching nearly \$12 million.

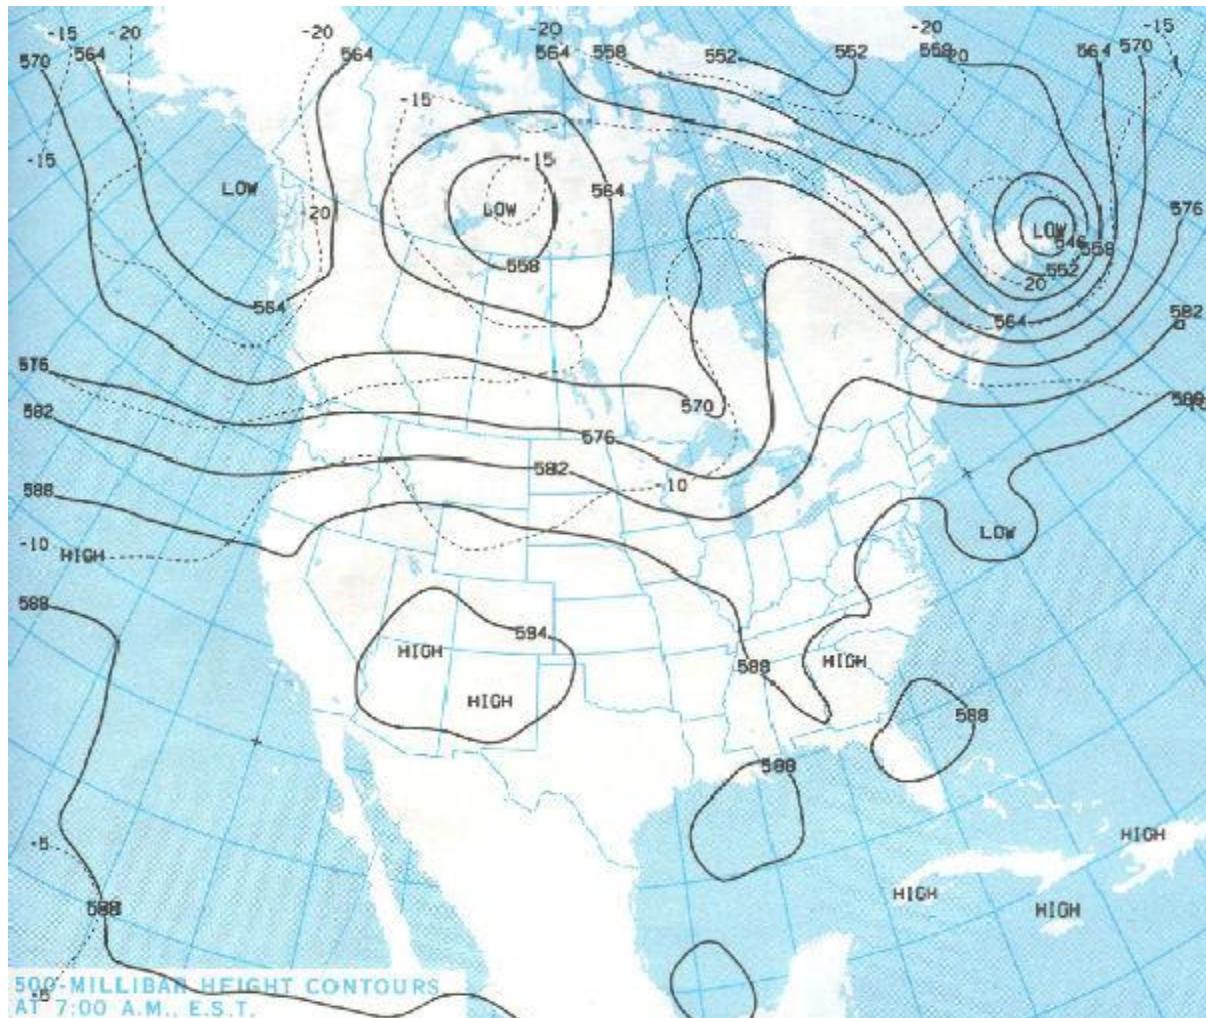
The weather pattern that day consisted of a large 500 mb low pressure centered just off the Newfoundland coast, with another across the northern Canadian territories, the latter's trough extending through central Canada and into the upper Midwest of the United States. An upper level ridge was squeezed in between the Newfoundland low and the central Canadian trough, slowly building east into western New England. With the leading edge of the upper ridge just entering the state during the early morning hours, much of Vermont was under the influence of northwest flow aloft. Any embedded pulses of energy riding along the top of the ridge would have traversed across northern Vermont, promoting strong upward motion across the region.

500 mb height analysis at 8 am EDT, 12 UTC, July 15, 1997

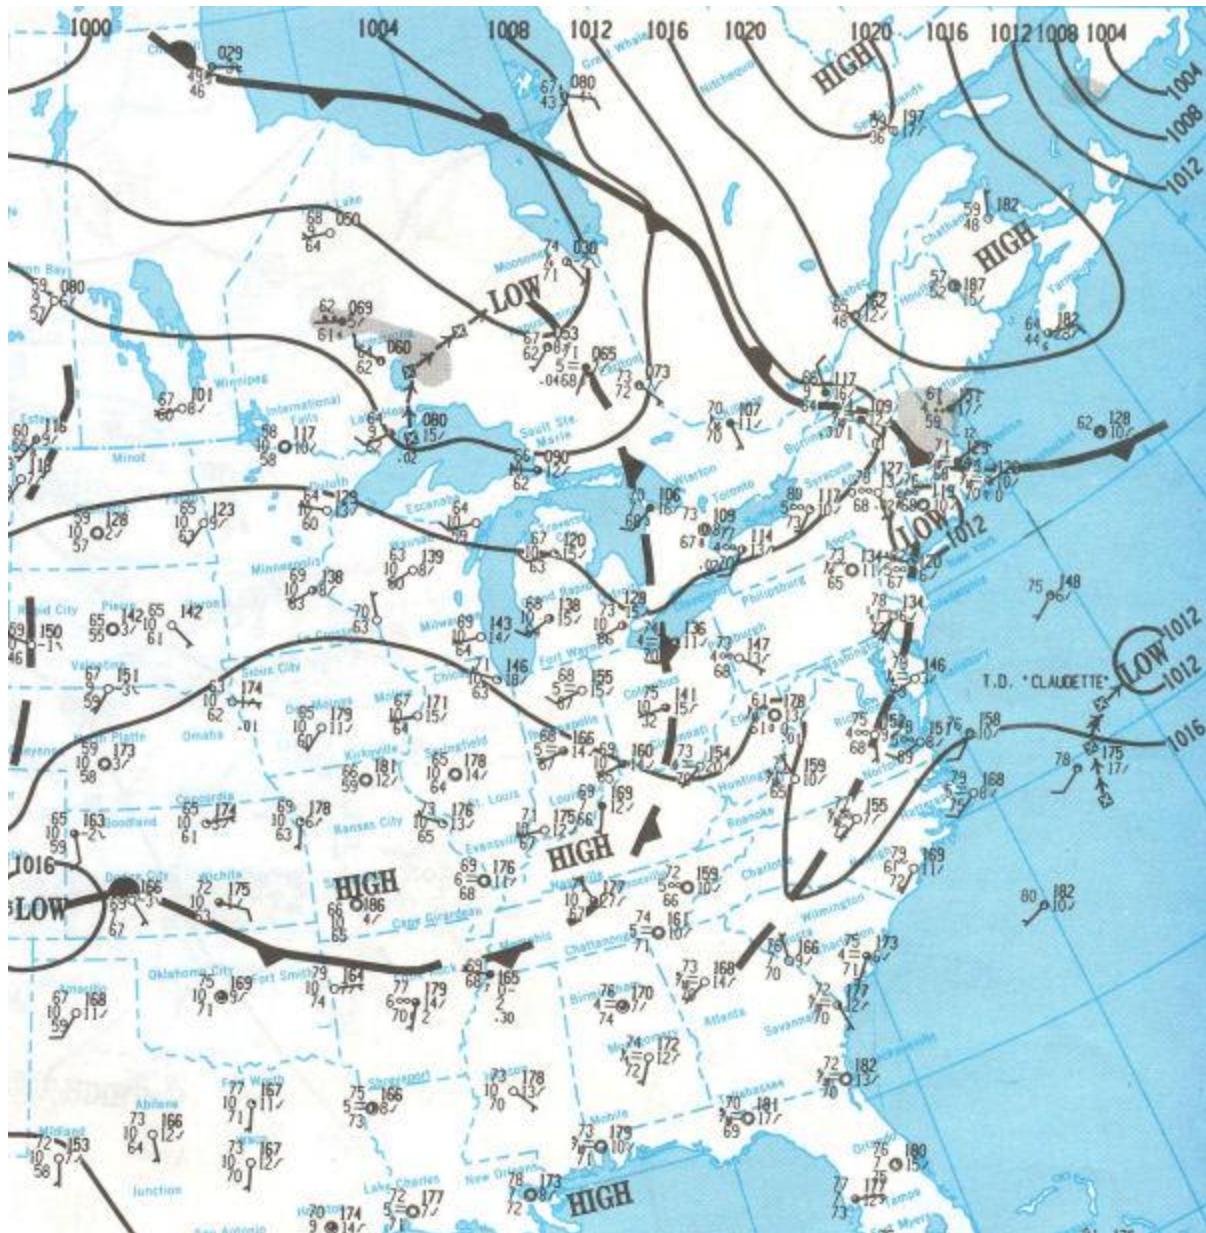
Meanwhile, at the surface, high pressure was spilling down across far eastern Canada and into Maine. To the west, across the rest of New England, a complicated scenario was setting up, with a low pressure center developing just north of Long Island, and a backdoor cold front, nearly stationary, lingering across central and northern Vermont, nearly parallel to the spine of the Green Mountains. The low pressure allowed Atlantic moisture, enhanced by the remnants of Tropical Storm Claudette, to stream into northern New England, riding up and over or just along the cold frontal boundary, providing more abundant lift to the atmosphere.

Surface analysis at 8 am EDT, 12 UTC, July 15, 1997

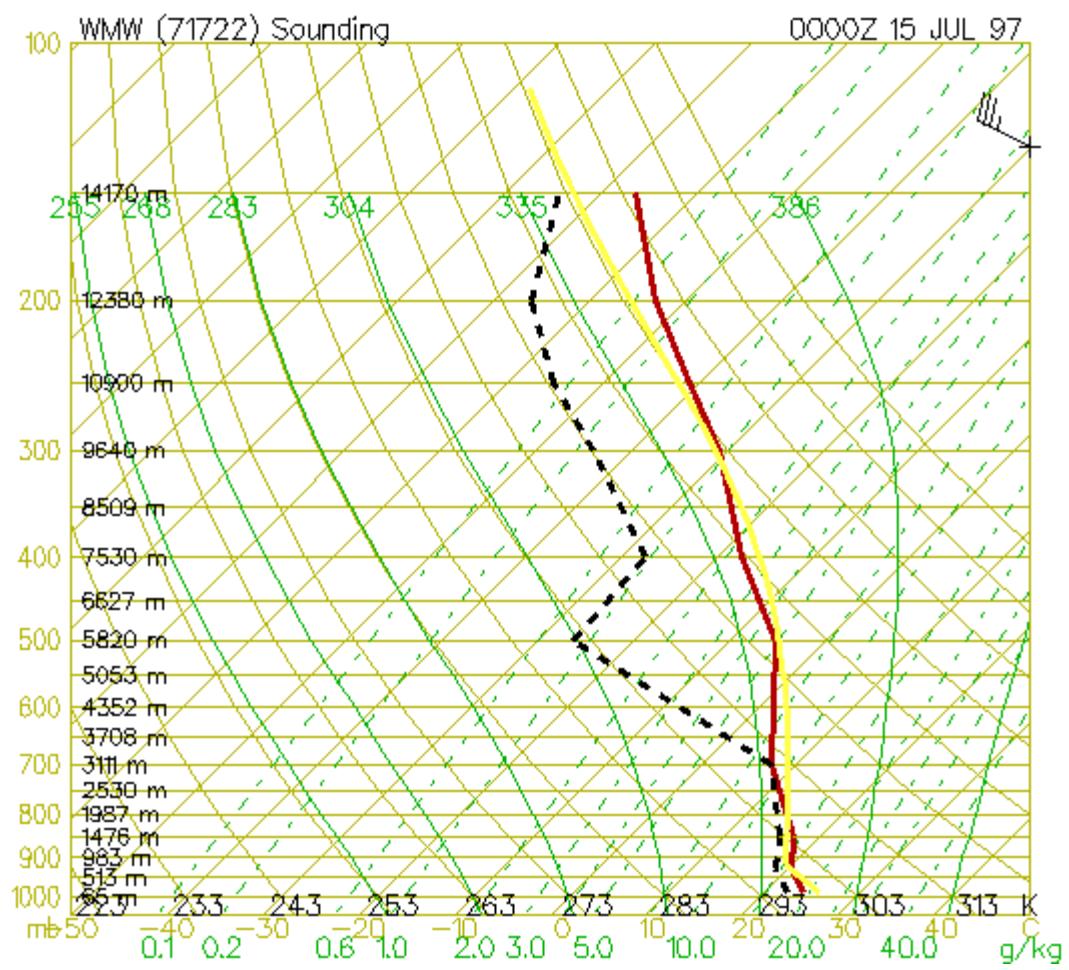
With the aforementioned feed from Tropical Depression Claudette, moisture was abundant over the area, with precipitable water values approaching 2 inches. The Maniwaki, Quebec, July 15 00 UTC (July 14, 8 pm EDT) sounding is indicative of the air mass that was being lifted up the western slopes of the Green Mountains and over the cold frontal boundary. A deep moist layer, with the sounding nearly saturated up to 700 mb, is clearly evident. Also notice that the freezing level is around 550 mb. This warm moist layer is indicative of a tropical air mass. Such air masses are very efficient at producing heavy precipitation.

July 15 00z Maniwaki, QC, Skew-T diagram, from Plymouth State University

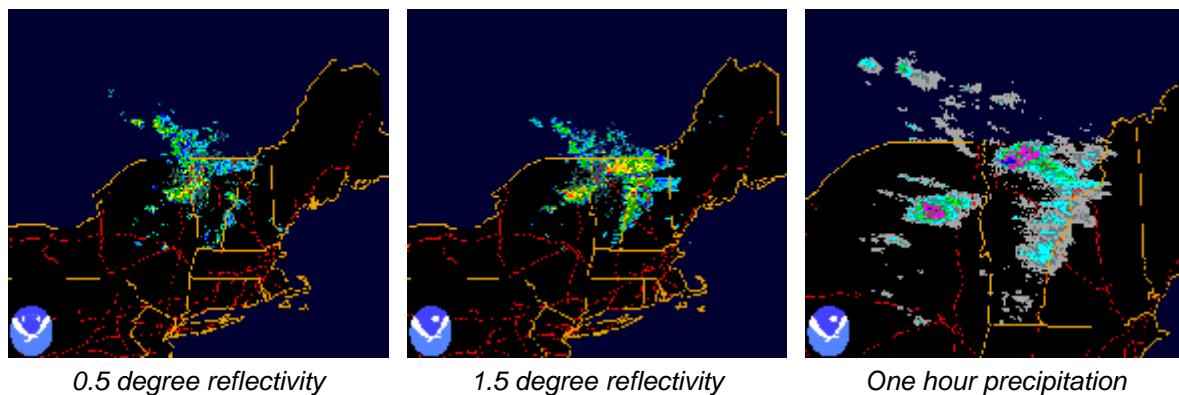
The combination of all these factors produced torrential rainfall, focused along the frontal boundary and terrain, that trained over the same area for hours. The first flash flood warning, for Franklin County, was issued from the NWS office in Burlington, VT at 3 am EDT (07 UTC); by that time, heavy rain had been falling on the area for a couple of hours. This is evidenced by radar imagery. Click on the images below to view a time-lapse animation.

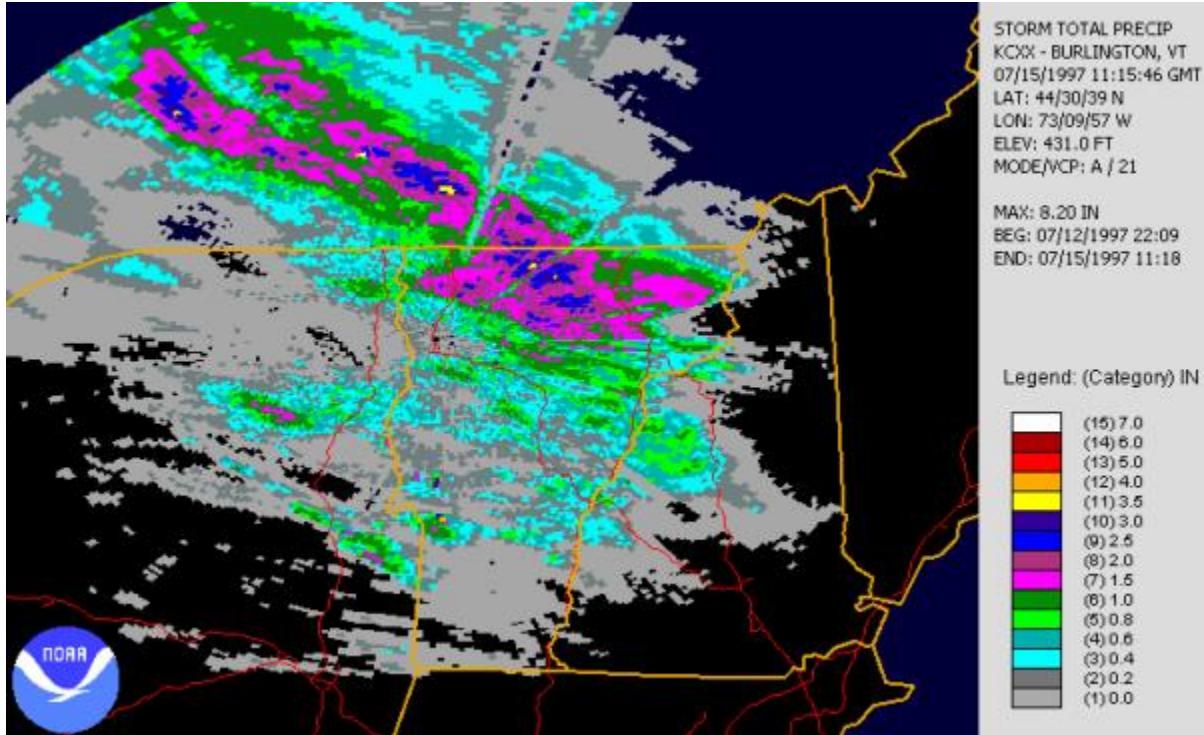
receiving 2.84 inches. It is important to note that rain also fell in the area the previous day, July 14, with area observers reporting anywhere from one-third to nearly one inch of precipitation. Radar-derived storm total precipitation, taken at 11:15 UTC, or 7:15 am EDT, shows a large swath of 2 to 3 inch amounts across northern Vermont, with localized areas of 3.5 to 4 inches. These numbers may be underestimated due to two factors. First, it appears that the radar was not placed in tropical mode. As mentioned previously, the airmass in place over the region was very warm and moist; if the radar operates in standard mode in this kind of environment, it often will underestimate the total rainfall by about a factor of two due to the atmosphere's increased efficiency at producing precipitation.

Secondly, the lower elevation of the radar beam were probably blocked by the Green Mountains.

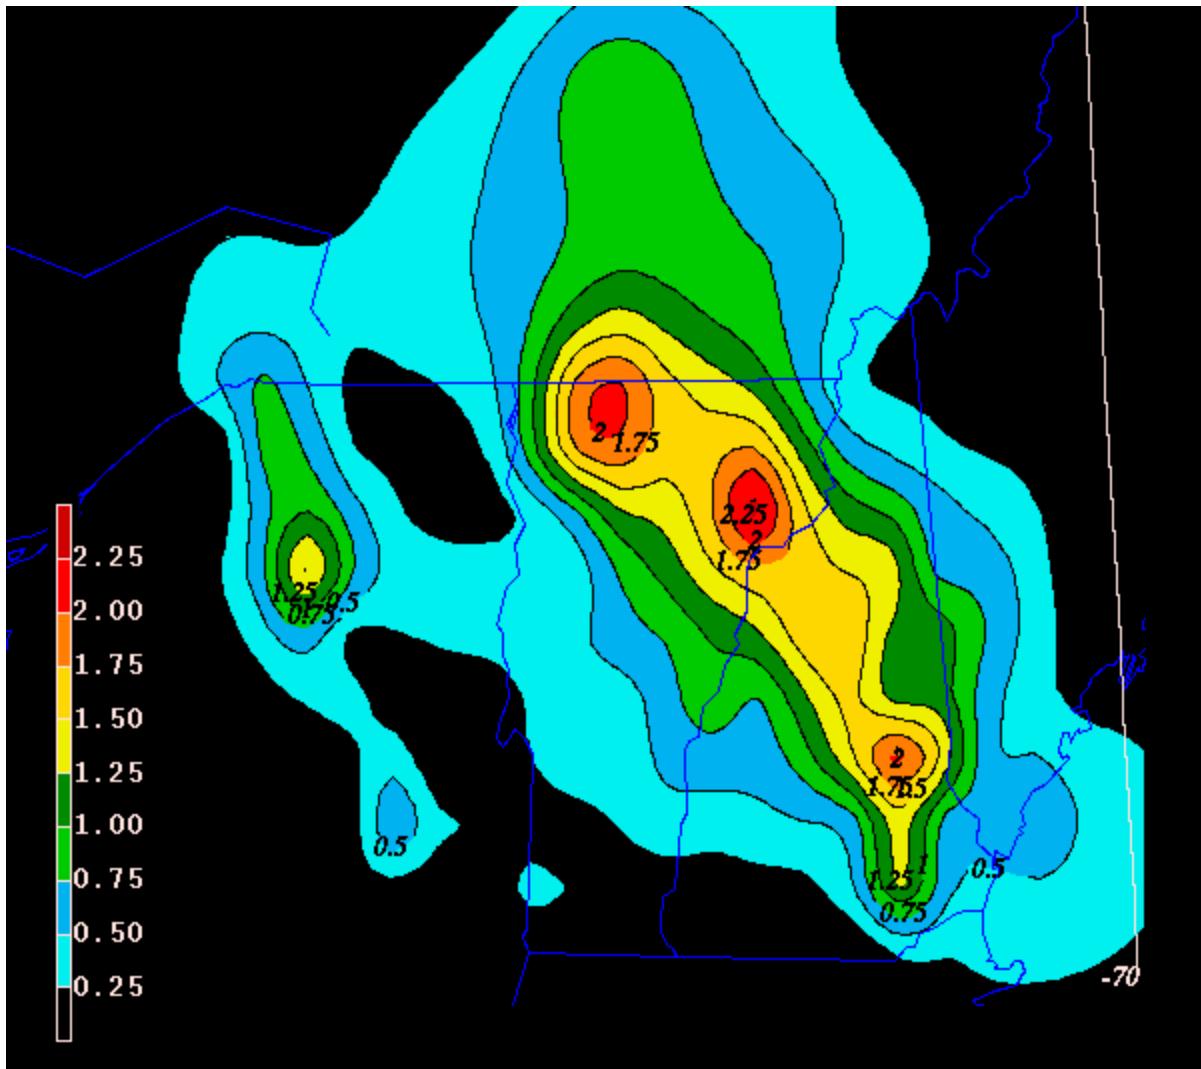
A combination of daily rain gauge data, from such sources as the NWS Cooperative Observer Program and the River Forecast Centers, is shown below. Like the radar-derived rainfall accumulation, the amounts depicted are under-represented due to resolution constraints of the gridded data. However, the graphic below clearly shows where the maximum rainfall occurred; namely, northern Vermont. The rain gauge dataset is compiled and provided by the [Climate Prediction Center's Earth System Research Laboratory](#).

24-hour rainfall at 8 am EDT, 12 UTC, courtesy CDC and John Gyakum and Eyad Atallah of McGill University

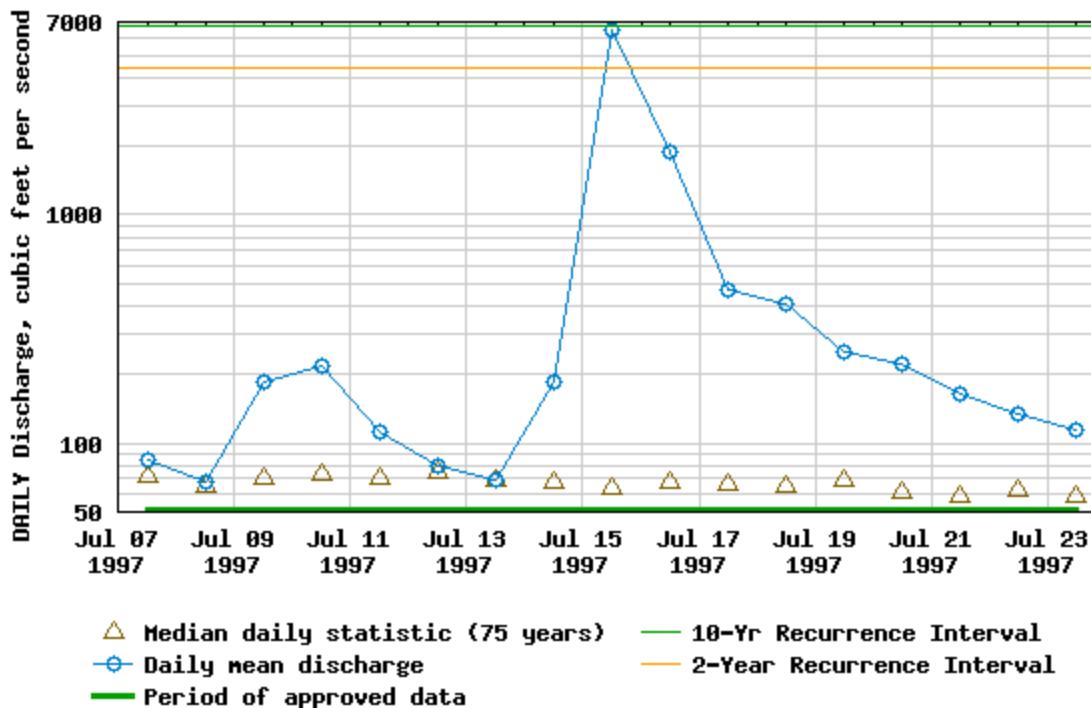
USGS 04293000 MISSISQUOI RIVER NEAR NORTH TROY, VT

With the ground most likely already saturated from antecedent precipitation, the 2 to 6 inches that fell across northern Vermont on July 15 quickly became runoff into the area's waterways, which were already on the rise. Streams and rivers were quickly overwhelmed. Smaller tributary rivers quickly swelled over their banks, followed by flooding along the larger, mainstem rivers. Along the Missisquoi River, North Troy recorded a new record peak flow value that exceeded the 10-year recurrence interval.

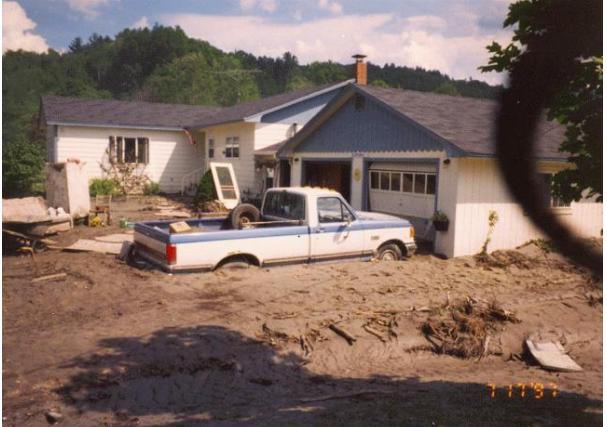
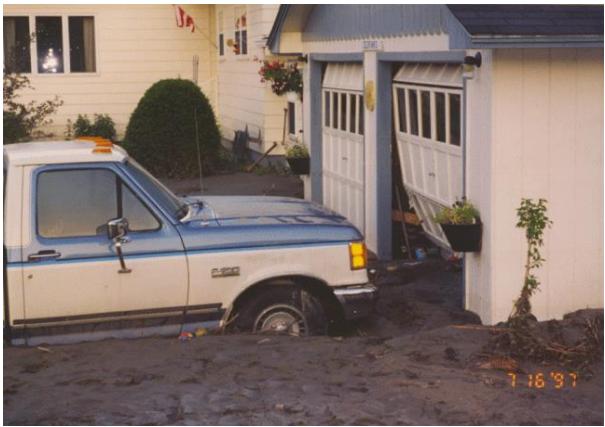
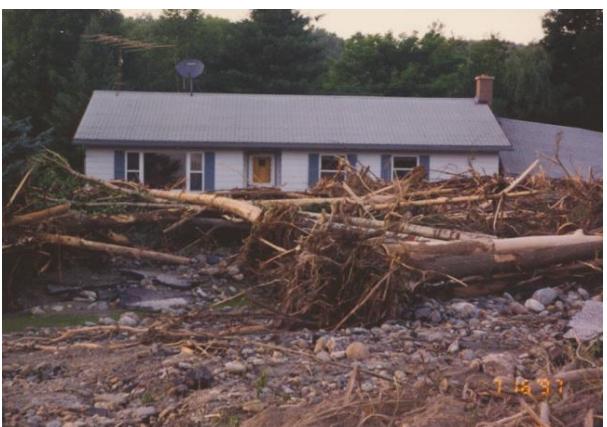
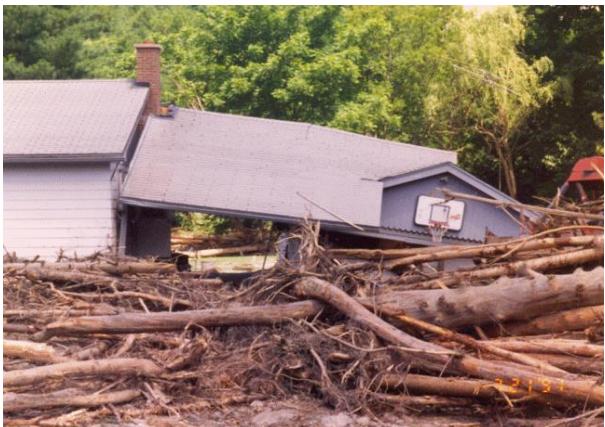
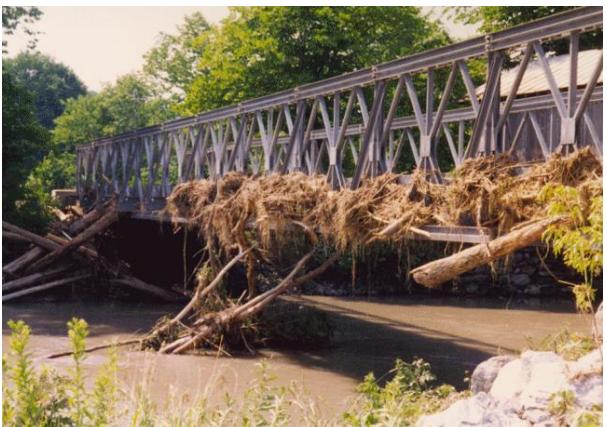
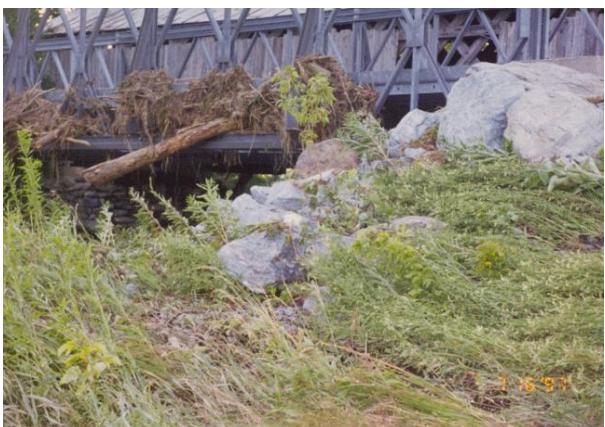
Flooding of the Trout River was especially severe, and it was this that resulted in the widespread devastation in Montgomery Center. As the river overflowed its banks, the rushing water was made all the more dangerous as it traveled down the surrounding terrain, picking up speed under the influence of gravity. Numerous roads and bridges were washed out, and many houses, cars, and other property sustained damage or were destroyed. Fortunately, no serious injuries or fatalities occurred with this flood. This may be attributed to the timing of the flooding; since the rains occurred during the early morning hours, people were more likely to be in the relative safety of their homes, as opposed to being outside or in a vehicle. Never drive across a flooded road; Turn Around, Don't Drown! To learn more about flood safety, click [here](#).

A selection of damage pictures in and around the Montgomery area are posted below. Click on the thumbnail to see a larger version of the photo.
