# Preliminary Hurricane/Tropical Storm Irene Weather Summary for the North Country

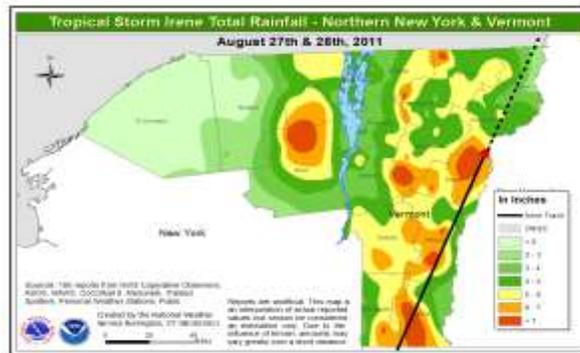
Figure 1 shows the 4-8 inches of rainfall that occurred from Irene and its storm track. The higher rainfall amounts occurred west of the storm track with local maxima over the mountains.

As was seen in Figure 1, much of the area was affected by widespread tropical rainfalls of 4 to 8 inches with the heavier amounts over the steep mountain slopes resulting in widespread severe flash flooding especially in central and southern Vermont.

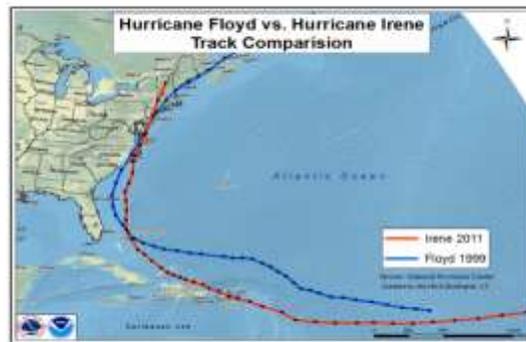
Figure 2 shows the track of Irene from the tropics to New England which was similar to Hurricane Floyd which produced similar rainfall amount, but because it was dry, less flooding. Tropical Storm Irene developed in the Lesser Antilles during the evening of August 20th and proceeded northwest crossing Puerto Rico on August 21st as it strengthened into a minimal Category 1 Hurricane (75 mph) on the morning of August 22nd. Hurricane Irene continued to travel just north of the Dominican Republic as it strengthened into a Category 2 storm during the evening of August 22nd. While moving across the Turks and Caicos Islands on August 23rd and 24th, Irene intensified into a Category 3 storm. Now classified as strong Category 3 hurricane (120 mph), Irene then passed through the southern and Eastern Bahamas on August 24th and 25th, before moving north-northeast paralleling the southeast coast of the United States until the morning of August 27th.

By mid-morning on August 27th, Hurricane Irene came ashore just east of Morehead City, NC as a Category 1 (85 mph) storm and proceeded north-northeast across eastern North Carolina and then paralleled the mid-Atlantic Coast until making landfall near Atlantic City, NJ during the early morning of August 28th. Irene passed just east of New York City, NY as a minimal hurricane (75 mph) during the mid-morning hours of August 28th, before weakening to a tropical storm (60 mph) near Carmel, NY at midday. Tropical Storm Irene then moved northeast to near Great Barrington, MA by 2 pm EDT and was located along the Vermont/Massachusetts border just south of Halifax, VT at 5 pm with sustained winds of 50 mph. Finally, Irene proceeded to track along the Connecticut River Valley of Vermont before exiting the state near Canaan around 10 pm EDT.

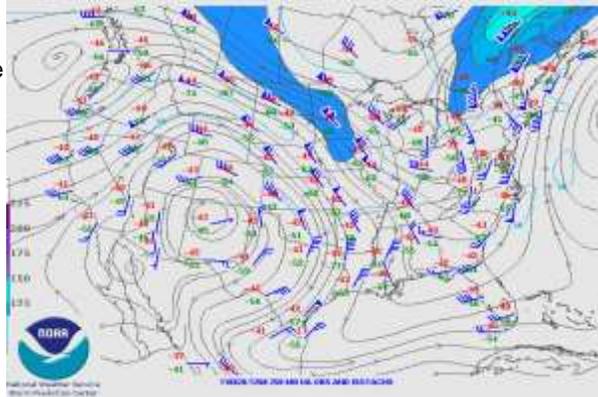
Figure 3 shows that Irene's storm track was largely determined by the jet stream winds in the upper atmosphere 20,000-34,000 ft above the ground. These winds steered the storm right up over the east coast of the U.S.

As Irene moved into the northeast U.S. she was influenced by jet stream wind speeds of over 100-150 mph (shaded blue) over eastern Canada which enhanced the rainfall rates over the North Country.

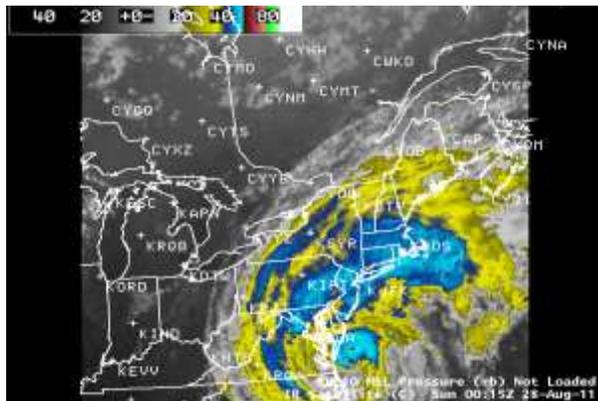
Figure 4 shows the infrared satellite imagery Saturday night and Sunday. The colors in the imagery show the temperatures at the top of the clouds which were as cold as -40 to -60 degrees Celsius.

Generally speaking the colder the tops of the clouds, the taller the cloud and heavier the rainfall on the ground below.

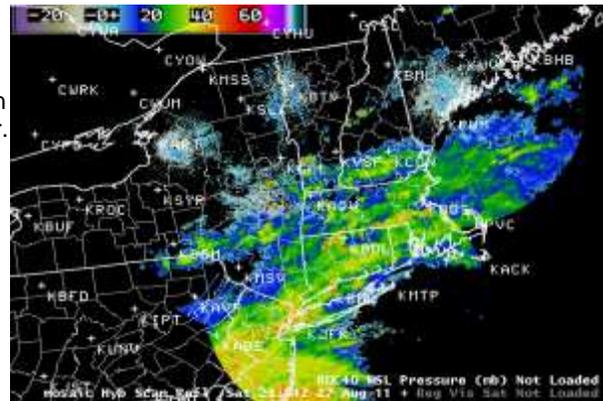
Figure 5 shows the lower level radar reflectivity from Saturday night Aug 27th into Sunday evening Aug 28th. Bands of heavier tropical rain from Irene can be seen moving into the Northeast and are indicated by the brown and red colors with rainfall rates of 1 to 2 inches per hour.

The heaviest rains can be seen moving up through Vermont focused on the Green Mountains and in New York in the Catskills and Adirondack mountains.

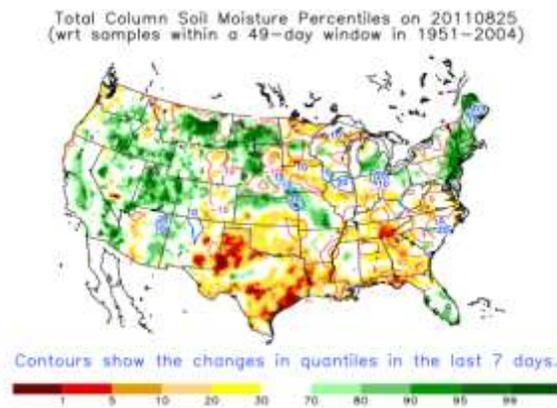
Another reason for the extreme flooding in Central and Southern Vermont was that the soil moisture content was abnormally high in those areas and a bit less in northern VT as seen in Figure 6 (courtesy of Princeton University Land Surface Hydrology Research Group).

Preceding Irene, on Aug 25th, the green shaded areas shows that southern Vermont and New England had moistures much higher than normal while northern New England and northern New York (in white) were closer to normal.

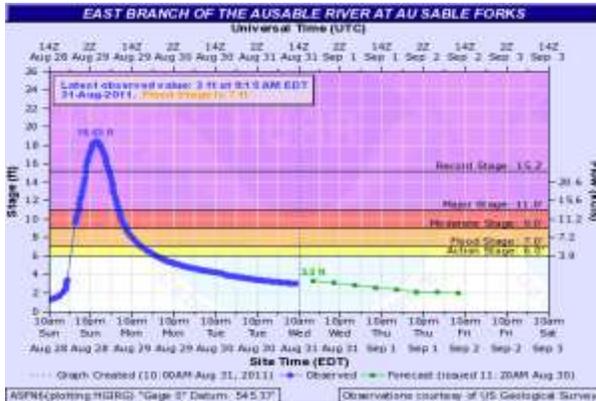
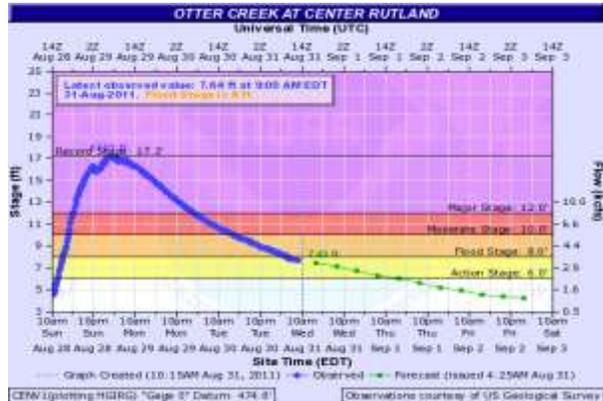
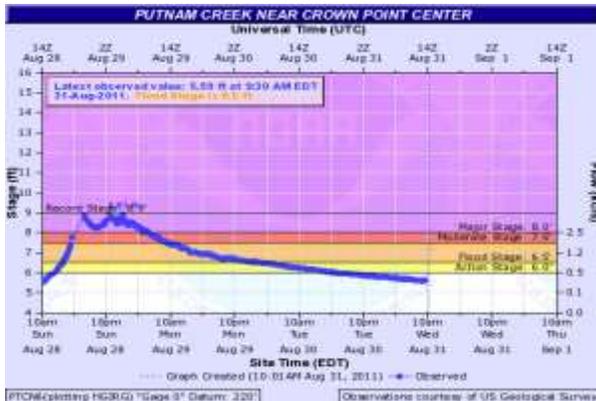
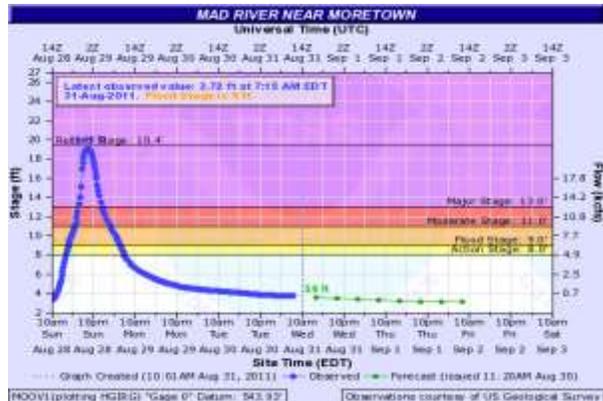
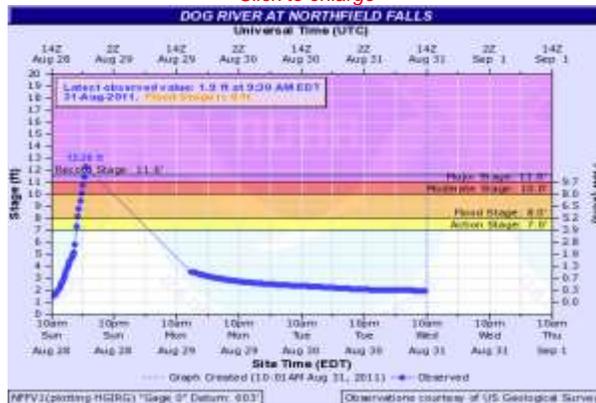
Several rivers reached record crests as displayed in the NWS Advanced Hydrologic Prediction System(AHPS): Ausable River @ Ausable Forks NY (Figure 7) exceeded the old record by over 3 feet, Otter Creek @ Center Rutland VT (Figure 8) exceeded the old record by almost 4 feet, Putnam Creek @ Crown Point NY (Figure 9), Mad River at Moretown VT(Figure 10), and the Dog River @ Northfield Falls VT (Figure 11) reached 12.26 feet (.6 ft above the record) before the gage stopped recording.

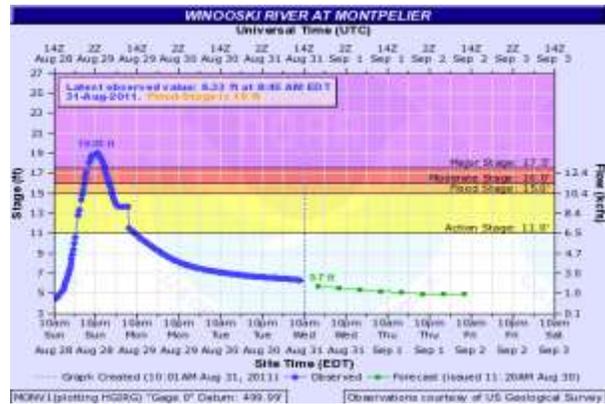
Crests on the Winooski River in Montpelier VT (Figure 12) were the second highest on record (1927 flood being the record), and coincidentally exceeding the previous second highest crest that was set back in May, and resulted in flooding in downtown portion of the city.

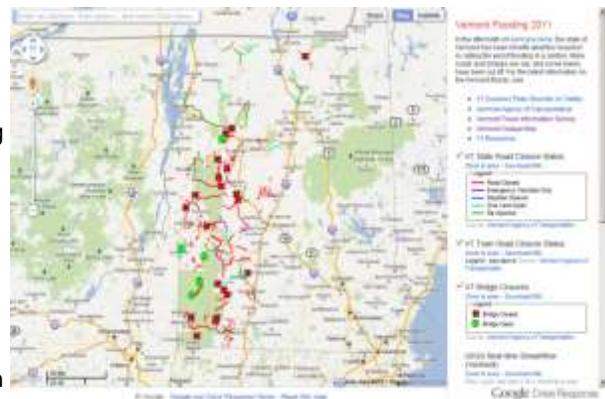
Numerous communities suffered significant road/bridge washouts or severe flooding that resulted in them being cut-off and isolated in the Green mountains. Figure 13 from VTRANS shows roads that were closed or damaged. At least 250 roads were closed due to flooding damage or downed trees across the region.
