November 23, 2018 Coastal Flood Event Post Mortem

Overview: The combination of a strong, inland wedge of high pressure and a developing coastal trough off the Northeast Florida coast produced frequent gale-force wind gusts across the coastal waters of Southeast South Carolina and Southeast Georgia during the morning hours of 23 November. These winds combined with some of the highest predicted tides of the year to produce moderate to major coastal flooding across the coastal counties with the mid-morning high tide cycle. Tide levels at both the Charleston Harbor and Fort Pulaski tide gages breached major flooding thresholds. This was the first major coastal flooding event experienced since Tropical Storm Irma impacted the region in September, 2017.

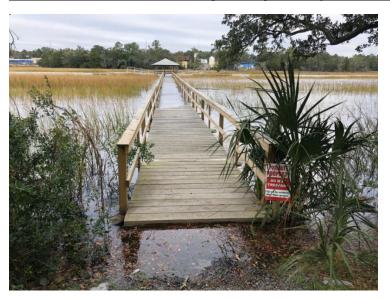
North Charleston: Docks submerged along the Cooper River at Park Circle

PIERS INUNDATED BY THE COOPER RIVER IN PARK CIRCLE. SEVERAL DOCKS DAMAGED. TIME ESTIMATED BASED ON TIDE GAGE.

SOCIAL MEDIA PICTURE INDICATED FLOODING OF A DOCK AND BOAT SLIP NEAR PARK CIRCLE.

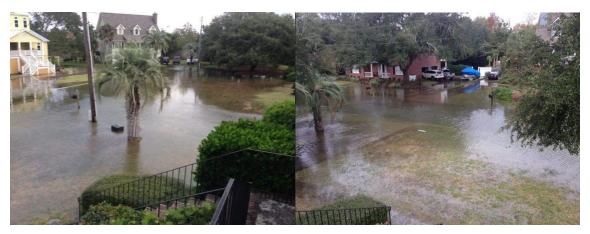
Mount Pleasant: Old Village near Williams Street

> SALTWATER FLOODING ALONG WILLIAMS STREET IN THE OLD VILLAGE. IMAGE SHOWED EXTENSIVE FLOODING IN YARDS WITH WATER AROUND SEVERAL HOMES. ONE ROADWAY ALSO FLOODED. TIME ESTIMATED BASED ON TIDE GAGE.

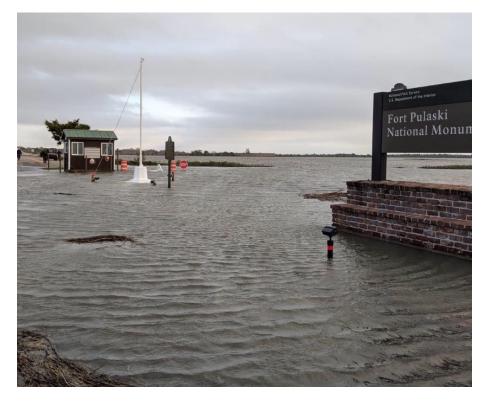
Fort Pulaski National Monument

THE FORT PULASKI NATIONAL MOUNMENT WAS CLOSED UNTIL 10:30 AM DUE TO HIGHWAY 80 BEING IMPASSABLE DUE TO FLOODING.

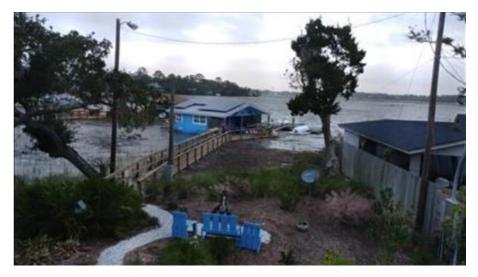
Tybee Island: Houses submerged
