## 2. TORNADO OUTBREAK in the UNITED STATES and CANADA on May 31, 1985

### UNITED STATES-CANADA TORNADO OUTBREAK of MAY 31, 1985

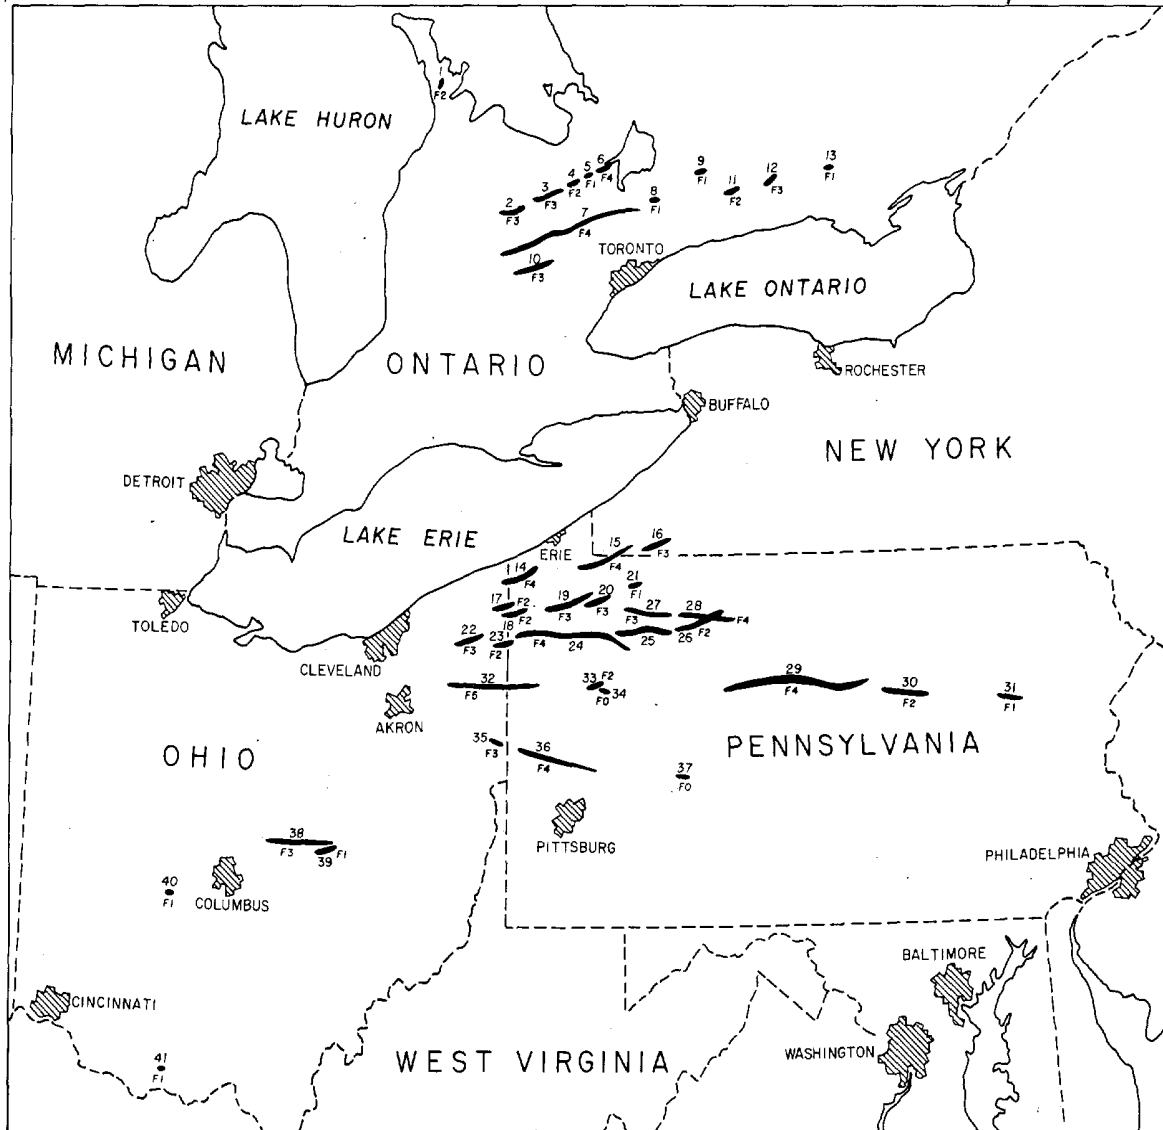
No.	TORNADO NAME	No.	TORNADO NAME	No.	TORNADO NAME	No.	TORNADO NAME
1.	Rush Cove	8.	Wagner Lake	17.	Dorset	26.	Lamont
2.	Hopeville	9.	Reavoro	18.	Linesville	27.	Tidioute
3.	Corberton	10.	Alma	19.	Saegerton	28.	Kane
4.	Borden	11.	Ida	20.	Centerville	29.	Moshannon State Forest
5.	Essa	12.	Rice Lake	21.	Thompson Run	30.	Watsontown
6.	Barrie	13.	Minto	22.	Mesopotamia	31.	Holenback
7.	Grand Valley	14.	Albion	23.	Kinsman	32.	Wheatland
		15.	Corry	24.	Atlantic	33.	Big Bend
		16.	Busti	25.	Tionesta	34.	Emlenton
						35.	Middleton
						36.	Beaver Falls
						37.	Penn Run
						38.	Utica
						39.	Cooperdale
						40.	London
						41.	West Union

---This outbreak map was prepared at the University of Chicago based on the following data sources available as of October 8, 1985:

Aerial and ground surveys of Ohio, Pennsylvania and New York tornadoes by Duane Stiegler, University of Chicago and Greg Forbes, Pennsylvania State University. Aerial survey of Canadian tornadoes by Brian Smith, University of Chicago and the Canadian Weather Service.

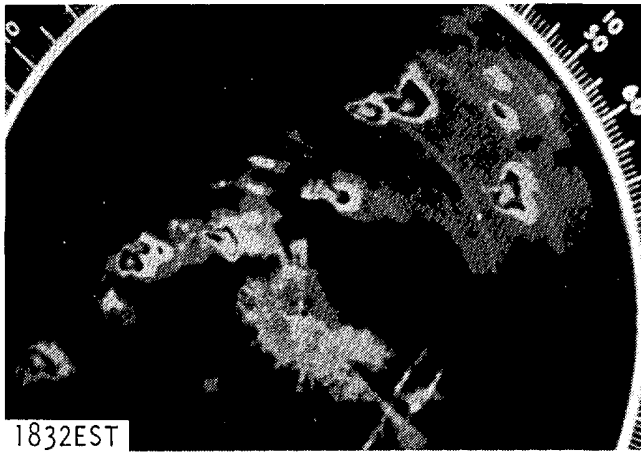
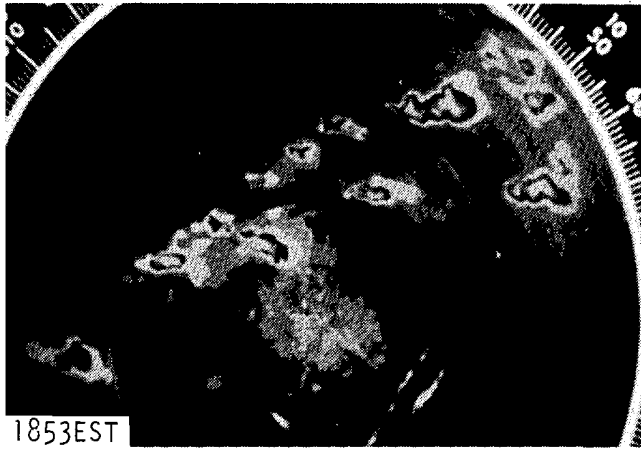
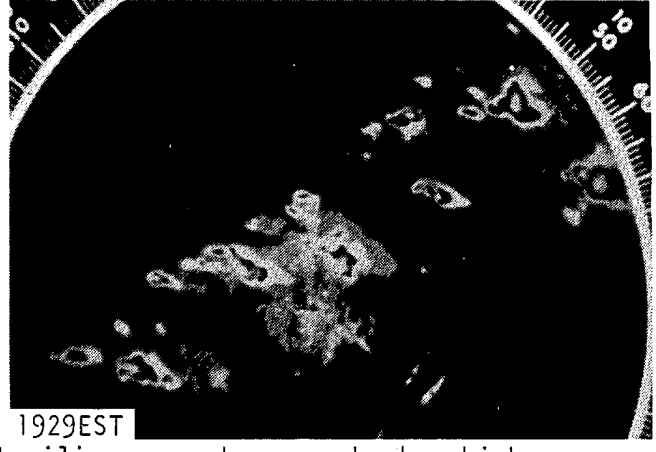
A sequence of PPI scope images taken from the WSR-57 radar at Pittsburg, Pennsylvania during the tornado outbreak on May 31st. The individual cells, many of which reached level 6 intensity, often exhibited characteristics associated with rotating thunder-

storms. Many displayed features such as trailing appendages or hooks which are additionally indicative of tornado production. ---Radar microfilm from NCDC.

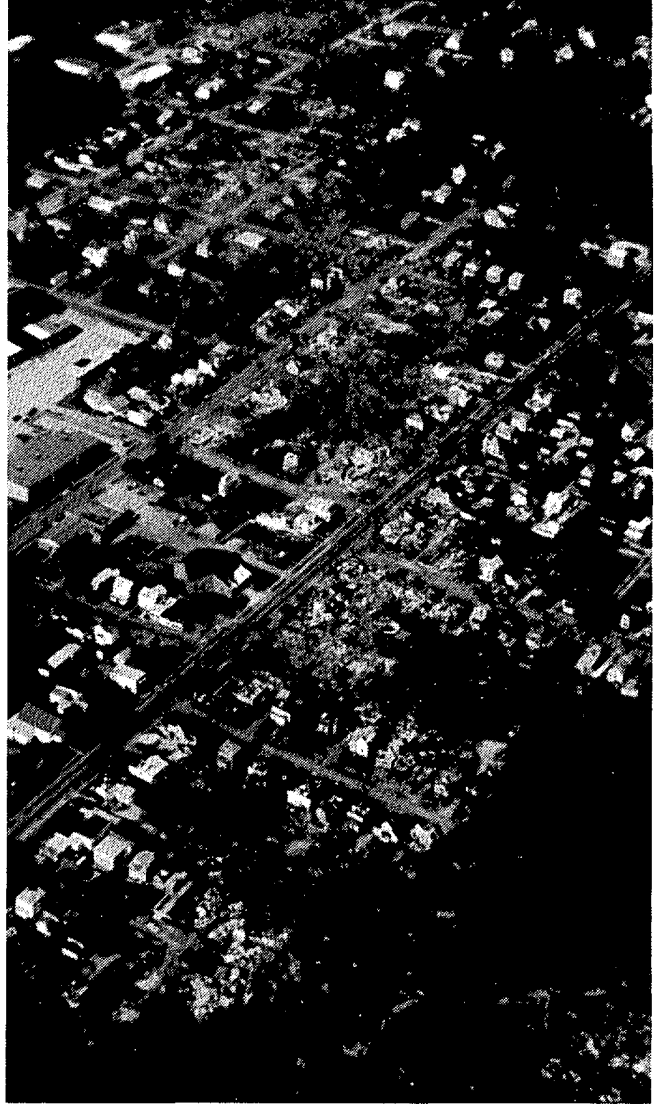
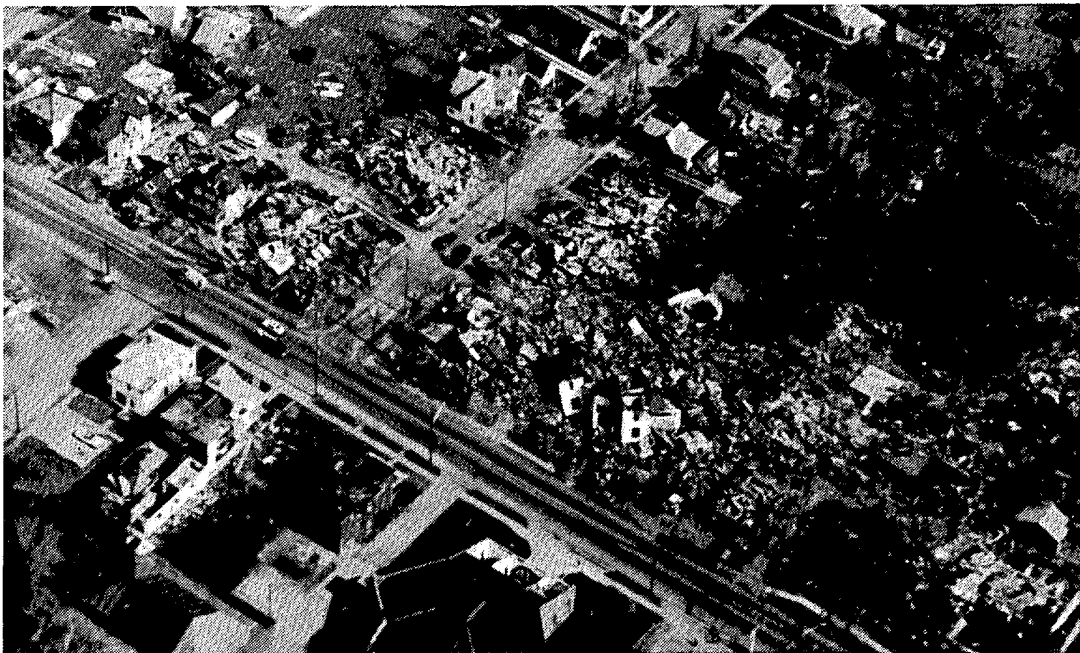
Above are two aerial views of Albion, Pennsylvania, looking northeast along the tornado's damage track from the southwest edge of town (left) and through the center of Albion (right). Below are destroyed homes along Albion's main street.

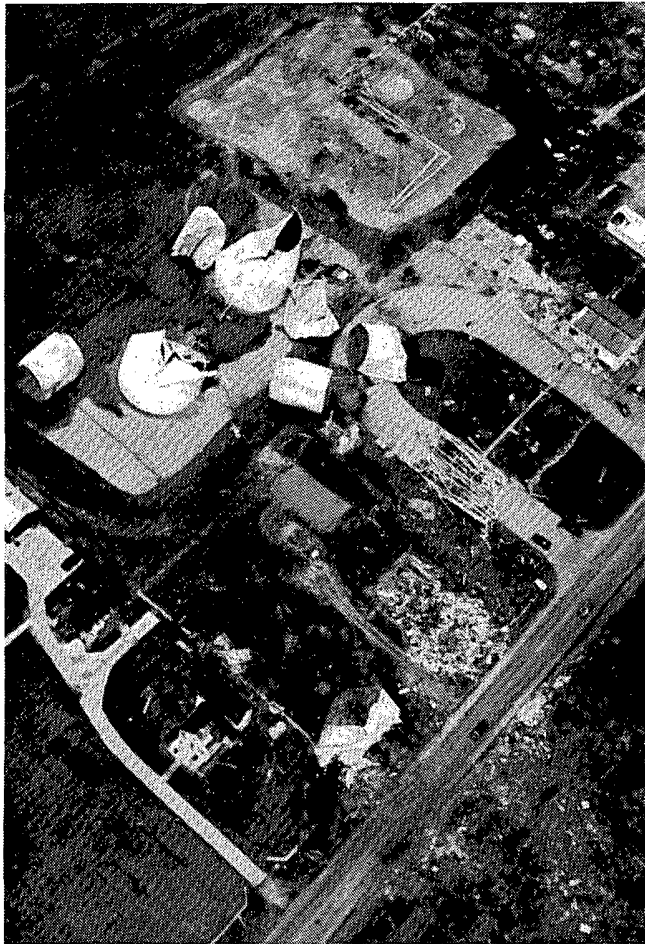
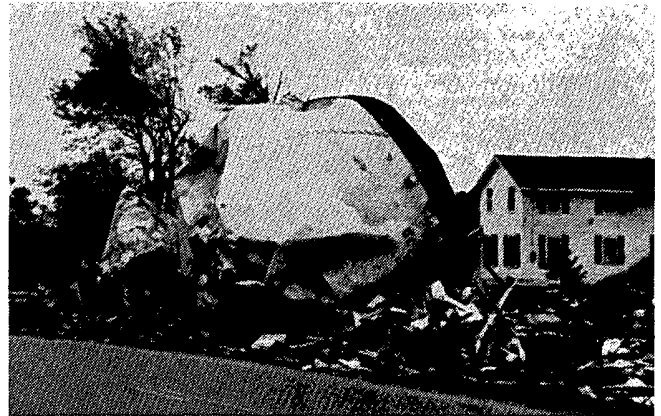
Destruction caused by the Wheatland Tornado included this petroleum tank farm (left and above) on the west edge of Niles, Ohio. Some of the tanks were bounced a considerable distance.

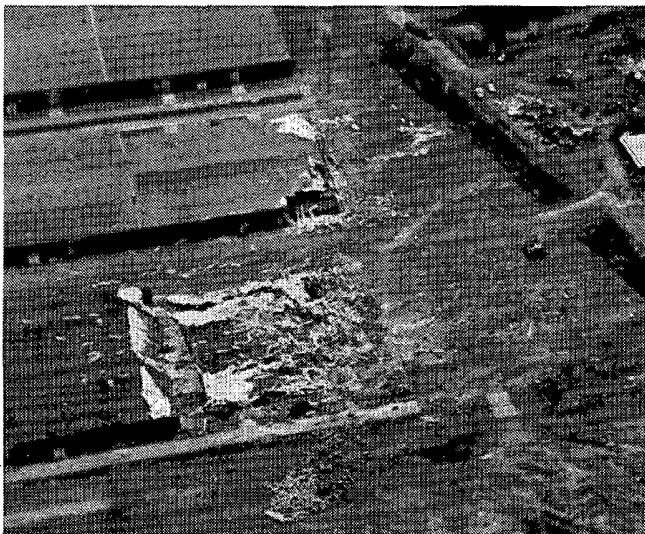
Warehouse damage in Niles included the collapse of the end of one building as the tornado clipped its edge.

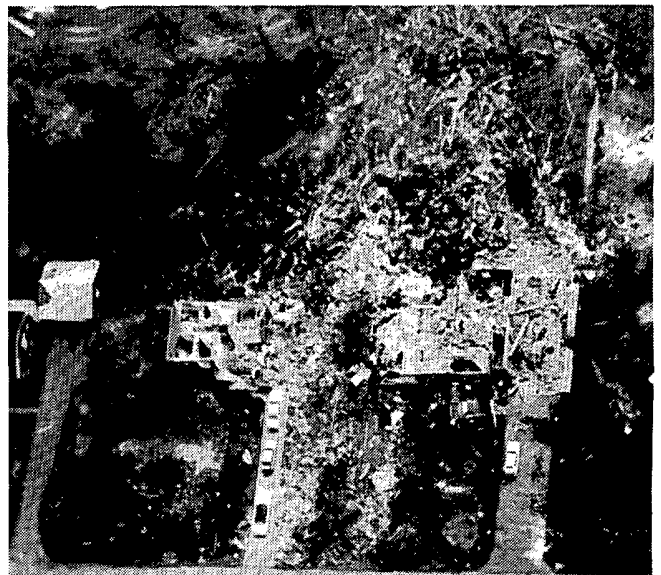
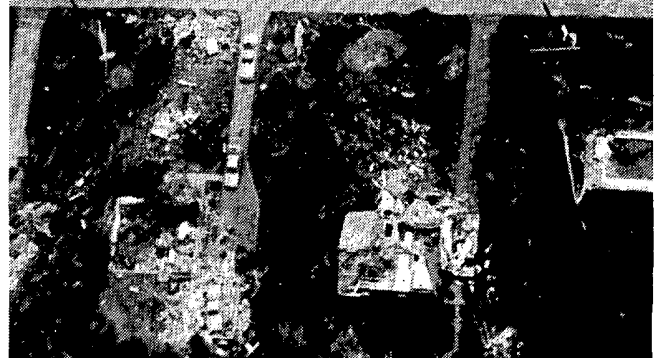
At right is typical damage and/or destruction that was received by many of the homes in Niles.

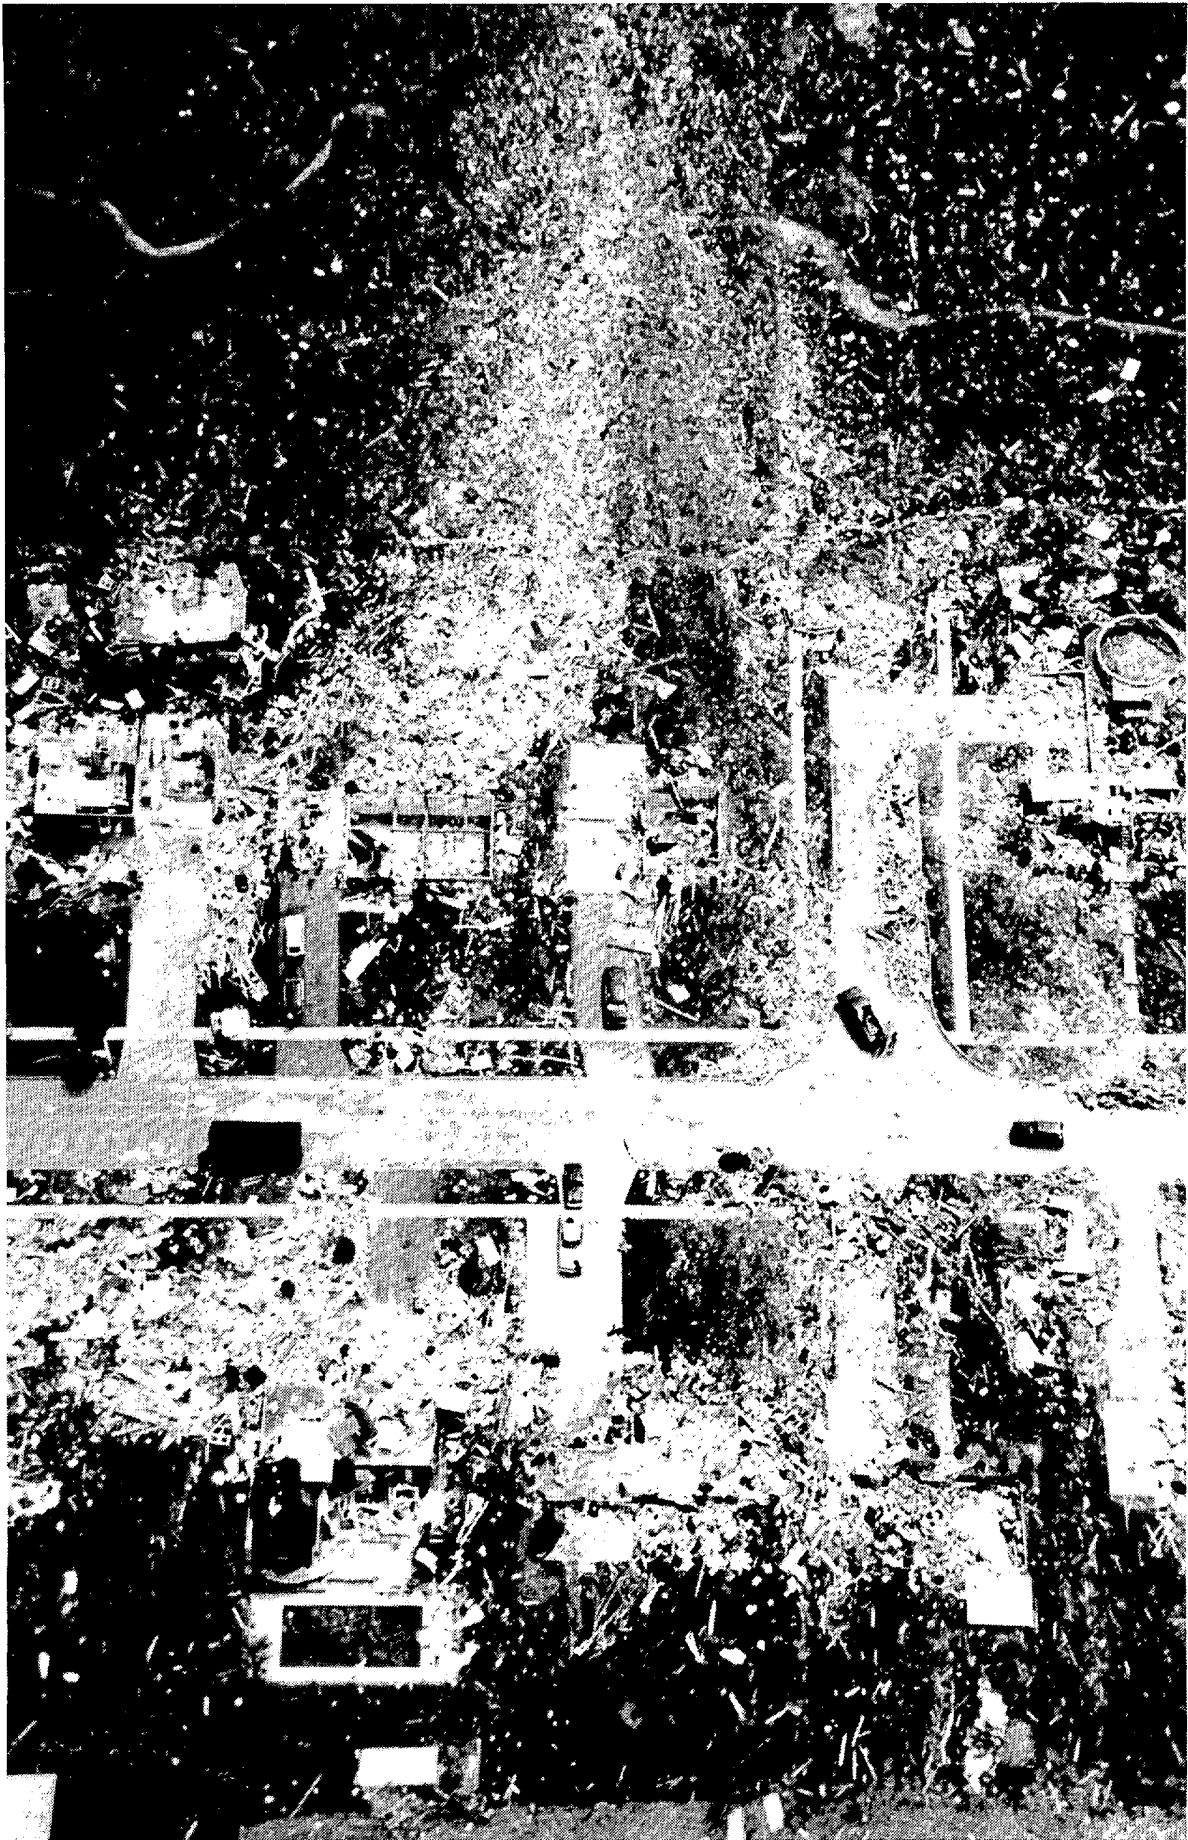
A residential area of Niles, Ohio that was obliterated by the Wheatland Tornado.

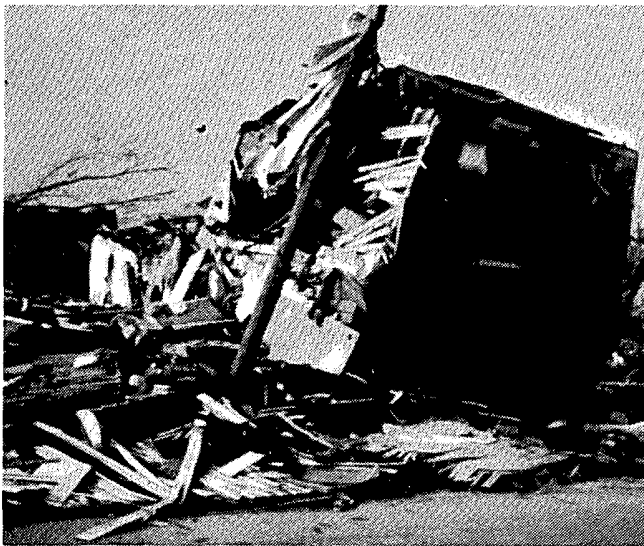
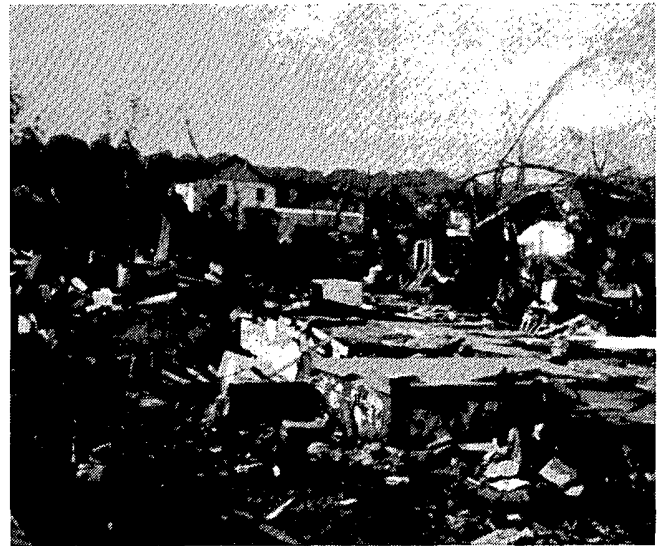
A Wheatland home that was blown loose from its foundation (left), and one where one person died and all that remains is the cellar and part of the foundation. ---Both photos by Matthew Goral, Hermitage, Pennsylvania.

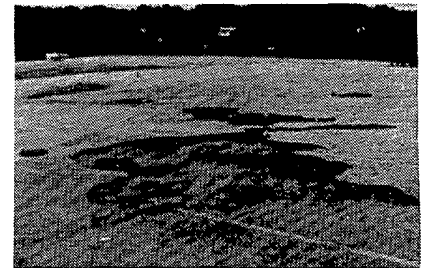
A trucking plant on the east edge of Wheatland that was twisted beyond recognition. Asphalt was peeled and lifted from the parking lot (right) by the tornado's winds, and routing slips from the plant were found wedged under the remaining asphalt.

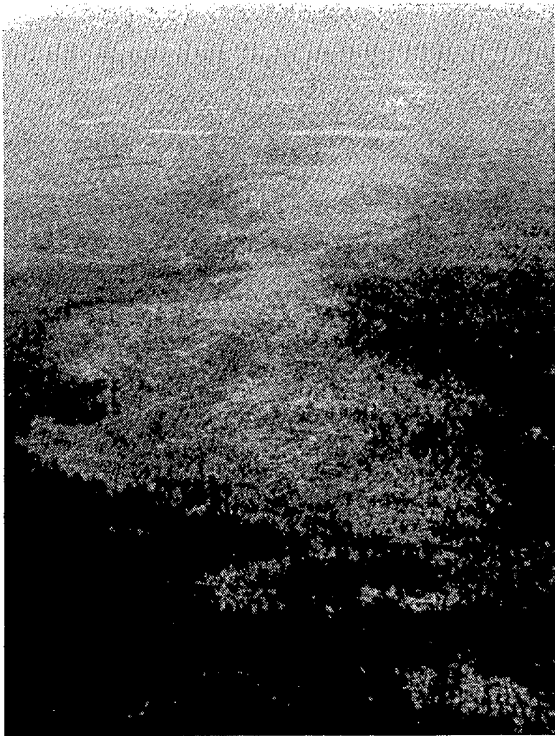
Above to right are increasingly closer views of the forest damage caused by the Kane Tornado. Devastation was so complete near the path's center that every tree was either uprooted or snapped off at the base. Many ended up defoliated and/or debarked.
