...FINAL DAMAGE SURVEY RESULTS FOR NORWALK AND CUMMING ...

ON MONDAY...JUNE 25...2007...IOWA HELICOPTER CONDUCTED AN AERIAL DAMAGE SURVEY OF THE CUMMING AND NORWALK TORNADOES THAT OCCURED ON JUNE 22...2007. AFTER REVIEWING THE AERIAL PHOTOS...THE FINAL DAMAGE SURVEY REPORT FOR THE TWO TORNADOES HAS BEEN UPDATED.

THE FOLLOWING IS A FINAL GROUND ASSESSMENT FOR THE DAMAGE THAT OCCURRED OVER NORWALK AND CUMMING ON JUNE 23...2007.

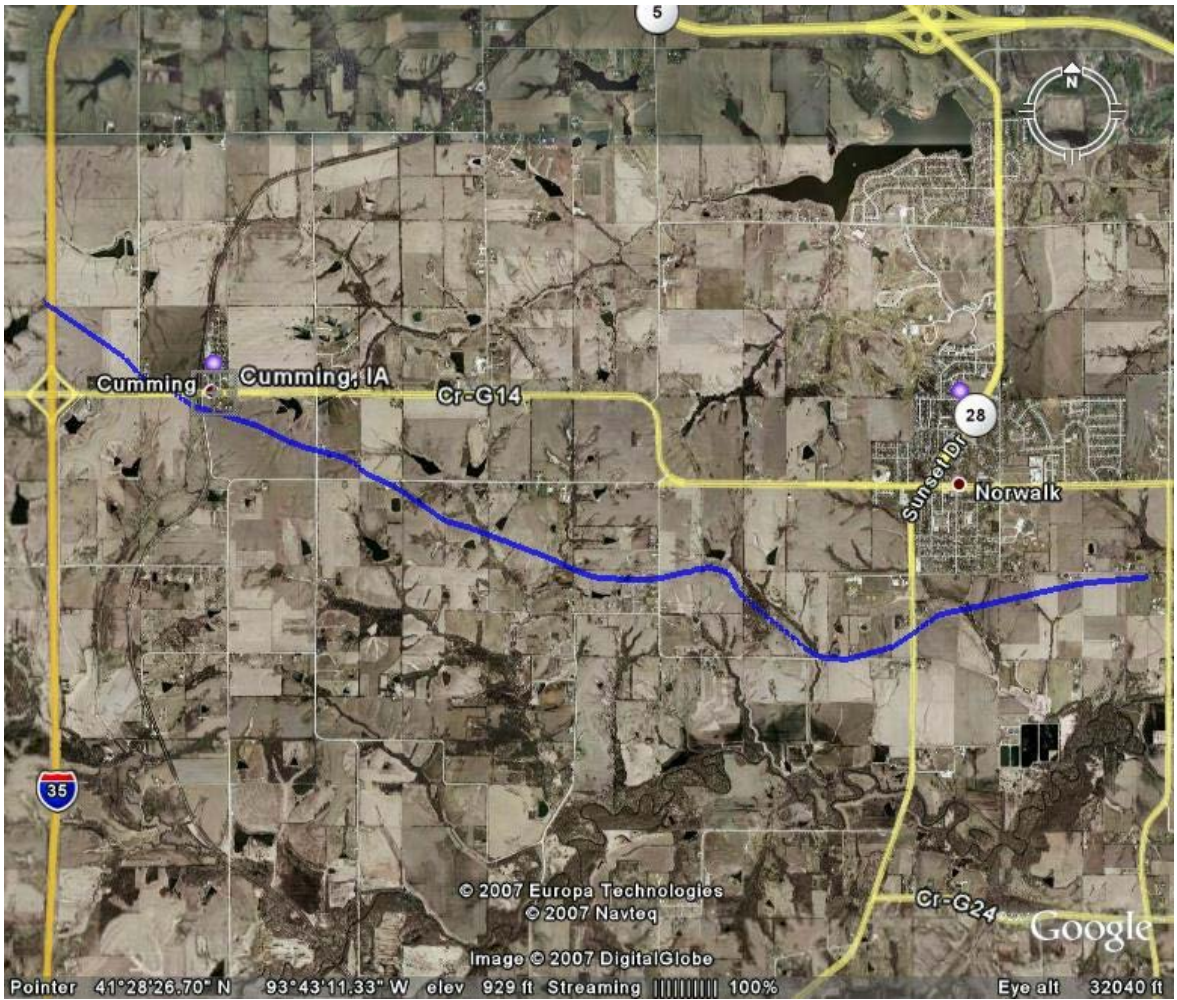
Cumming to Norwalk tornado track rated EF2 just southeast of Norwalk. Courtesy of IowaHelicopter.com

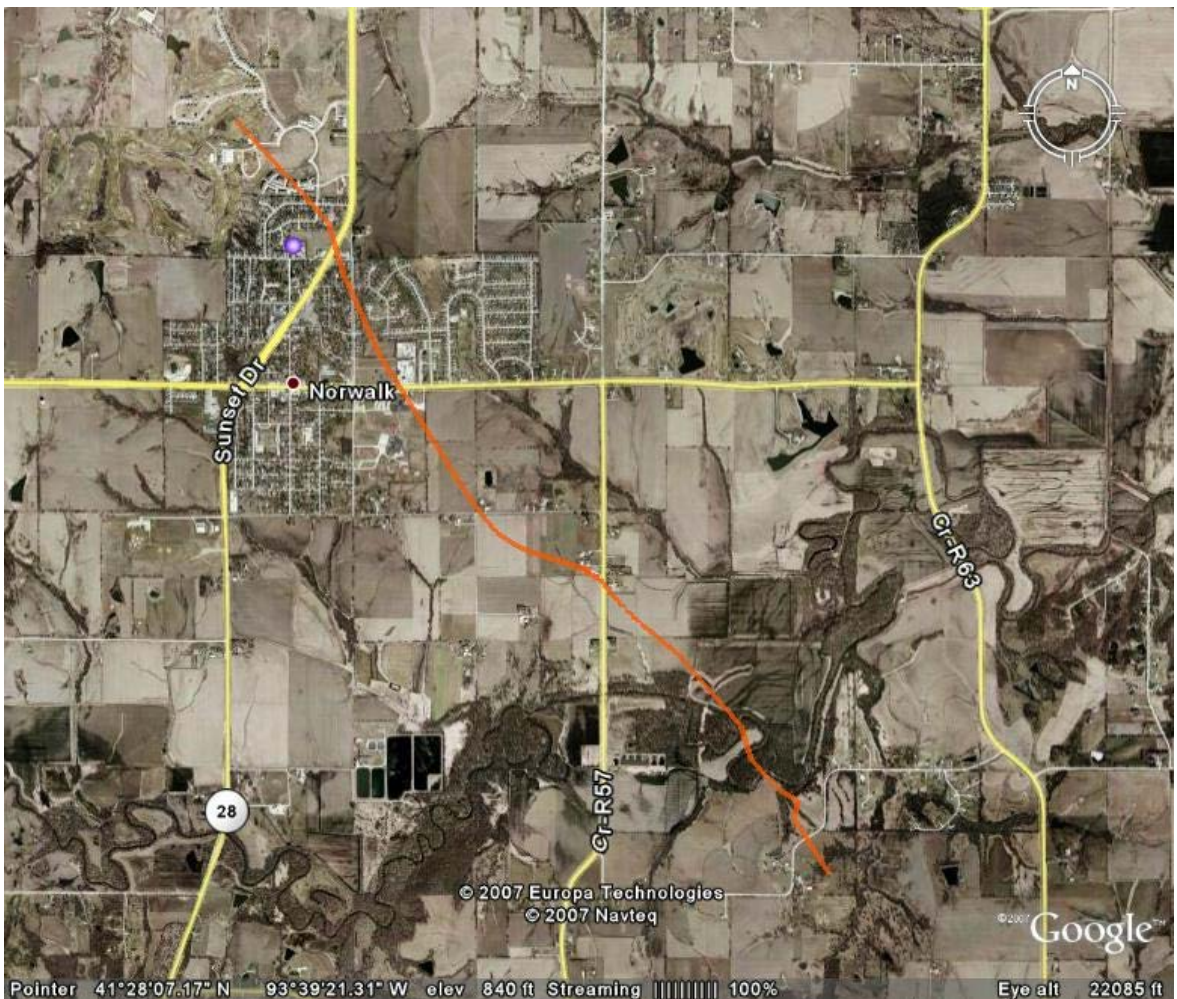
Norwalk tornado which was weaker than the first tornado. It produced EF1 damage in northeast Norwalk. Courtesy IowaHelicopter.com

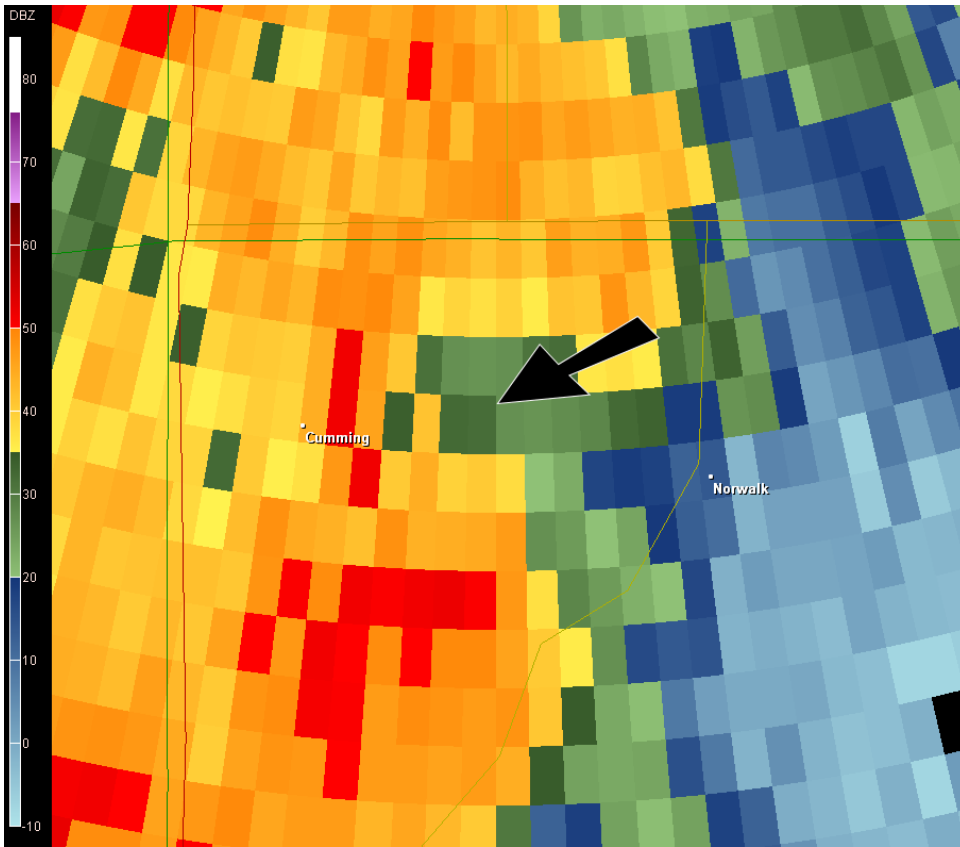
1) KDMX WSR 88-D radar Reflectivity image around 4:37 PM CDT, shortly after an EF-1 tornado touched down in Cumming. The arrow depicts the notch in the reflectivity image that developed as the 1st tornado occurred.

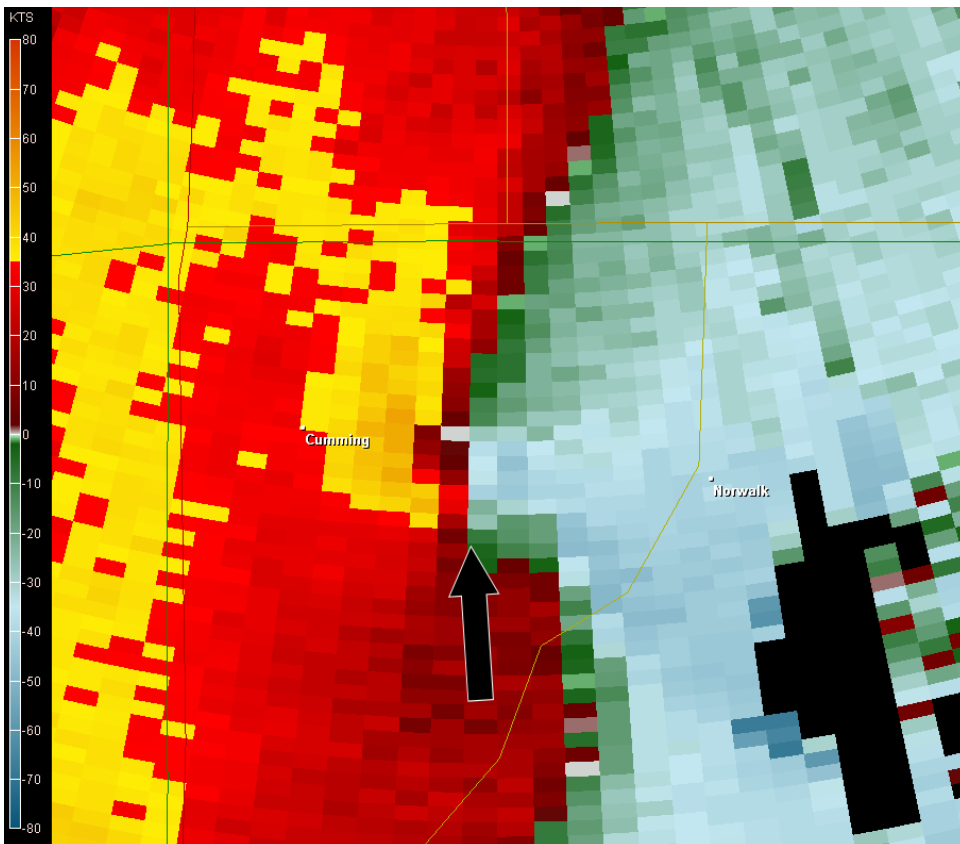
2) KDMX WSR 88-D Storm Relative Motion image around 4:37 PM CDT corresponding with the reflectivity image in graphic #1. On this image, yellow displays strong motion away from the radar while blue displays strong motion towards the radar. The arrow points to the area of strongest rotation at this time which is now between Cumming and Norwalk.

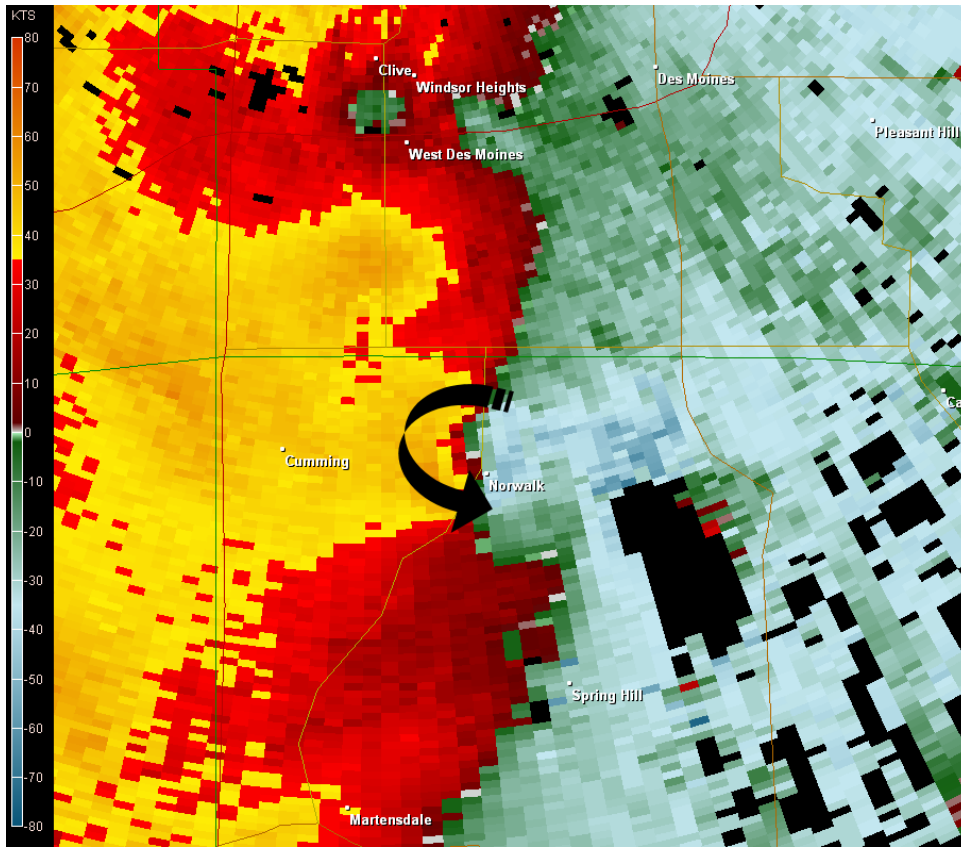
3) KDMX WSR 88-D radar Storm Relative Motion at 4:40 PM CDT near the time a second tornado touched down, this time in Norwalk. Once again the yellow color depicts strong motion away from the radar and the blue is strong motion towards the radar. The arrow demonstrates the cyclonic (counter-clockwise) motion displayed by the radar.

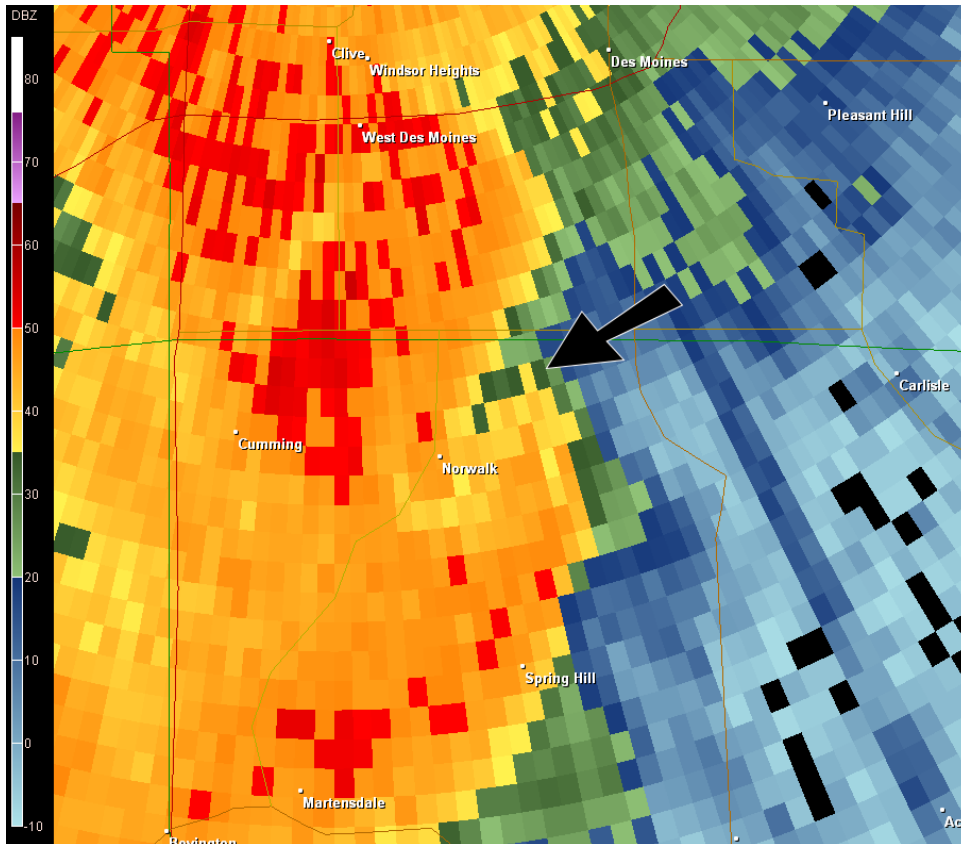
4) The above reflectivity image from KDMX WSR 88-D radar is at 4:44 PM CDT with the arrow pointing to the notch in the reflectivity image as it passed over Norwalk. This image is near the time EF-2 damage (estimated 125 mph wind) was occurring on the southeast side of Norwalk.

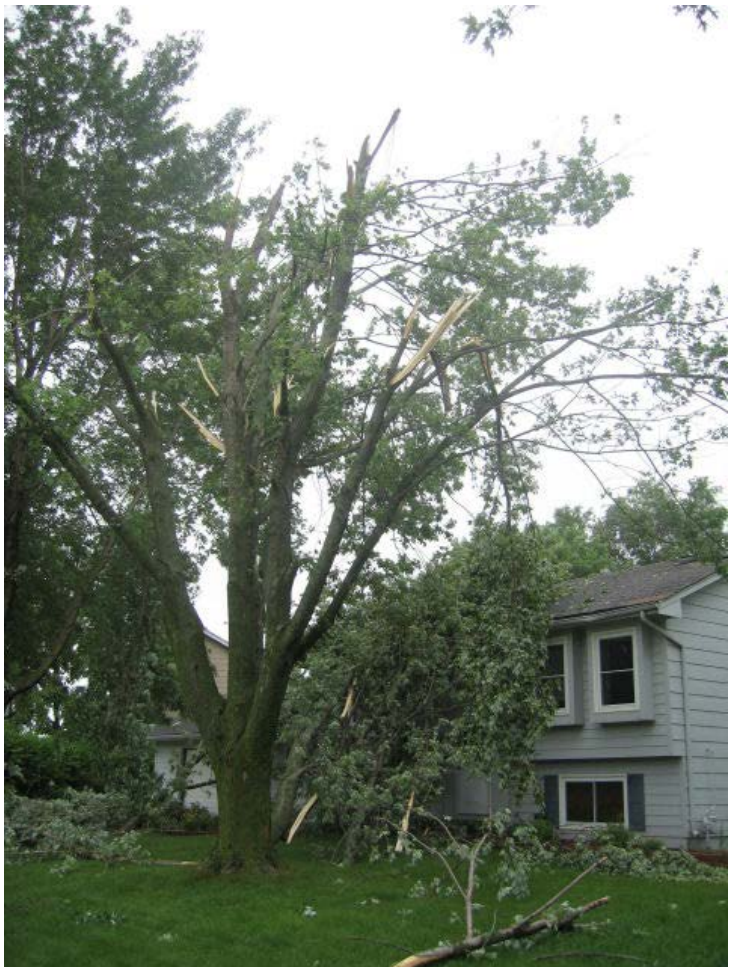
5) Tree Damage in Norwalk southeast of the Casey's area. The tree damage throughout town was rated EF-0 to EF-1 with estimated windspeeds of 88 to 107 mph based on the tree damage.

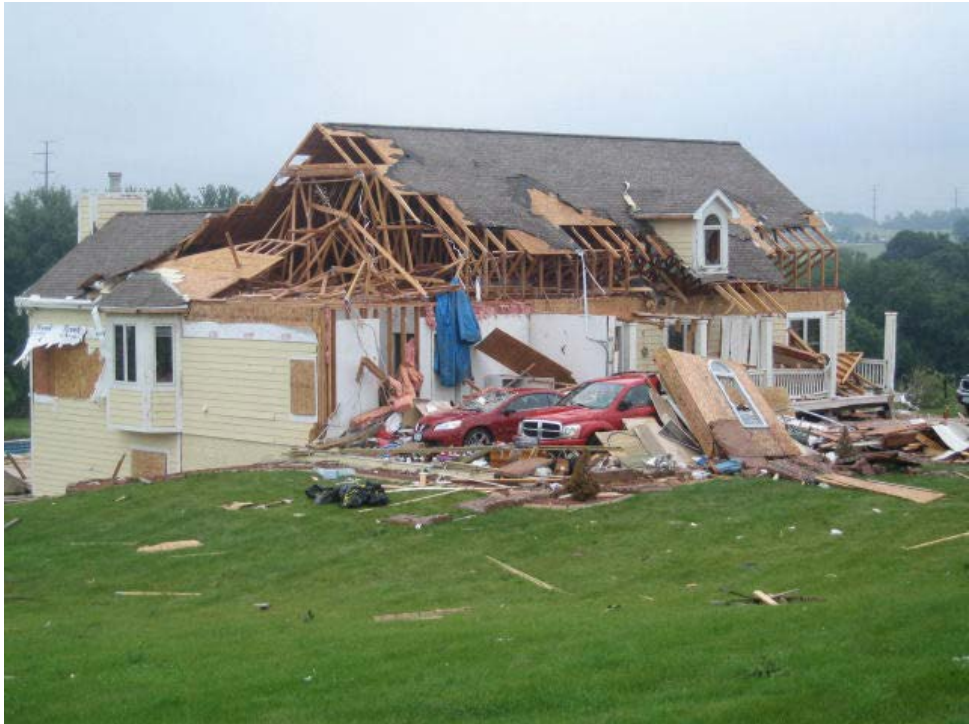
\* PEAK WIND: TORNADO ONE HAD ITS MAXIMUM WIND DAMAGE ON THE SOUTHWEST SIDE OF NORWALK WHERE A HOME WAS SEVERLY DAMAGED. OTHER EF0 AND EF1 DAMAGE OCCURRED ALONG ITS TRACK FROM CUMMING TO NORWALK. THE MAXIMUM ESTIMATED WINDS WAS BASED ON DAMAGE TO THE HOME IN SOUTHEAST NORWALK AT 125 MPH OR EF2. TORNADO ONE WAS WEAKER AND PRODUCED EF1 DAMAGE TO TREES IN NORTHEAST NORWALK. THE ESTIMATED WIND SPEED BASED ON THE DAMAGE WAS AROUND 100 MPH.

6) Home on the southeast side of Norwalk where the most intense tornadic damage occurred. The damage at this home was rated an EF-2 with windspeeds of 125 mph were estimated based on the damage.

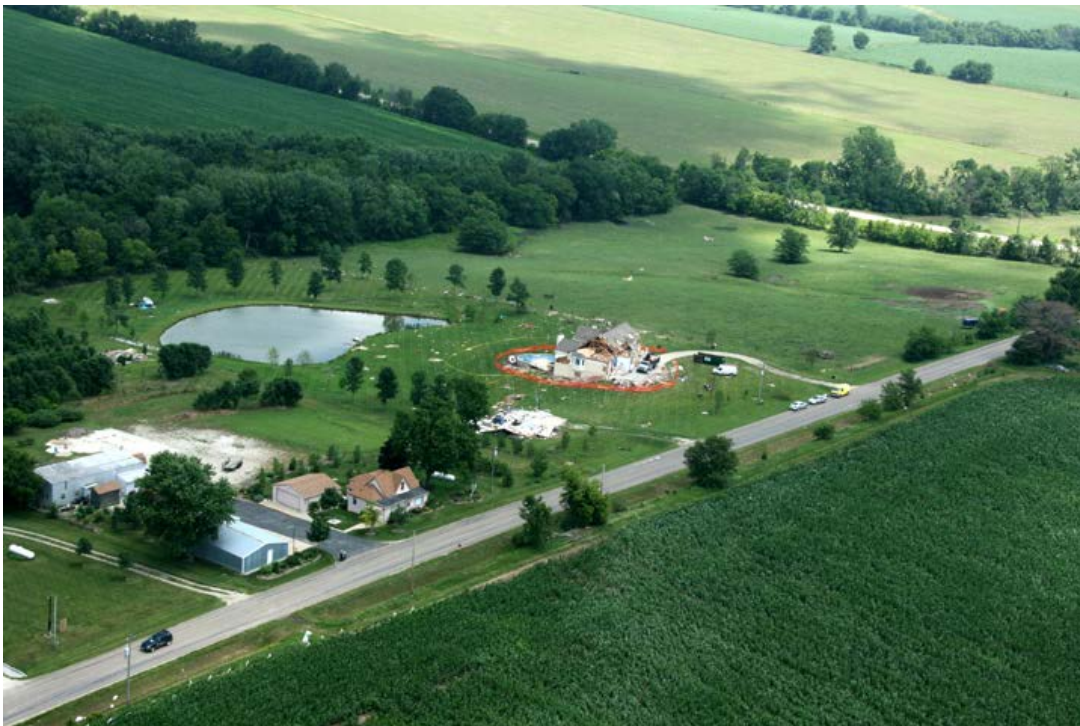
Aerial photo of home with EF2 damage southeast of Norwalk. The picture is looking northeast. Note the damage path in the corn approaching the home suggesting a northeast movement at this point. Courtesy of IowaHelicopter.com

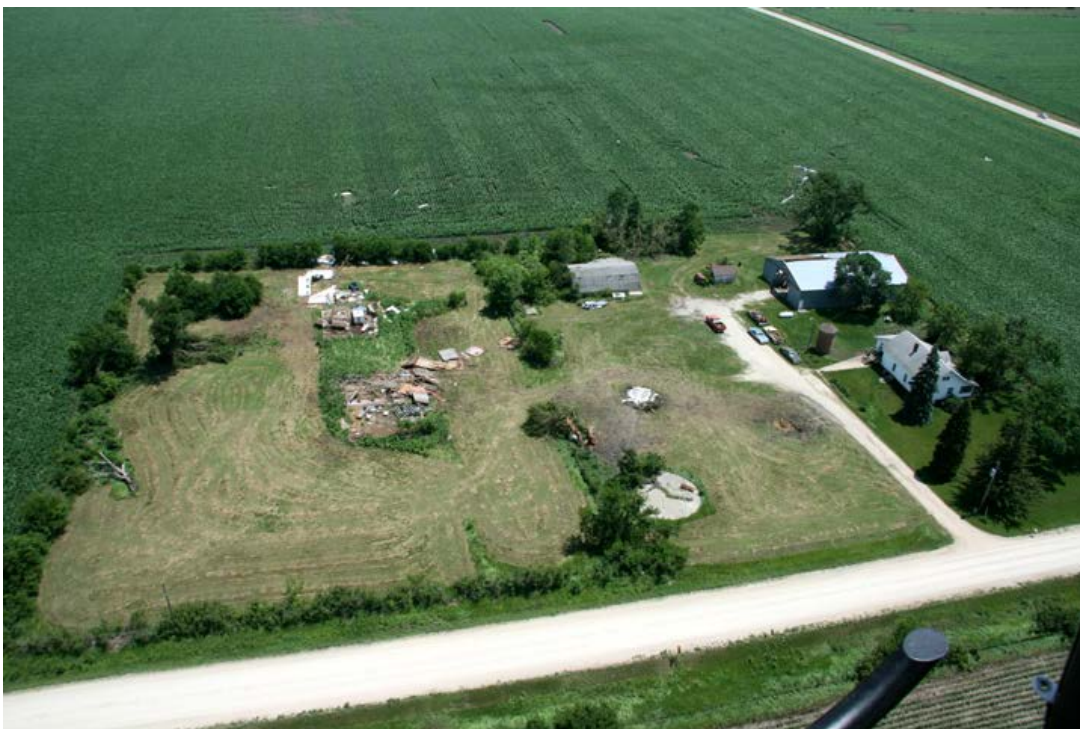
Tornado damage west of Cumming just east of I35. Courtesy IowaHelicopter.com
