National Weather Service Des Moines

Storm Survey Results from Union County/Creston on April 14, 2012

Updated on April 17, 2012

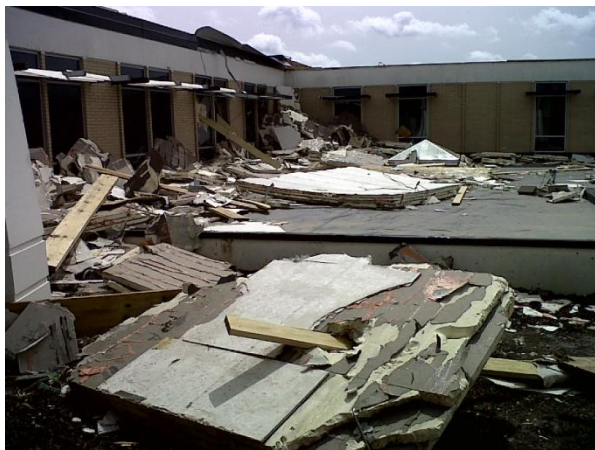
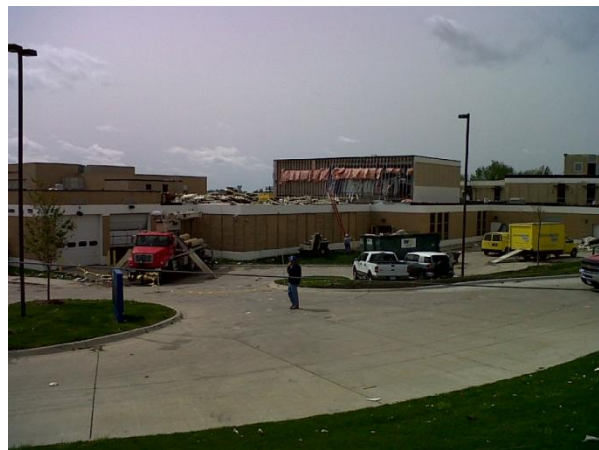
EF2 Damage Area 1:

The Greater Regional Medical Center in northwest Creston sustained rather substantial damage. A part of the building lost much of its roof and had a wall collapse. Winds were estimated near 120 mph.

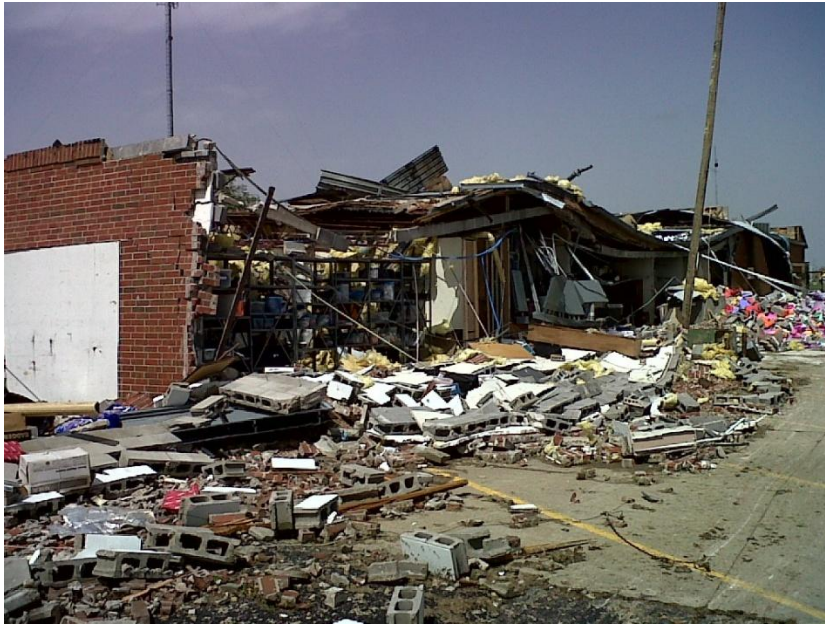
EF2 Damage Area 2:

The Green Hills Educational Center also sustained significant damage as the storm rolled through. The school completely lost its roof and one of its walls. Winds at this point were estimated near 130 mph.

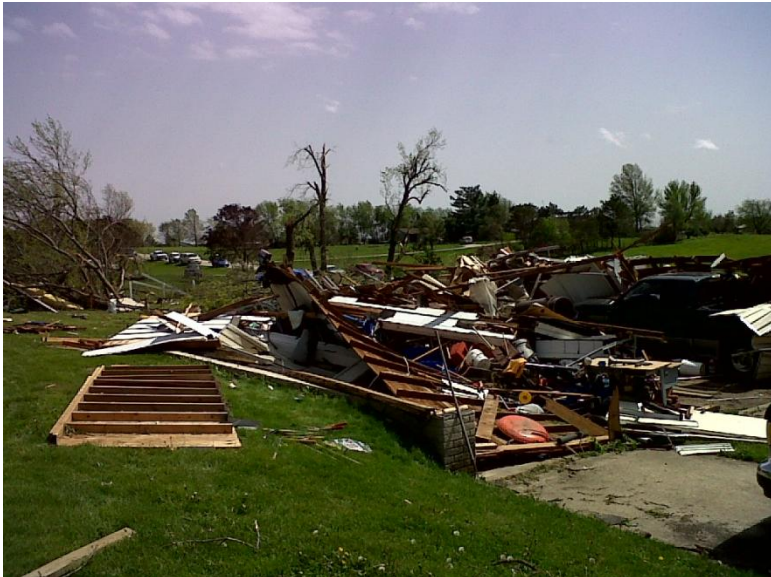
A one-story residence sustained major damage just west of Creston.

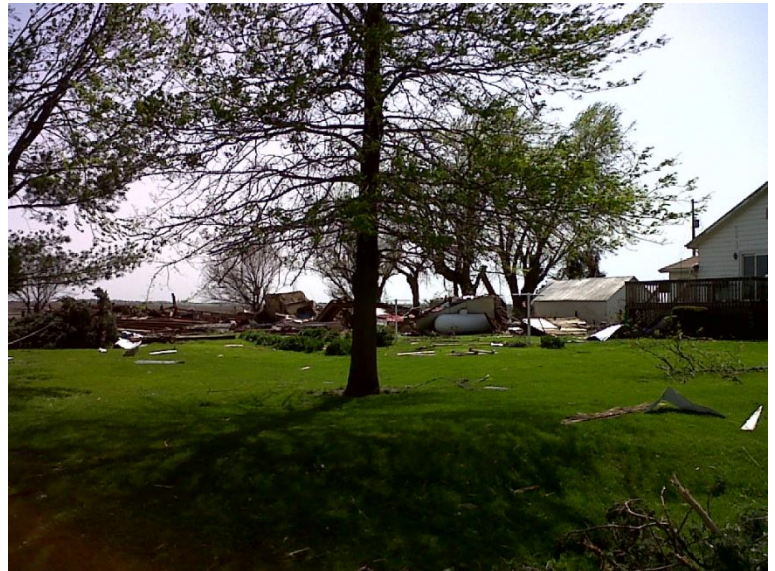
Debris clutters a yard north of Creston.

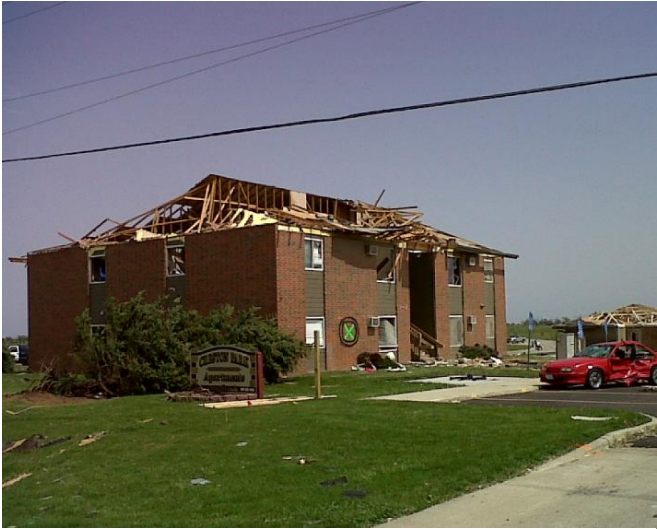
*An apartment building sustained roof damage.
Cars in the parking lot were dented and
damaged.*

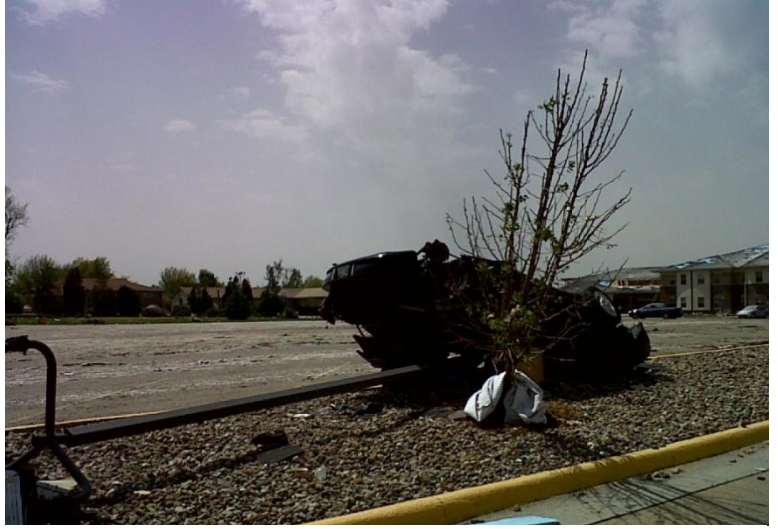
*A car was completely flipped on the north side of
Creston.*
