# National Weather Service Des Moines

## May 11, 2015 Storm Survey for the Lake City/Rockwell City Tornadoes

Updated on May 16, 2015

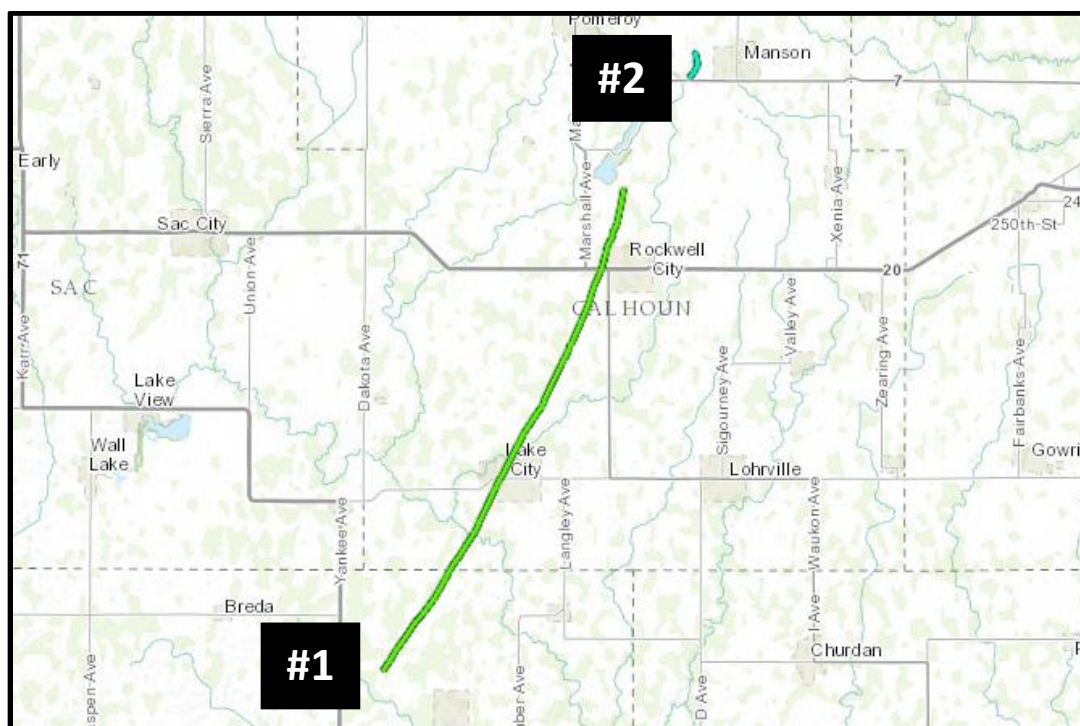
Track map of the two tornadoes that hit west central Iowa on May 10, 2015

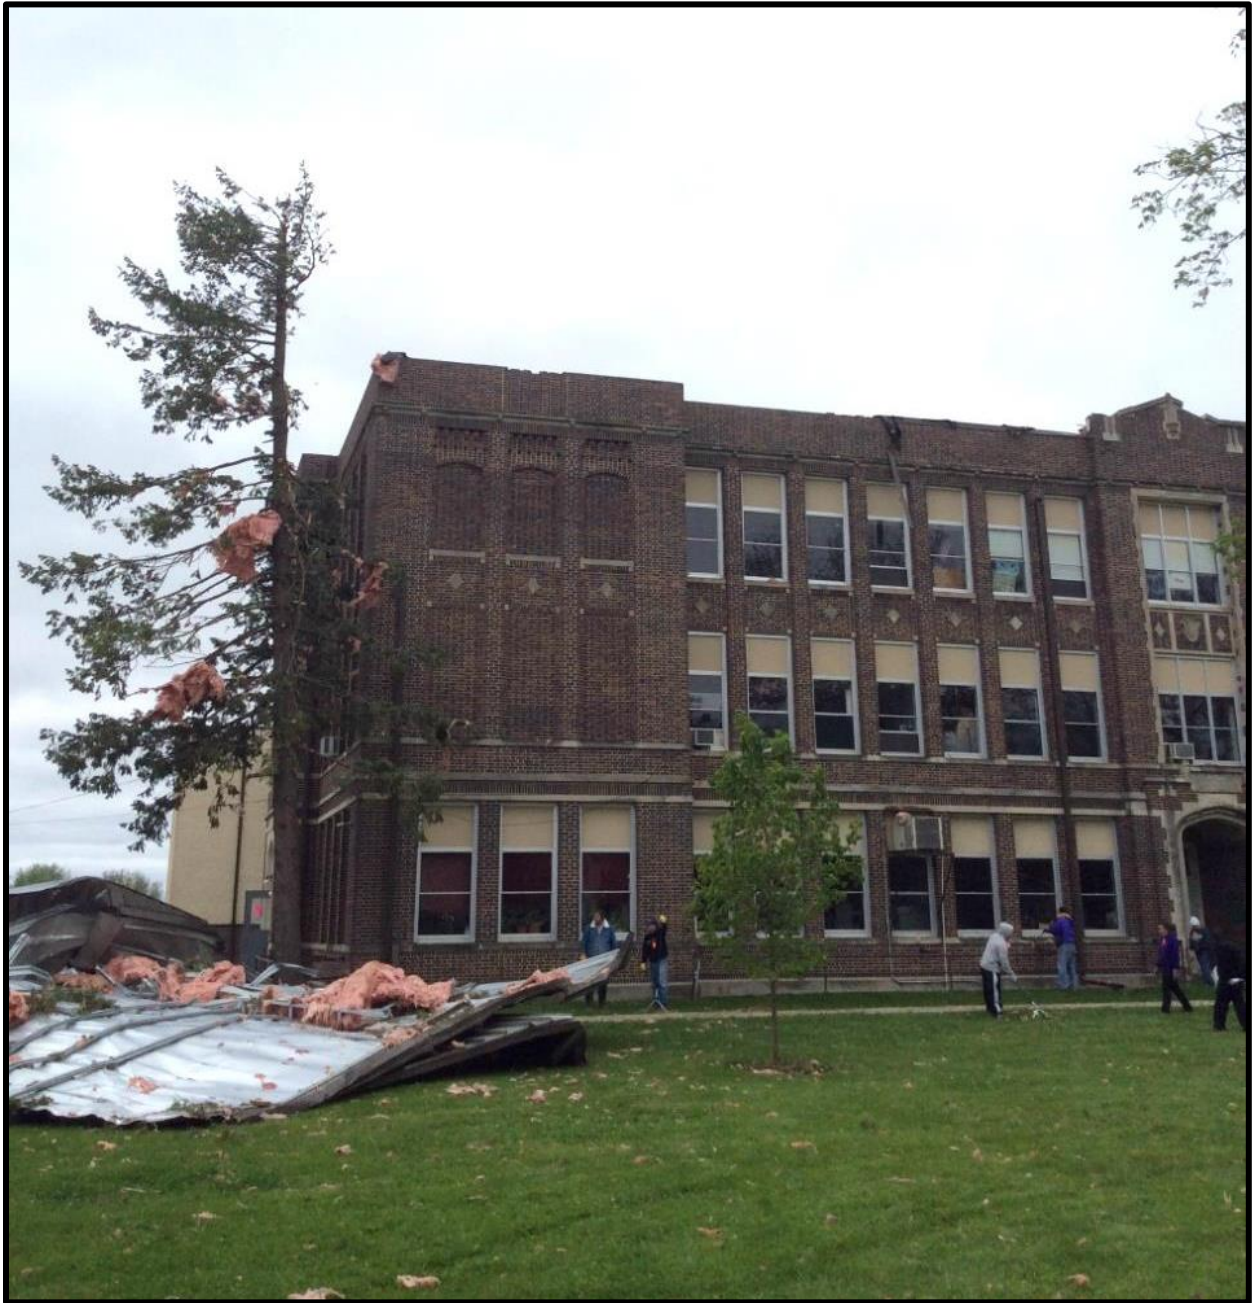
*The roof was torn off the high school in Lake City. The tornado was rated a higher-end EF-1 with a maximum wind speed of 100 mph at this location*

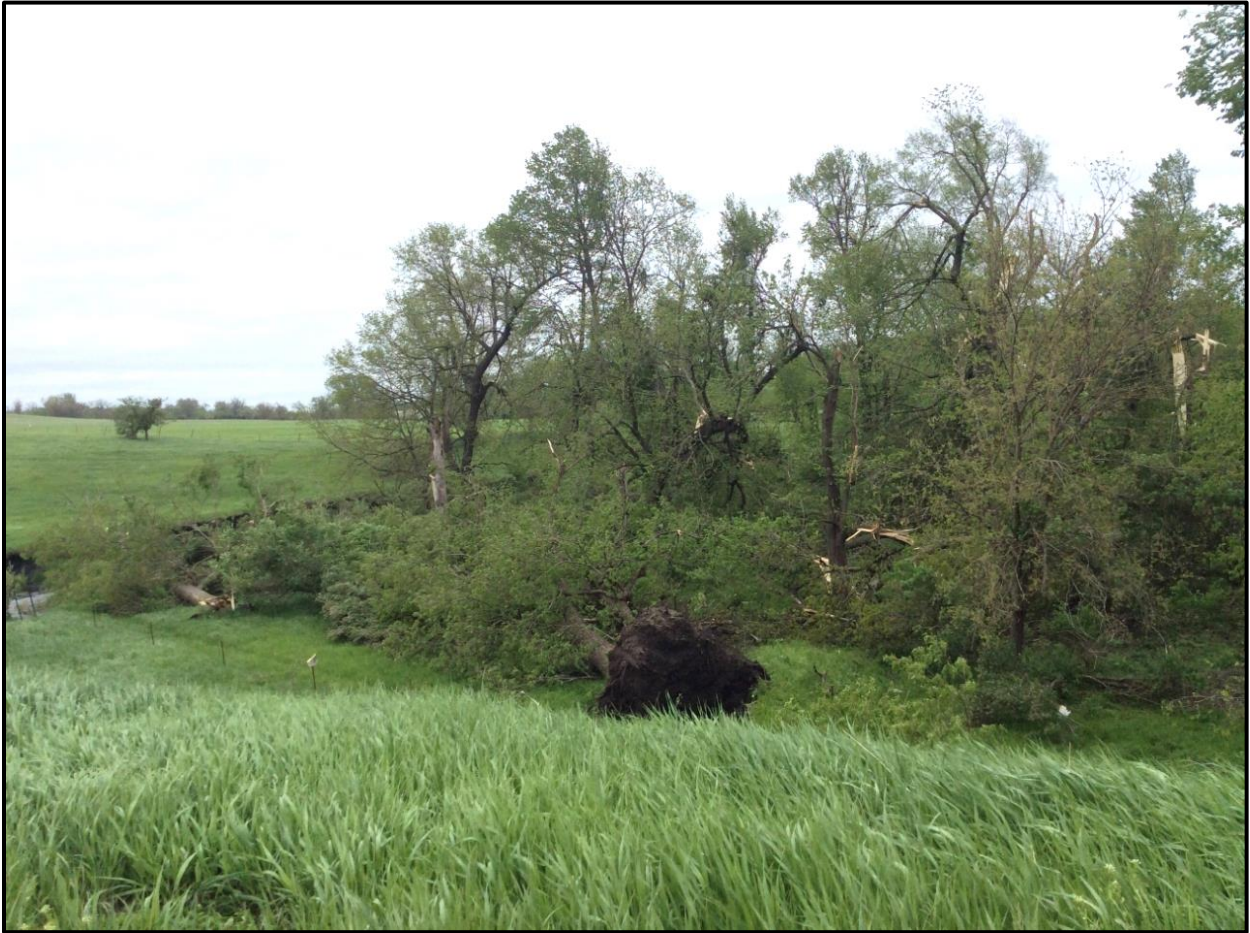
*Large trees were snapped or uprooted to the south and north of Lake City, where the tornado was of EF-1 intensity.*
