# Preliminary Damage Survey

## St. Libory, NE Tornado

## Hebron, NE Tornado

# ...NWS Damage Survey for May 17, 2026 Tornado Event...

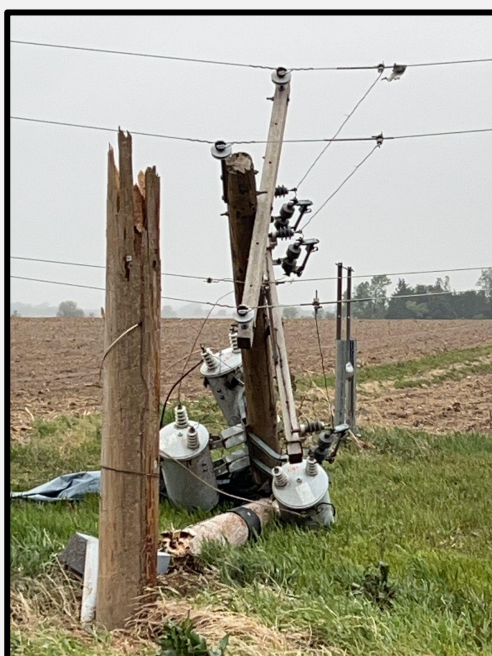
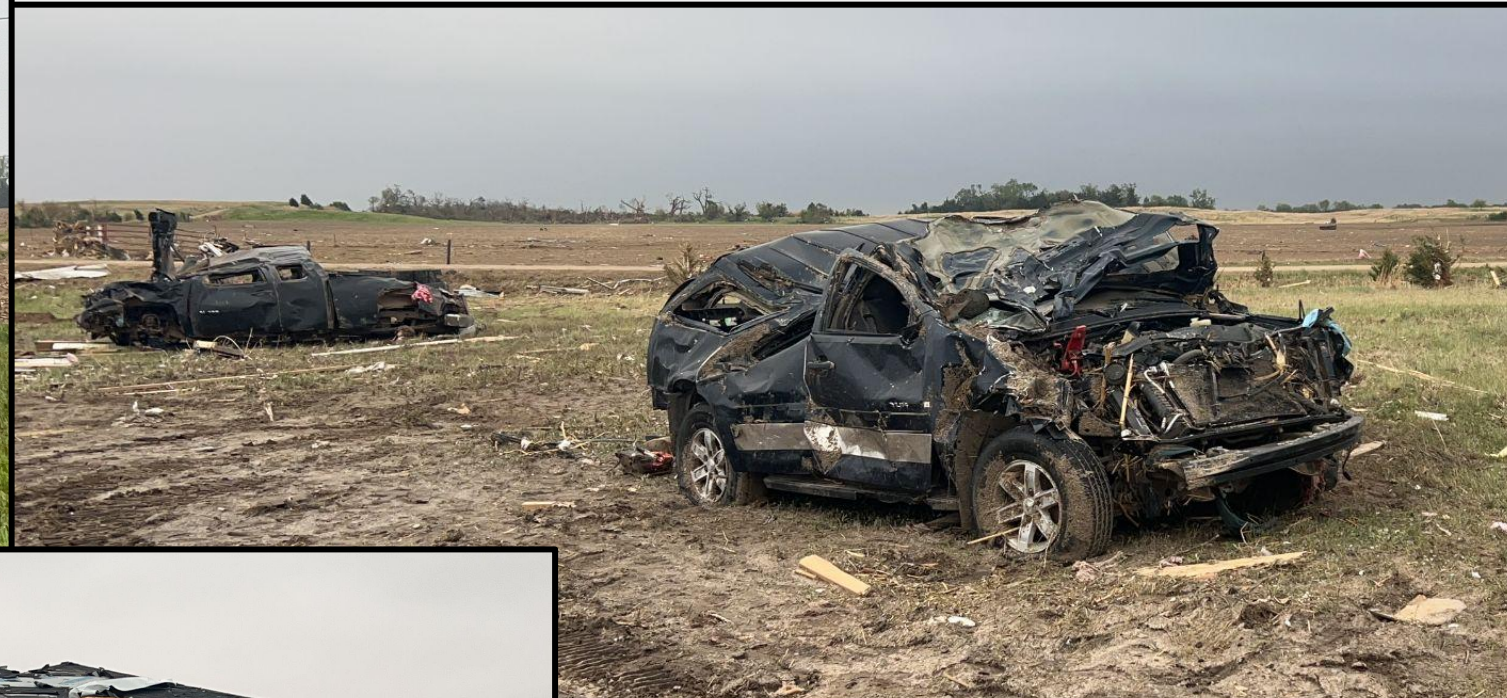
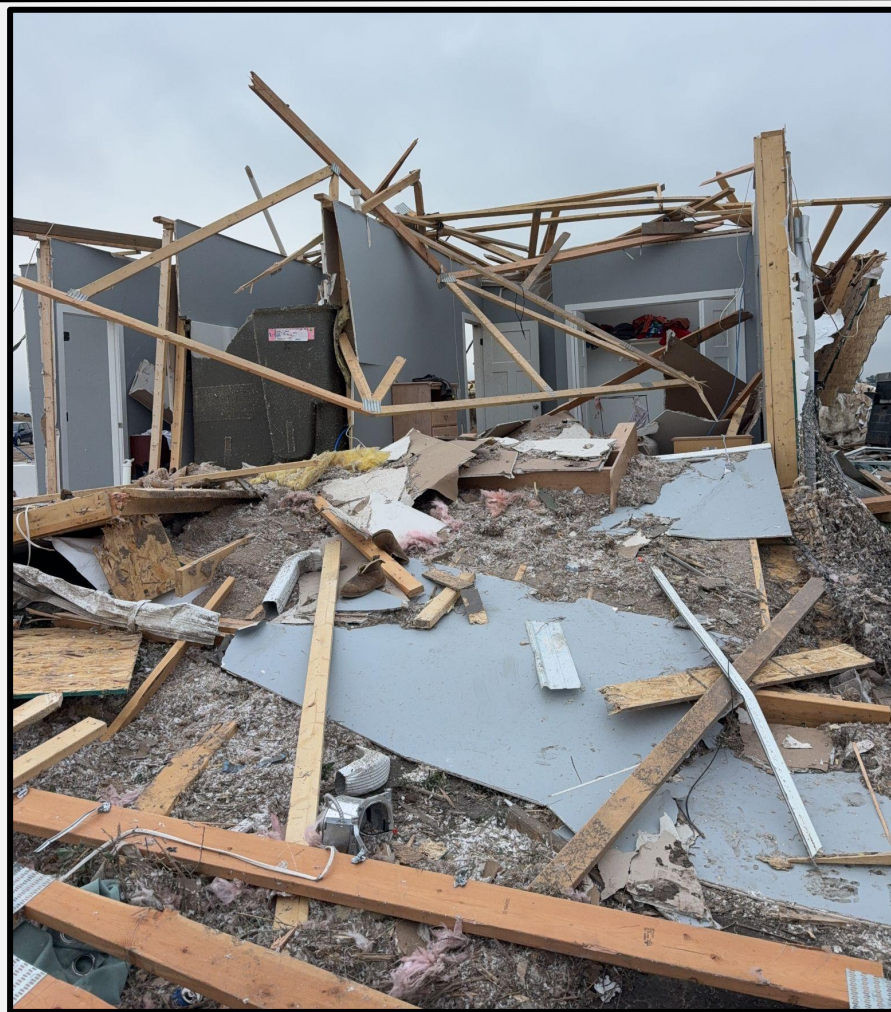
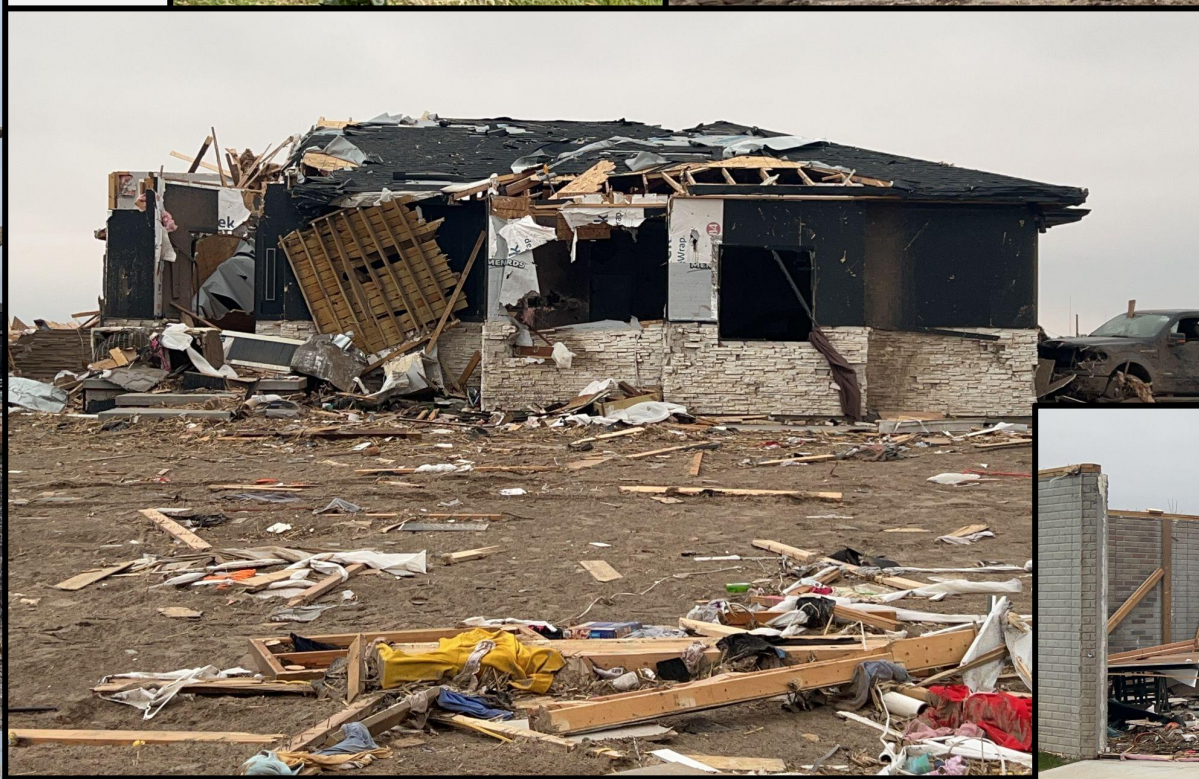
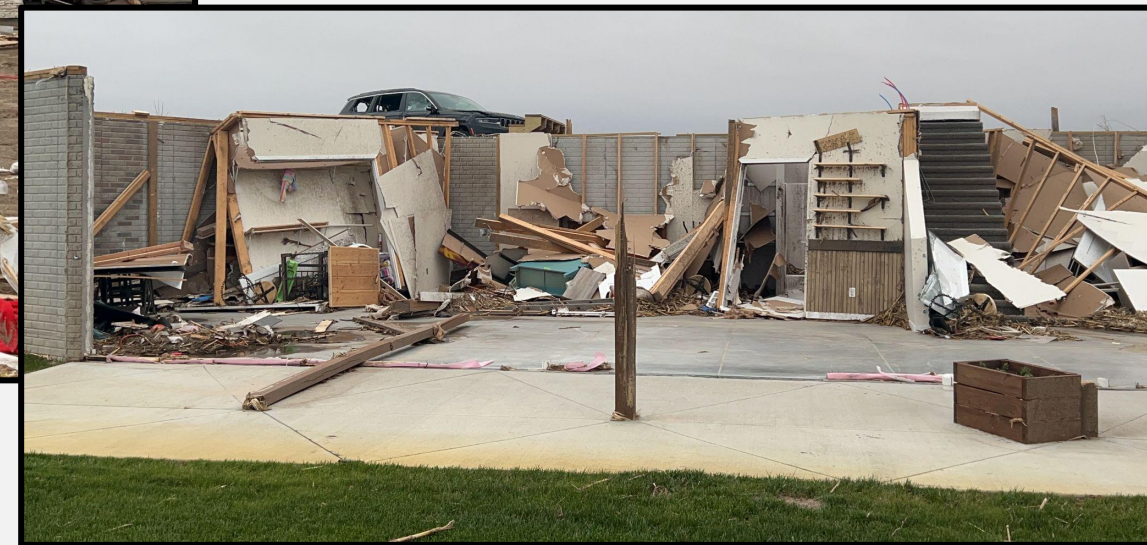
This photogenic tornado took a roughly west-to-east trek across southeast Howard county north of St. Libory for about 11 minutes. The tornado came together quickly on the edge of a farmstead west of Highway 281 where some small outbuildings were destroyed and many trees damaged. As it moved east, it quickly snapped power poles and moved across Highway 281 about 1.9 miles north of the Highway 58 intersection.

East of Highway 281, the tornado continued to strengthen as it rolled into a rural housing development. Four dwellings were essentially destroyed. At least two more detached garage type structures were destroyed. Residents who were home at the time took shelter after receiving tornado warning information and seeing the tornado approach. Video evidence suggests two homes likely took a direct hit from the tornado. Power poles were snapped and a pivot nearby was tumbled over and broken into several pieces.

From there, the tornado powered east through a grove of trees while also damaging power poles, fencing and exhibiting ground scouring. Eventually, damage became less widespread and intense in nature. The tornado lifted just prior to the Merrick County line about 4 miles northeast of St. Libory.

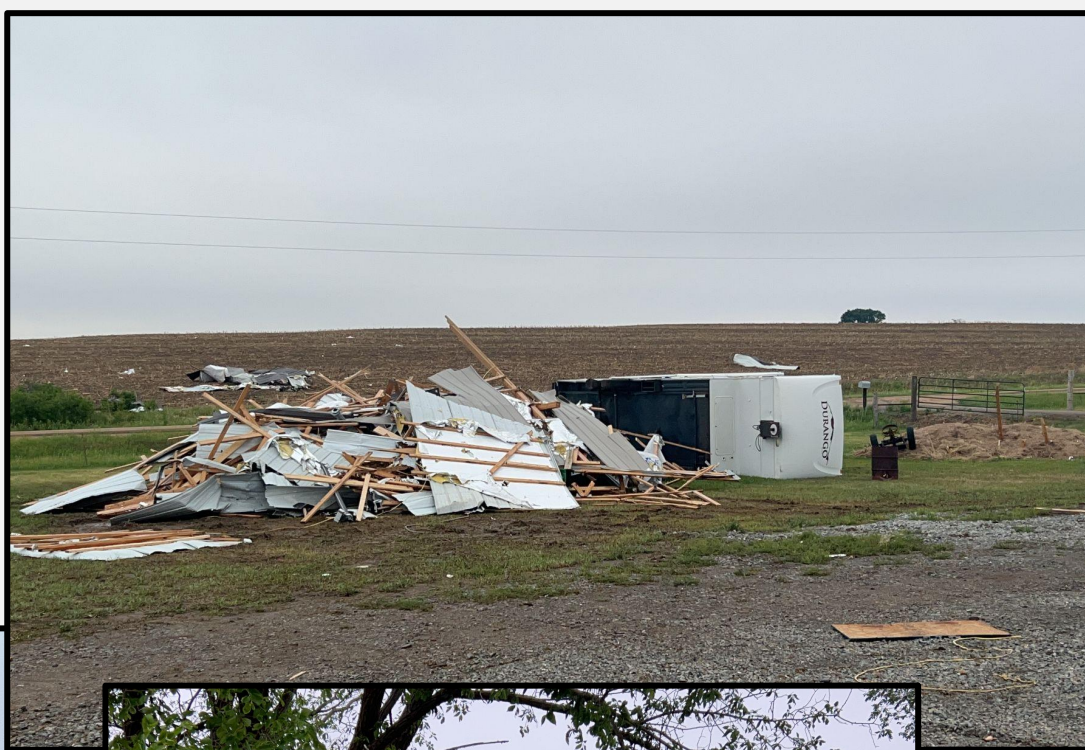
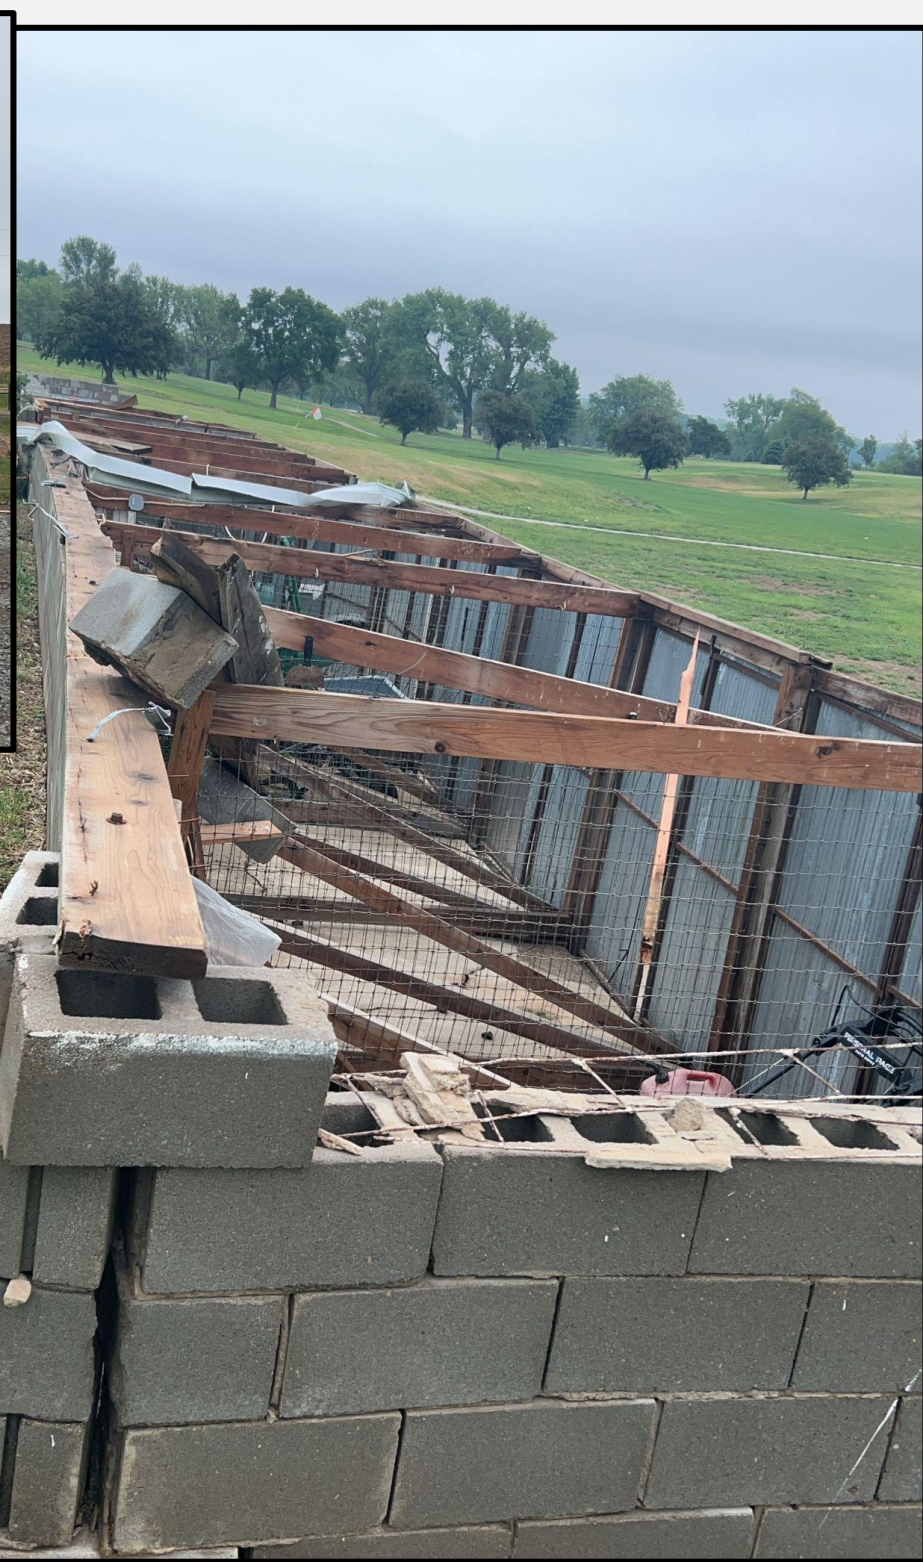
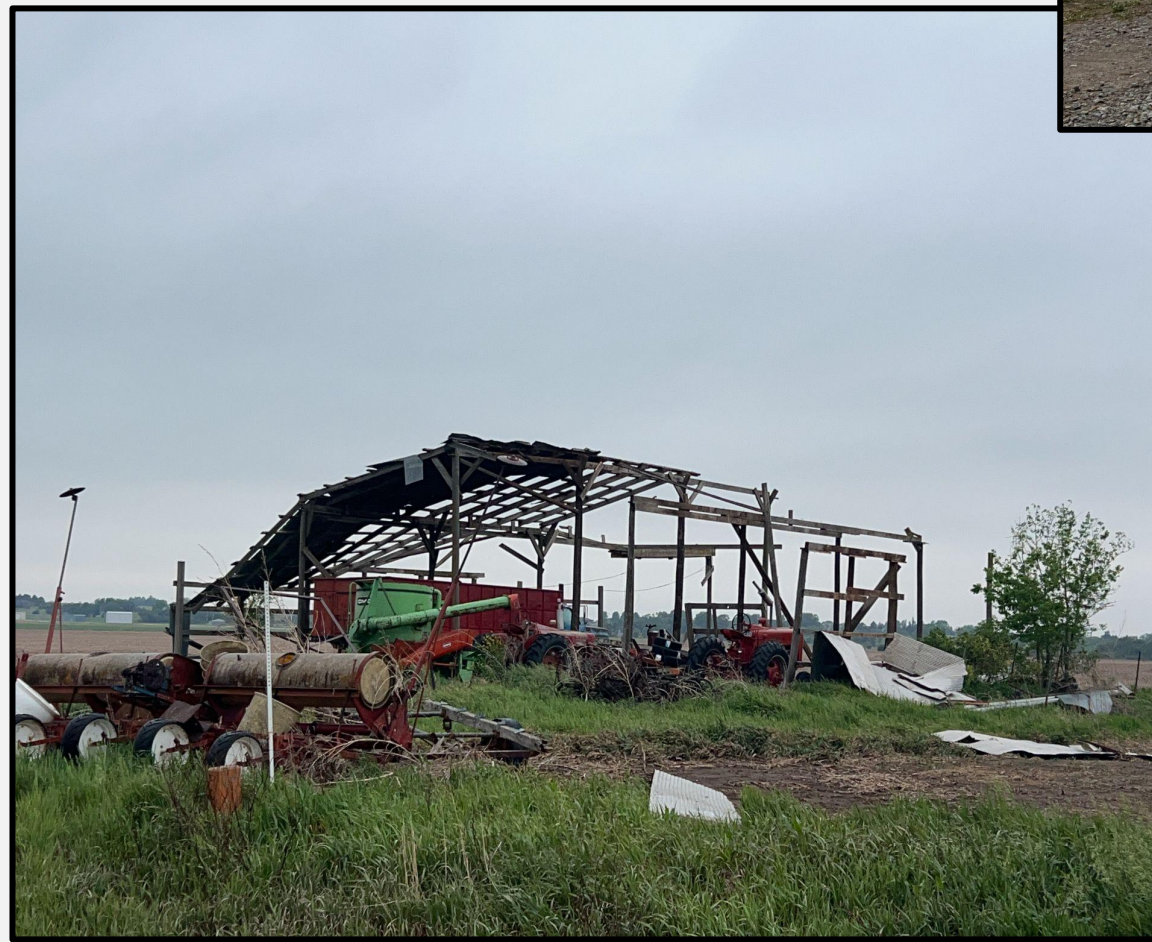
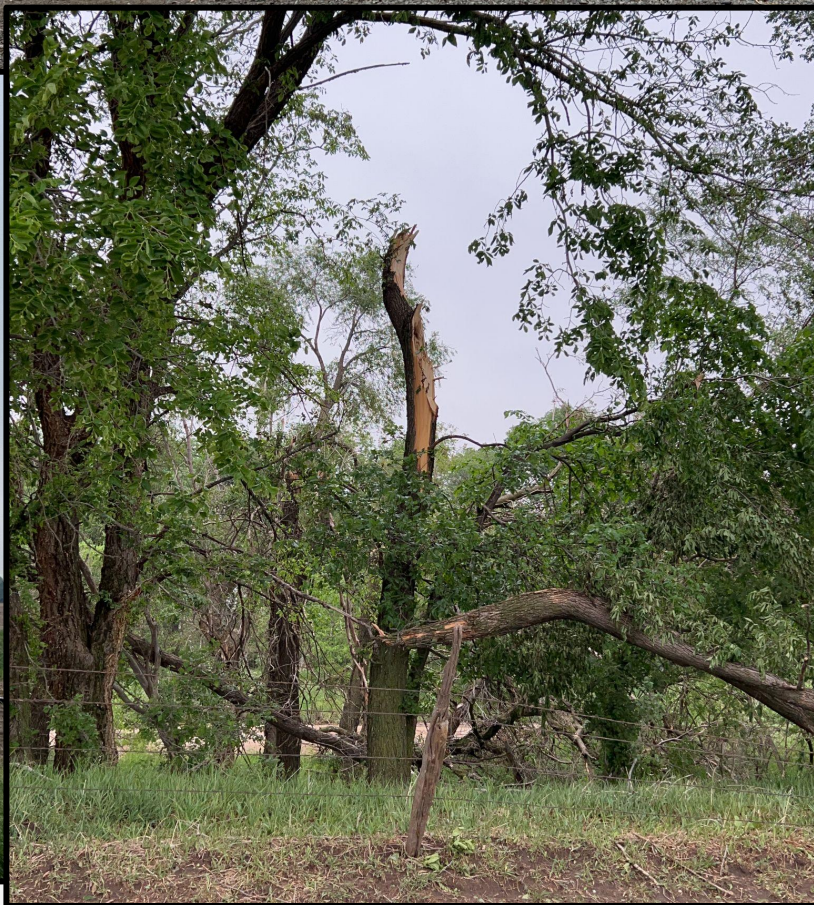
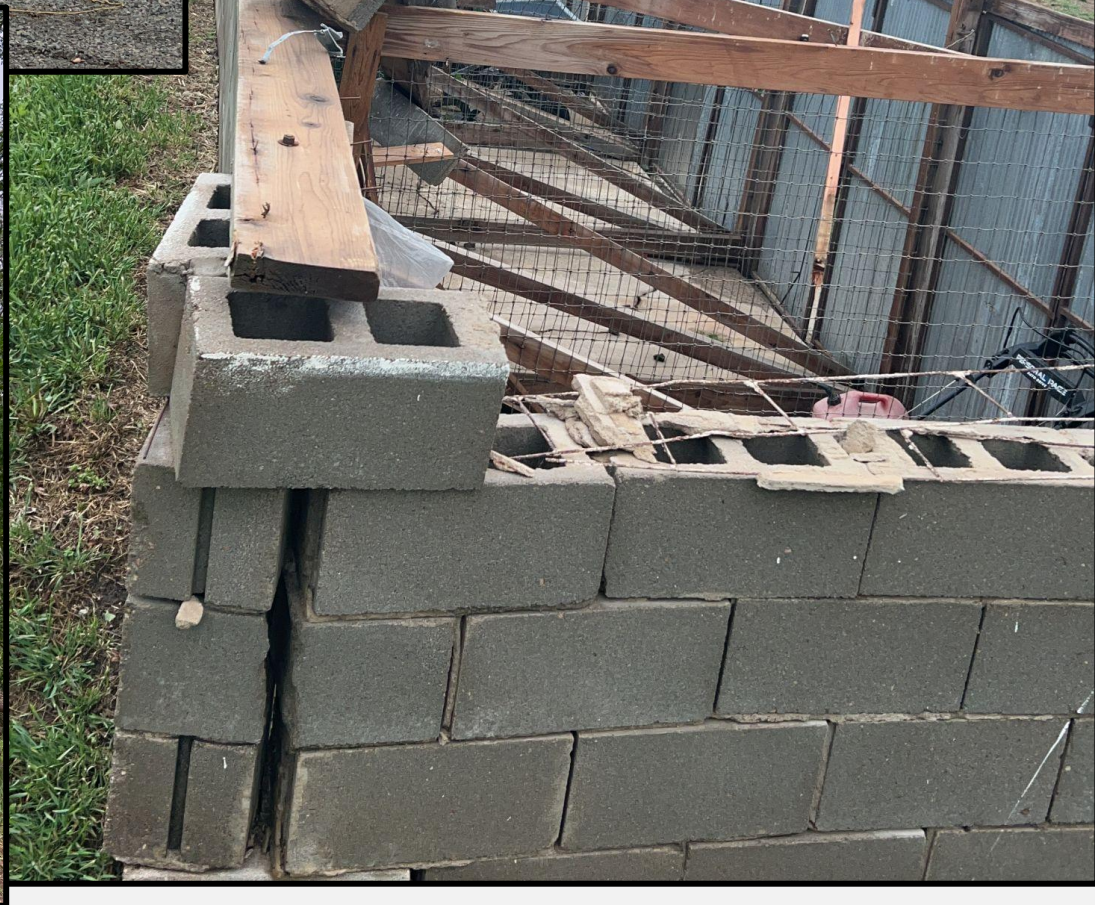
The Hebron tornado started with estimated EF-0 level damage to tree limbs near the Spring Creek, approximately 3.5 miles southwest of town. It intensified to an EF-1 as it moved east-northeast, causing trees to be uprooted and the uplift of the roof of a golf cart shed at the Hebron Country Club. The tornado then weakened as it traveled northeast, crossing over the airport before ending on the east-southeast side of town, with the loss of roofing material on a farm shed and additional tree damage near the Little Blue River.

The peak wind was estimated to be about 95 mph based primarily on the tree damage.
