## The 2014 Water Year for Western Colorado and Eastern Utah: Impacts and Mitigation

Michael P. Meyers, A. Strautins, D. Phillips, J. Daniels, and J. Malingowski NOAA/NWS/WFO, Grand Junction, Colorado

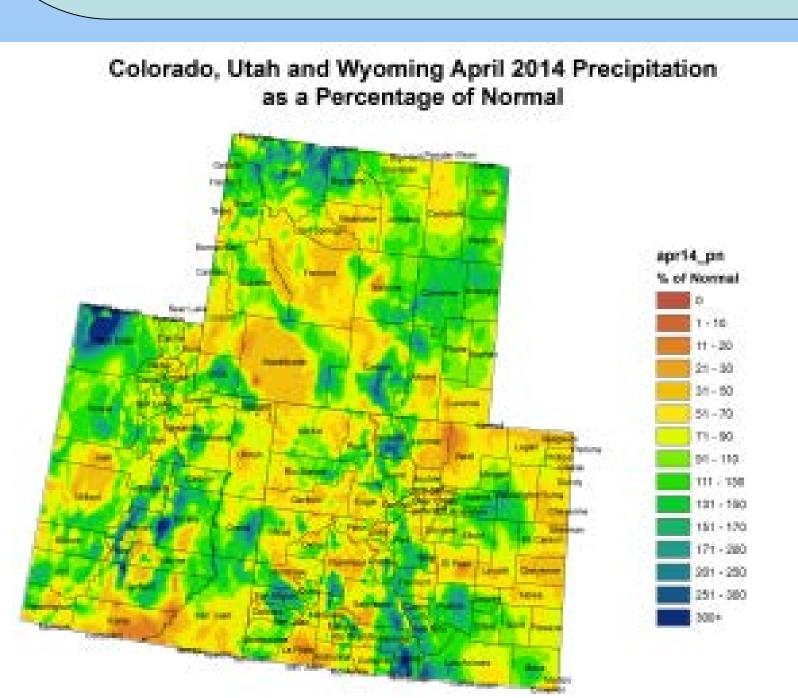
Departure from Normal Temperature (F) 4/1/2014 - 4/30/2014

- > April precipitation was above normal across east-central Utah, the northern mountains of Colorado and areas of southwest Colorado, and at or below normal elsewhere.
- ➤ May precipitation was above to much above normal for most of the region with amounts 300% of normal in some areas. Below normal precipitation was observed in northeast Utah and northwest Colorado.
- ➤ Average monthly temperatures remained 1 to 2 degrees (F) below normal for both April and May.

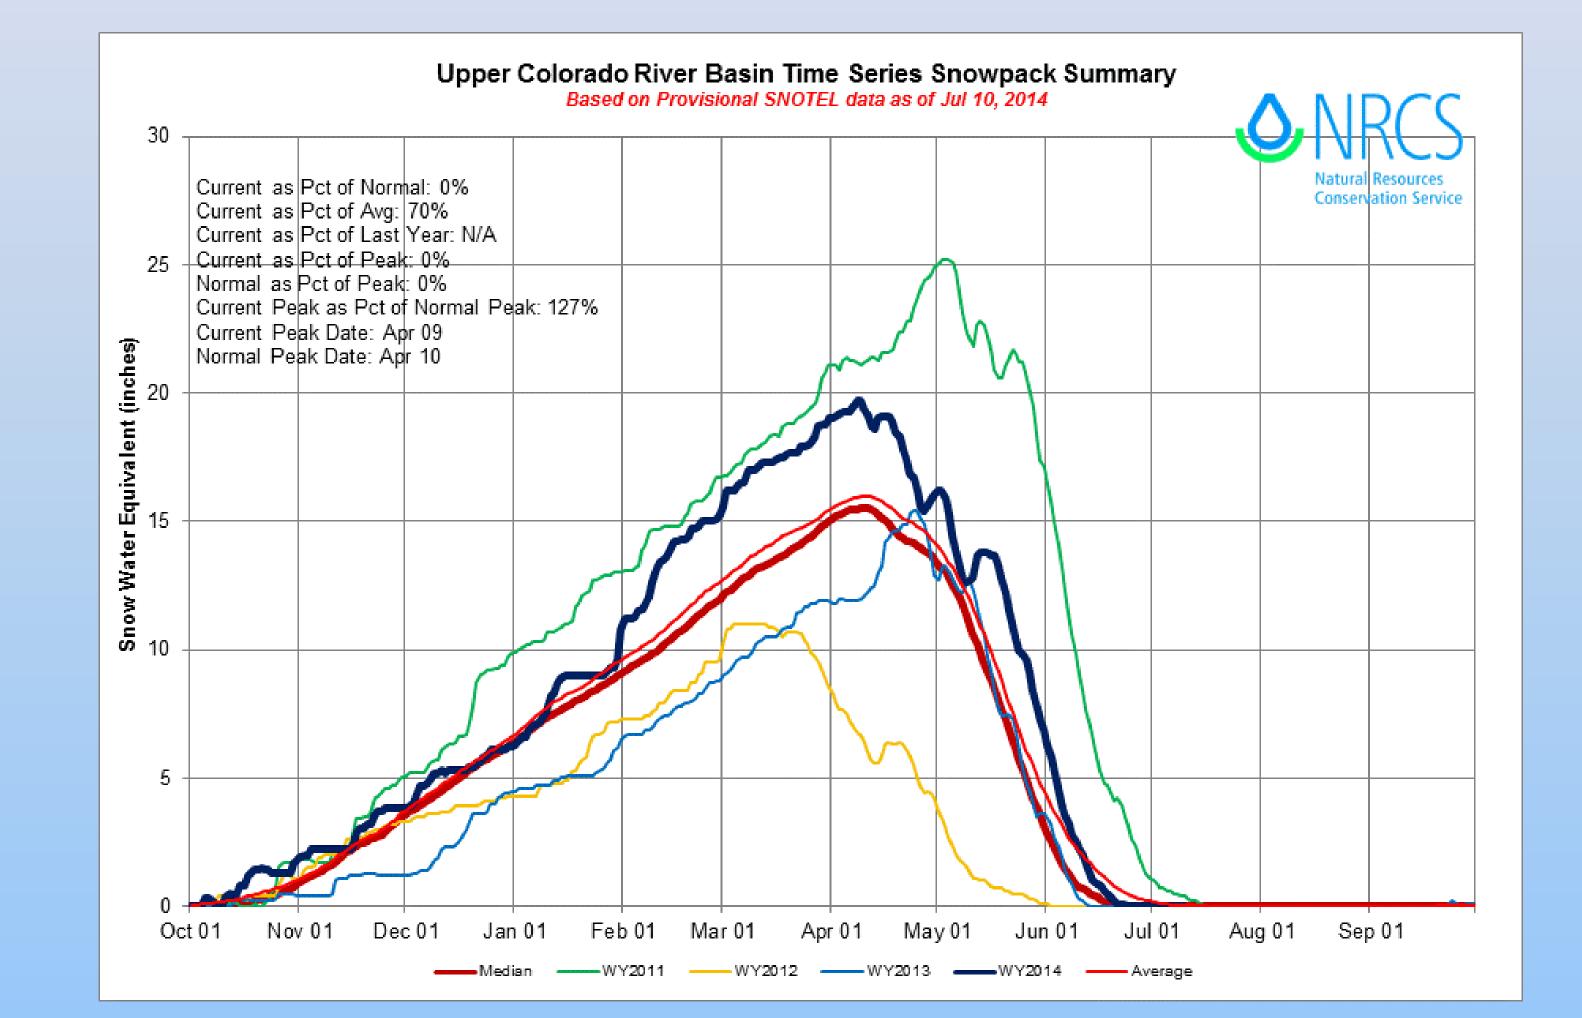
- ➤ Above normal precipitation occurred during September and October 2013.
- > Above normal snowfall (February into the spring) wet period.
- > Central to northern mountains of western Colorado and southwestern Wyoming well above normal snowpack.
- Southwest Colorado and eastern Utah below to well below normal snowpack.

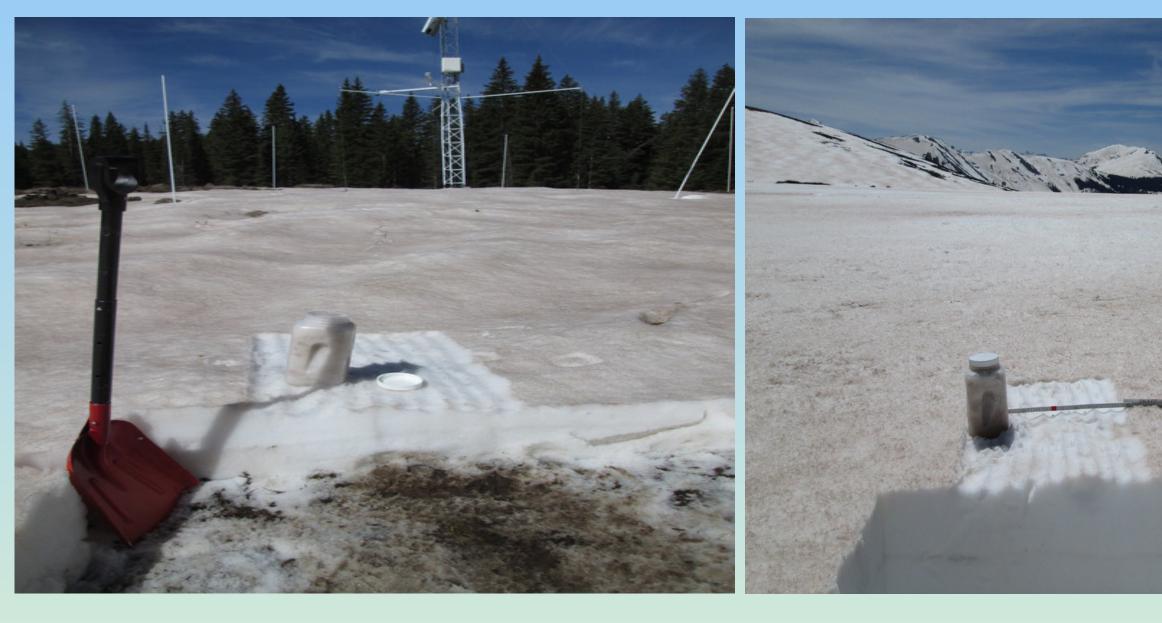
- ➤ The photographs above, (left) Grand Mesa and (right) Independence Pass in the central Colorado mountains show the profound dust deposition which occurred during the 2014 spring months.
- ➤ Ten dust events occurred during the water year with the first on February 24<sup>th</sup> and the last on June 19<sup>th</sup>.
- > Significantly altered snow albedo across the region.
- ➤ Photos courtesy of Center for Snow and Avalanche Studies (www.codos.org).

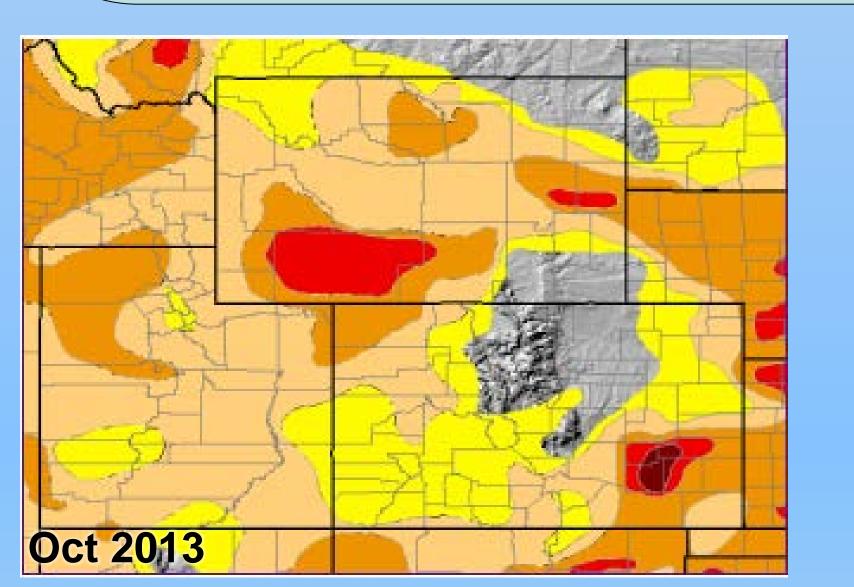
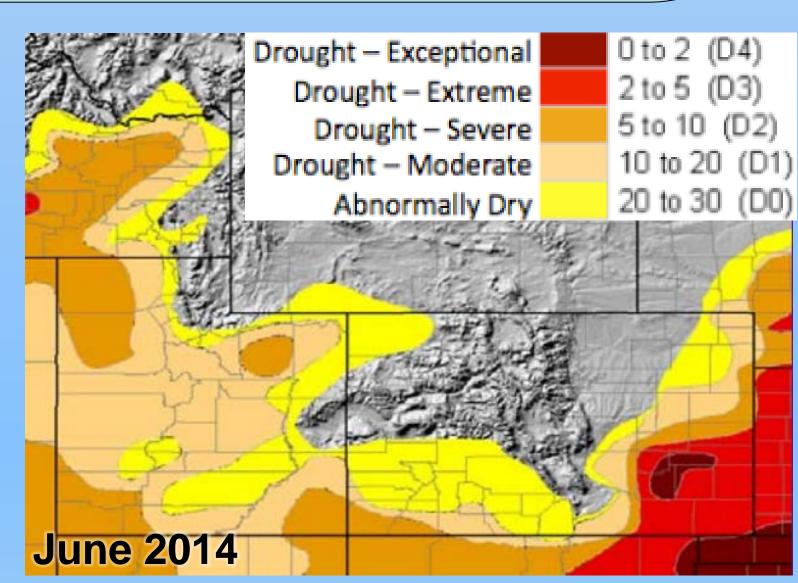
- The U.S. Drought Monitor map is shown above for October 2013 (left) and June 2014 (right).
- ➤ The 2014 water year precipitation provided a surplus across the northern two-thirds of western Colorado and eastern Utah improving drought concerns in those areas.
- > Areas near the Four Corners region showed some degradation down to the D2 category.

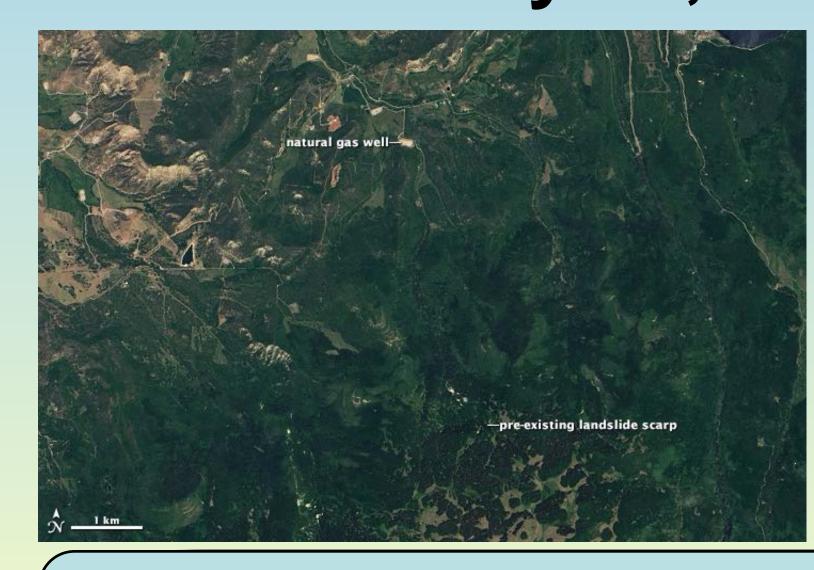
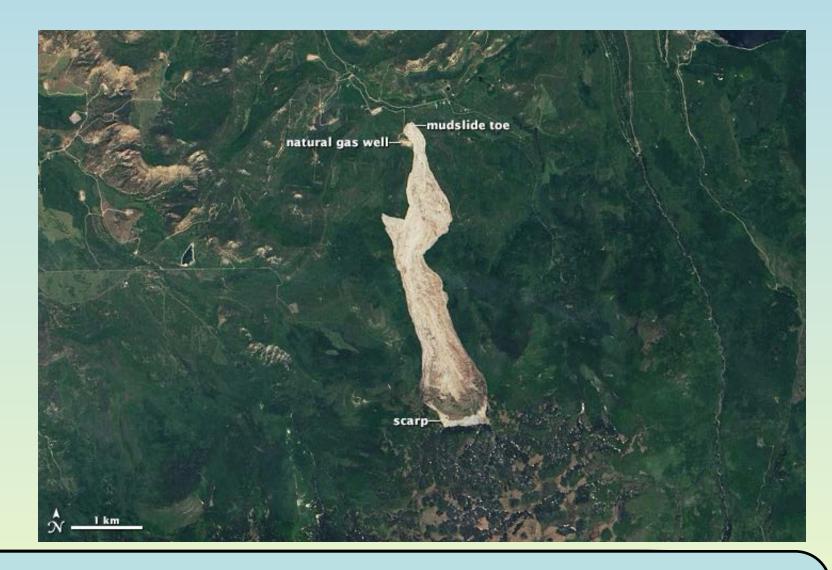
## May 25, 2014 Landslide

On May 25, 2014, a large landslide occurred near the town of Collbran covering an area three miles long and three-quarter of a mile wide. It claimed the lives of three people. Rainfall estimates near the slide were ~ 1 inch (2.5 cm). However, antecedent moisture, moist ground due to runoff, and unstable geology were believed to be the main factors which caused the slide.
