Hurricane Fran in North Carolina

September 5-6, 1996

By
Richard D. Marshall
Wind Research Services
P.O. Box 121
Poolesville, MD 20837

January 1998

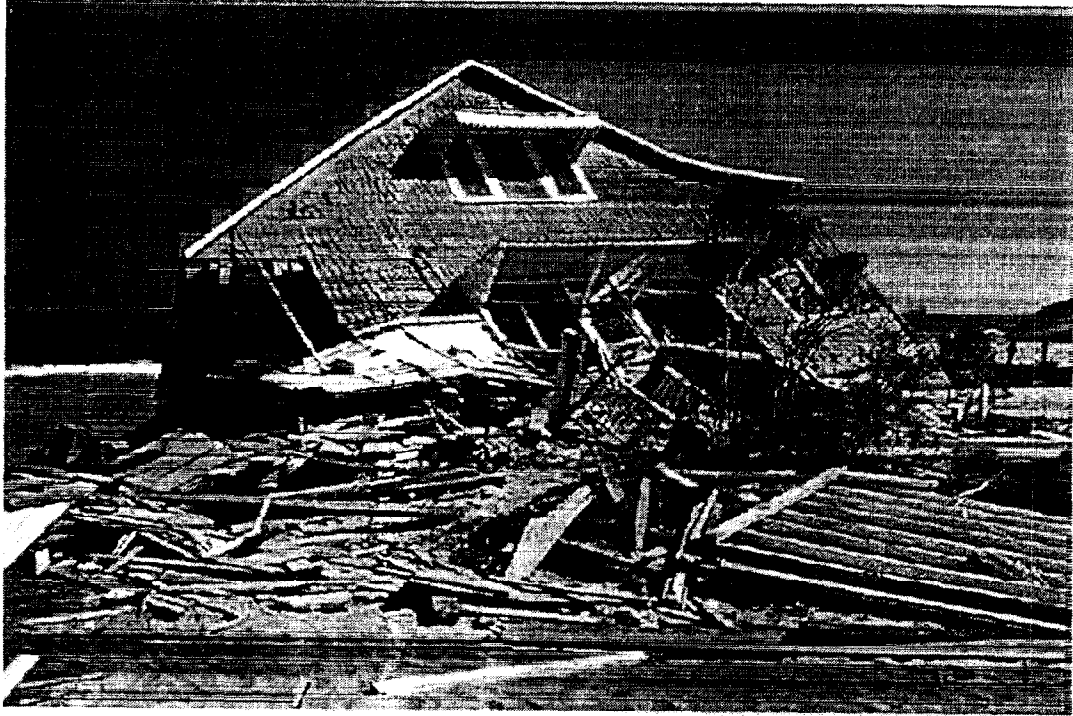
The combined effects of beach erosion and scour resulted in the collapse of more than 100 homes founded on shallow pile foundations in the area extending from Topsail Beach to North Topsail Beach. In general, wood-frame structures on elevated pile foundations outperformed all other types of foundations, including masonry piers, solid perimeter masonry walls, and slab-on-grade systems. The lack of sufficient embedment of vertical foundation members for items such as decks, porches, and roof overhangs resulted in the collapse of several hundred of these building extensions. Typical damage to wood-frame structures in the affected coastal area can be seen in Figures 3 and 4.

Figure 3. Surge and Wave Damage, North Carolina Coastal Area (Source: FEMA).

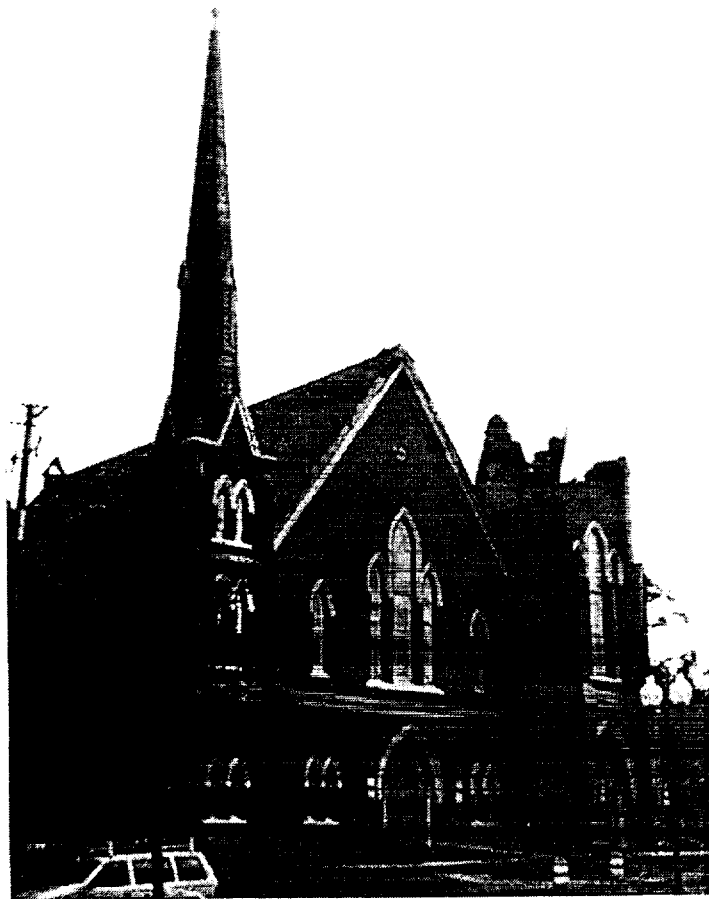
Figure 5. First Baptist Church, Market Street, Wilmington.

While numerous occurrences of significant structural damage were observed inland from the coastal area of New Hanover, Pender and Onslow Counties, the general level of structural damage in these areas was moderate when compared with inland damage in other recent landfalling hurricanes. Perhaps the most spectacular structural failure in the Wilmington area was that of the east spire of the First Baptist Church on Market Street, as shown in Figure 5. The view is to the east-northeast, the approximate direction of the wind at the time the east spire failed.

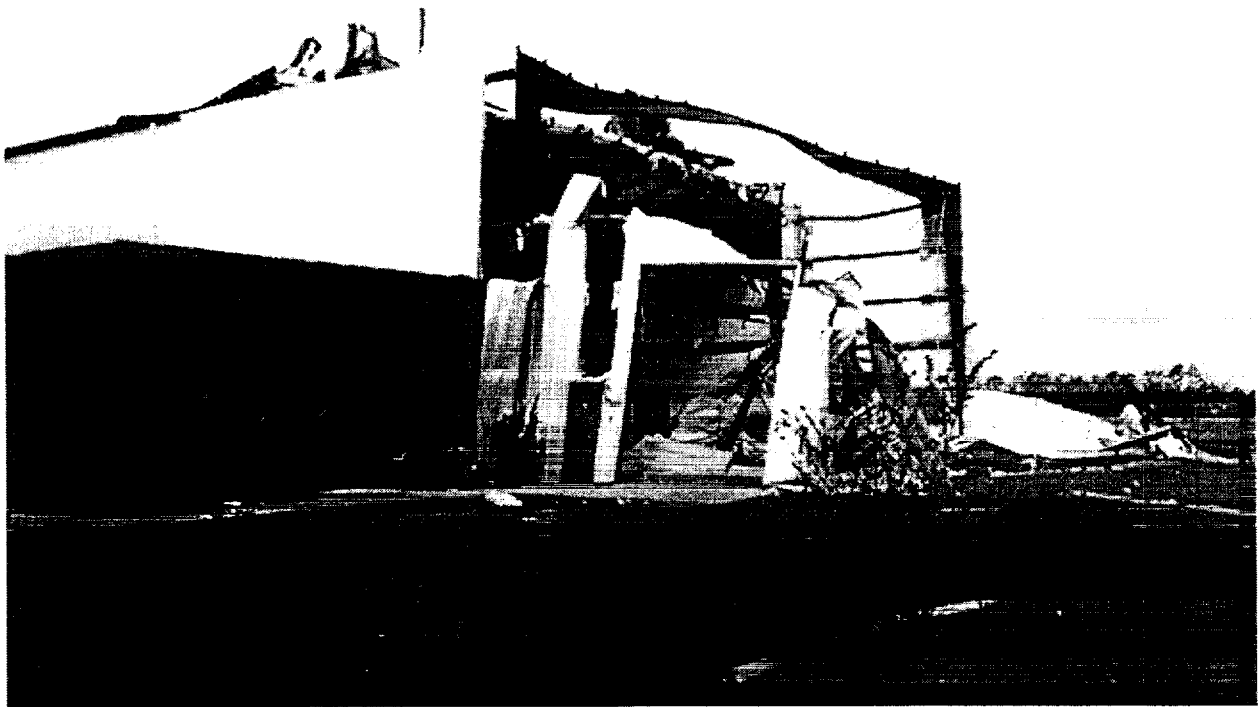
A recently-completed light-aircraft hanger located near the south boundary of Wilmington International Airport is shown in Figure 6. The view is to the north-northwest. Another view of the opposite side of the failed hanger is shown in Figure 7 looking to the southwest. Maximum sustained wind speeds in this area were approximately 31 m/s. At the time of failure the winds were from the east, and it is likely that failure initiated in the end-bay purlins (subjected to combined axial thrust and uplift forces) or in the purlin-end wall connections. Loads on these purlins and their connections probably were increased with failure of the door near the windward face of the hanger as can be seen in Figure 6.

Figure 6. Aircraft Hangar, Wilmington International Airport (view to northwest).

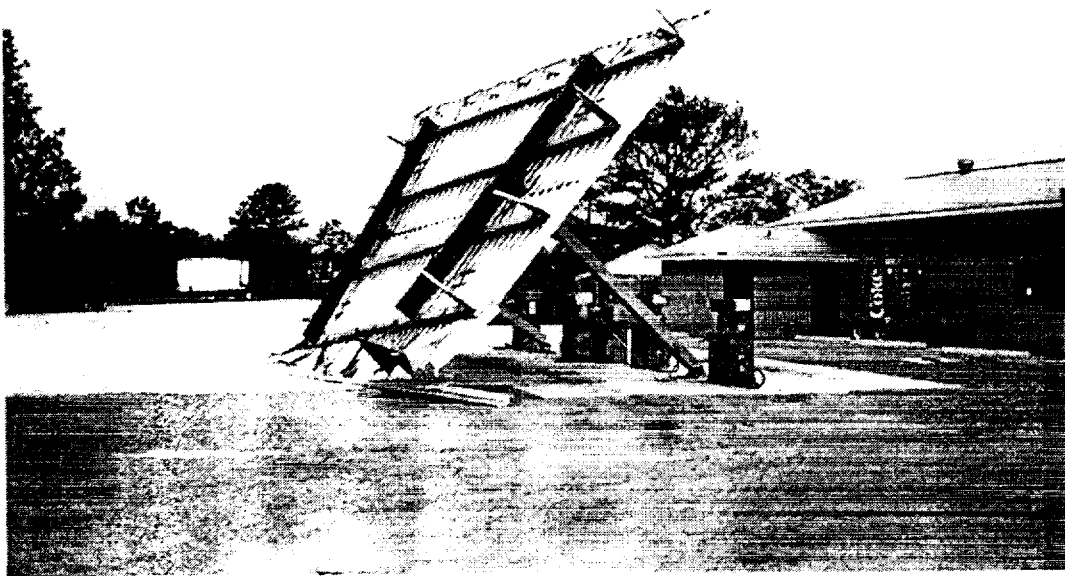
Figure 8. Gasoline Pump Canopy, US 421 Northwest of Wilmington.

Typical of numerous failures of light commercial construction in the Wilmington area is the gasoline pump canopy shown in Figure 8. However, this particular structure suffered from severe internal corrosion of the square-tube supporting columns as could be observed at the failure points directly above the concrete service island. This site is located 25 km to the northwest of Wilmington along US 421.

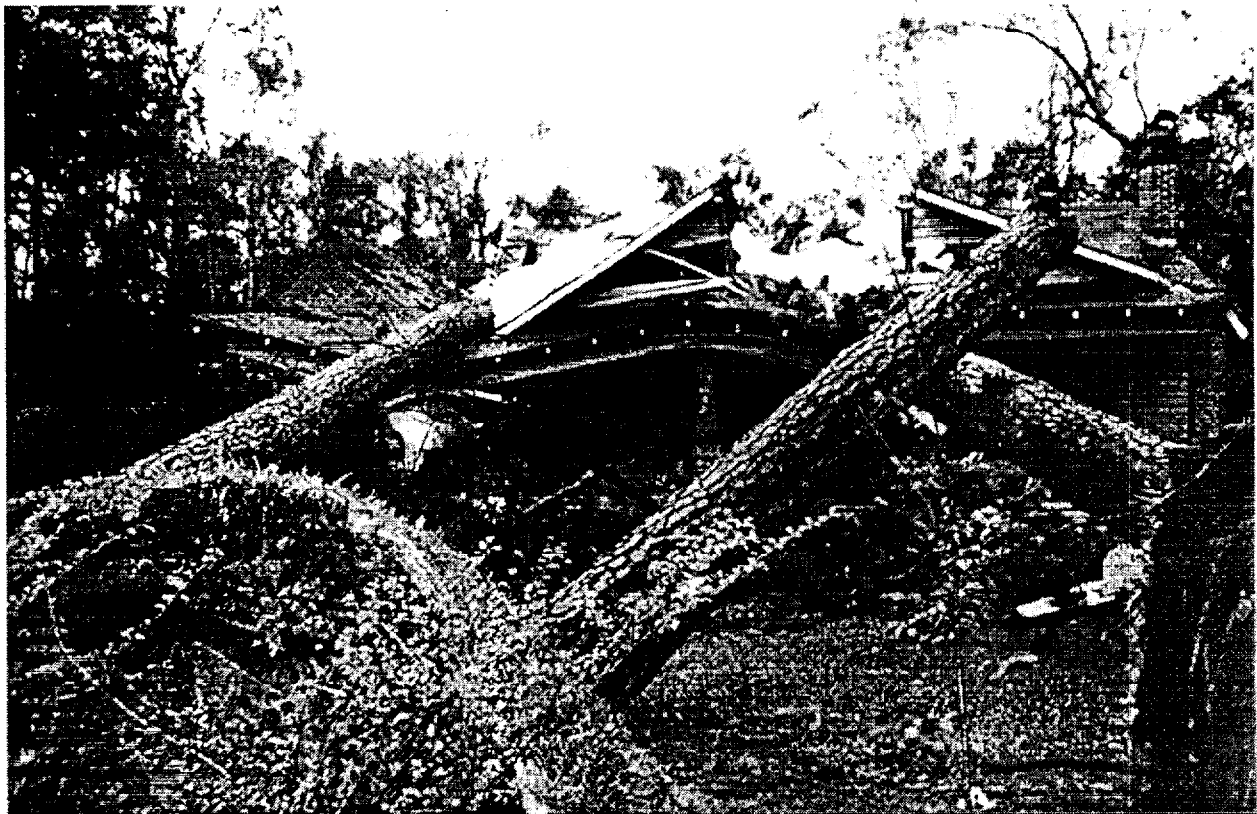
The most common damage mechanism observed in the Wilmington area as well as in the Raleigh-Durham area some 250 km inland to the northwest is shown in Figure 9. Falling trees took a heavy toll on most forms of construction, single-family dwellings in particular. The fact that Hurricane Bertha brought heavy rainfall to the area about two months prior to Fran may have increased the potential for uprooting trees in Hurricane Fran.

Figure 9. House Damage by Fallen Trees Along US 17 Northeast of Wilmington.

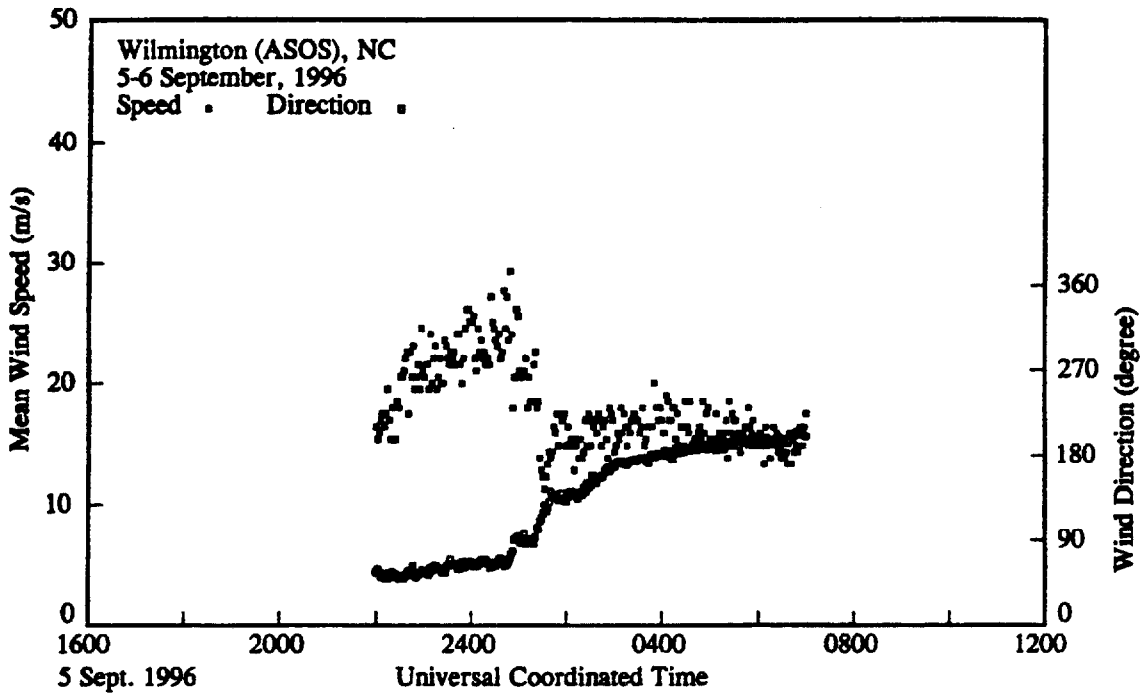
Figure A-11. Record of mean wind speed and direction, Wilmington (ASOS), NC.

Station:	Wilmington (ASOS)
Coordinates (deg):	34.27 N 77.91 W
Anemometer Ht. (m):	10
Max. Observed Mean Speed (m/s):	29.8 (06/0049 UTC)
Averaging Time (minutes):	2
Observed Pk. Gust (m/s):	38.6 (Est. = 38.5)
Est. Max. Sustained Speed @ 10 m (m/s):	30.7
Surface Roughness Length (m):	0.03 (Reference)
