The Wilmington Area Ice Jam on the Lower Kankakee River During January 2024

W. Scott Lincoln
Senior Service Hydrologist, NWS Chicago

Completed: March 27, 2024
Updated: December 17, 2024

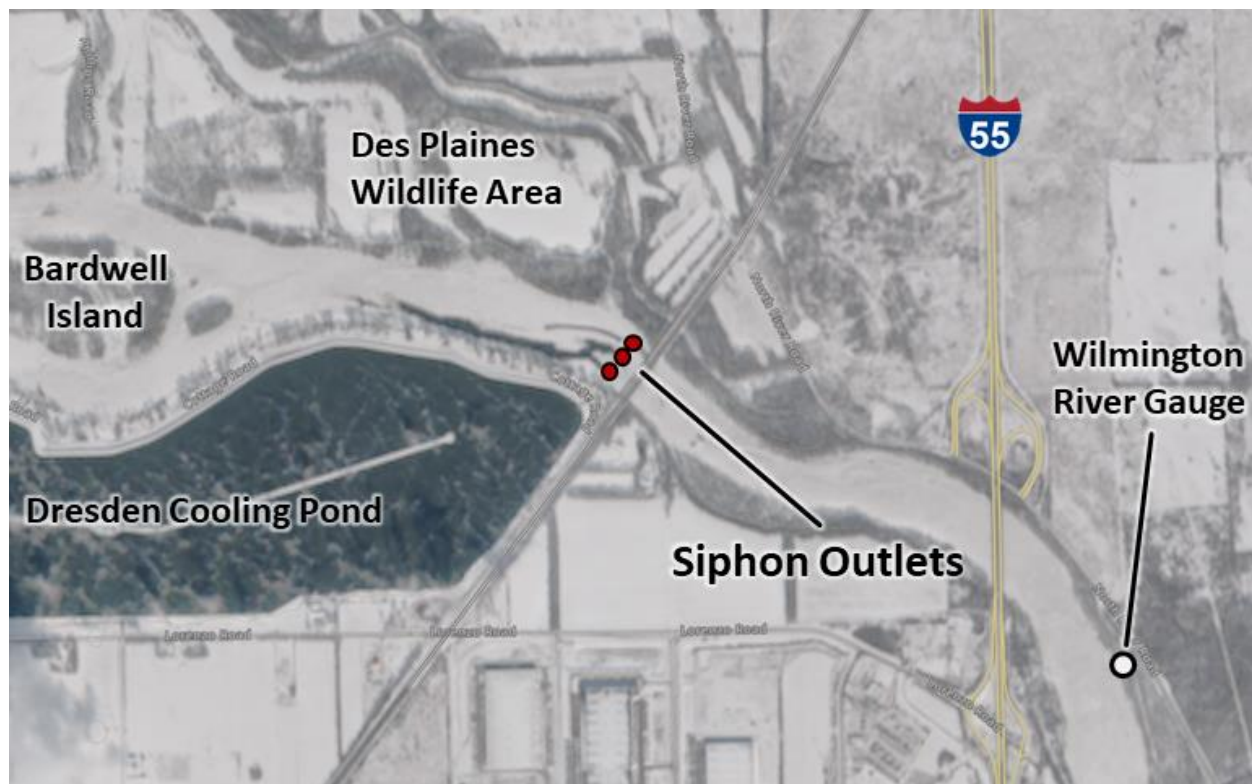
Figure 6. Aerial imagery of the lower end of the ice jam on January 20, 2024, captured by the Sentinel2 satellite. Paths of melting ice due to operation of the warm water siphon system are visible extending from near the railroad bridge downstream toward Bardwell Island. Imagery courtesy of Copernicus Sentinel data.

A small channel of melted water extending approximately 0.5 miles downstream and 100 yards in width was noted in the ice jam the morning of January 19. Satellite imagery collected by Sentinel2 on January 20 showed the areas of melting ice cover (open river) moving downstream (Figure 6). By the morning of January 22, a channel of melted water extended approximately 1.5 miles downstream. The extent of the melted water reached 1.7 miles on the morning of January 23. On January 24, the extent of the melted water reached 1.8 miles in the morning and 2.2 miles in the afternoon, with areas of open water also being noted just downstream of the ice jam near the Will-Grundy county line bridge. By the morning of January 25, a nearly continuous open channel was noted from near the siphon discharge location at the railroad bridge downstream to almost the confluence with the Illinois River, and large pieces of ice were noted flowing down river.

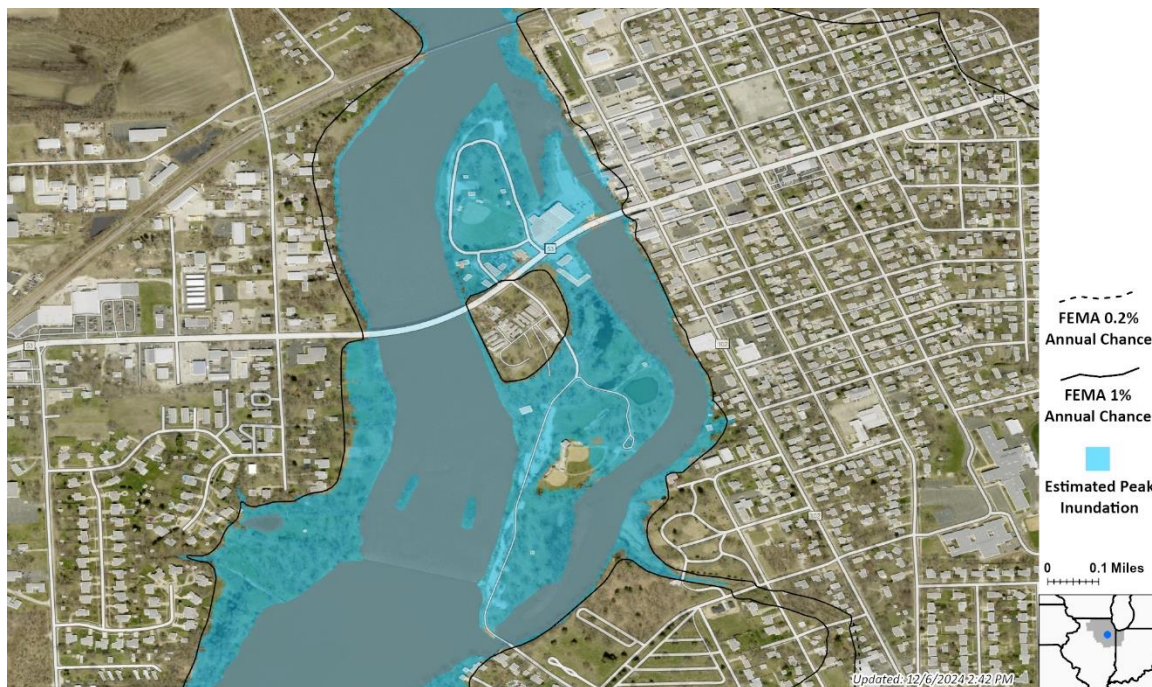
Figure 12. Estimated peak inundation along the lower Kankakee River at Wilmington from the ice jam related flooding of mid-January, 2024. The estimated flood extents associated with the 0.2% annual chance and 1% annual chance floods, as published by FEMA, are added as an overlay.

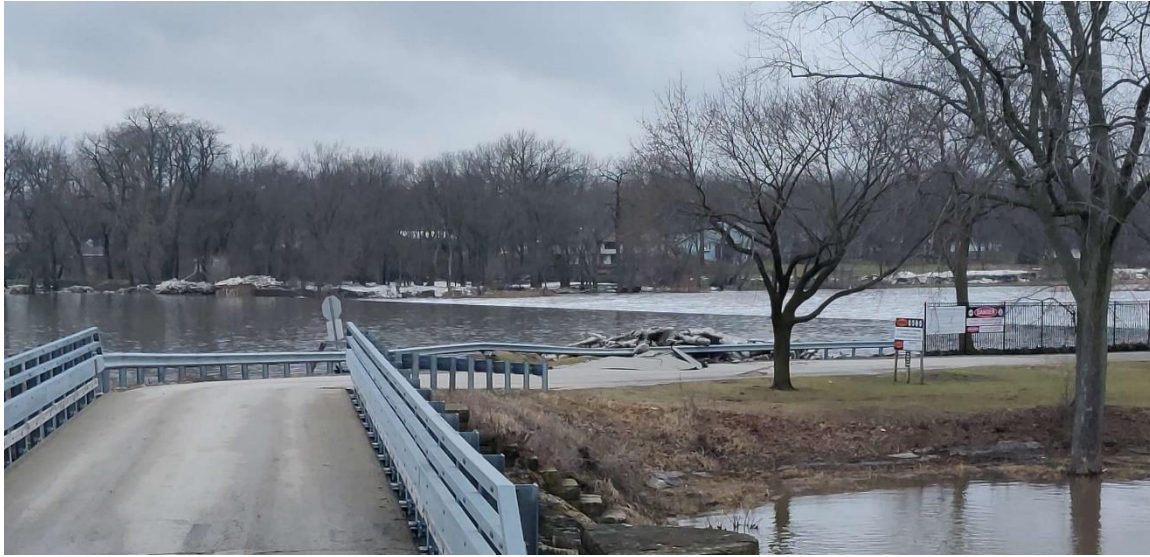
Figure 15. Damage to the roadway through Island Park in Wilmington. Note the piles of ice and shear walls on the opposite river bank still visible on January 30.

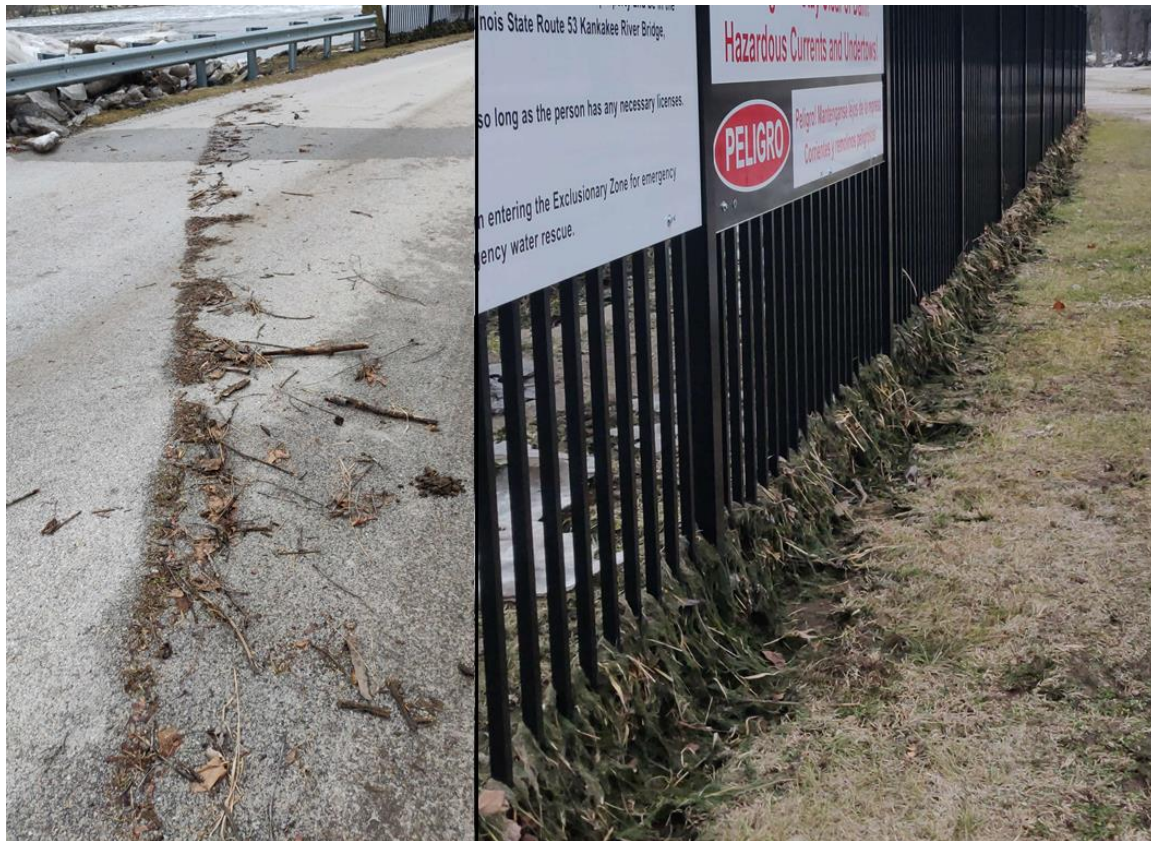
Figure 16. Vegetation debris lines on the roadway in Island Park and vegetation stuck in the fence near Wilmington Dam visible on January 30. These high water marks suggest a peak water level of about 539 feet elevation.

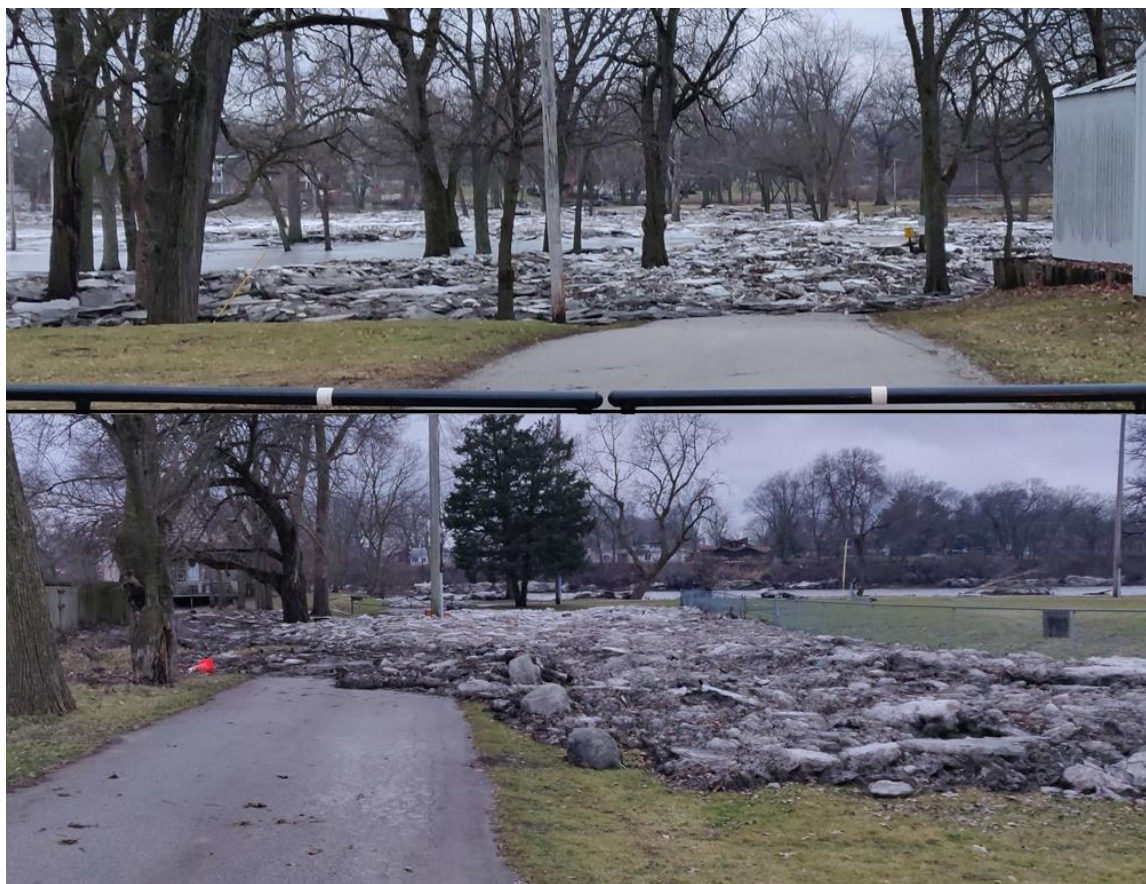
Figure 17. Large pieces of ice and flood debris cover portions South Island Park (top) and North Island Park (bottom) in Wilmington on January 30.

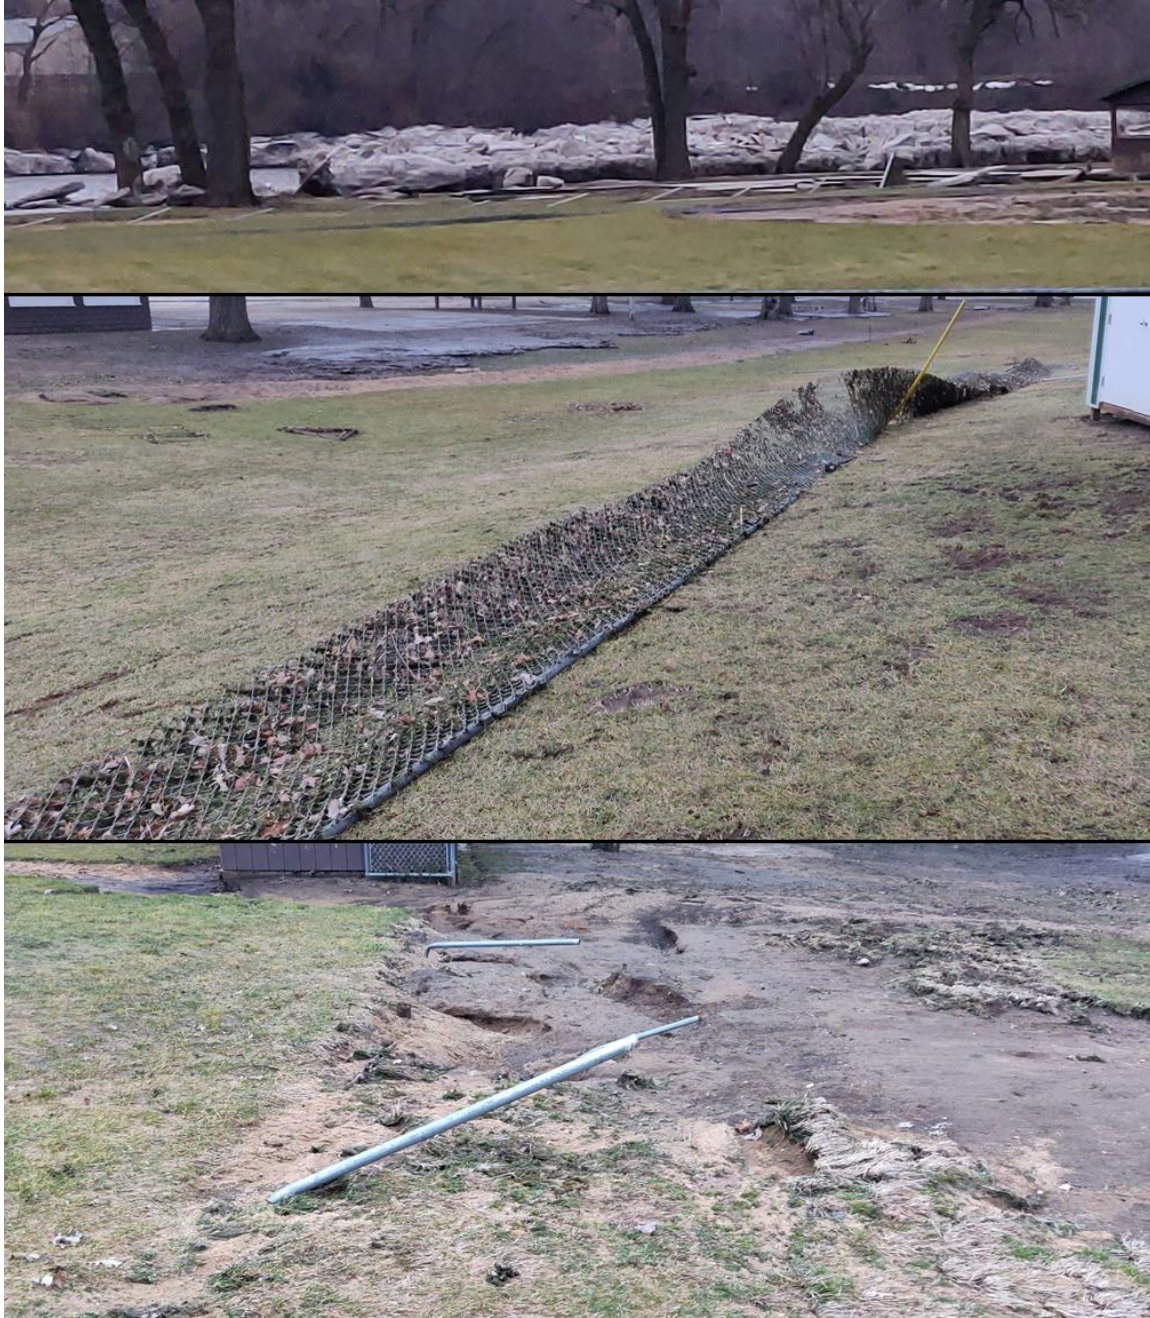
Figure 18. Chain link fencing damaged at the north (downstream) end of Island Park in Wilmington due to flooding and ice flows. Photographed on January 30.

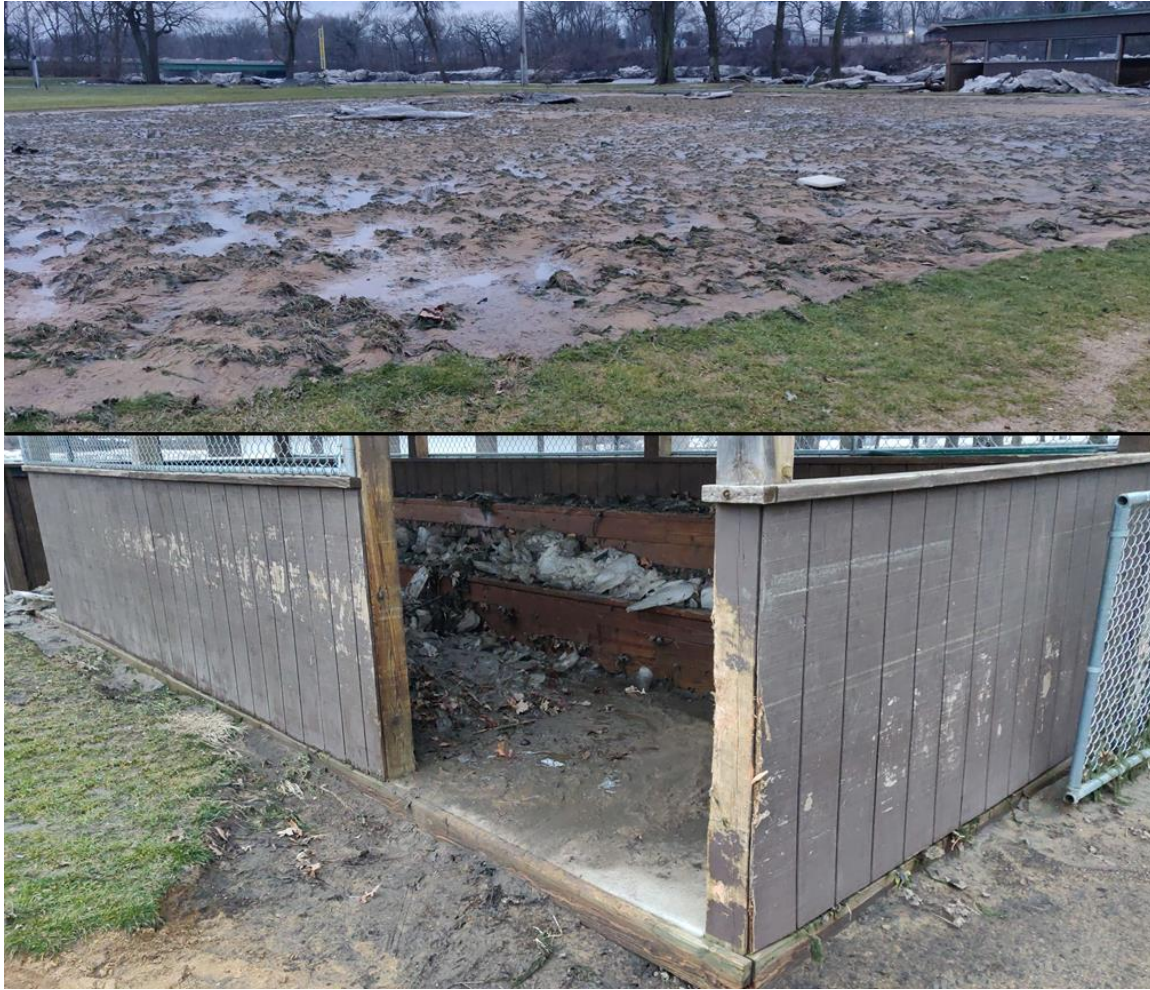
Figure 19. Damage to a baseball field at the North Island Park (downstream end) in Wilmington due to flooding and ice flows. Photographed on January 30.

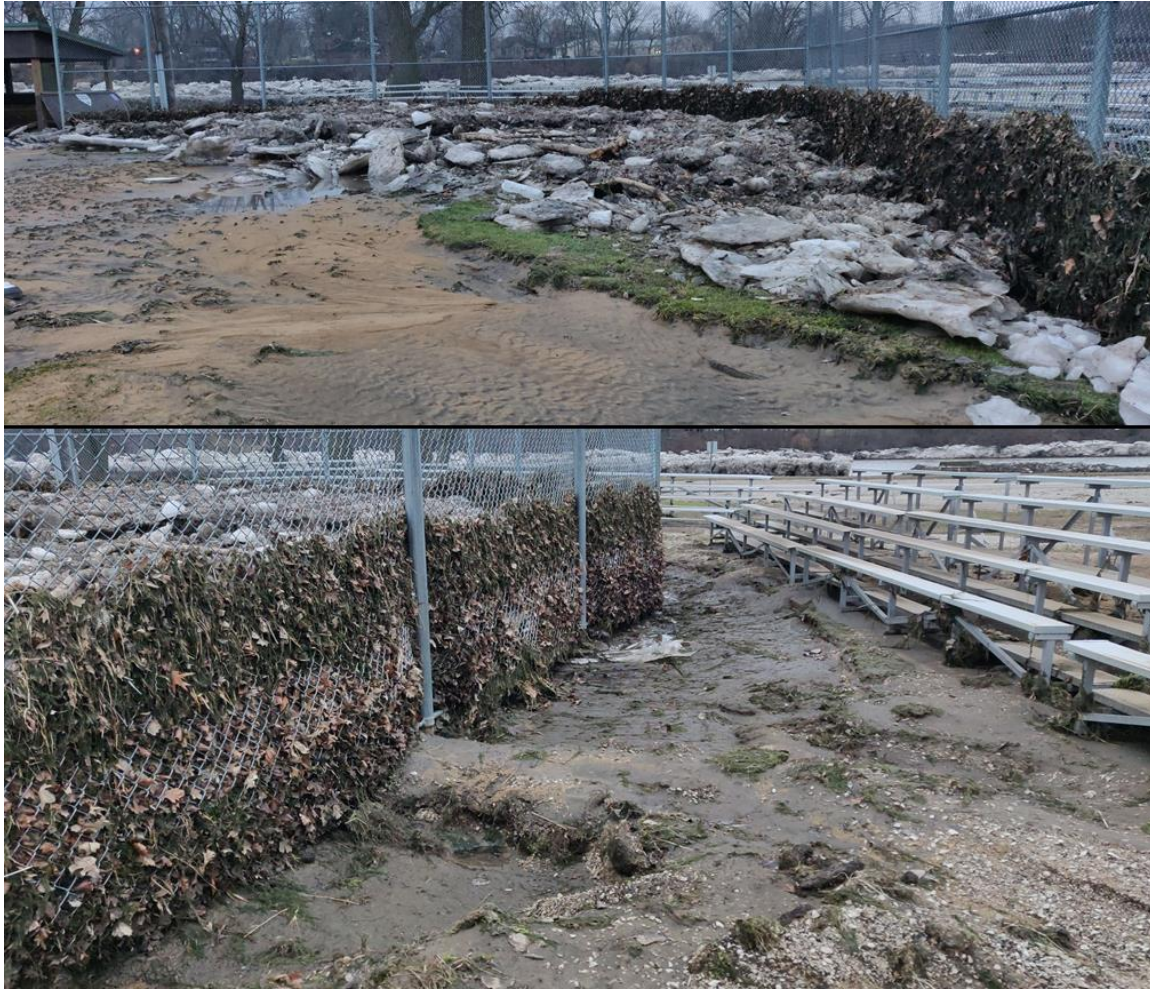
Figure 20. Vegetation stuck in the fence at baseball field at North Island Park (downstream end) in Wilmington. These high water marks suggest a peak water level of about 536 feet elevation. Photographed on January 30.

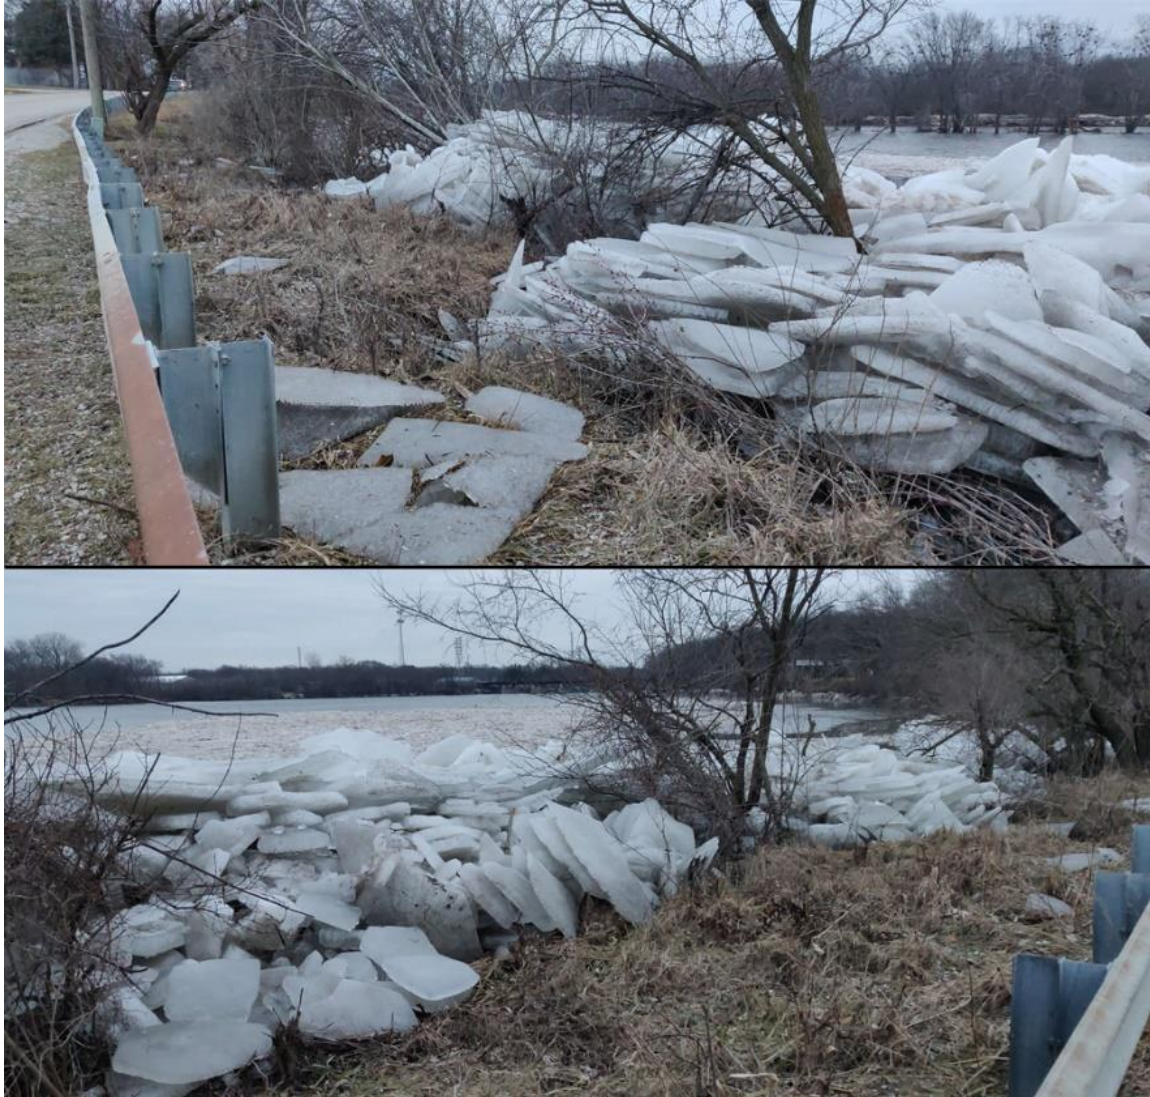
Figure 22. Large pieces of ice remain piled against the side of Widows Road near the Wilmington water treatment plant on January 30. During the ice jam break-up phase, water overtopped the road near this location and flooded part of the water treatment plant, suggesting a peak water level of at least 533.5 feet elevation.

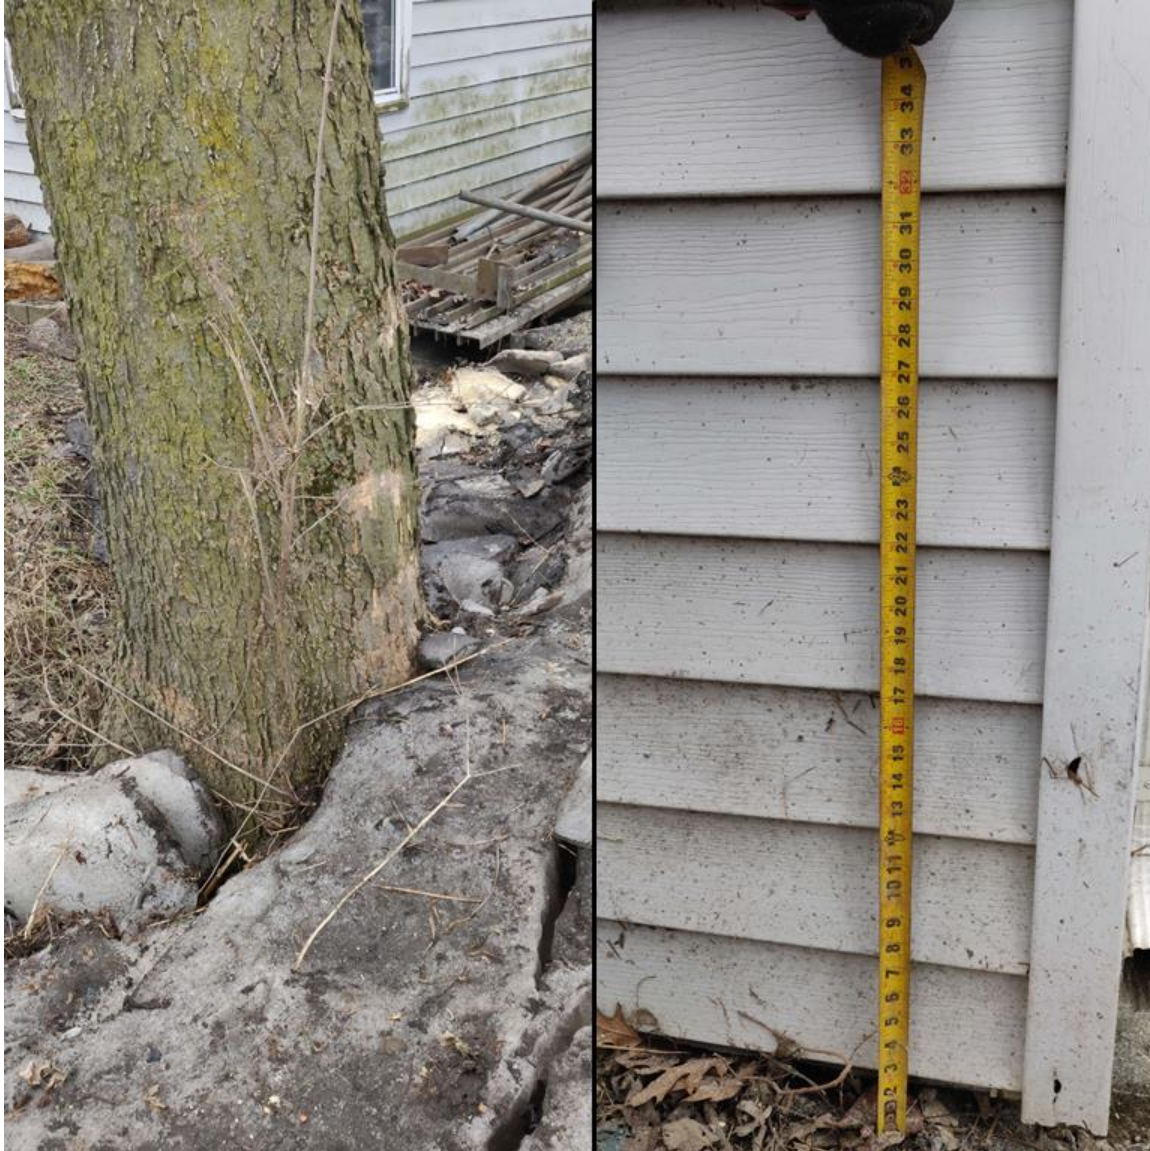
Figure 23. Damage marks to a tree and debris marks on a garage approximately 2 miles downstream of Wilmington remain visible on February 6. These high water marks suggest a peak water level of about 531.5 feet elevation.

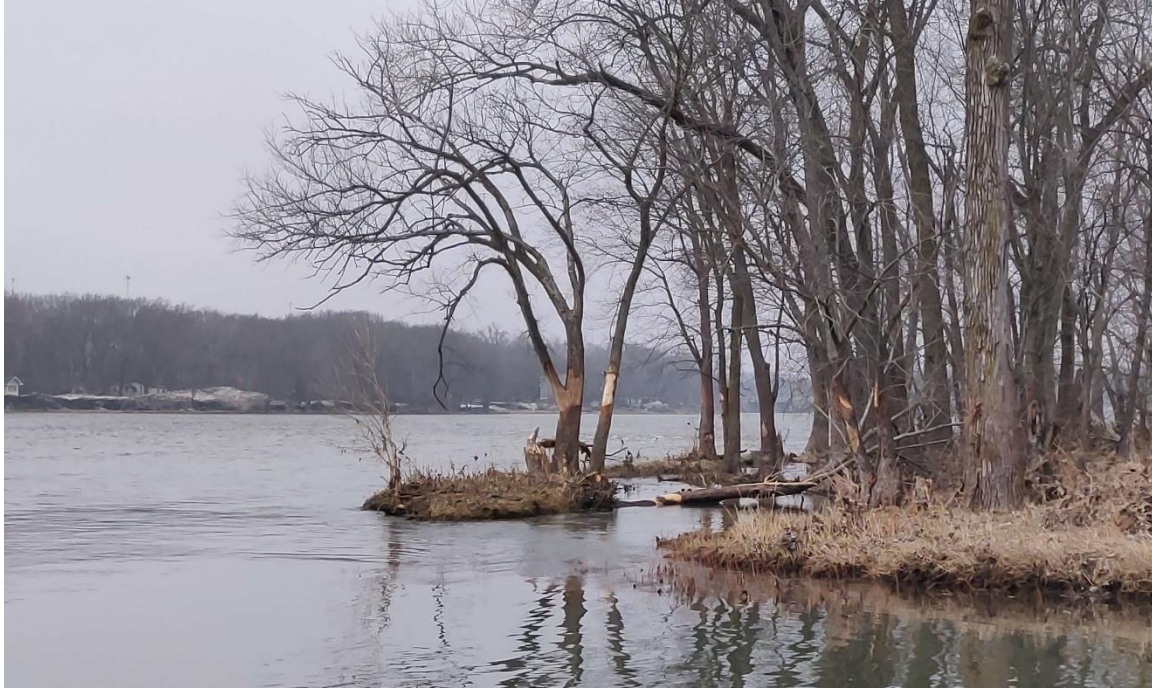
Figure 24. Multiple trees were damaged by flowing ice near Milliken Lake and the outlet of Prairie Creek. Note the shear walls on the opposite shore still visible on February 6.

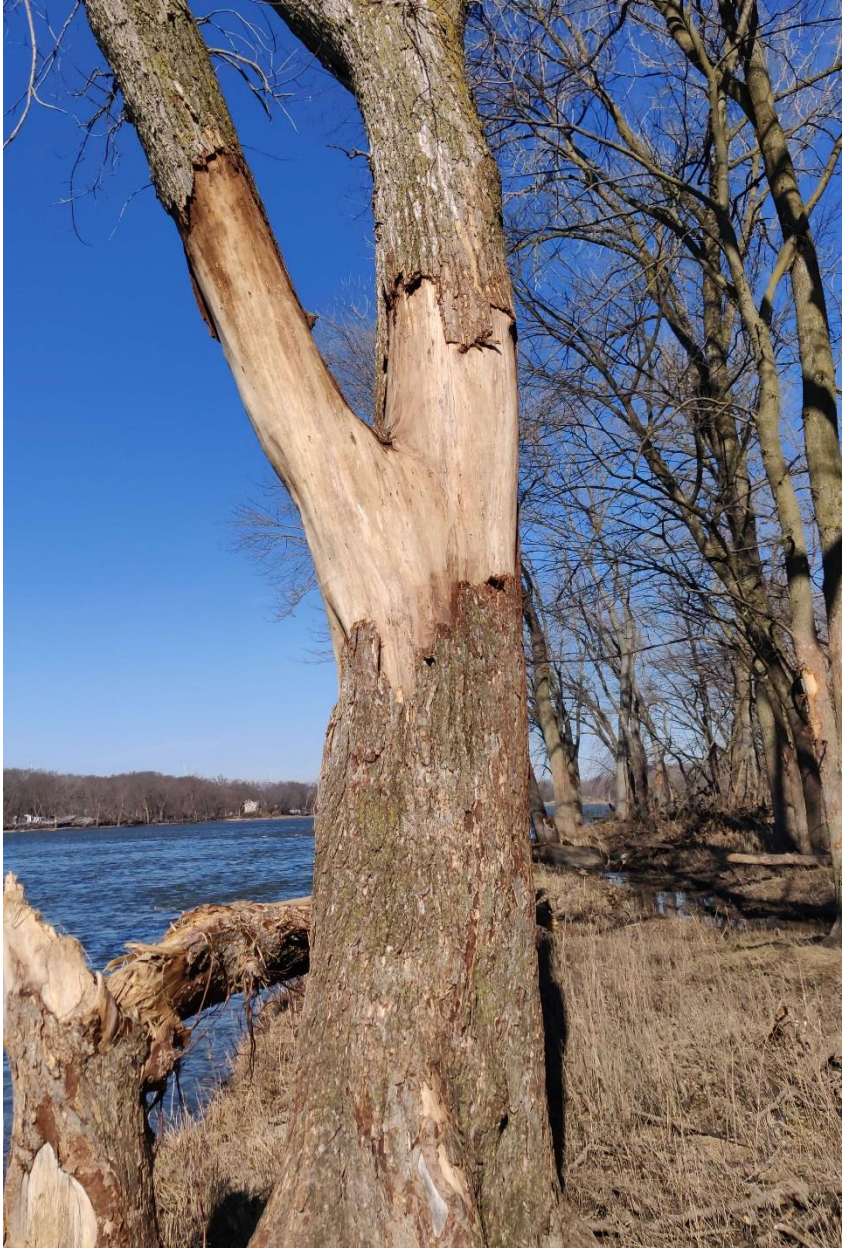
Figure 25. Closer view of trees damaged by ice on a small islet near the outlet of Prairie Creek. Photographed on February 14.

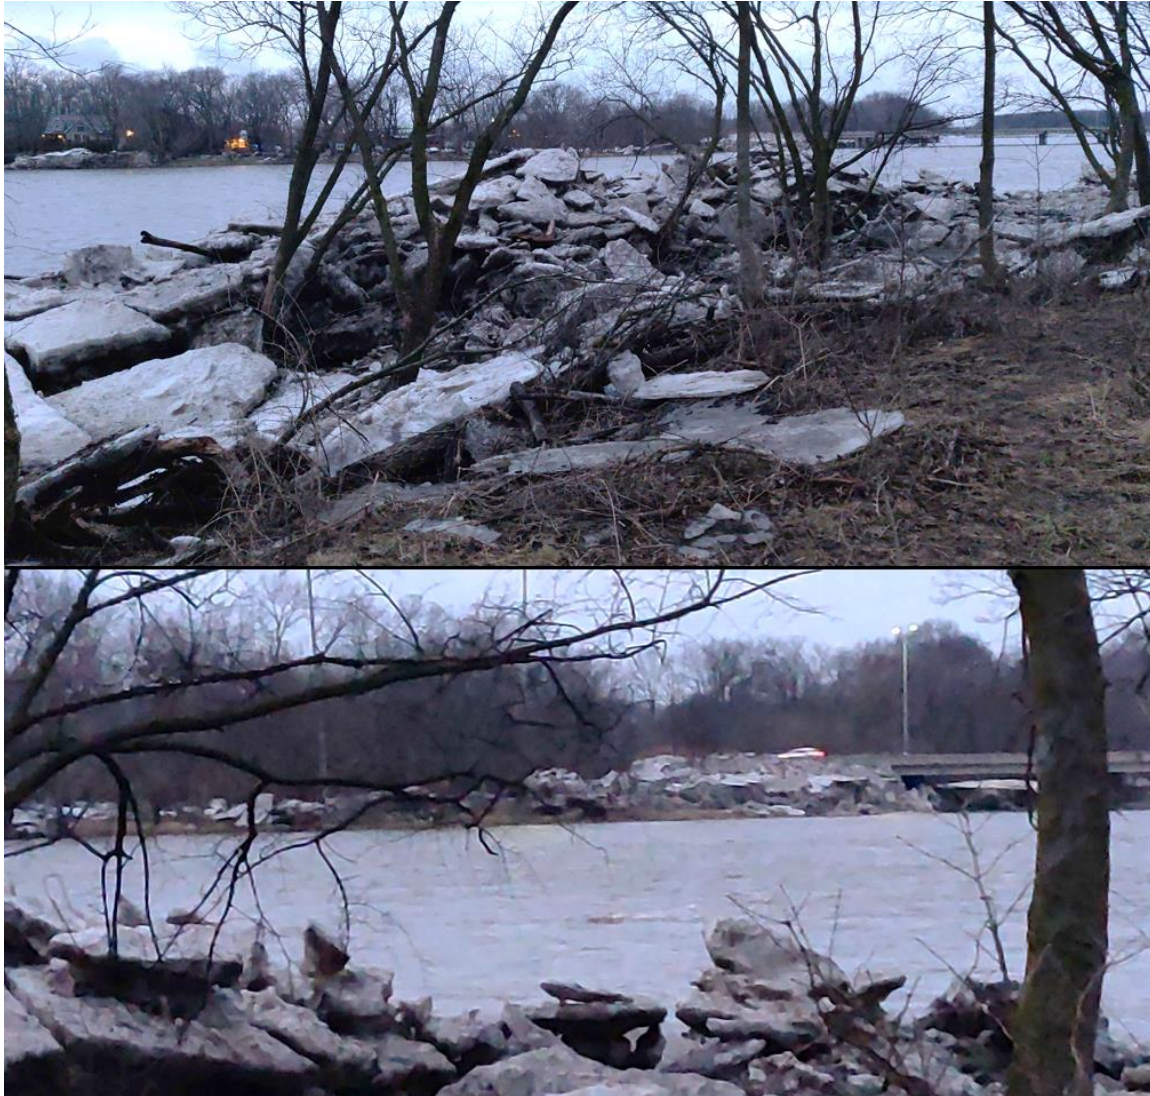
Figure 26. Large pieces of ice remain piled against the bank near the Wilmington river gauge and South River Road (top) and against the bank along the northbound I-55 bridge (bottom) on January 30. Photos were slightly adjusted to increase brightness and contrast.

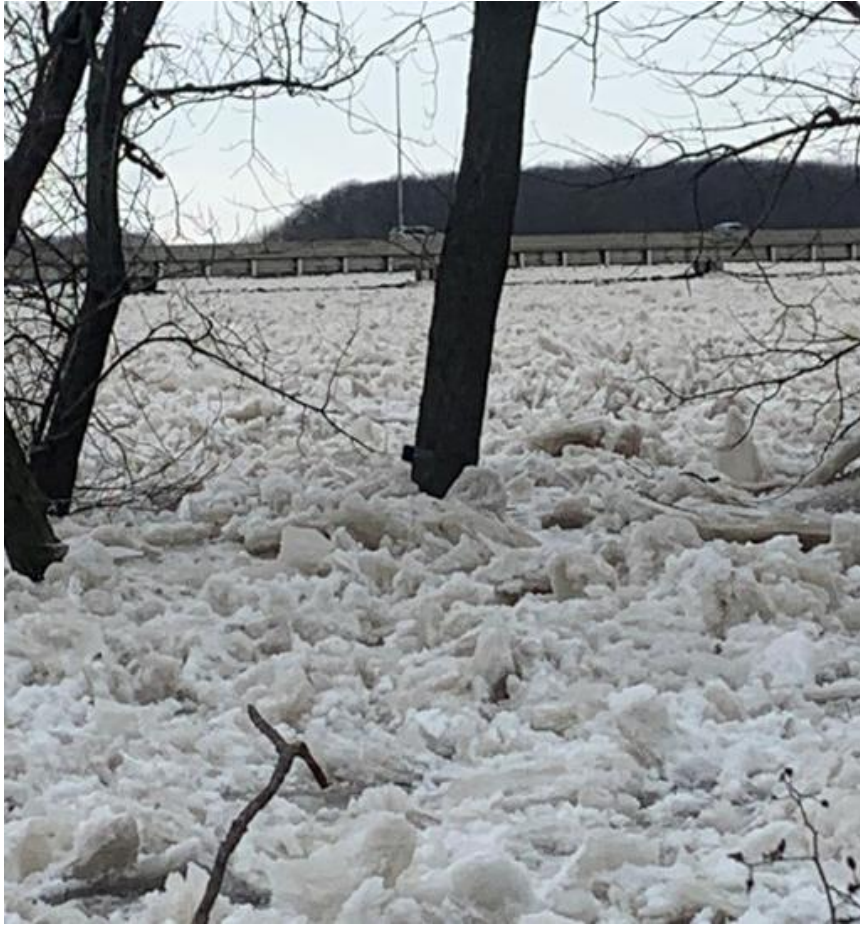
Figure 27. This photo, taken by Erin Ward of Will County EMA, shows an Ice jam in progress just upstream of I-55 at 9:33 AM CST on January 17. Note the web cam attached to the tree in the center of the photo which was installed prior to ice jam formation near the river bank at a height approximately 10 feet above ground level. The stage recorded by the nearby Wilmington river gauge was 12.3 feet at the time of this photo; the river crested over 3 feet higher at approximately 15.6 feet on January 26 and the camera was lost due the resulting ice flow.

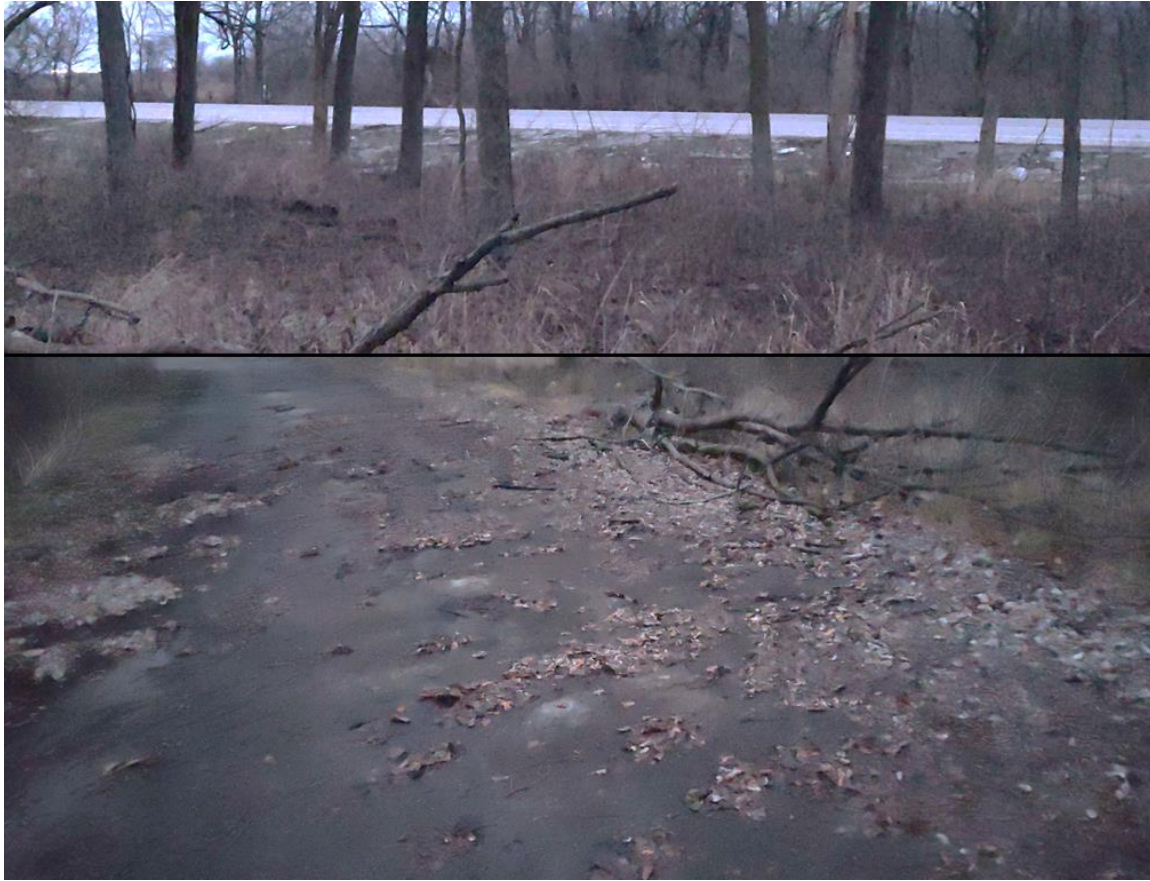
Figure 28. Evidence of ice and flowing water remains along South River Road and near the Wilmington river gauge on January 30. Pieces of ice were noted on both sides of South River Road (top), suggesting a peak water level of at least 525 feet elevation, or at least a stage of approximately 14 feet on the Wilmington river gauge. Debris and mud marks were noted on the access road to the river gauge (bottom), suggesting a peak water level of at least 526 feet elevation, or at least a stage of approximately 15 feet. Flood impacts were generally consistent with the peak stage value of 15.6 feet (526.5 feet elevation) recorded by the nearby river gauge.
