The 20th Anniversary of the Dead River Flood

May 14th to May 16th, 2003

National Weather Service
Marquette, MI May 2023

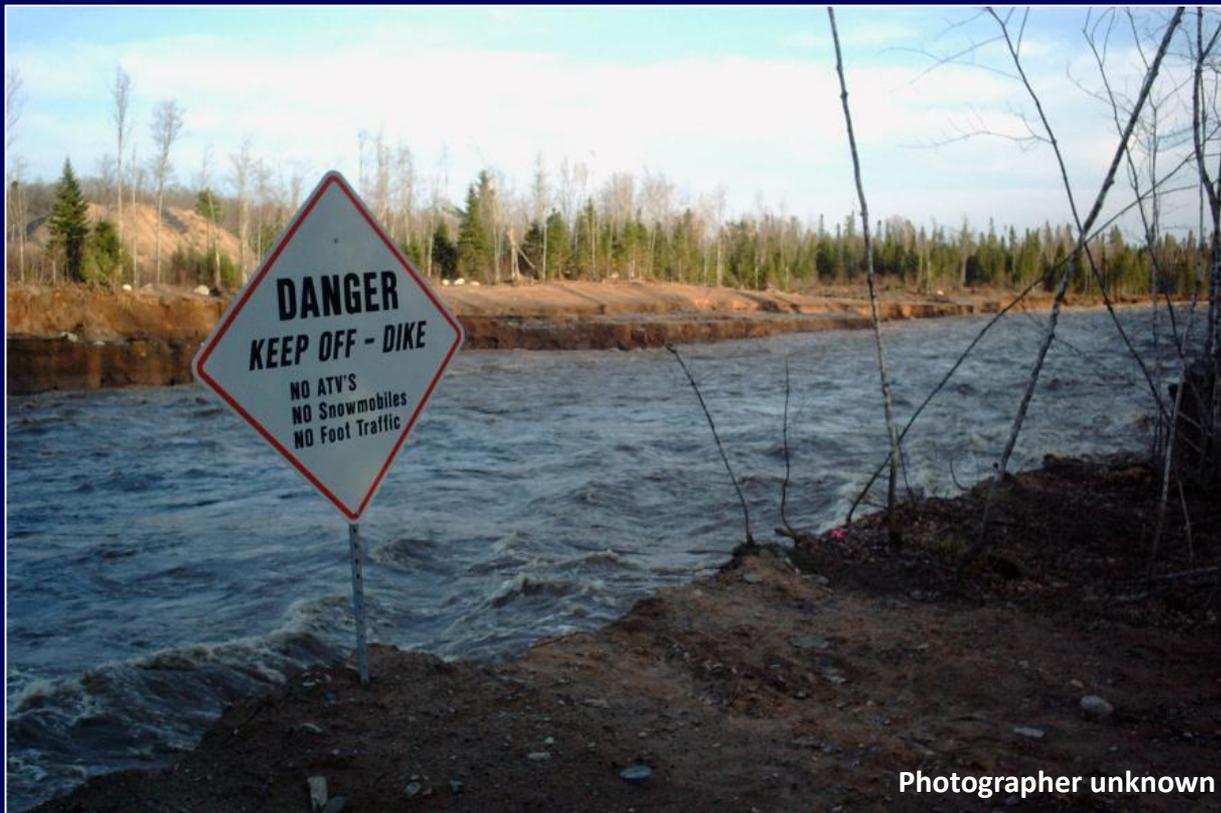
Silver Lake fuse plug failure near the beginning of the event

- May 14, 2003. Two days after the end of the heavy rainfall, the Silver Lake Basin fuse plug fails – approximately 5:00 p.m.

The combination of spring snowmelt and the heavy rain event of May 11th and 12th were contributors to the fuse plug failure.

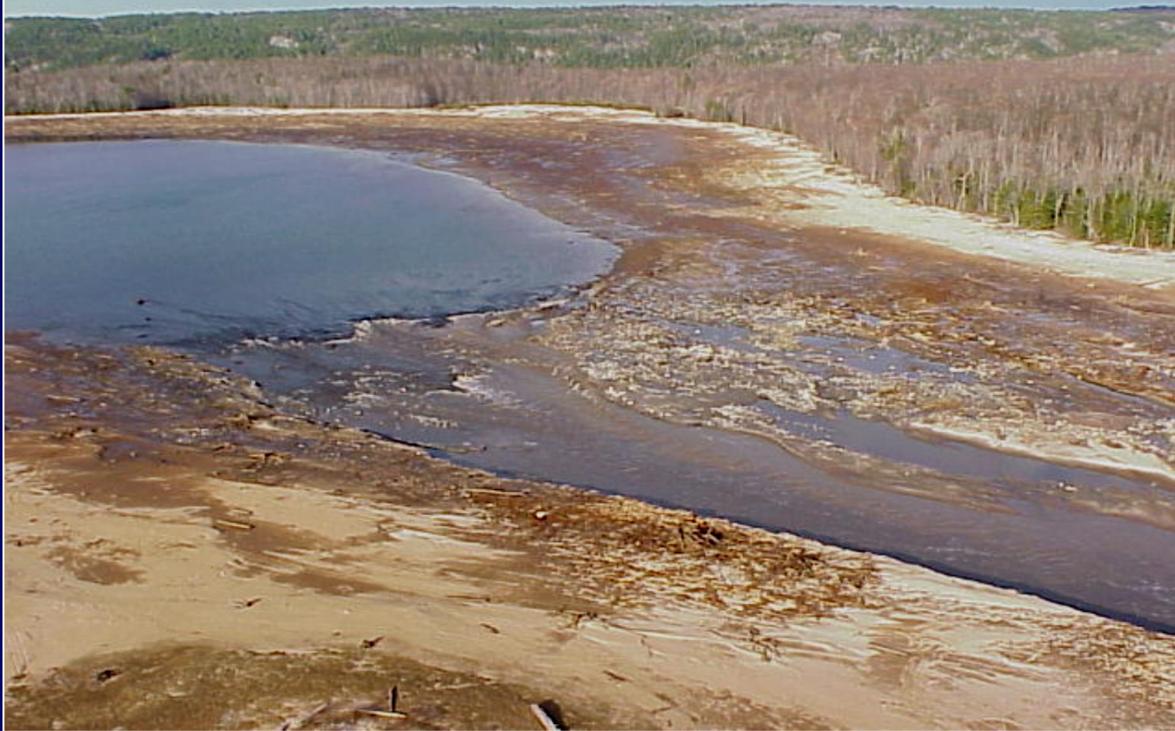
Silver Lake basin breach

Silver Lake reservoir has a surface area of about 1500 acres and a storage capacity of approximately 34,000 acre-feet. Through the section of the fuse plug that failed at Silver Lake, the rapidly flowing water carved out a new channel approximately 100 yards wide by 25 feet deep and one-half mile long. It was estimated that 25,300 acre-feet of water passed through the new channel with the remaining water being held back by a high point in the lake bottom.

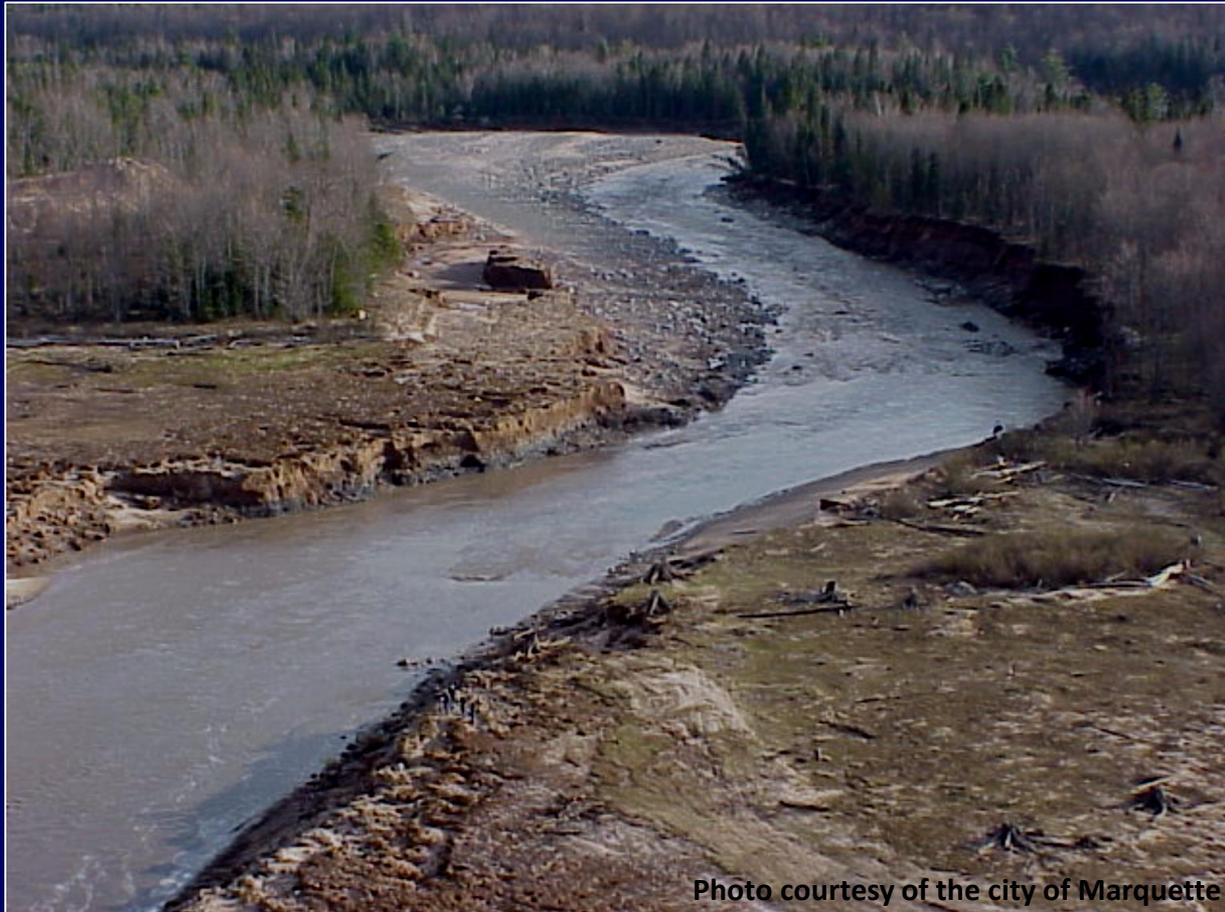
Just downriver from Silver Lake

- Break unleashed an estimated 8-9 billion gallons of water downriver from Silver Lake.

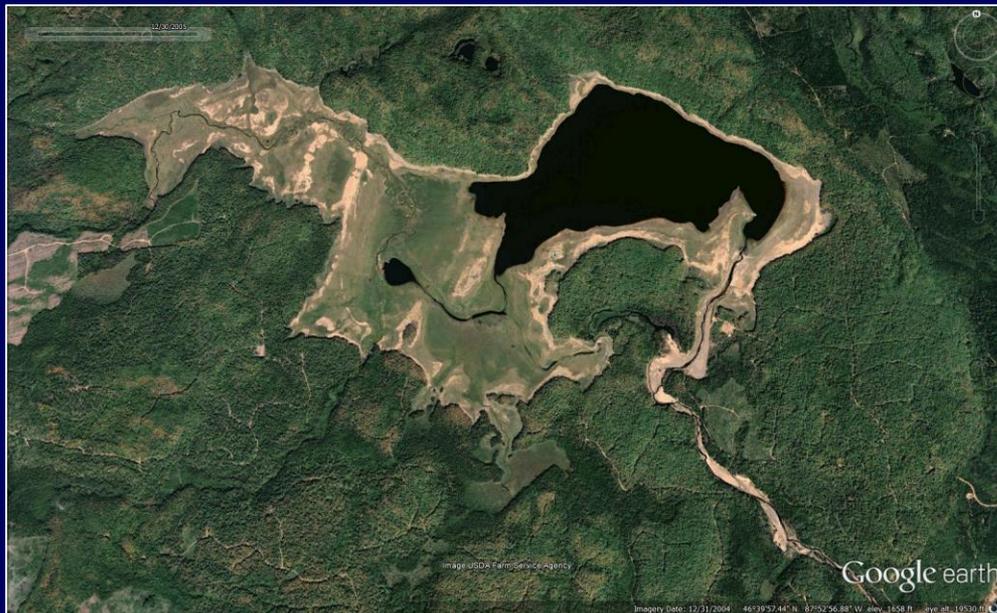
Silver Lake basin in 2005, two years after the flood.

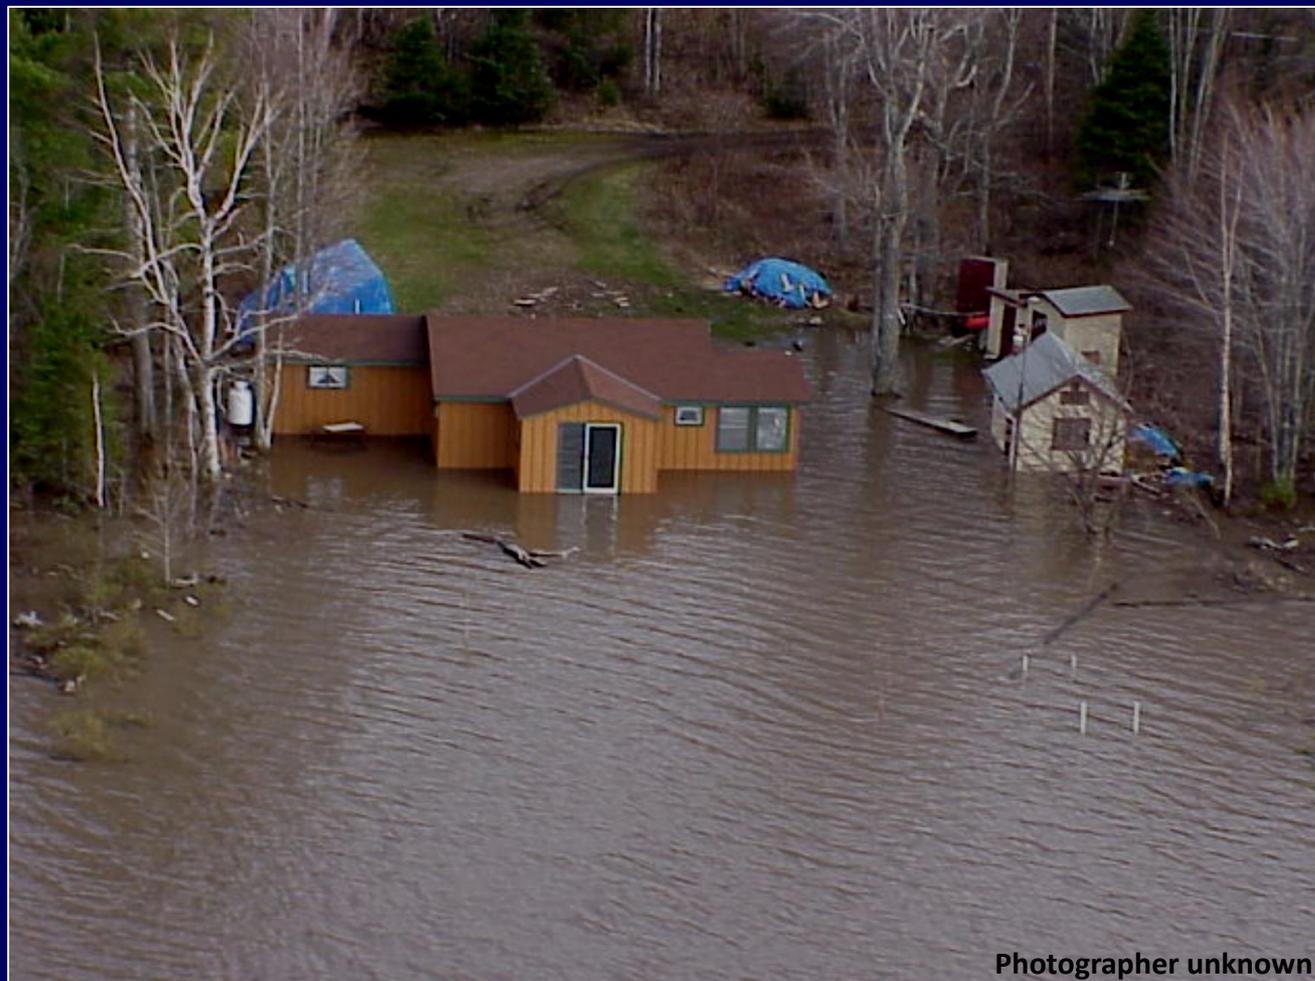
Dead River Basin

- Floodwaters reach Dead River Basin, damaging camps and homes

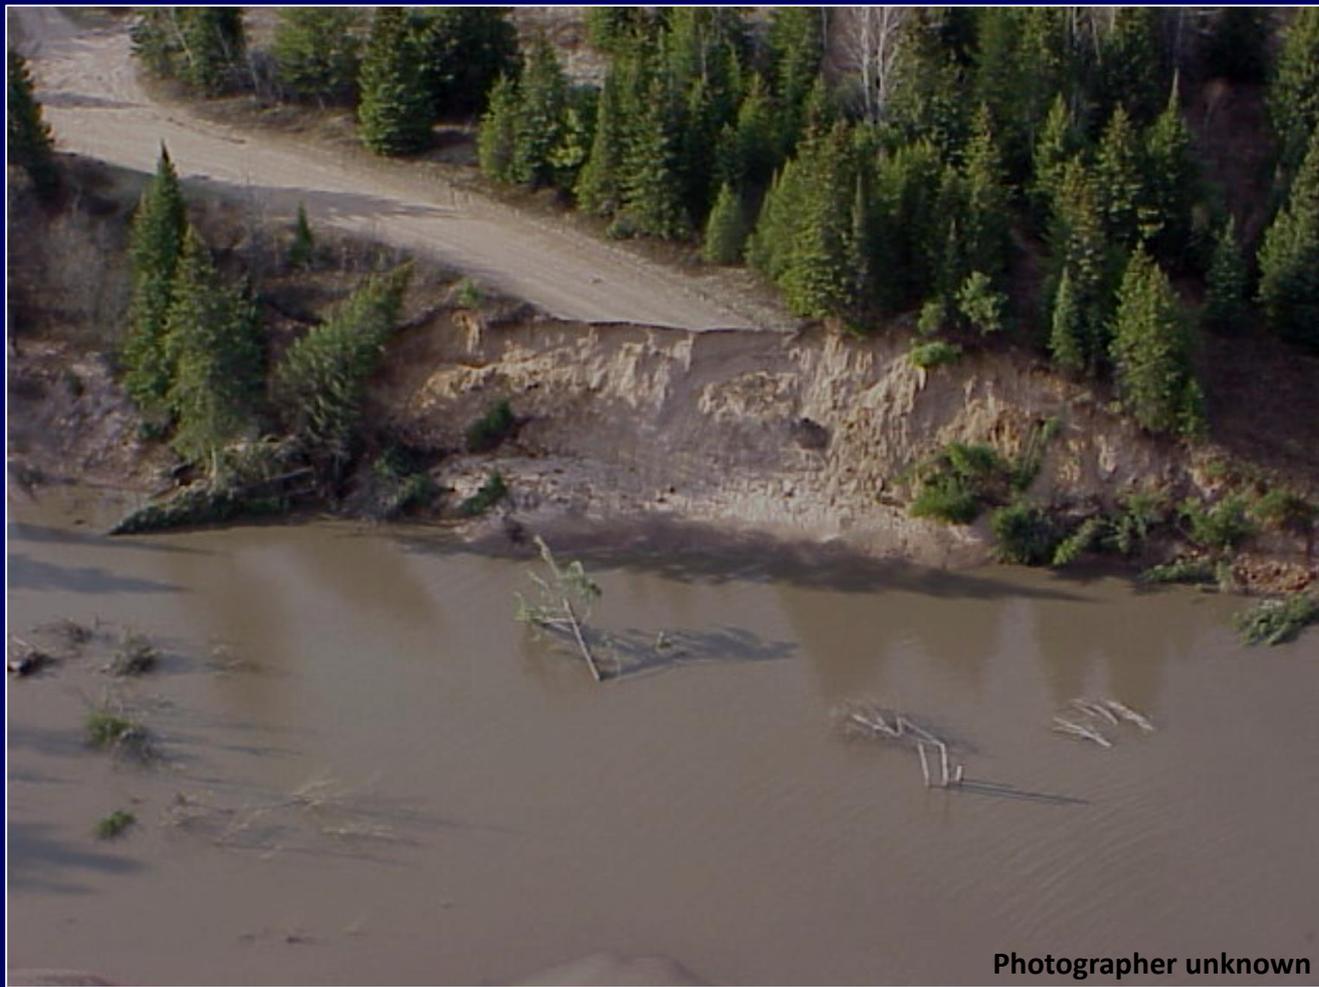
Dead River Basin

- The torrent of water also destroys roads along the way

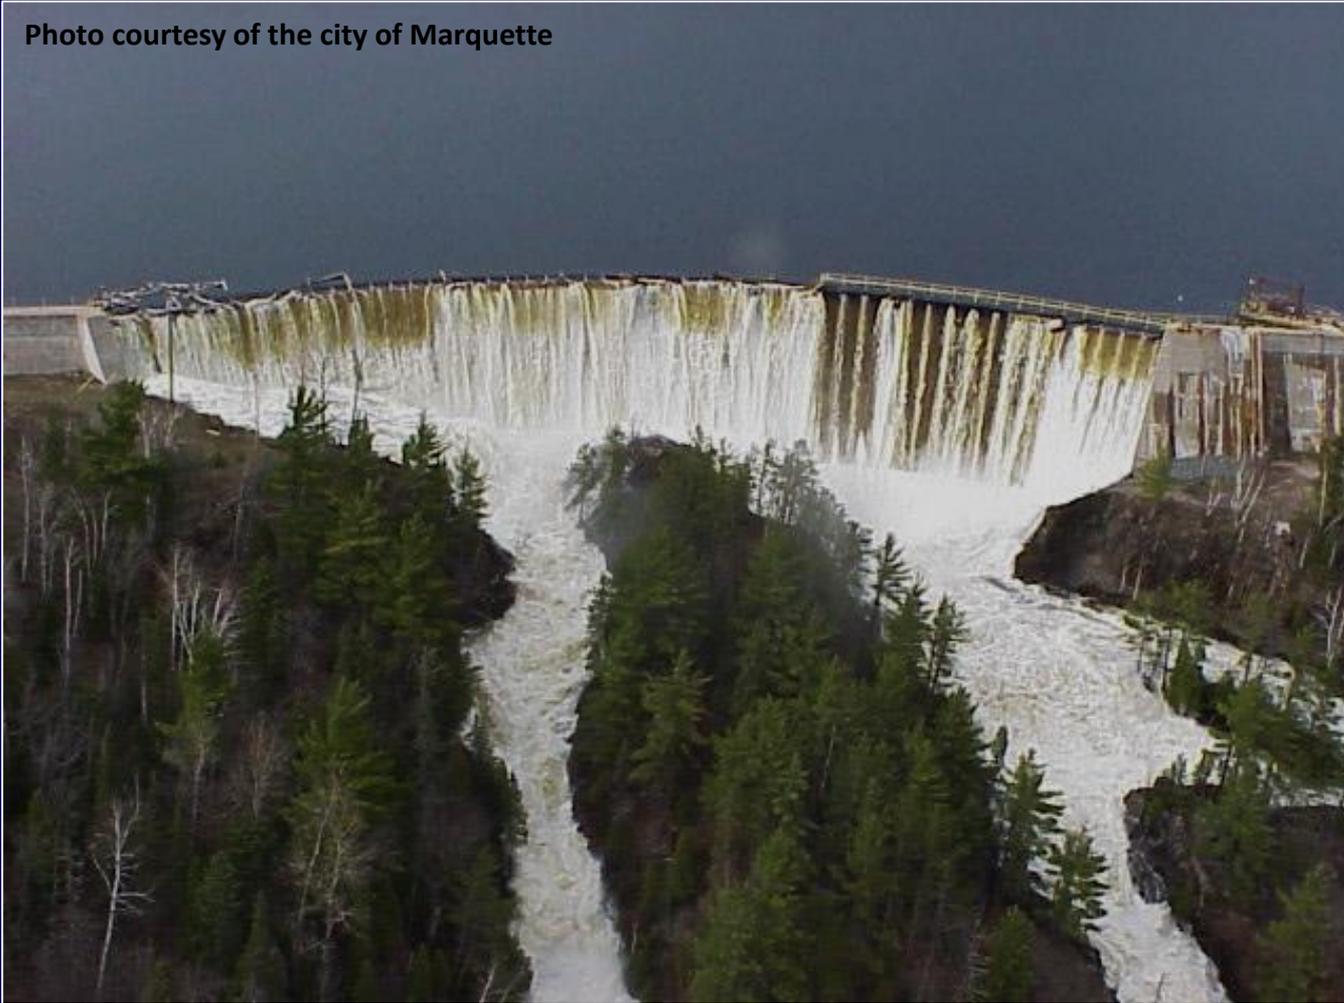
- Floodwaters crest the Hoist Dam and flow farther downriver
- Peak water level at the Hoist Dam was 4.44 feet above the spillway level

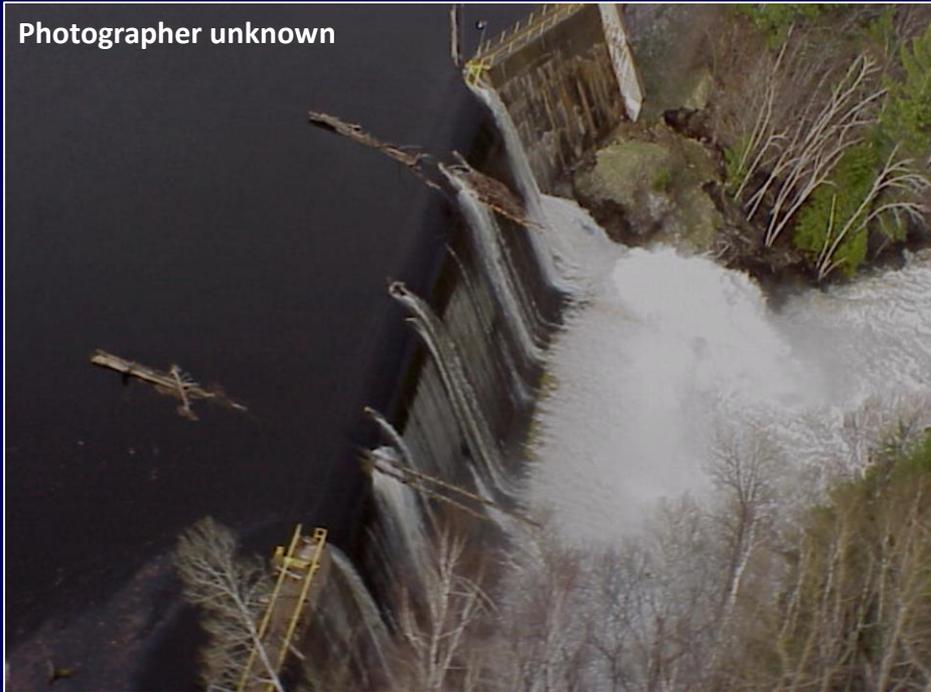
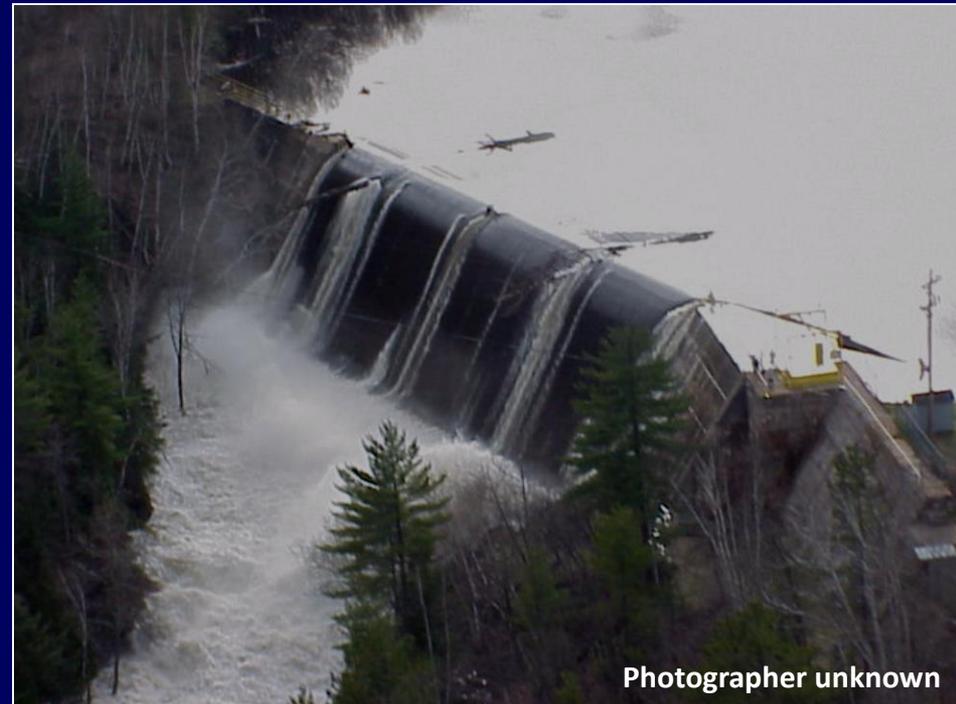
- Downriver, the floodwaters crest the McClure Dam
- Peak water level at the McClure Dam was 5.13 feet above the spillway level

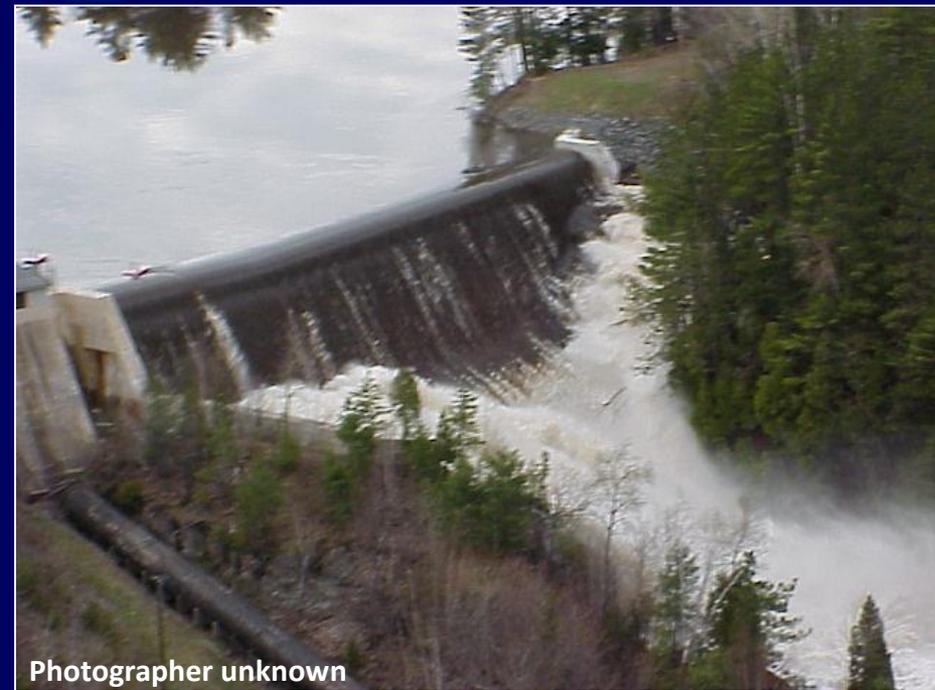
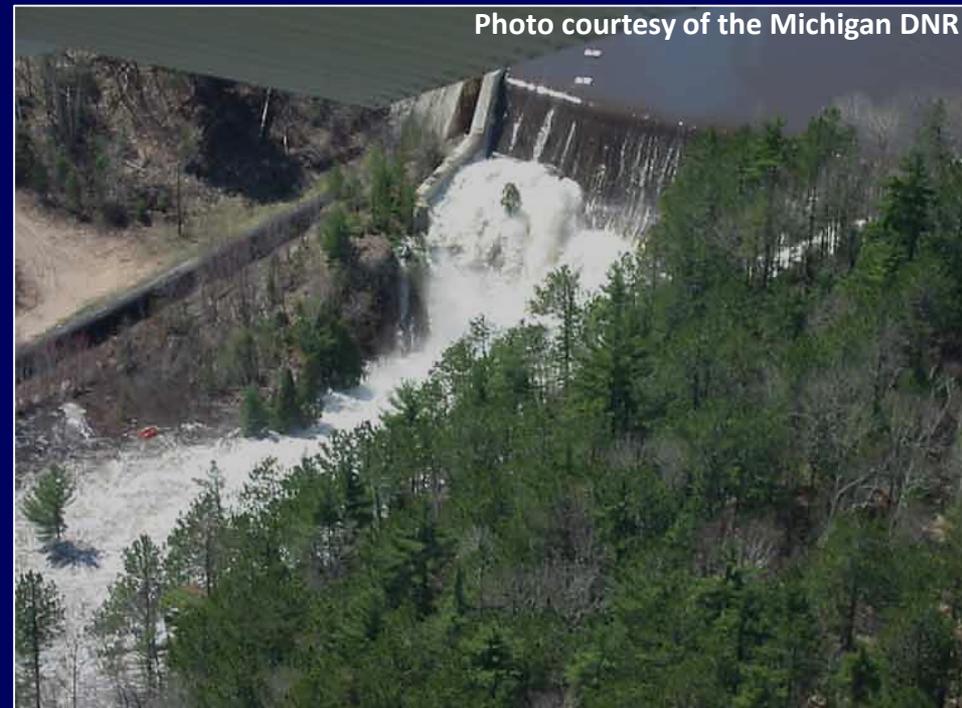
- Floodwaters reach Forestville Dam
- Peak water level at the Forestville Dam was 4.4 feet above the spillway level

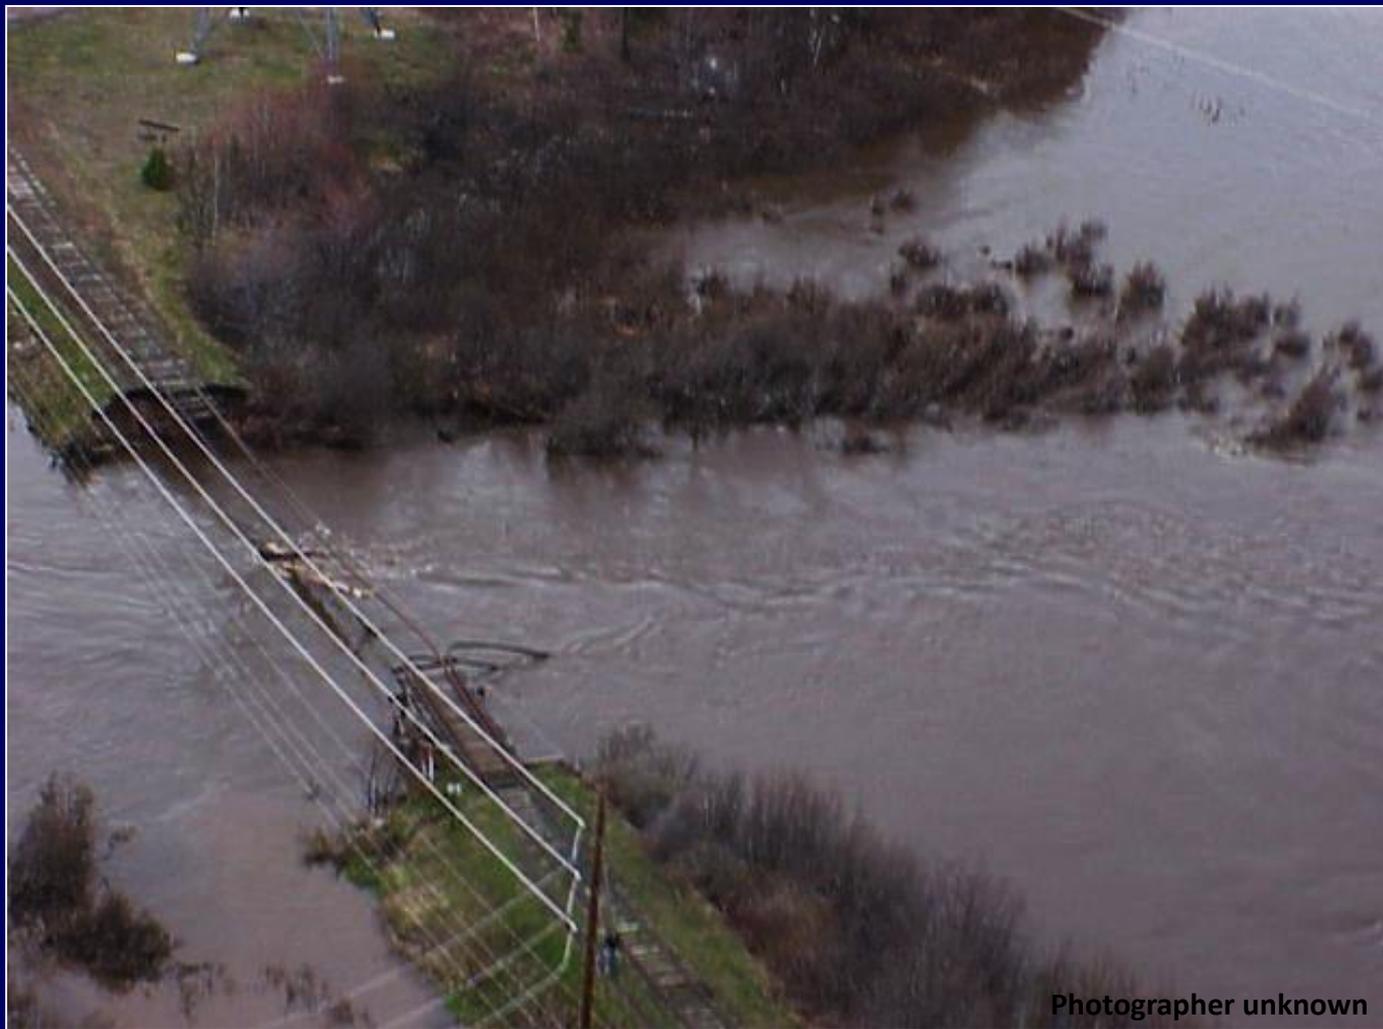
- Floodwaters destroy train trestle

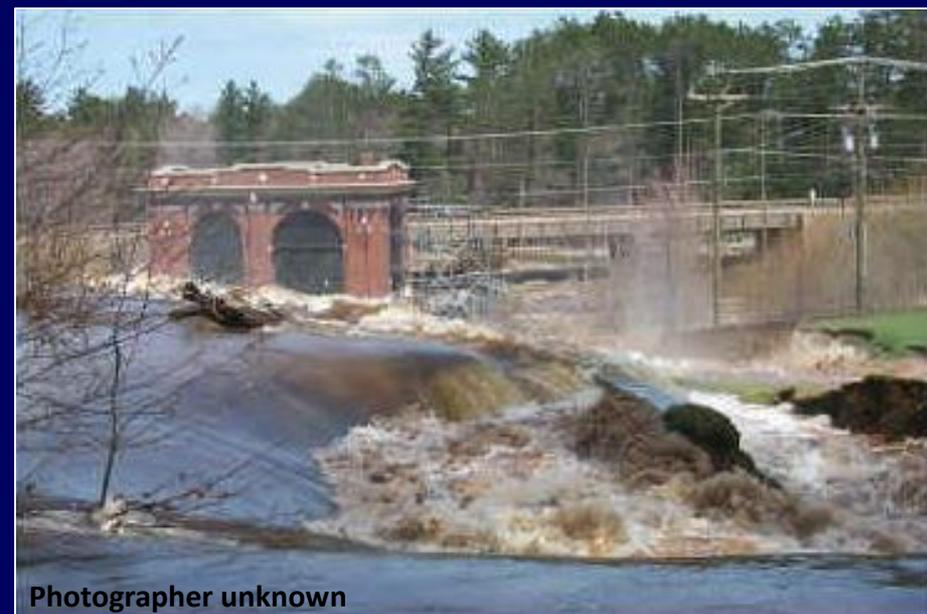
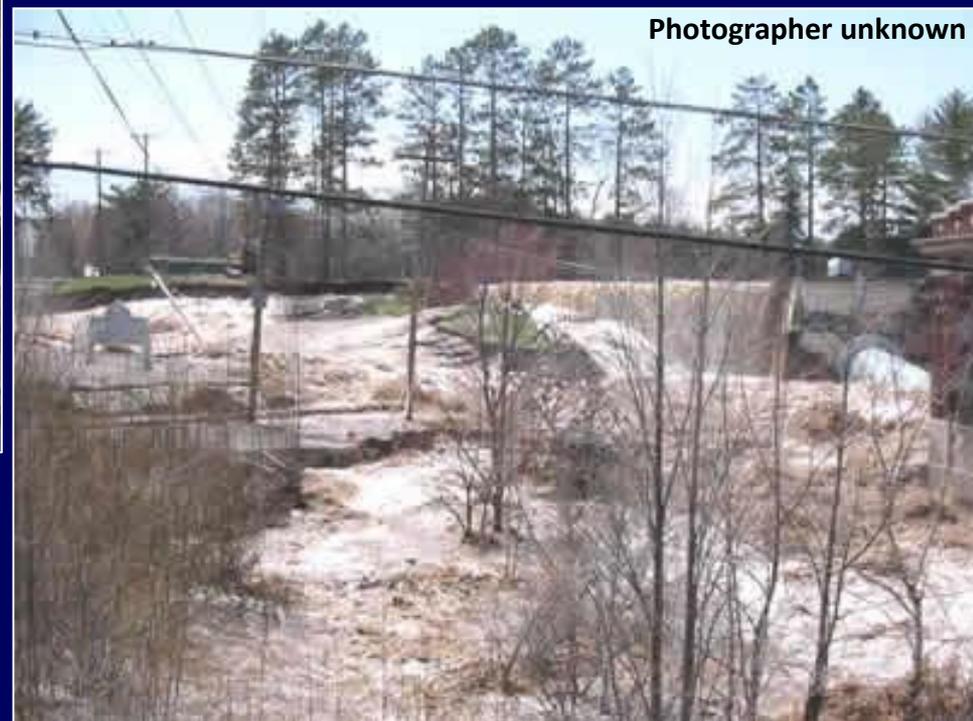
Tourist Park
Marquette

Flood water reaches Tourist Park. Despite the water level being drawn down 5 feet behind the Tourist Park dam prior to the arrival of the flood wave, water still overtops the dam, and the tremendous surge of water also carves out a new outlet away from the dam near the swimming area.

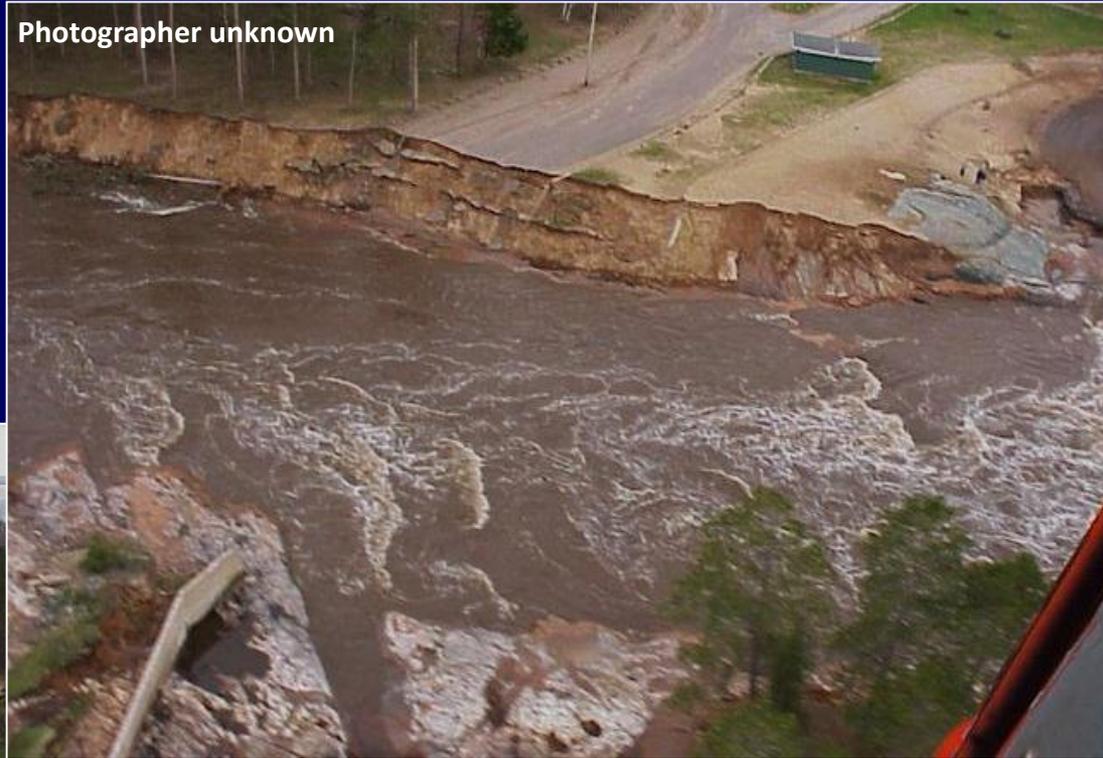
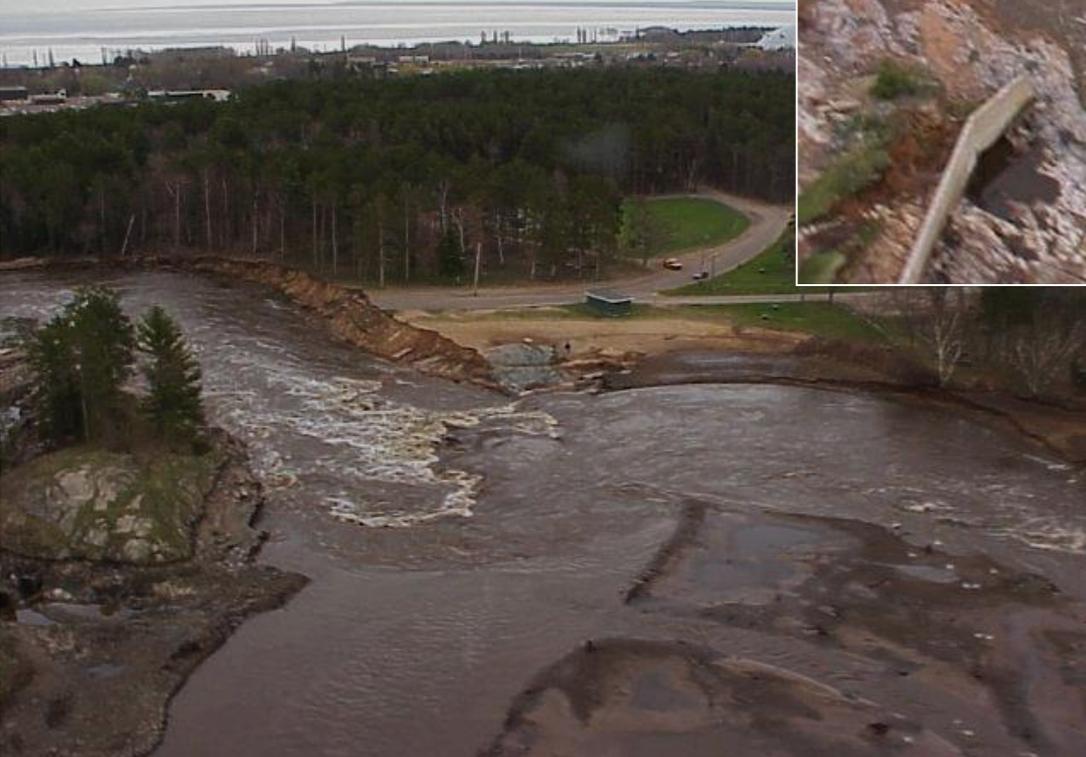
Damage to Tourist
Park in Marquette

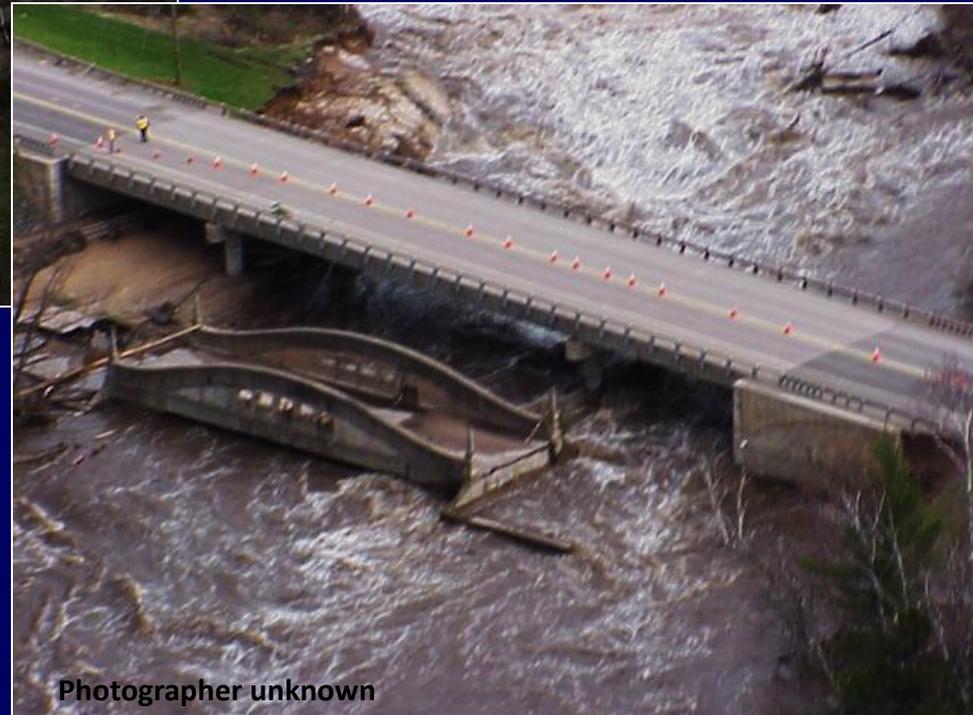
CR 550 near Tourist
Park in Marquette

- Flood damages bridges on CR 550
- Utility service interrupted to Big Bay

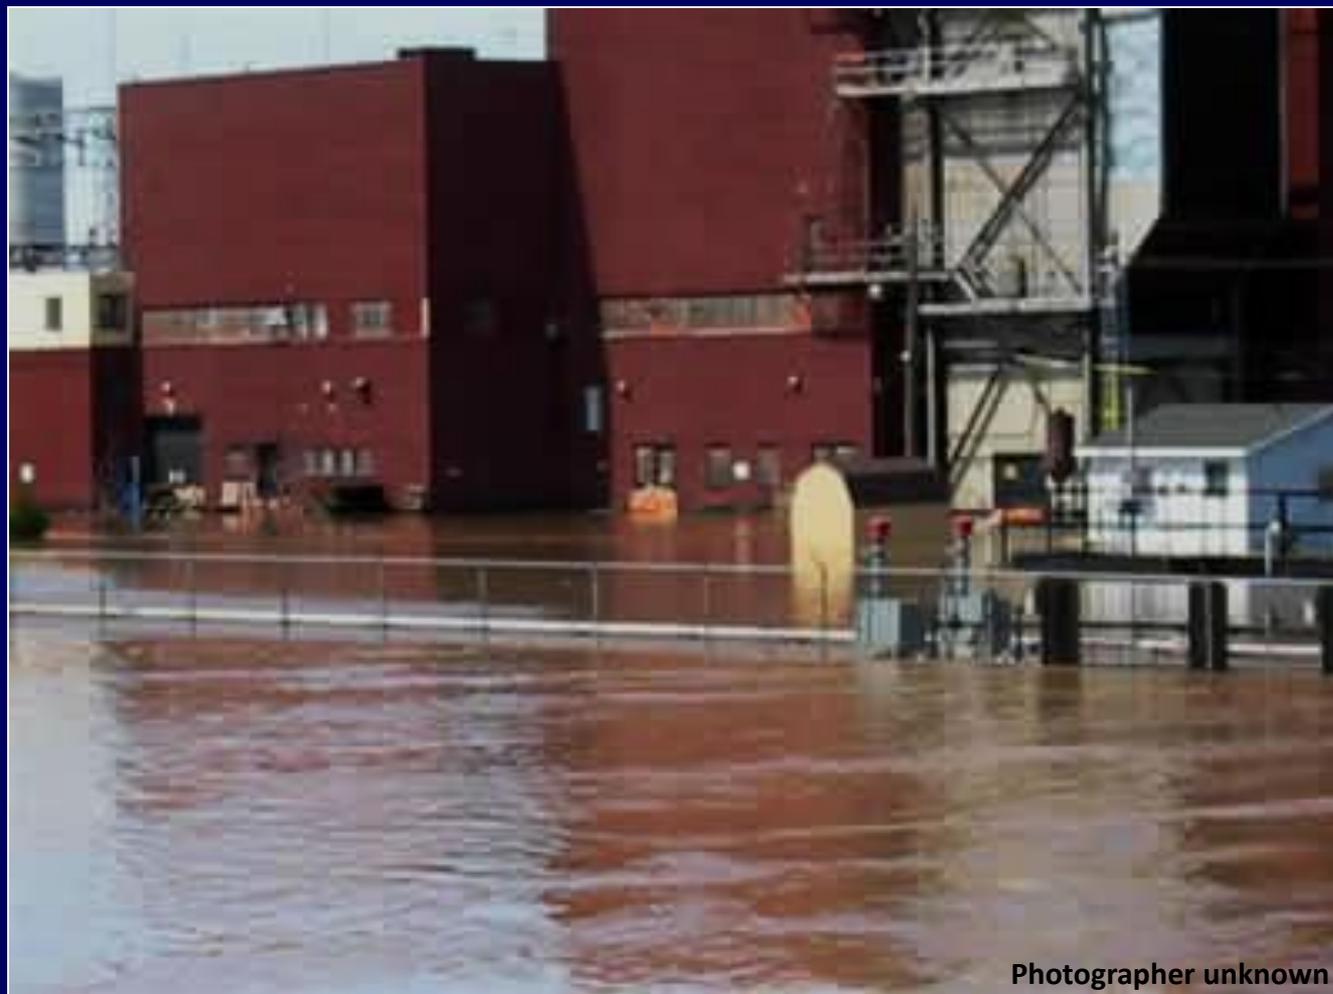
Presque Isle Power Plant in Marquette

- Considerable damage to Presque Isle Power Plant

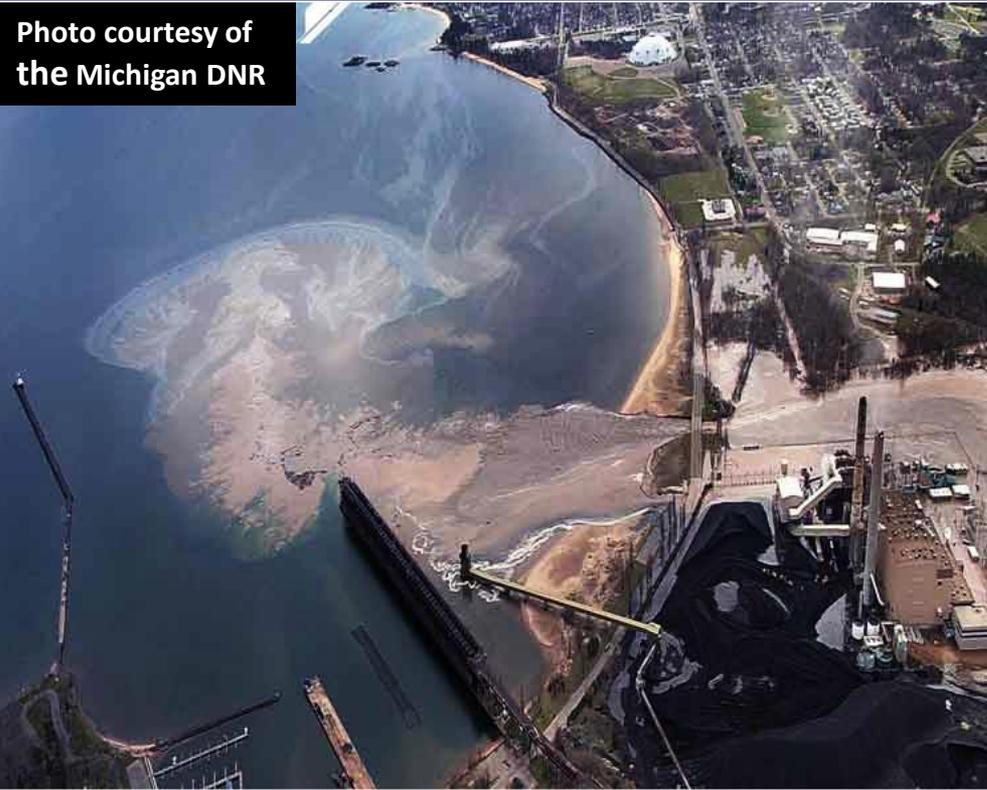
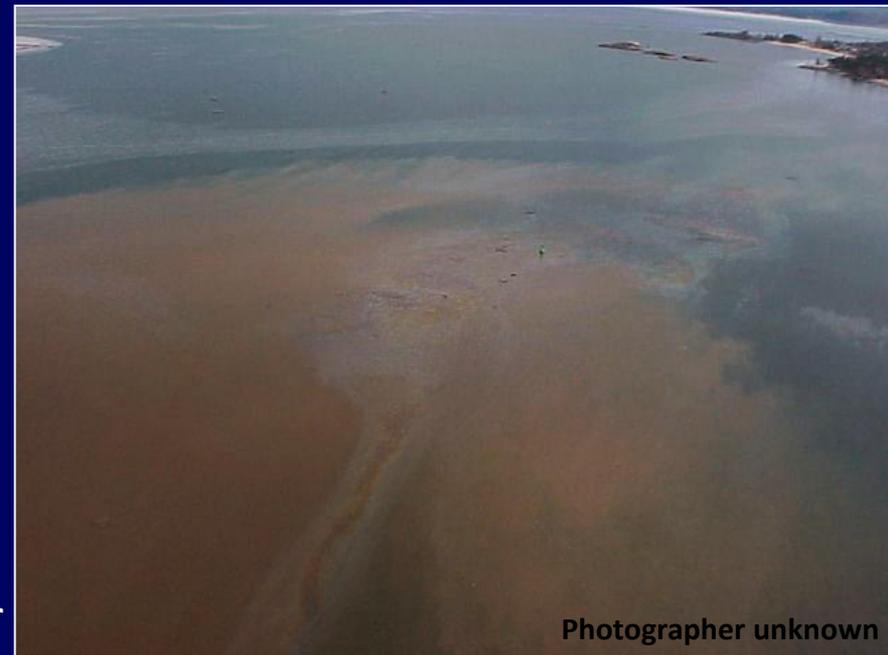
Mouth of Dead River. Presque Isle Power Plant, which no longer exists, in lower right of photo

- Silt and debris flow into Lake Superior

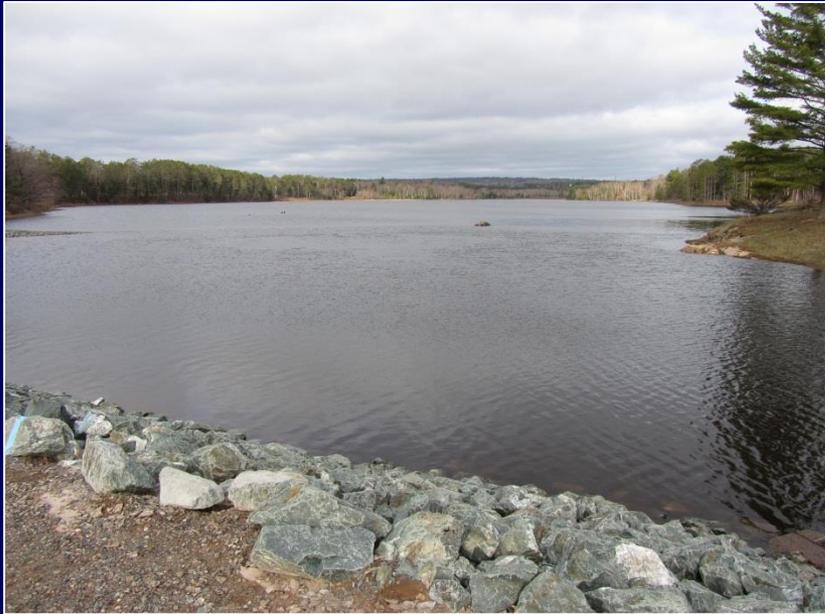
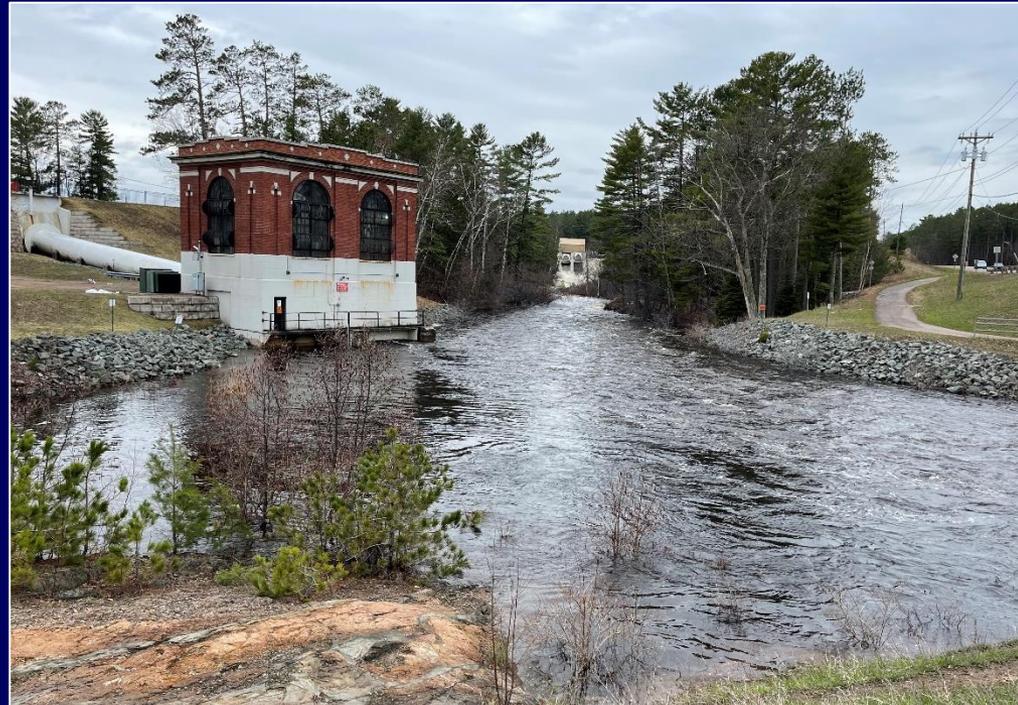
Storage basin at Tourist Park has refilled.

Water is being released at the Tourist Park dam.
