NOVEMBER 6, 2005 Evansville Area Tornado

THE FOLLOWING IS A PRELIMINARY DAMAGE ASSESSMENT FOR THE TORNADO THAT TRACKED FROM HENDERSON COUNTY KENTUCKY NORTHEAST ACROSS VANDERBURGH...WARRICK AND INTO SPENCER COUNTIES IN SOUTHWEST INDIANA.

...DAMAGE SURVEY RESULTS FOR CRITTENDEN-WEBSTER COUNTY KENTUCKY F-3 TORNADO...

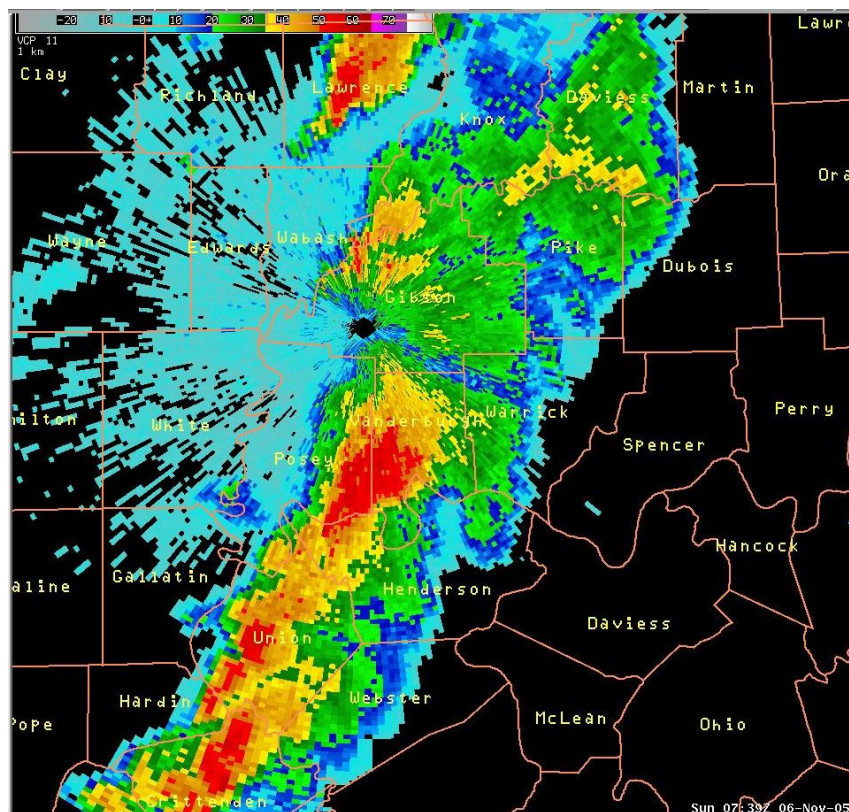
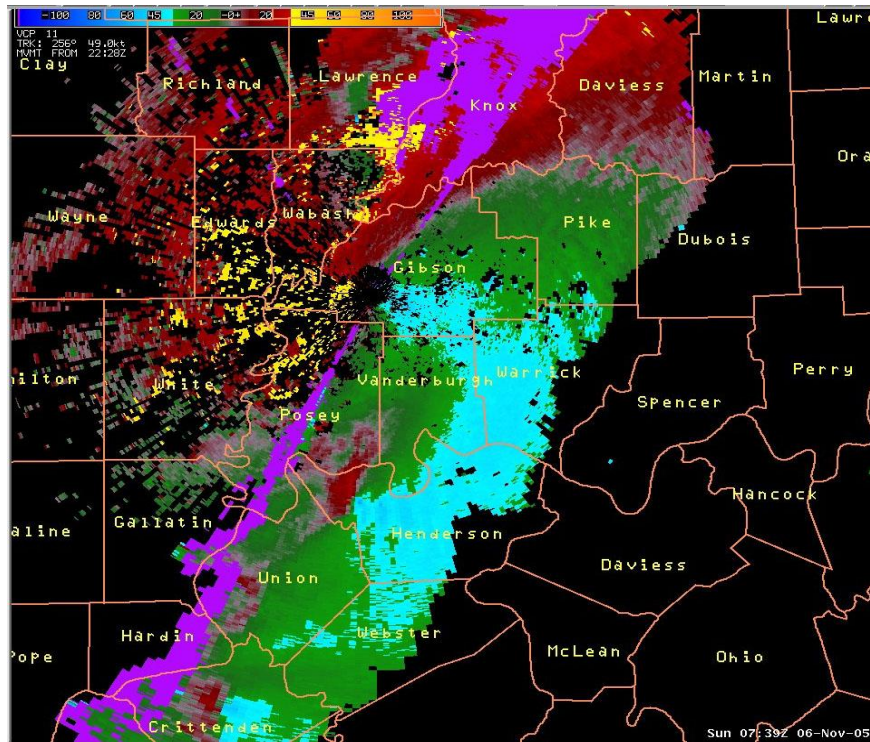
Lowest angle (0.5°) reflectivity and storm relative motion images respectively from the Evansville Doppler Radar (VWX) at 1:39 a.m. This was near the time of tornado touchdown and depict the storm rapidly intensifying and acquiring supercell characteristics.

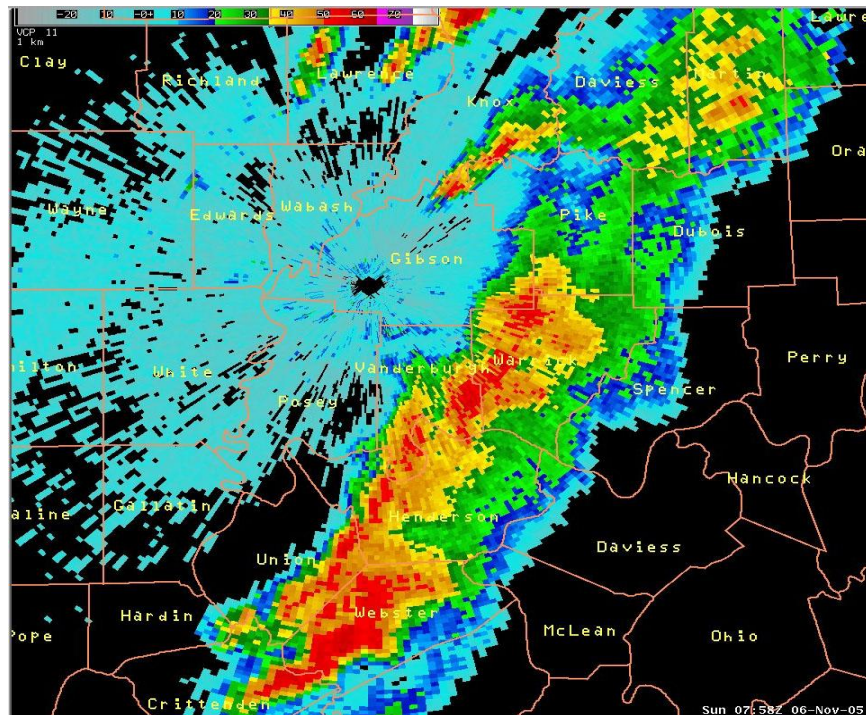
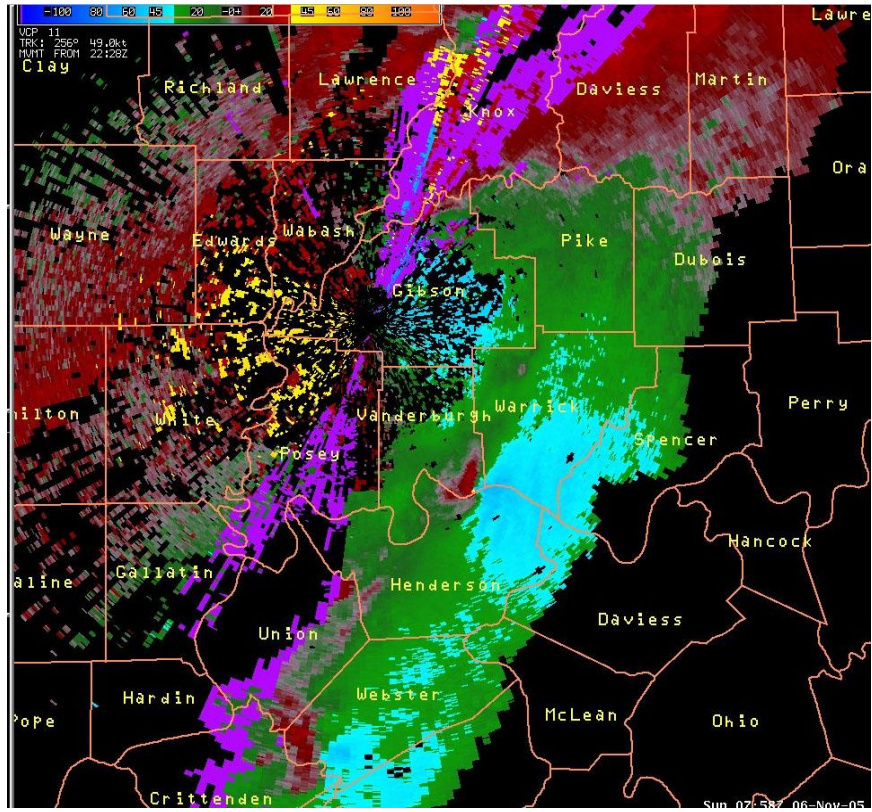
Lowest angle (0.5°) reflectivity and storm relative motion images respectively from the Evansville Doppler Radar (VWX) at 1:58 a.m., which was near the time the tornado ripped through the Eastbrook Mobile Home Park. Note the appendage-like shape of reflectivity that correlates with the strong rotational couplet.

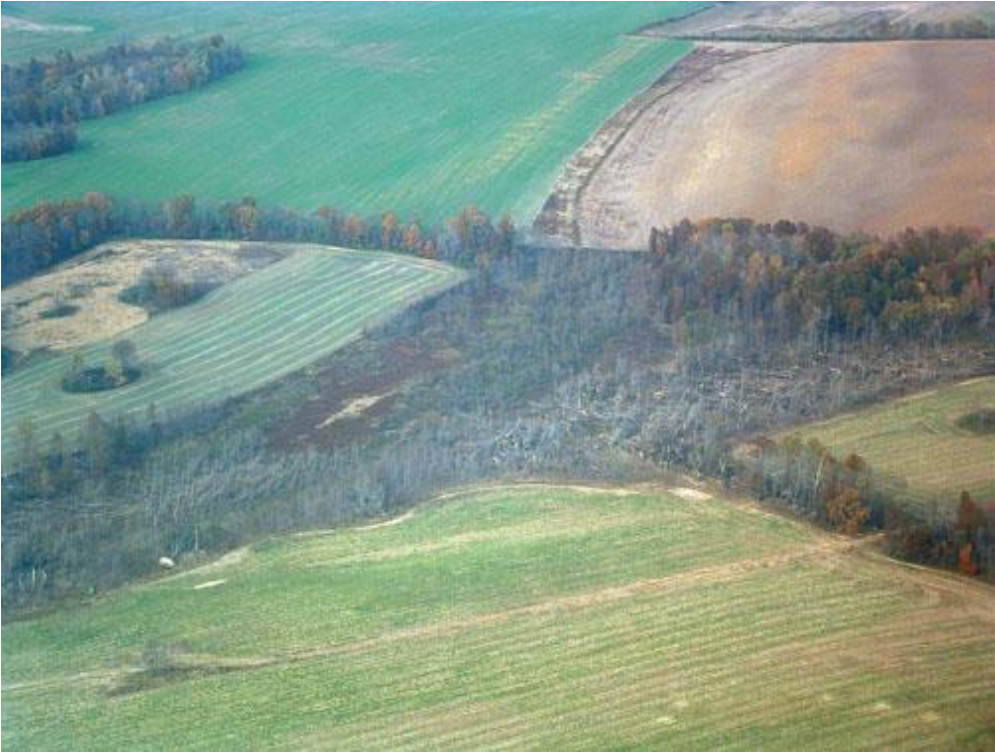
Widespread path of large trees snapped and uprooted in northwestern Henderson County, KY.

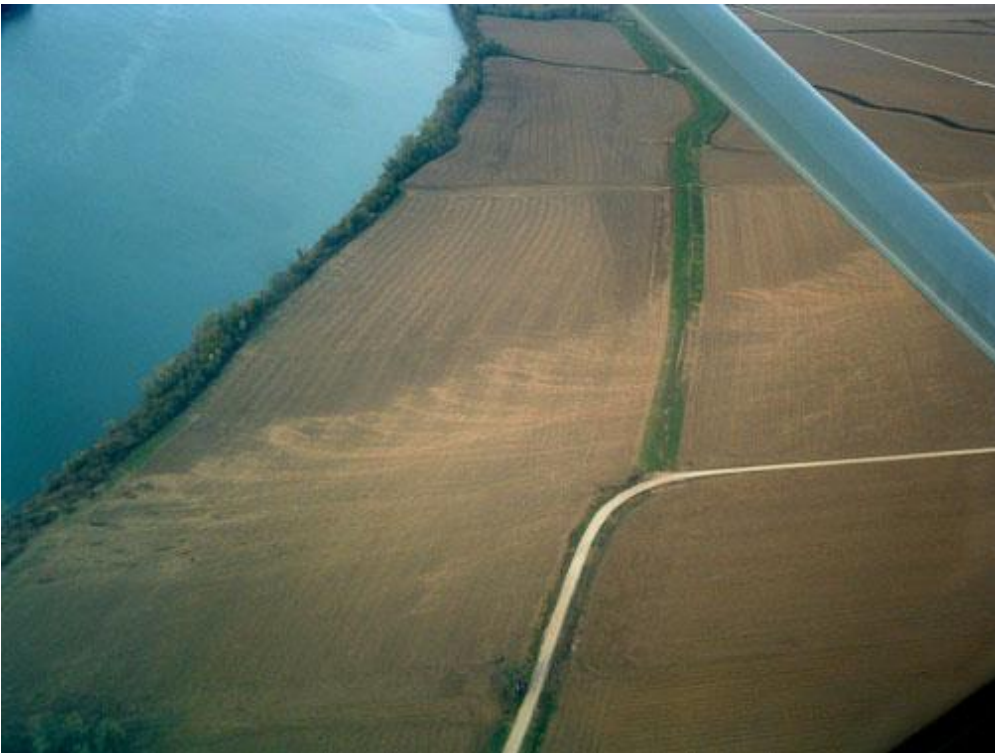
Scoured land in the floodplain peninsula of southwest Vanderburgh County, IN.

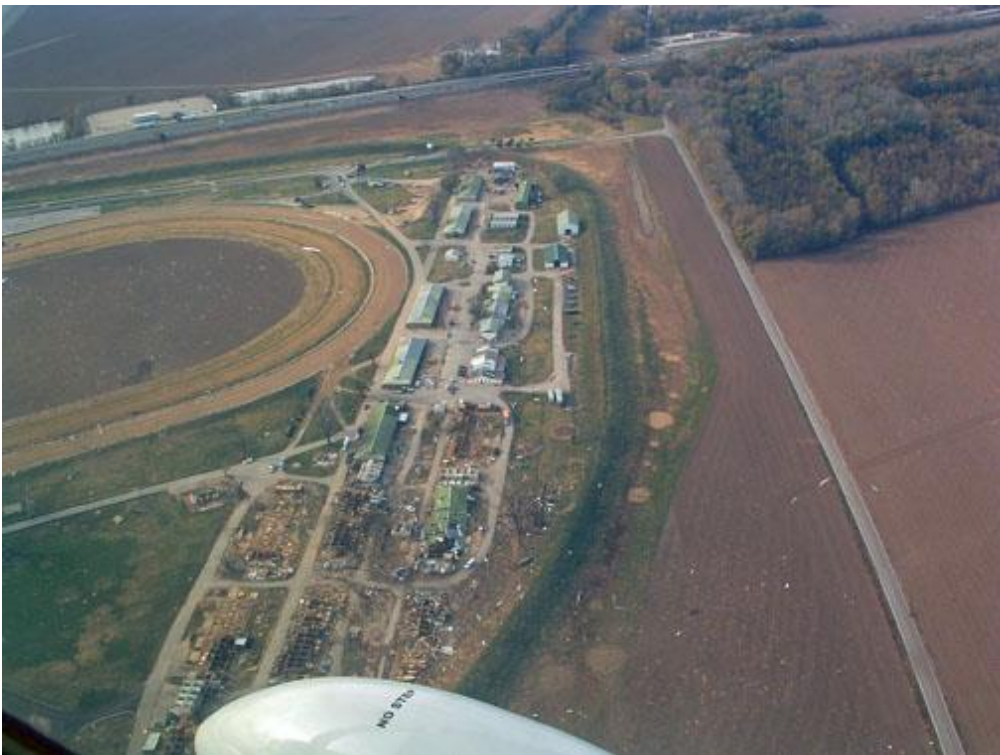
Damage to Ellis Park racing facility, located just north of the Ohio River.

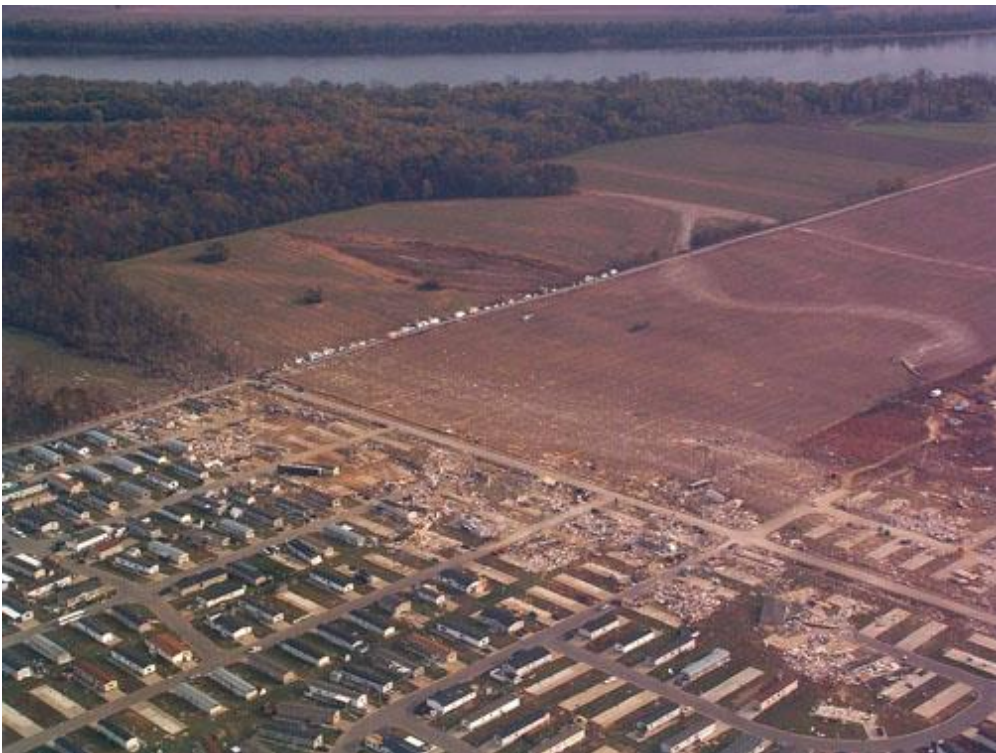
Aerial view of the most extensive damage at Eastbrook Mobile Home Park.

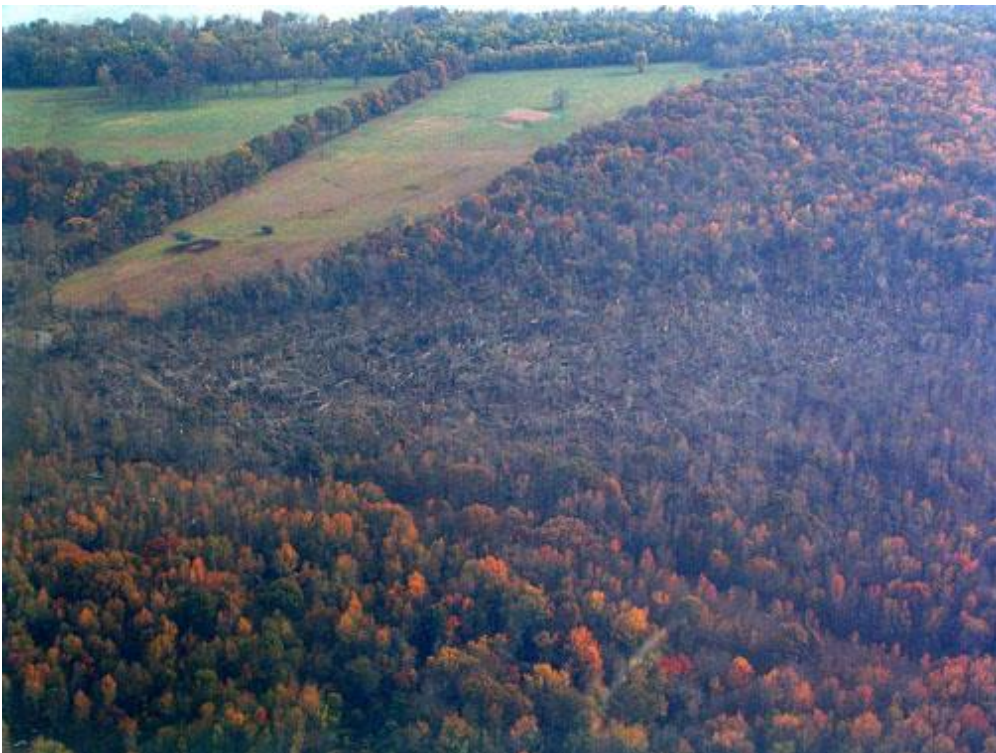
Damage between mobile home park and Vanderburgh/Warrick county line.

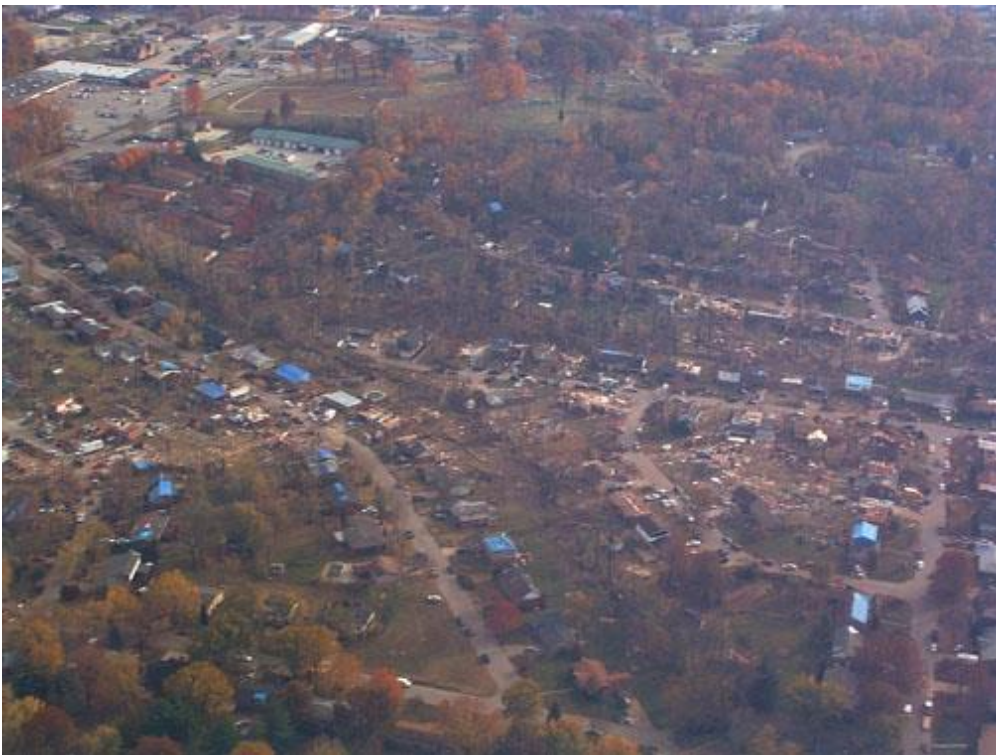
Damage on the northern side of Newburgh, IN.

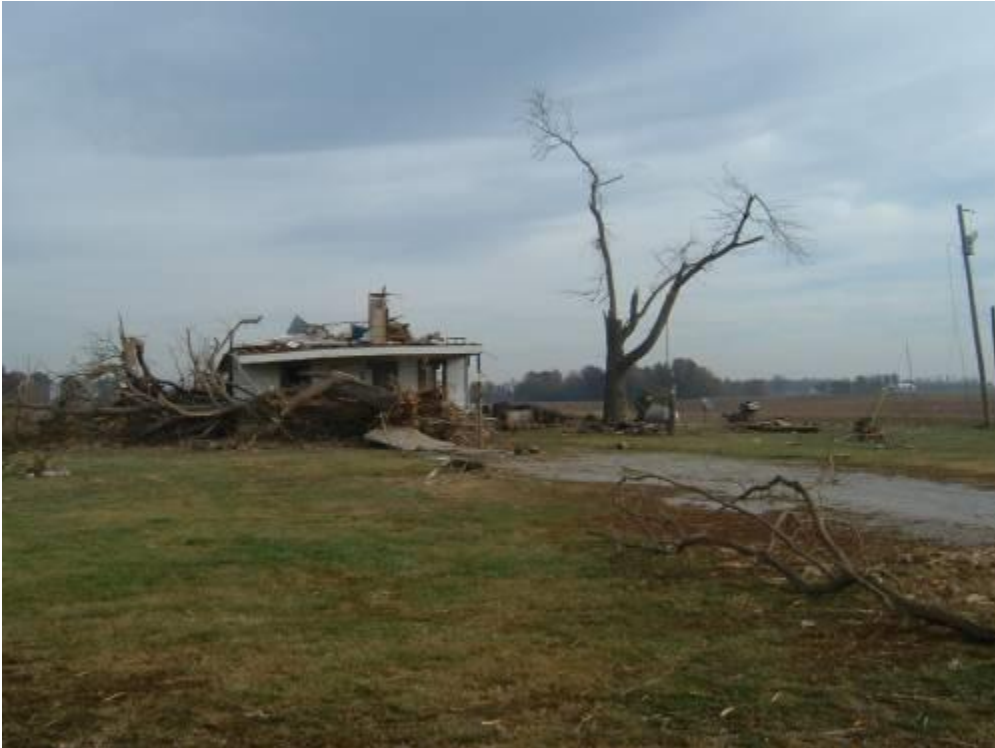
Photo of destroyed house and tossed truck (to right of standing tree) taken a few miles northeast of Smith Mills, Kentucky in Henderson County.

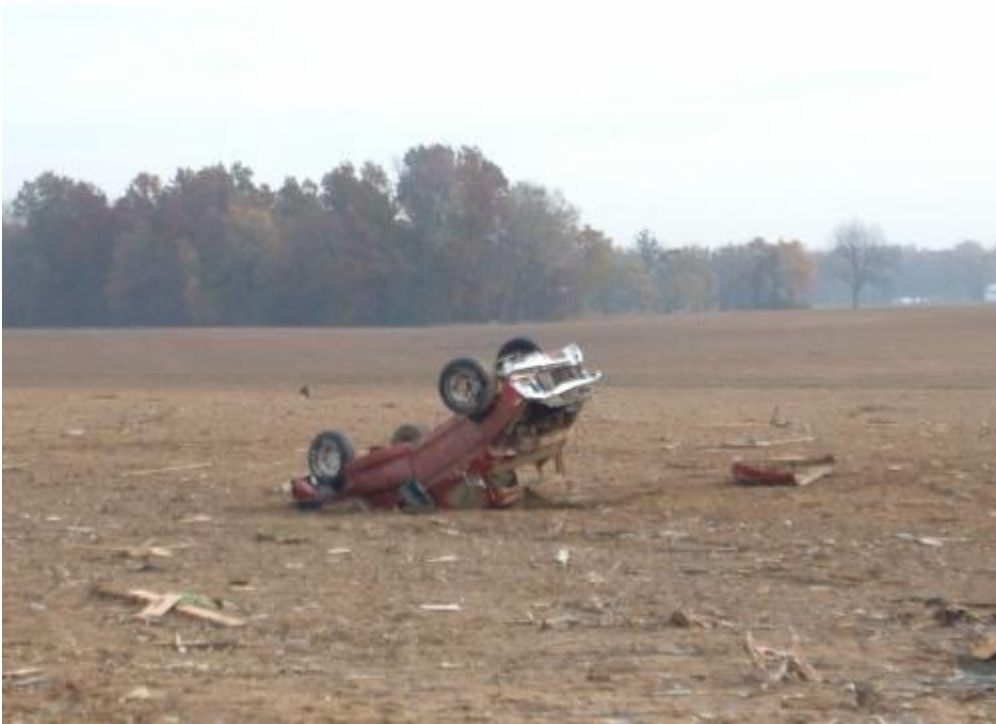
Photo of tossed truck, taken a few miles northeast of Smith Mills, KY. This is a close-up of truck in above photo.

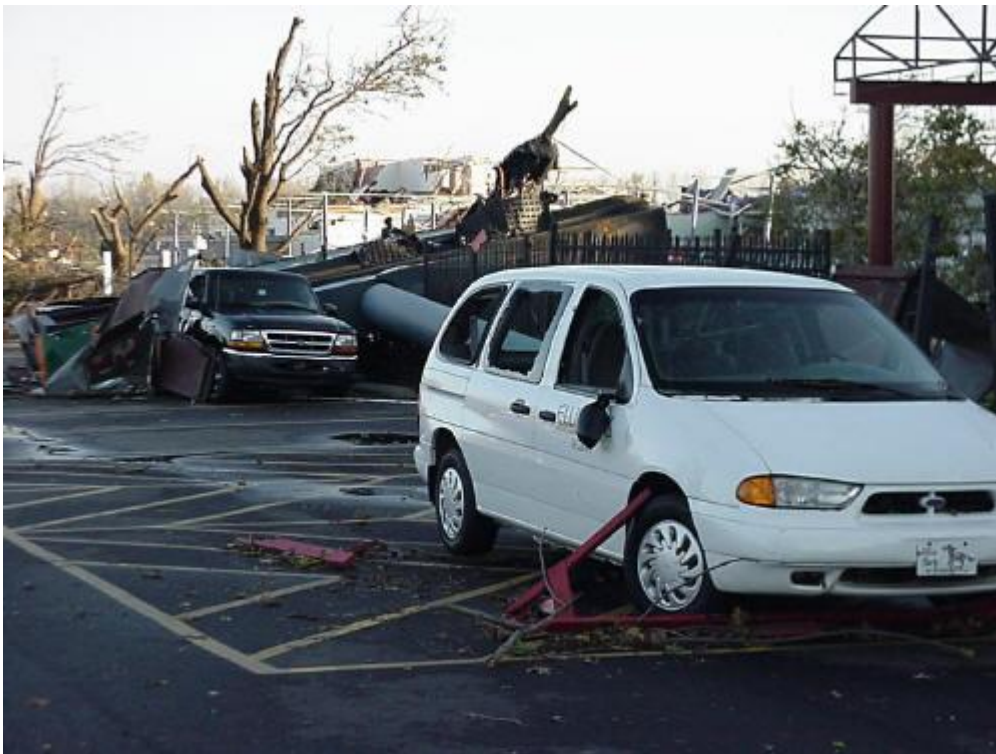
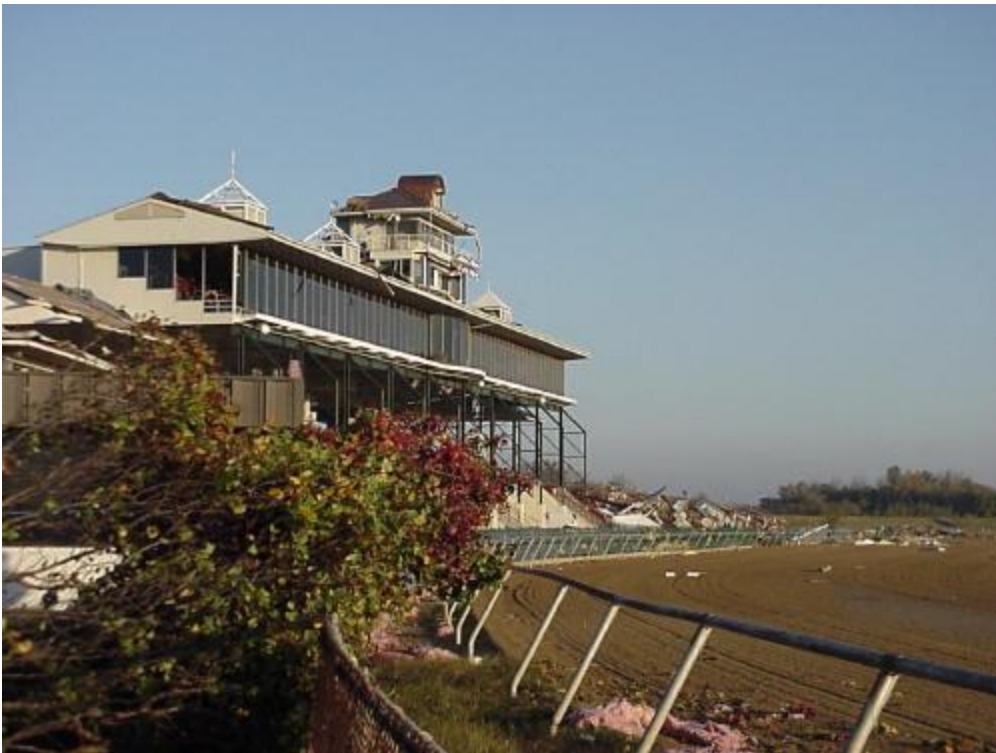
The next two photos were taken at Ellis Park, a racing facility off U.S. 41 near the Henderson County, KY/Vanderburgh County, IN line.

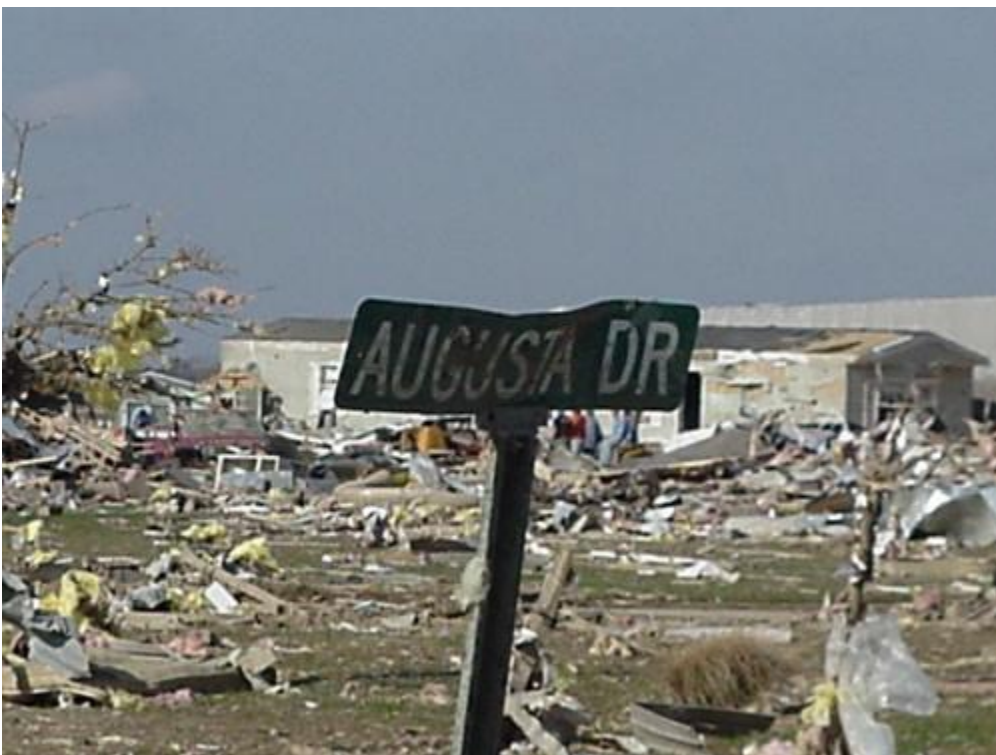
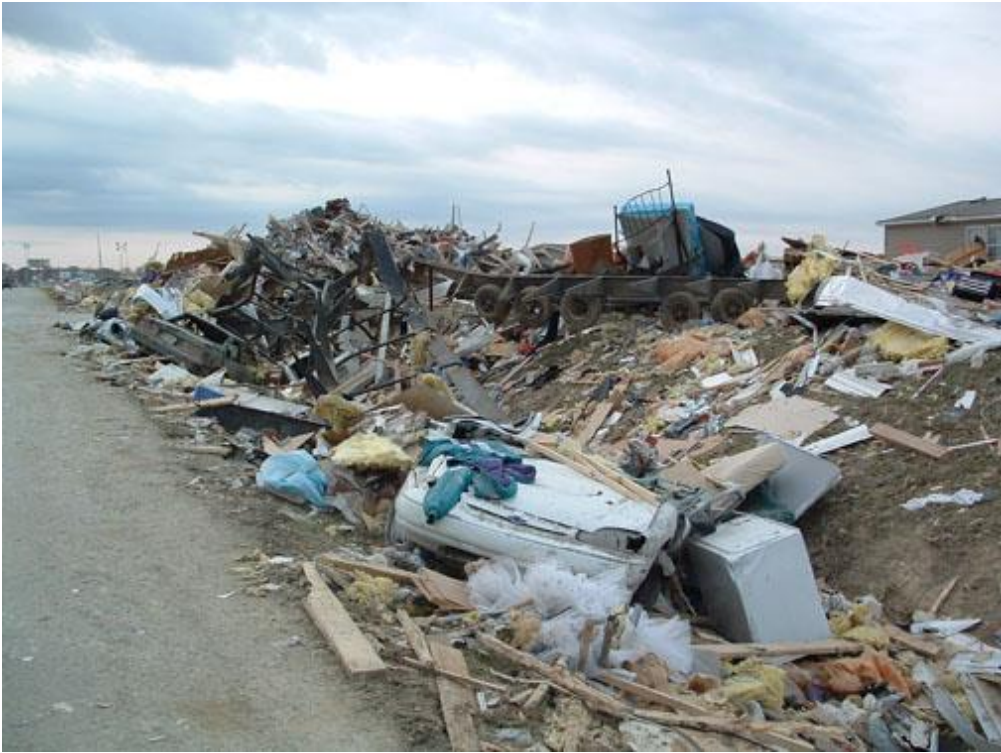
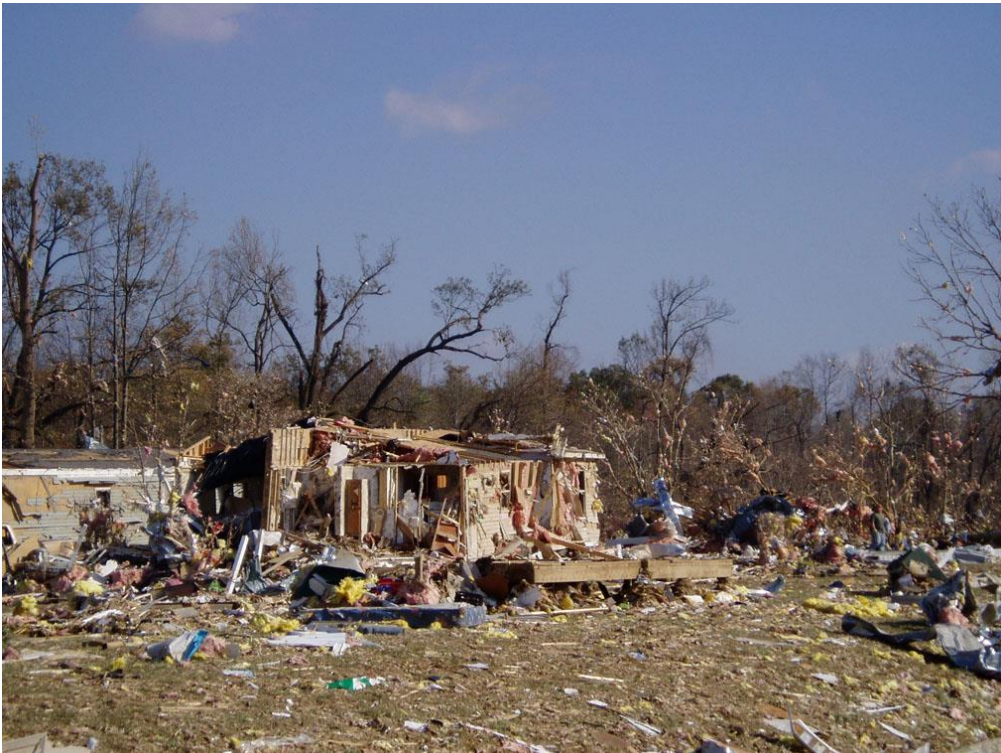
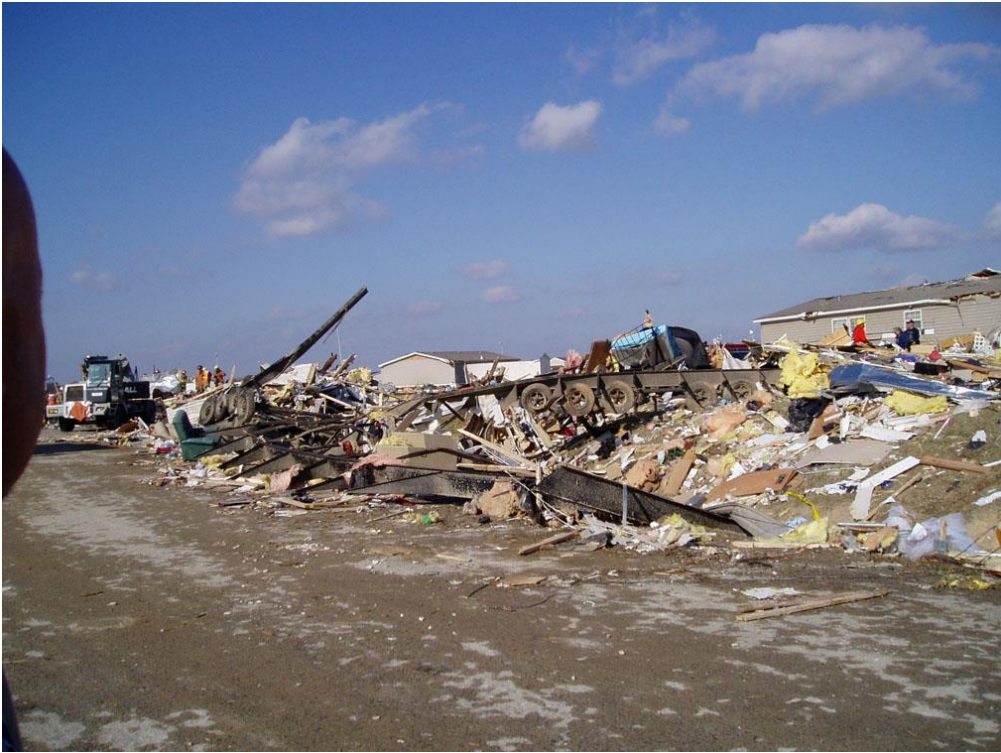
The following photos were taken at a mobile home park off of Interstate 164 where many of the fatalities and injuries occurred.

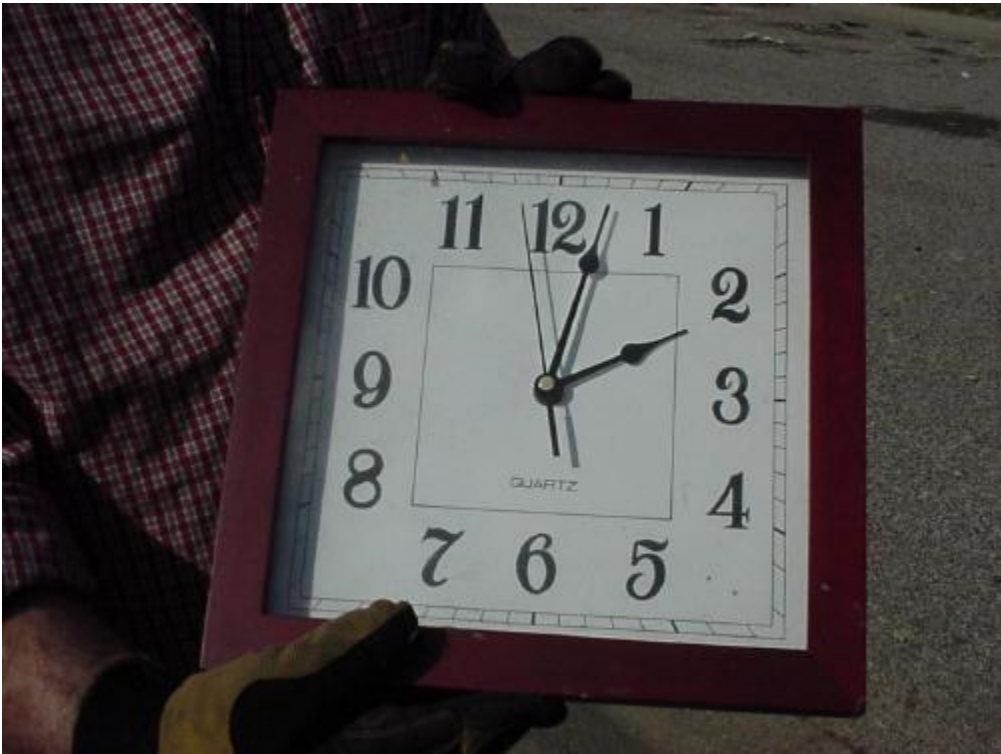
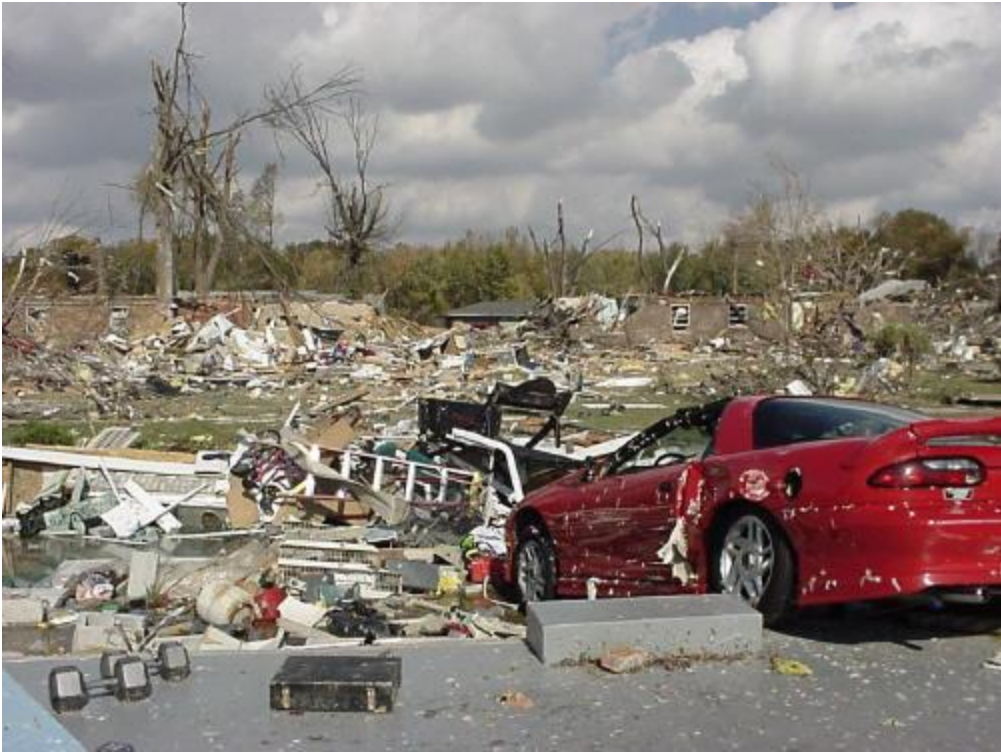
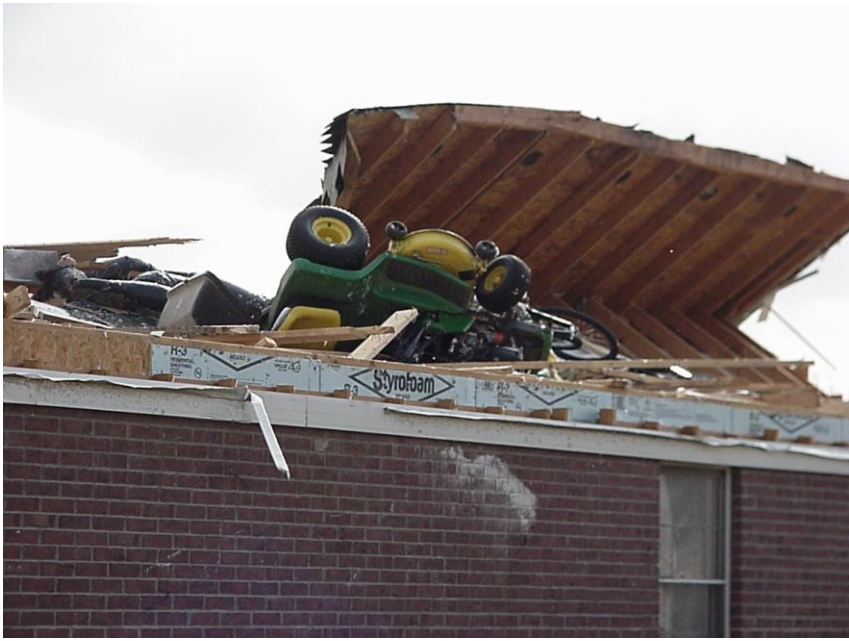
The following photos were taken near Angel Mounds, which is near the Vanderburgh/Warrick County line.

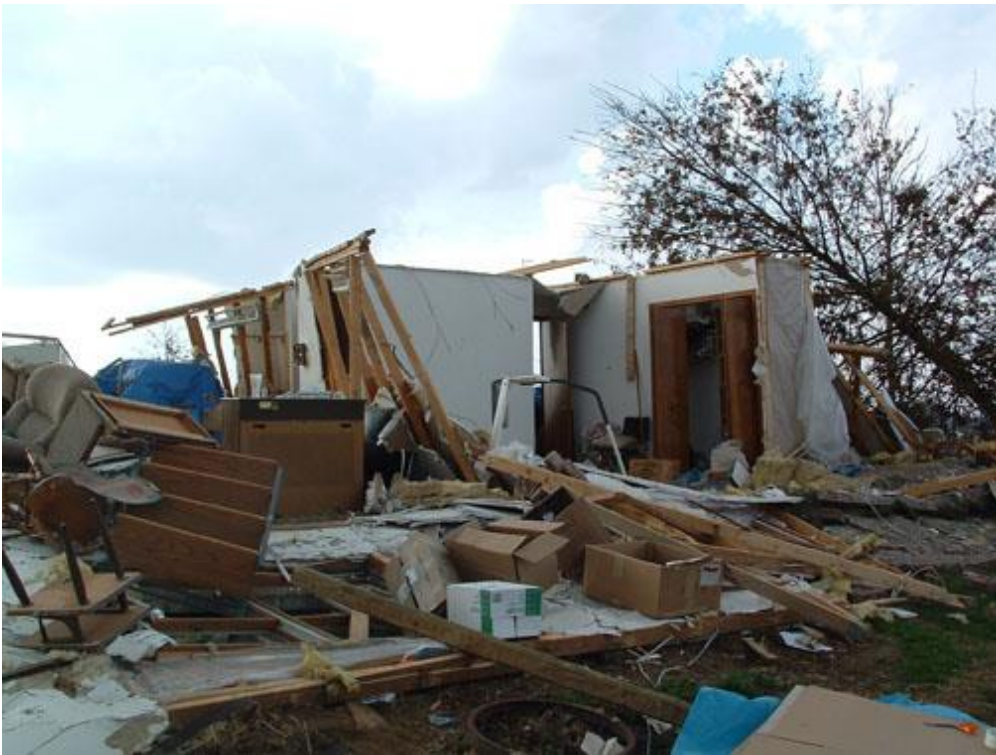
Residents in this house took shelter in the bathroom, which is in the part that is still standing behind the white wall in the picture below.

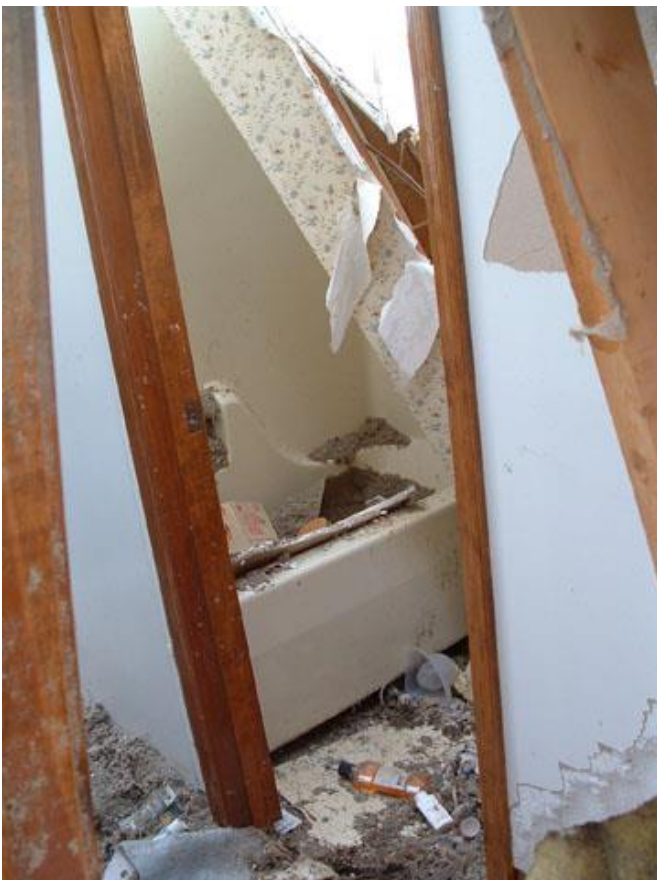
Here is a picture of the bathroom mentioned above:

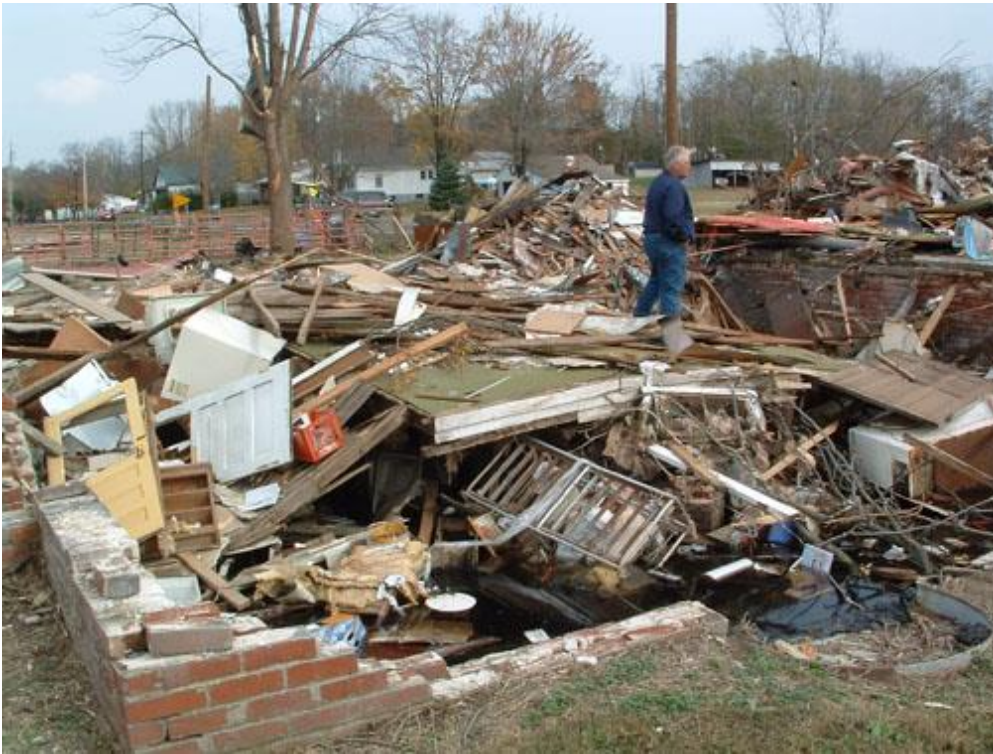
Another house destroyed in Degonia Springs:

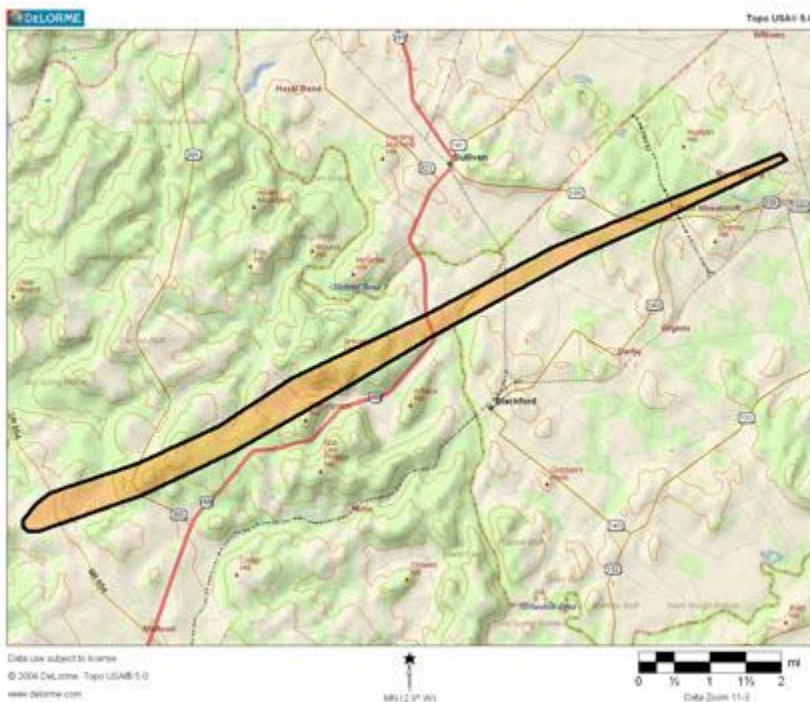
Map of damage path:

* EVENT LOCATION: ONE QUARTER MILE WEST OF HIGHWAY 654 IN CRITTENDEN COUNTY...(APPROXIMATELY TWO MILES NORTHWEST OF MATTOON KENTUCKY)...TO THE NORTH SIDE OF WHEATCROFT KENTUCKY IN WEBSTER COUNTY.

* DAMAGE AREA DIMENSIONS:
PATH LENGTH: APPROXIMATELY 11.25 MILES
MAXIMUM WIDTH: 150 YARDS

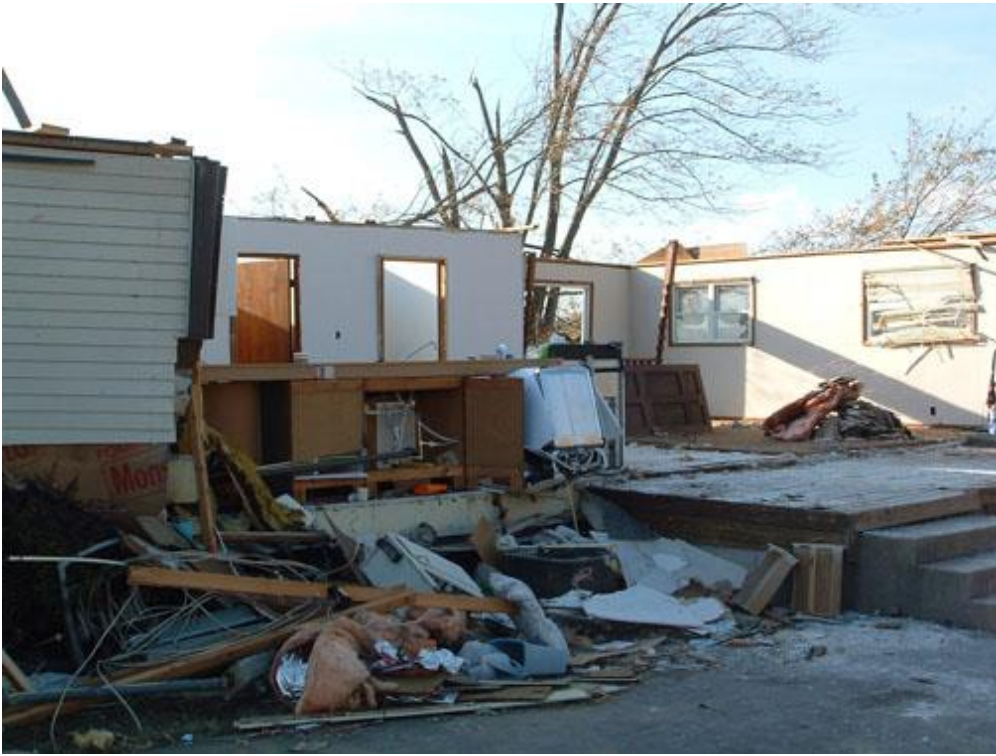
Home damaged on Highway 654...northwest of Mattoon.

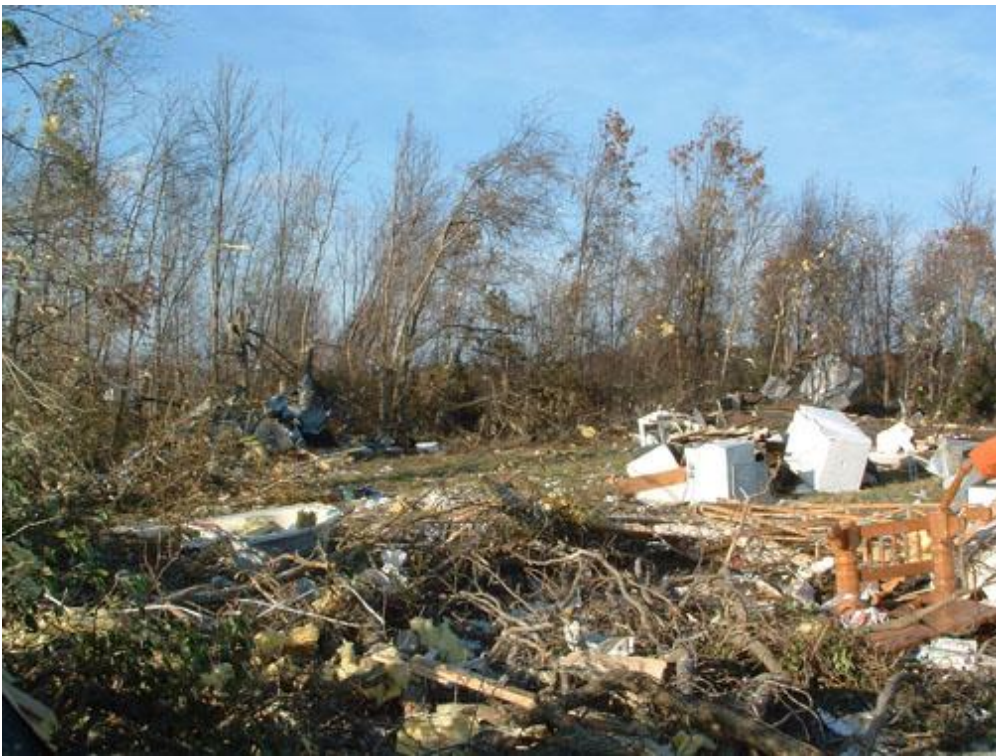
This is a mobile home that was destroyed adjacent to the home pictured above.

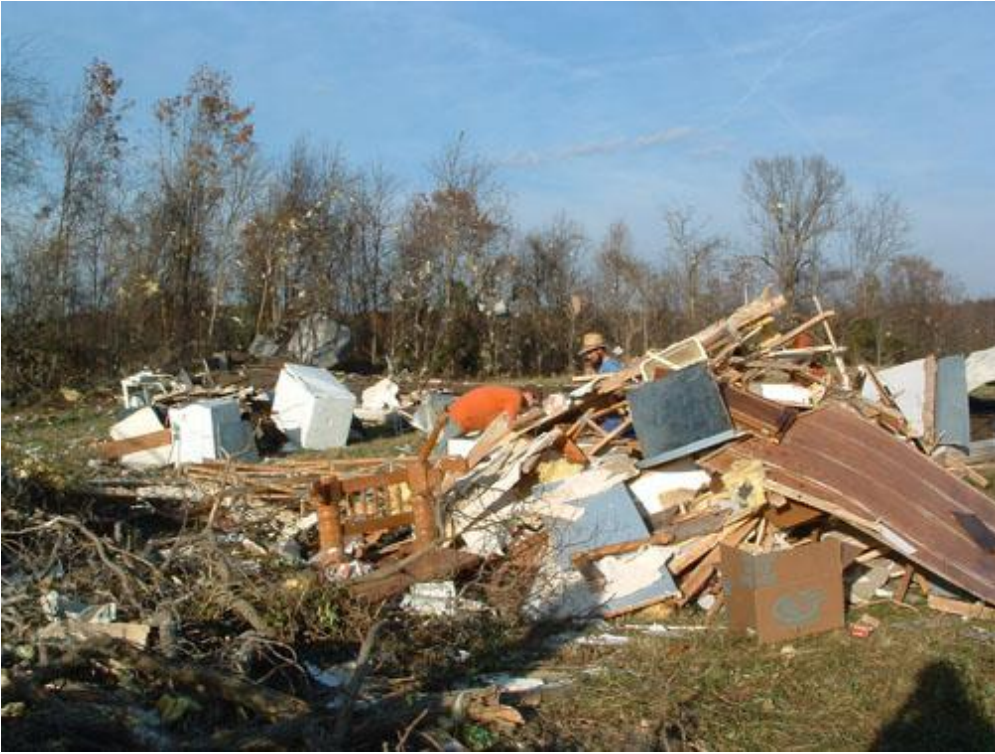
Panning further to the right...the rest of the destroyed mobile home can be seen.

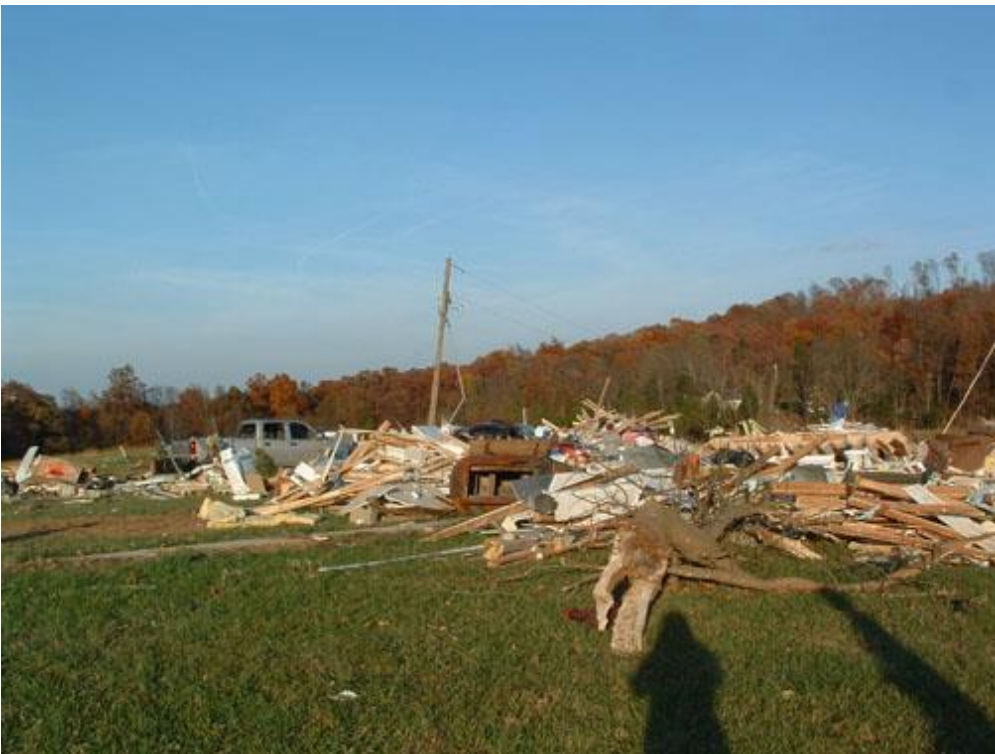
This was a two story home that was destroyed on Highway 365.

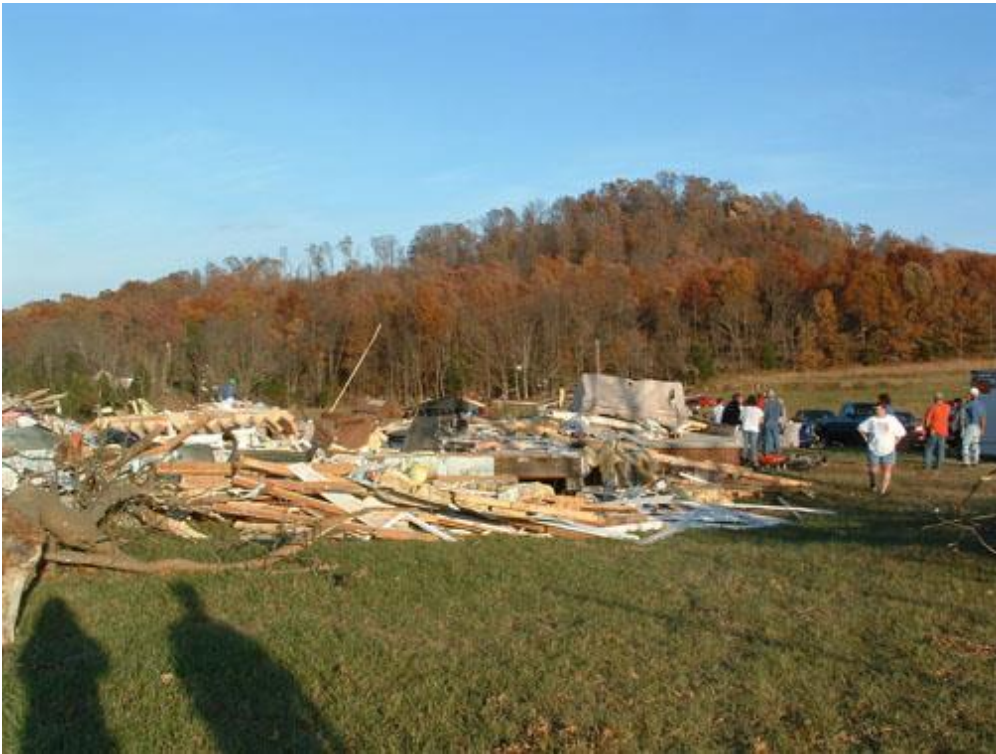
Panning further to the right...the rest of this destroyed home can be seen.

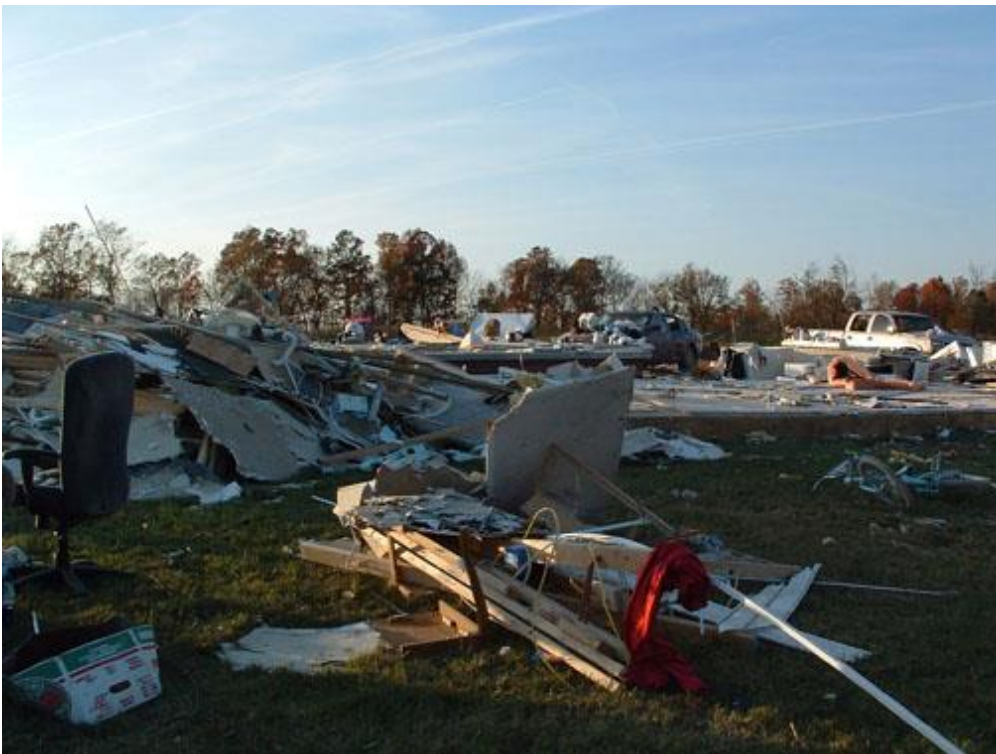
Another view of the destroyed home on Highway 365.
