NOVEMBER 6, 2005 Evansville Area Tornado

THE FOLLOWING IS A PRELIMINARY DAMAGE ASSESSMENT FOR THE TORNADO THAT TRACKED FROM HENDERSON COUNTY KENTUCKY NORTHEAST ACROSS VANDERBURGH...WARRICK AND INTO SPENCER COUNTIES IN SOUTHWEST INDIANA.

...DAMAGE SURVEY RESULTS FOR CRITTENDEN-WEBSTER COUNTY KENTUCKY F-3 TORNADO...

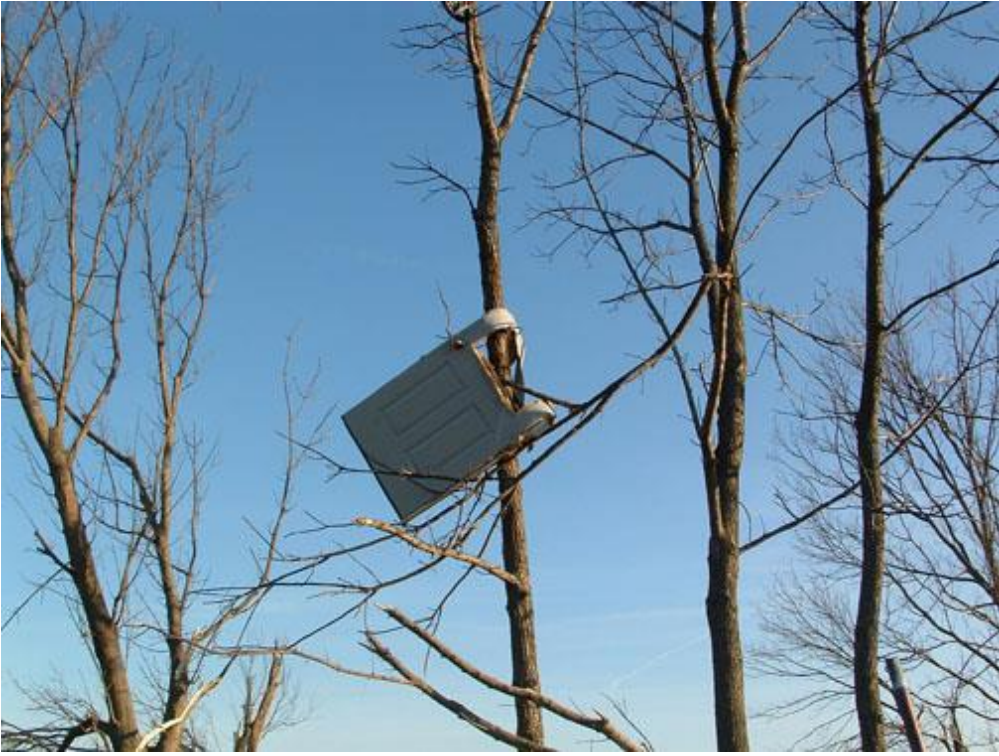
A door hoisted into a tree.
