Hurricane Ivan's Tornadoes: 10 years ago (September 17, 2004) National Weather Service, Blacksburg, VA

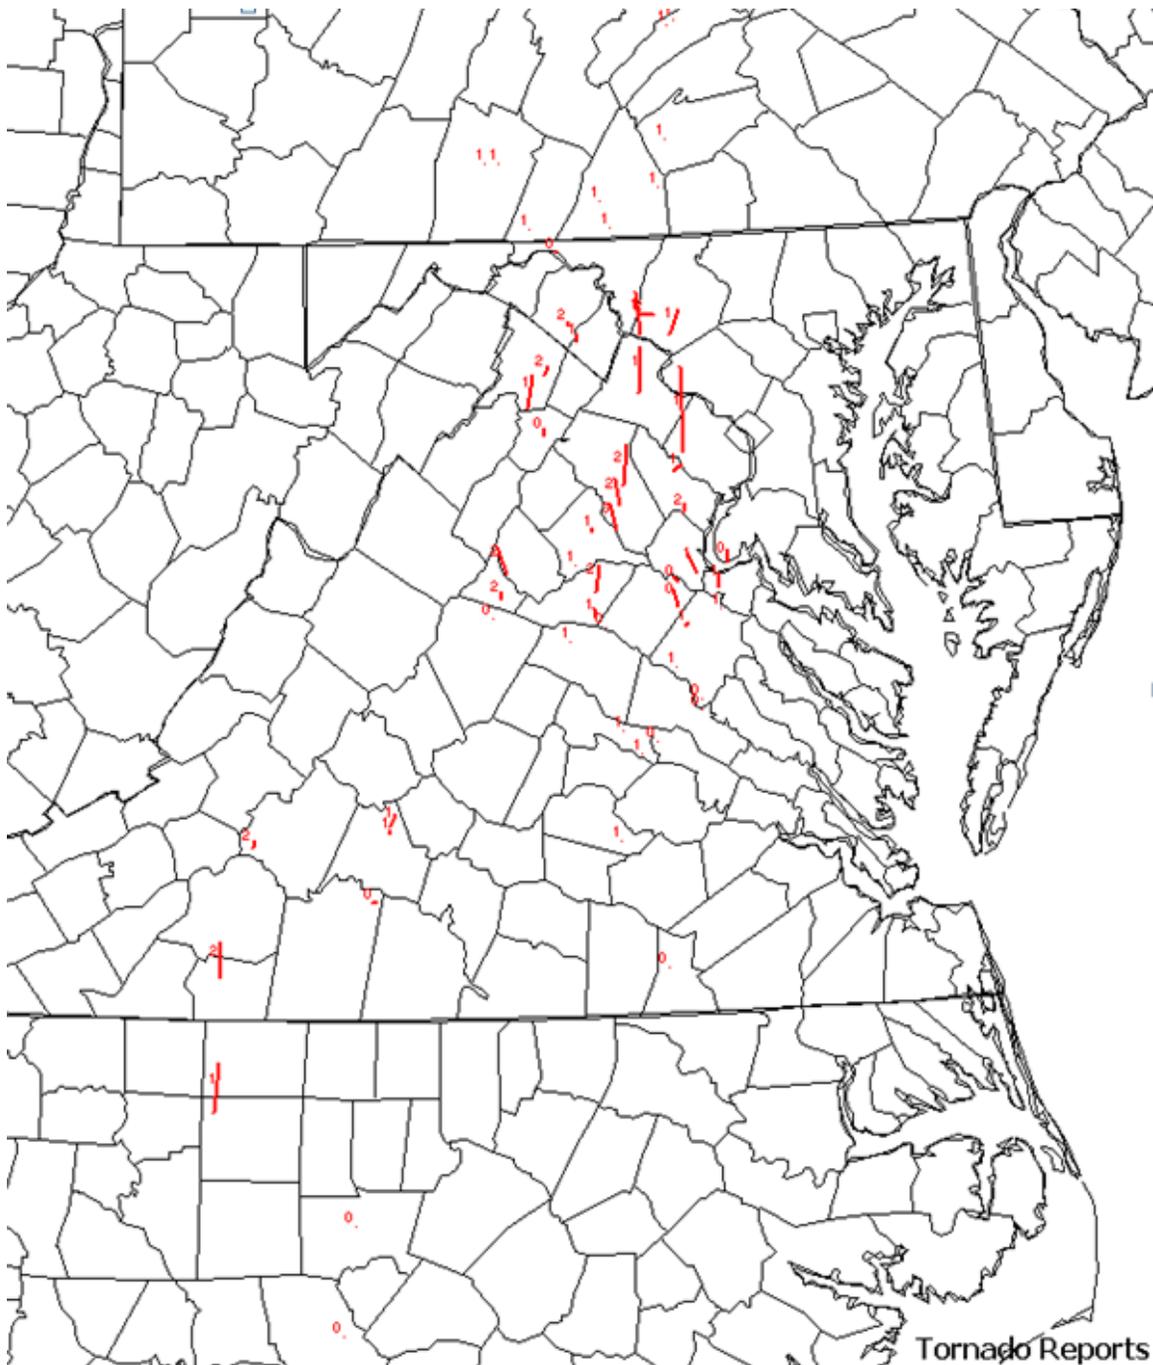
Map of tornado touchdowns and tracks in the mid-Atlantic region on September 17, 2004, with F-scale value plotted next to track.

The map below shows the tornado touchdowns and tracks that occurred on the 17th alone, from North Carolina to Pennsylvania. In the Commonwealth of Virginia the outbreak of tornadoes added up to 38, which is by far the largest ever one-day total not only for Virginia, but for any state east of the Appalachians north of South Carolina. A grand total of 118 tornadoes were associated with Ivan from Florida to Pennsylvania, which is more than any other tropical system since modern day tornado records have been kept starting in 1950.

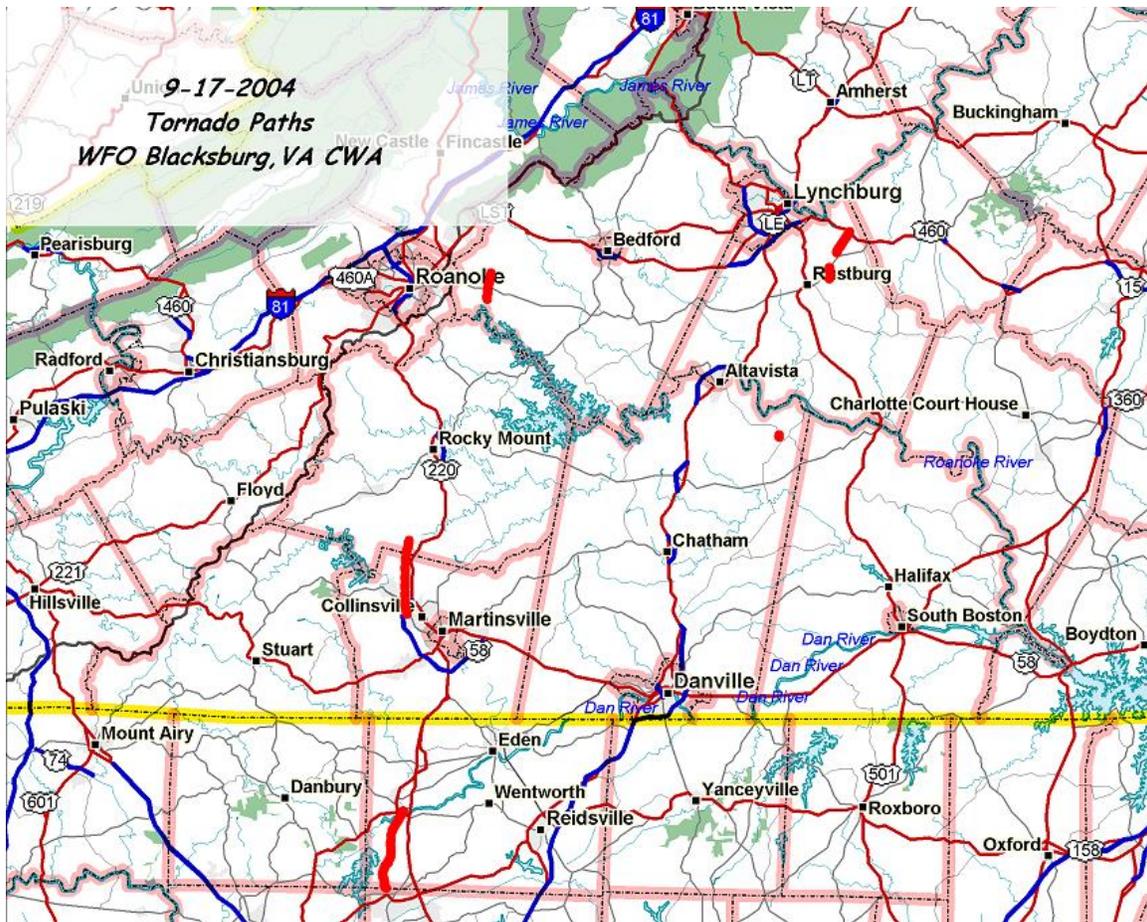
Tracks of six separate confirmed tornado touchdowns in the NWS Blacksburg, Virginia County Warning Area, on September 17, 2004.

In the Blacksburg County Warning area, there were six confirmed tornado touchdowns (five in Virginia and one in North Carolina), and we suspect there may have been a couple more in remote areas that we could never find. Two of these produced F2 damage, one on the high end of the scale with winds of up to about 150 mph (Henry County, VA), and another on the low end with winds around 120 mph (Bedford Co, VA). Three other tornadoes produced F1 damage, and one brief touchdown produced F0 damage. The map below shows a close-up of the tornado tracks in our area.

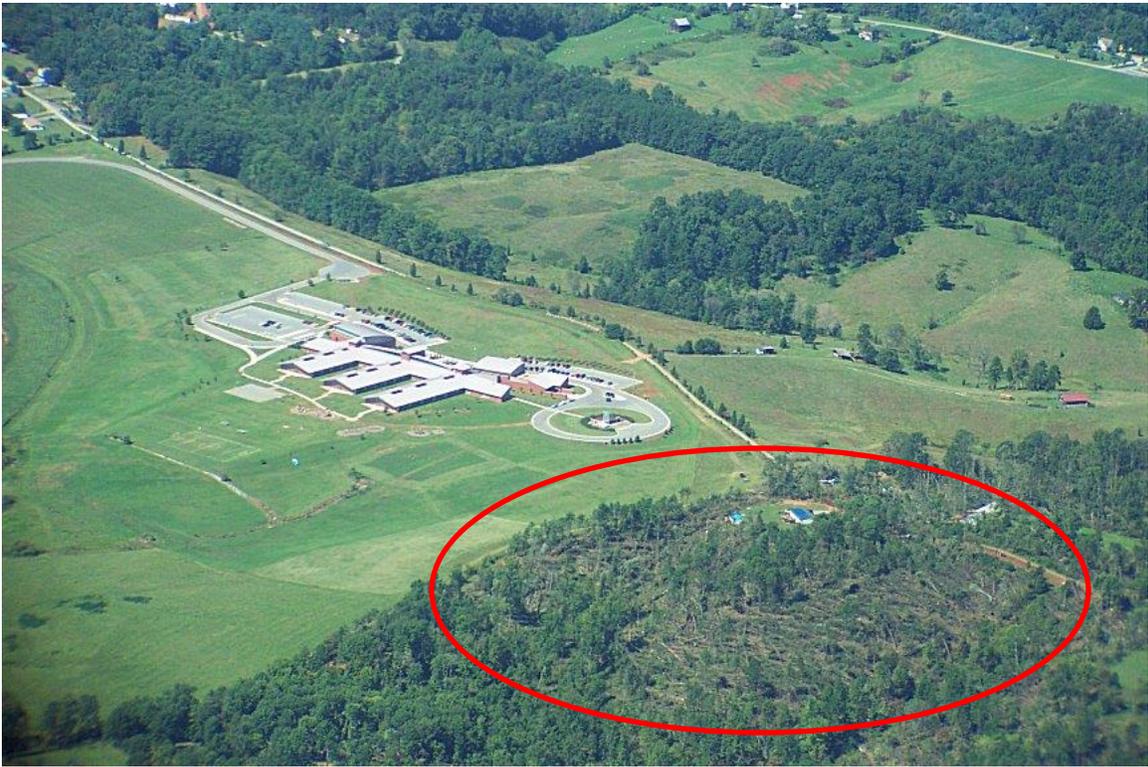
This F1 tornado tracked very close to the Goodview Elementary School in Bedford County near Stewartville, Virginia. A swath of downed trees in the nearby woods can be seen within the red oval area, where there was also some damage done to homes. Soon after this, it produced some low-end F2 damage off to the right of this image.

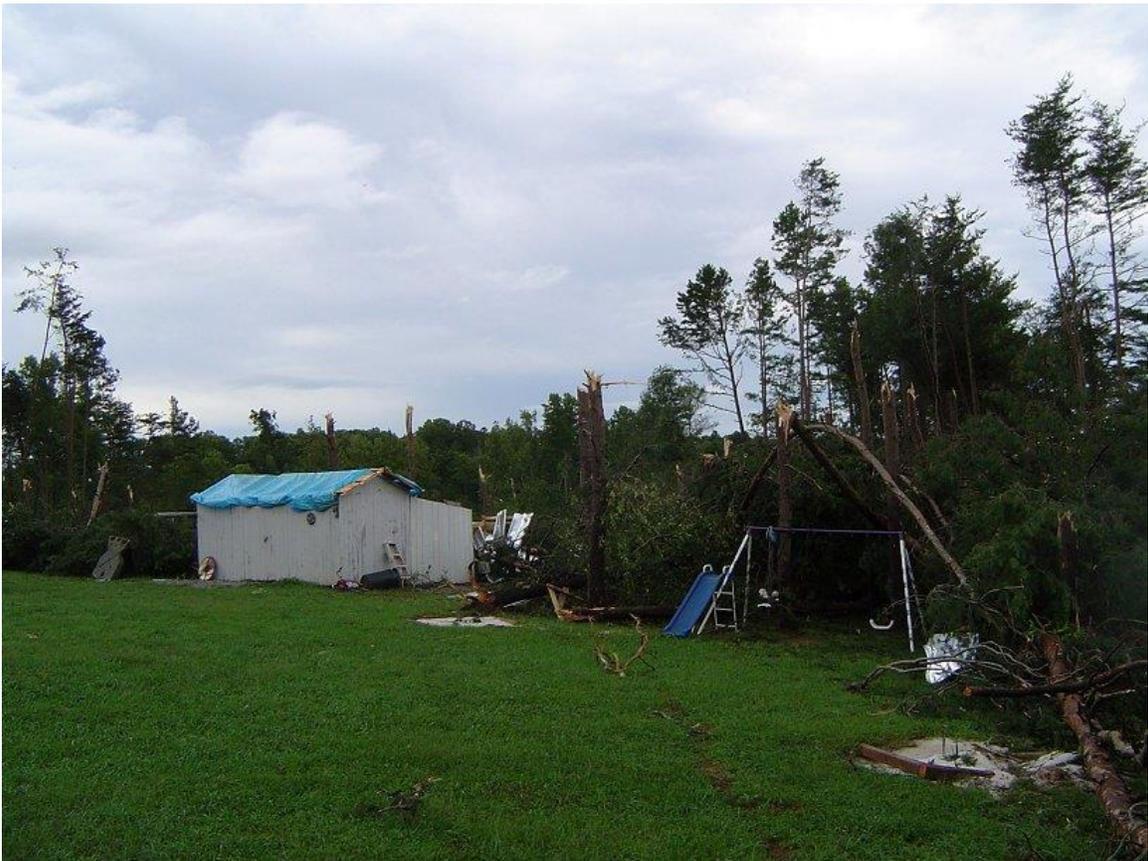
Some of the damage from the F1 tornado near Stewartville, Virginia

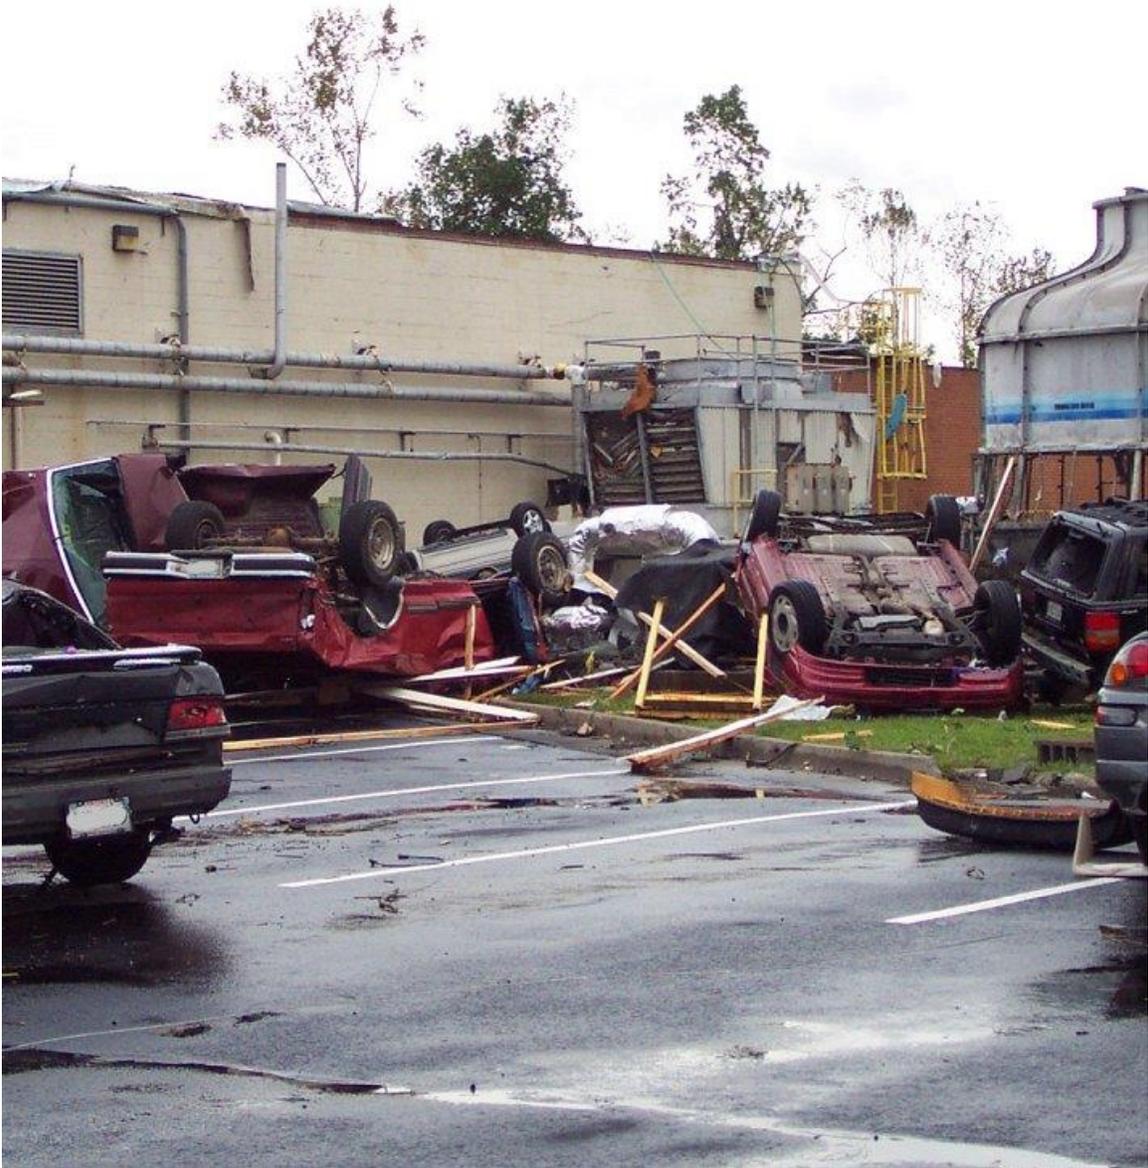
Around 40 vehicles were flipped over and destroyed in this high-end F2 tornado that hit the CP films plant in Fieldale, Virginia (Henry County), which also experienced significant damage.

Damage from the tornadoes was extensive in some areas, with 4 injuries reported with the F2 tornado in Fieldale, Virginia (just northwest of Martinsville), but no direct fatalities. Below are a few photos of some of the destruction left by these tornadoes. This was an event that many in Virginia and the mid-Atlantic region will never forget, including the meteorologists and support staff who worked this day.

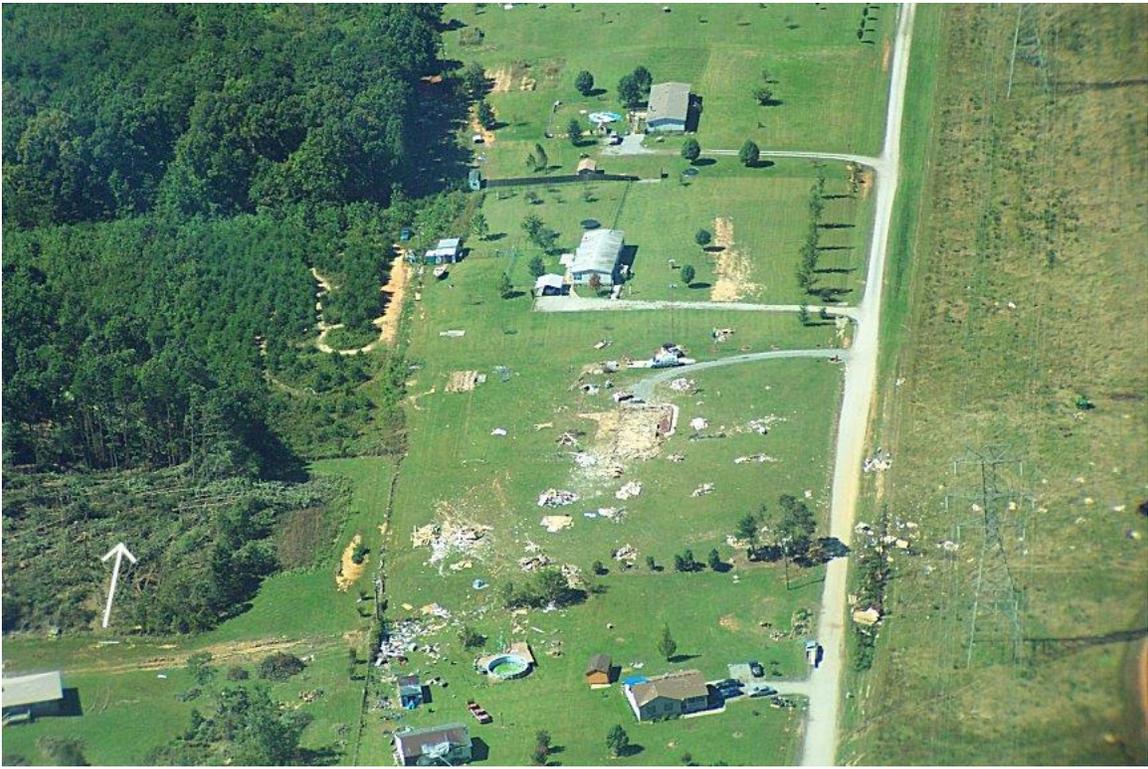
Aerial view of some of the F1 damage to homes and trees (note the white arrow on left side of photo) in southwestern Rockingham County, North Carolina.
