# June 2003 Summary

## Heavy Rains Produce Record River Flooding

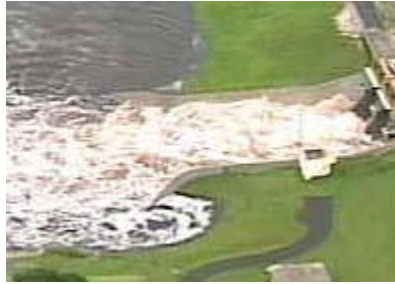
Spill gates opened at Lake Manatee Dam, June 21, 2003.

A one-two punch of localized torrential rains on June 20 and 21 dropped between 10 and an estimated 15 inches at the mainstem of the Manatee and Myakka Rivers, unleashing record river flooding on each river soon after (Table 1, below). A spillover gate temporarily failed at Lake Manatee early on the 22nd, exacerbating flood conditions immediately downstream. Fortunately, the problem was fixed before major flooding could affect hundreds of downstream homes.

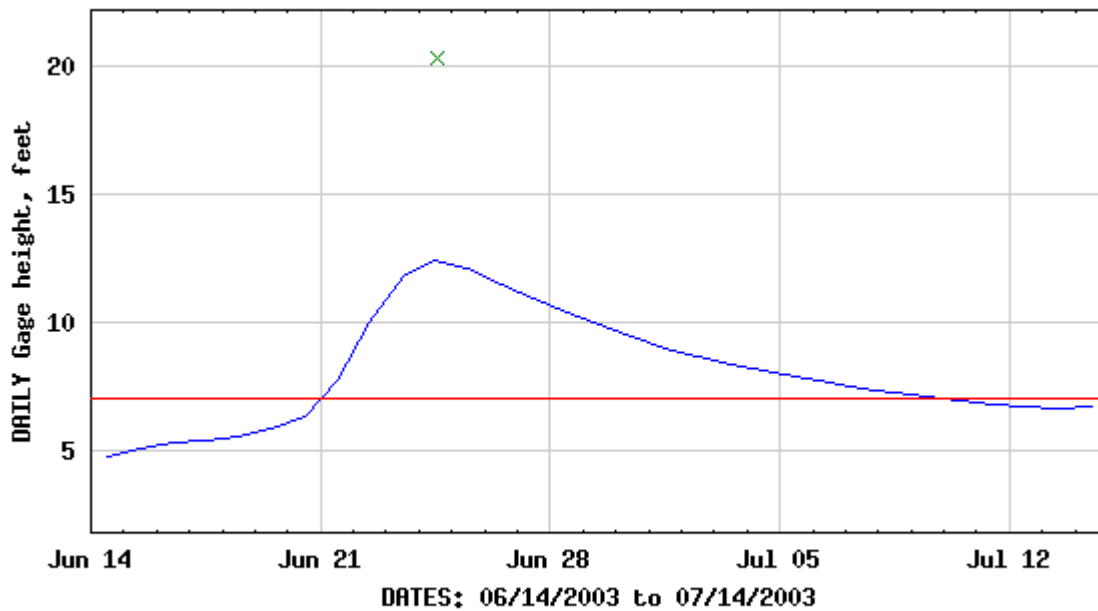
USGS 02298830 MYAKKA RIVER NEAR SARASOTA FL

Figure 5. USGS streamflow, Myakka River at Myakka Head, mid June through early July 2003.

Such was not the case in Sarasota County, where at least 750 residences were affected for more than a week in North Port due to continued major flooding (Figure 5 at left) on the Myakka River. Freshwater flooding damaged 60 roads in Hardee County; at least five were washed out. Widespread sheet flow flooding was reported in Sarasota, Desoto, Charlotte, and Lee Counties, closing dozens of roads and flooding dozens of homes, some with more than 3 feet of water.

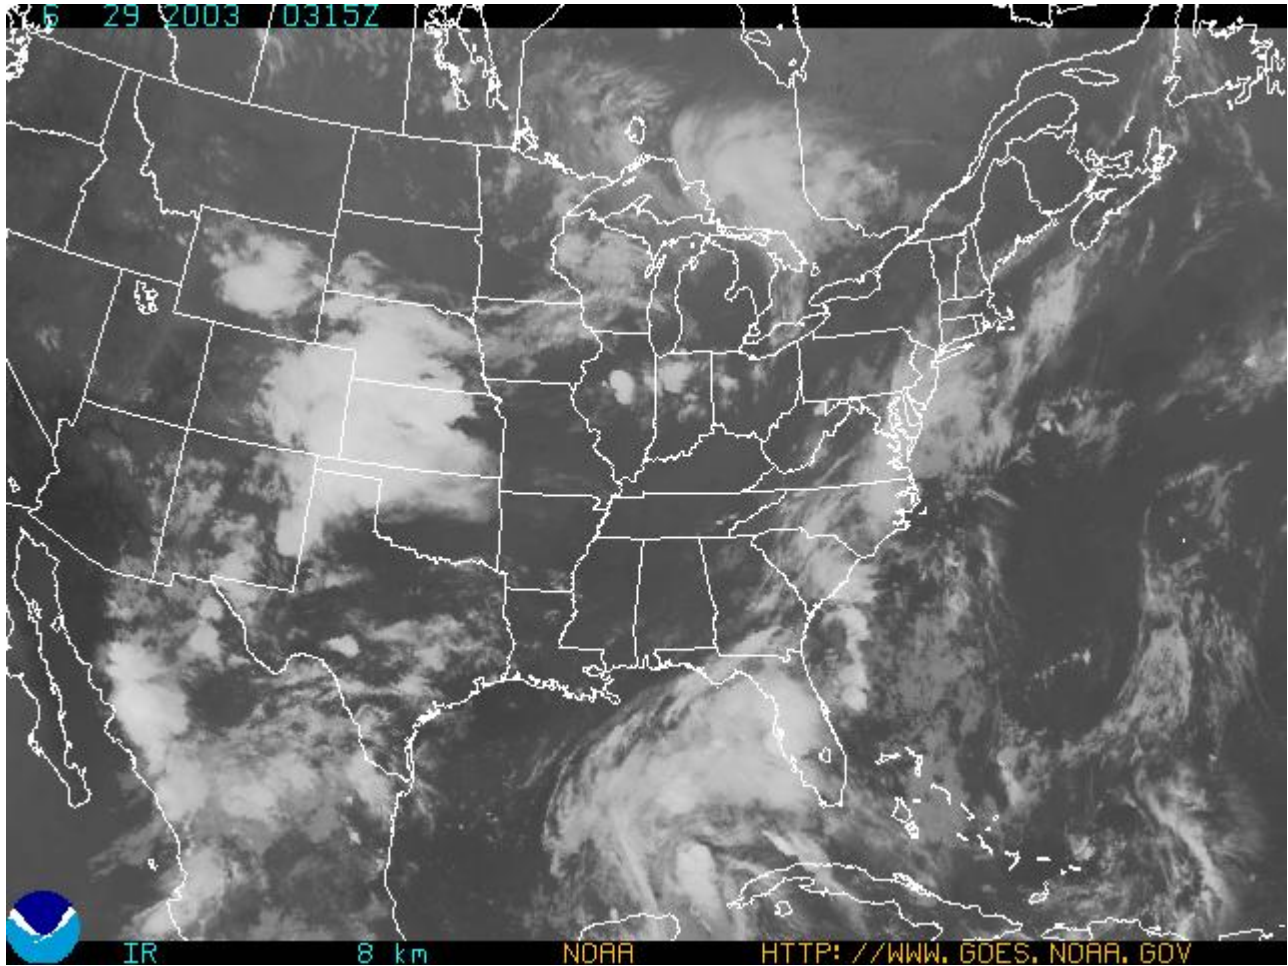
*Figure 2.* GOES-East infrared photograph, 1115 PM EDT June 29th, 2003, showing a developing squall line moving onshore. This would be the last widespread rain episode of the month.

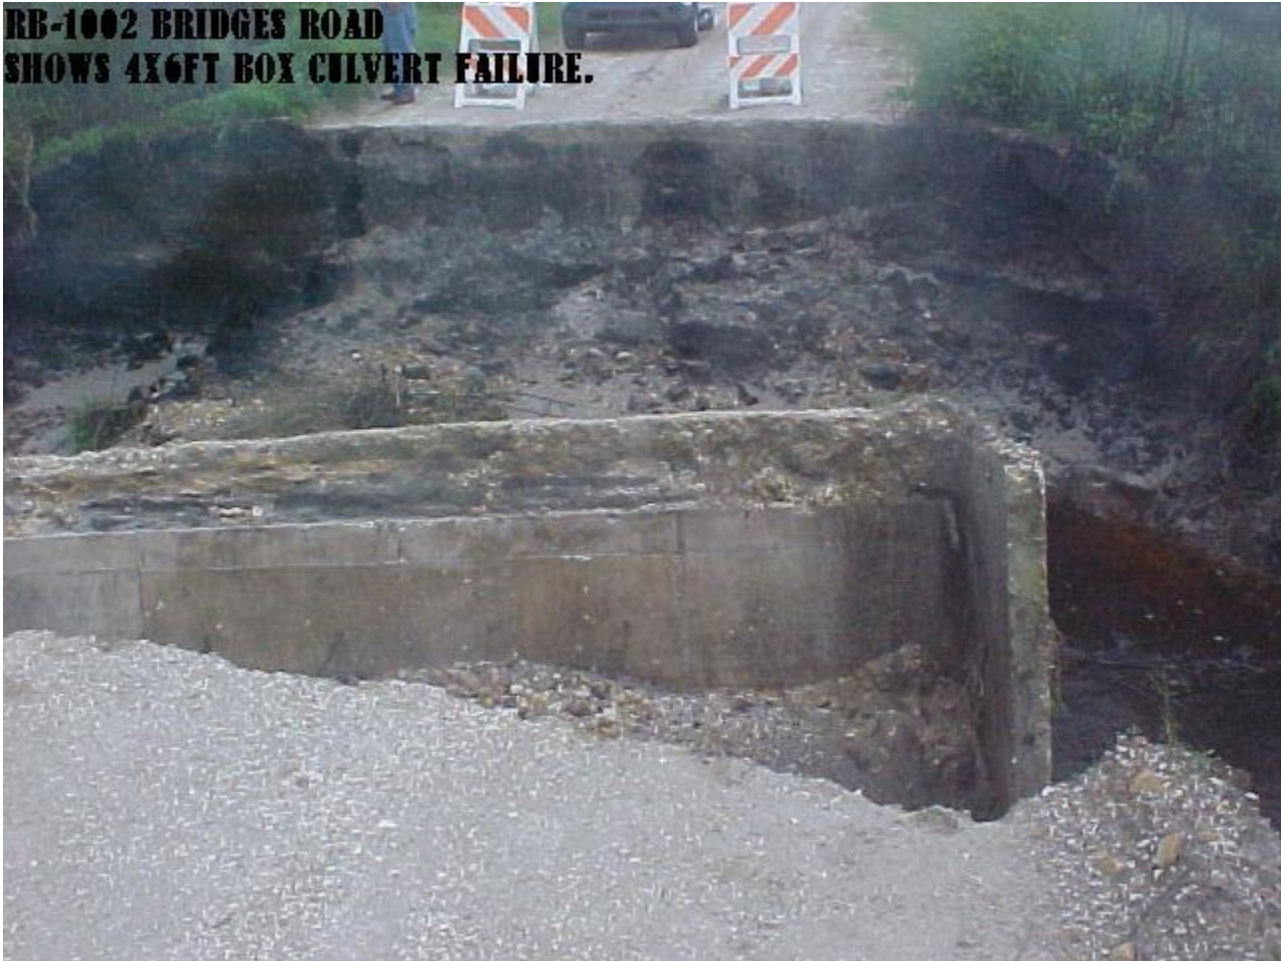
Hardee County Road Washout - Photograph from Bill Muhlfeld, Hardee County Director of Emergency Management.
