NOAA - National Weather Service

Jan. 27, 2012 EF-1 Port Charlotte Tornado

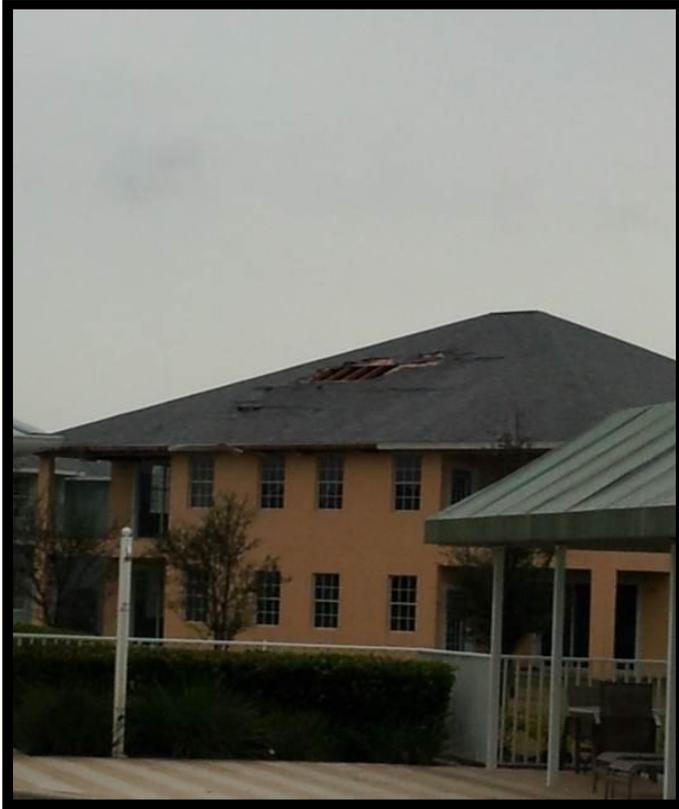
Tornado Damage at Point 1. Courtesy of Charlotte Co. EM

Point 1 shows tornado damage to an apartment building near Royal Tern Circle.

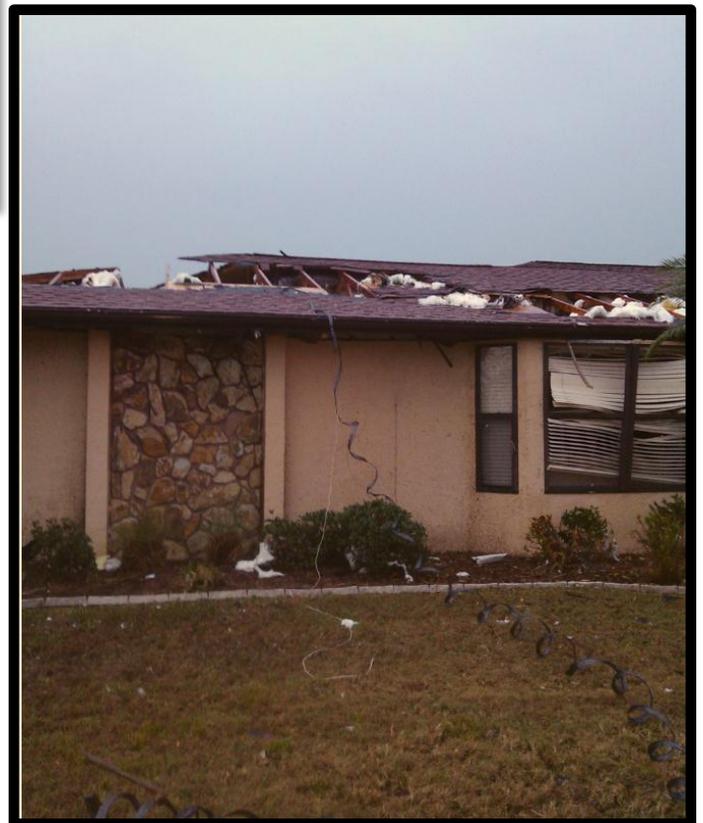
Tornado Damage at Point 2. Courtesy of Charlotte Co. EM

Point 2 shows significant damage to a house on Nuremberg Blvd. The tornado lifted after damaging the apartment complex and briefly touched back down near this house.

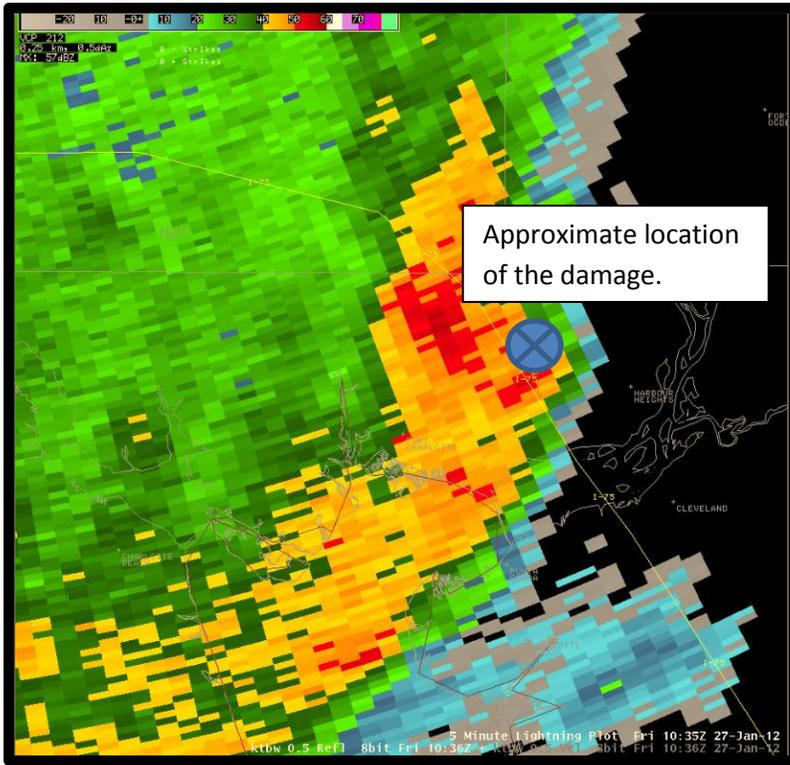
0.5 deg KTBW Reflectivity at 1036 UTC.

This reflectivity image from the KTBW radar shows a line of thunderstorms beginning to “bow” as it moves through Charlotte County.

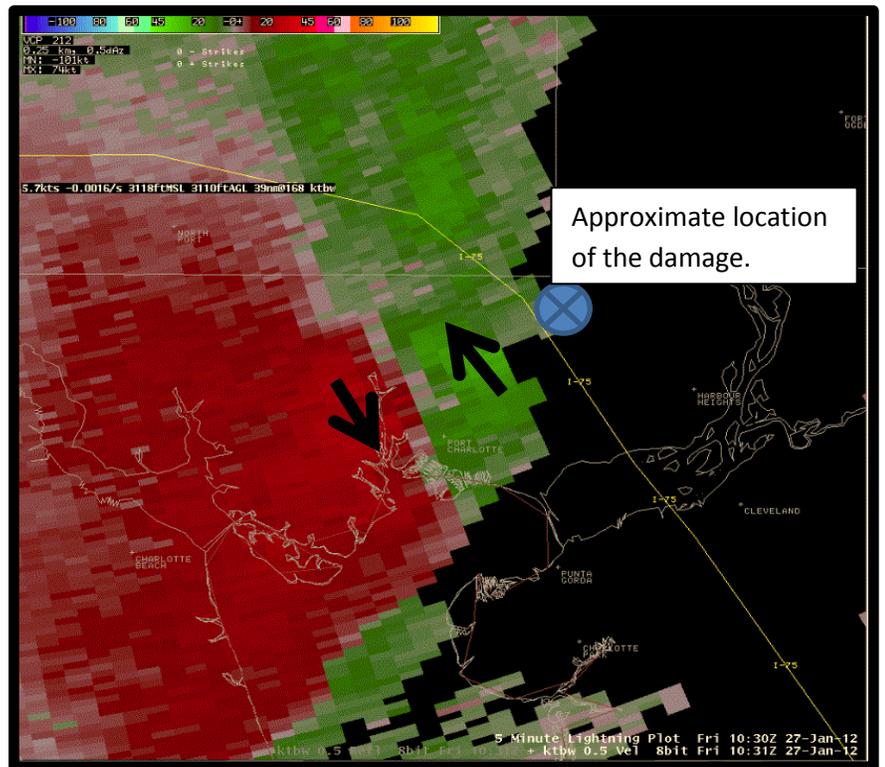
0.5 deg KTBW Base Velocity at 1031 UTC

The velocity image from KTBW shows a broad area of relatively weak rotation near Port Charlotte. Since the lowest level that radar can sample in this area is around 4,000 ft., it is difficult to determine what is actually going on closer to the surface.
