## Hurricane Wilma Preliminary Storm Survey

Disclaimer: Hurricane Wilma track and intensity information from our surveys are preliminary. Final official intensity and track will be determined by the National Hurricane Center.

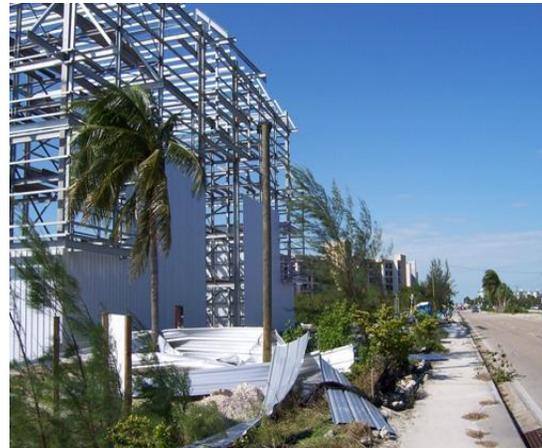
### Effects on West Central and Southwest Florida

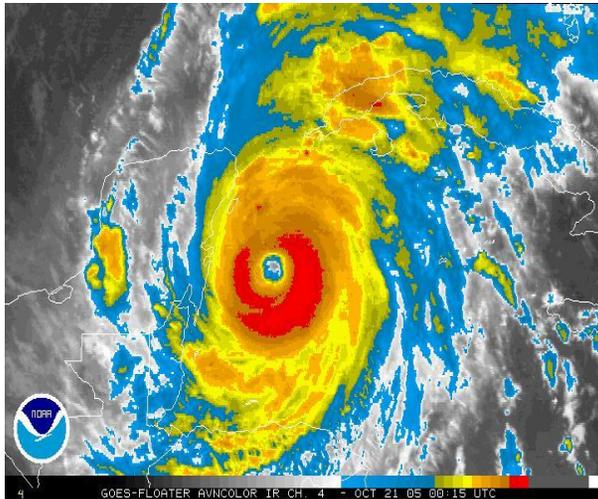
Now a category 4 storm, Wilma was more formidable (Figure 1, above). First, the expanded core of hurricane force winds was now able to raise very high seas in the northwestern Caribbean - as high as 36 feet at one NOAA Buoy east of the Yucatán peninsula. Second, the system was moving slowly northward, toward the major resorts of Cozumel and Cancún, Mexico. Through the afternoon and evening of the 20th, Wilma slowly approached Cozumel, and conditions gradually deteriorated. By daybreak on the 21st, conditions quickly deteriorated across Quintana Roo province of the eastern Yucatán peninsula. Cozumel was raked by the northern eyewall for the entire morning and early afternoon, causing extensive and in some cases devastating damage. As the large center passed over the island, the eyewall headed for Cancún.

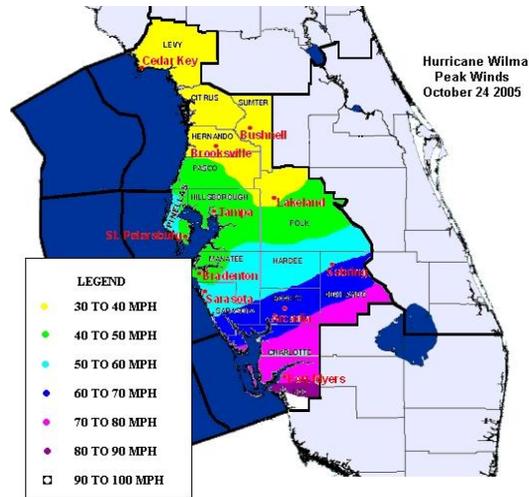
Storm surge was not a factor. Rather, as expected with the strong northerly winds, tide departures became negative, as shown on the tide charts for [Old Port Tampa](#) and [Fort Myers Beach](#). Locally heavy rains created areas of urban flooding in Lee County. For most other areas, the rains were a welcome sight for many areas which experienced a dry end to the rainy season. In fact, the widespread [rains](#) from the Tampa Bay area south ensured that October would be above normal in these areas. The exception was across the Nature Coast, where dry air associated with the cold front raced into the backside of the storm, greatly
