**Evaluation of Regional Calibration Parameters using a Distributed Rainfall-Runoff  
Model: Borrego Palm Canyon near Borrego Springs, California**

## ABSTRACT

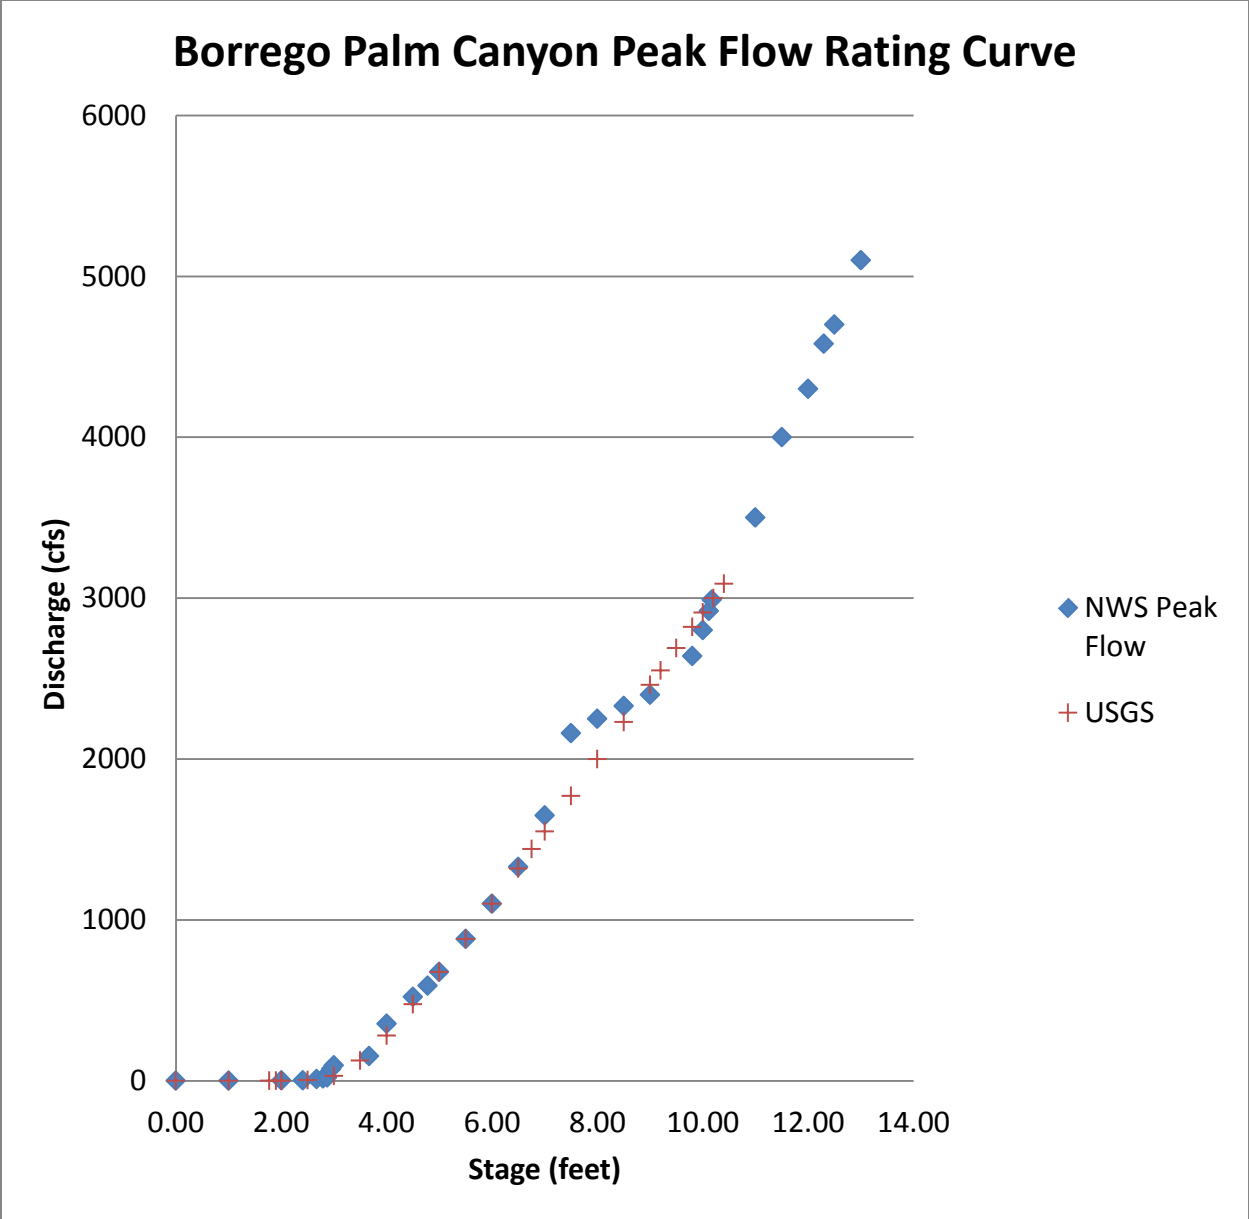
Figure 5. NWS developed peak flow rating curve compared with USGS rating curve.

The USGS California Water Science Center provided a copy of the last rating curve for the discontinued stream gage. The USGS rating curve compares well with the peak flow curve developed for the model (Figure 5).

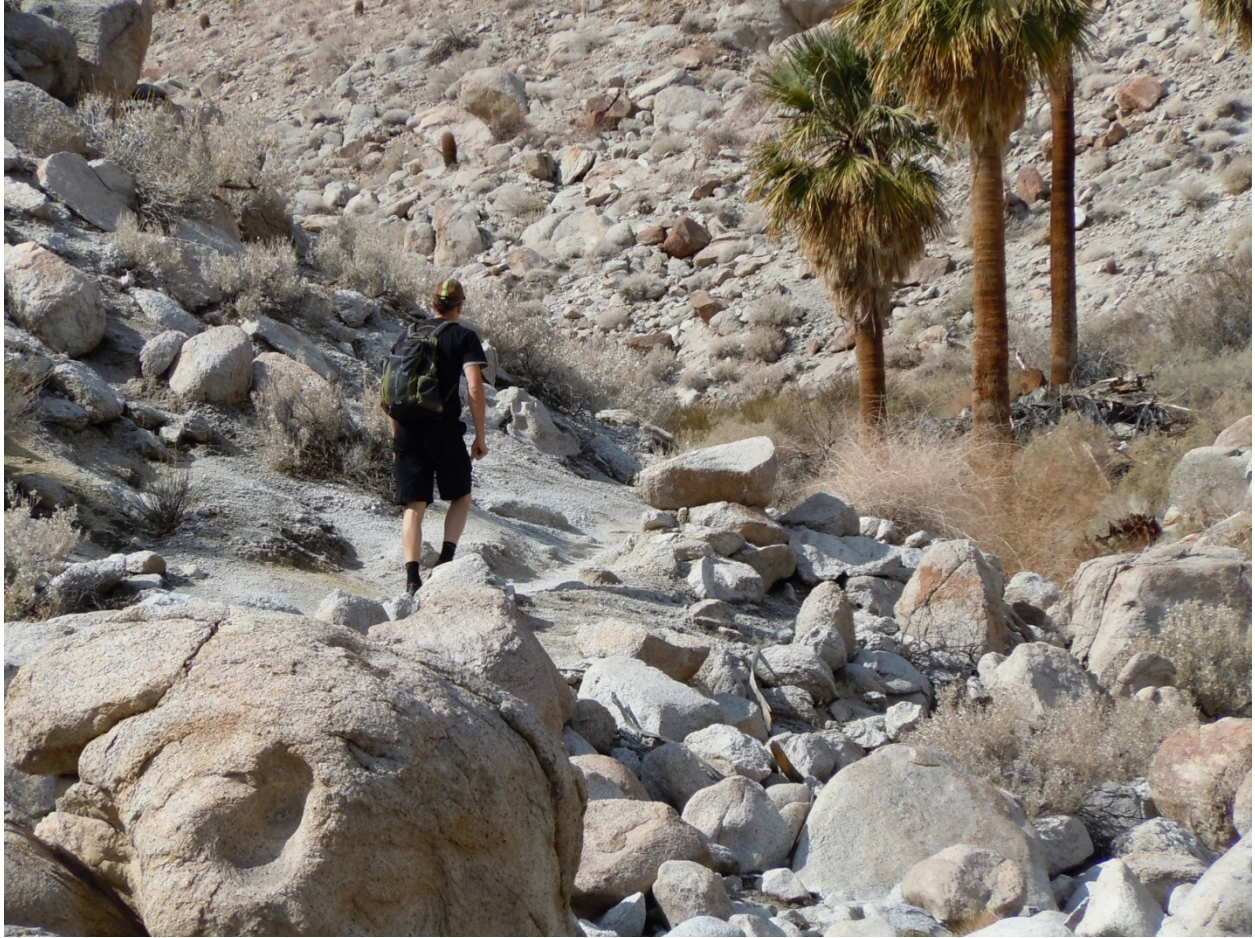
Figure 7. Image of section of Borrego Palm Canyon Trail with channel nearby. Image source: <http://mudlips.files.wordpress.com/2013/02/anza-borrego-2013-035.jpg>

Minor Flood Stage was set at 5.5 feet which correspond to an estimated peak discharge of 882 cfs. This equates to greater than a 5-year peak flow and less than a 10-year peak flow. At Minor Flood Stage, water begins to exceed the low flow channel in sections. Portions of Borrego Palm Canyon Trail closest to the channel would be inundated (Figure 7).

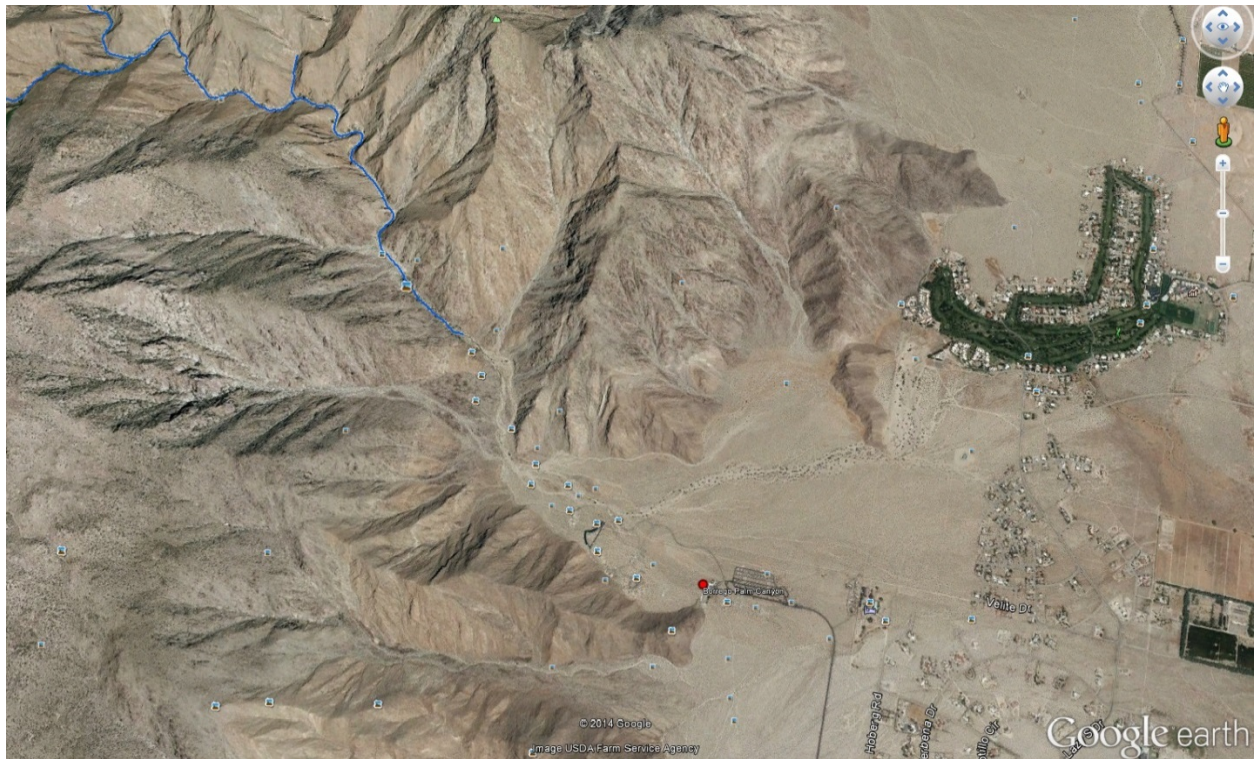
Figure 8. Google Earth Image. The outlet point for the model is shown by the downstream terminus of the light blue line located in the upper left portion of the image. The red circle identifies the location of San Diego County Flood Control rain gage.

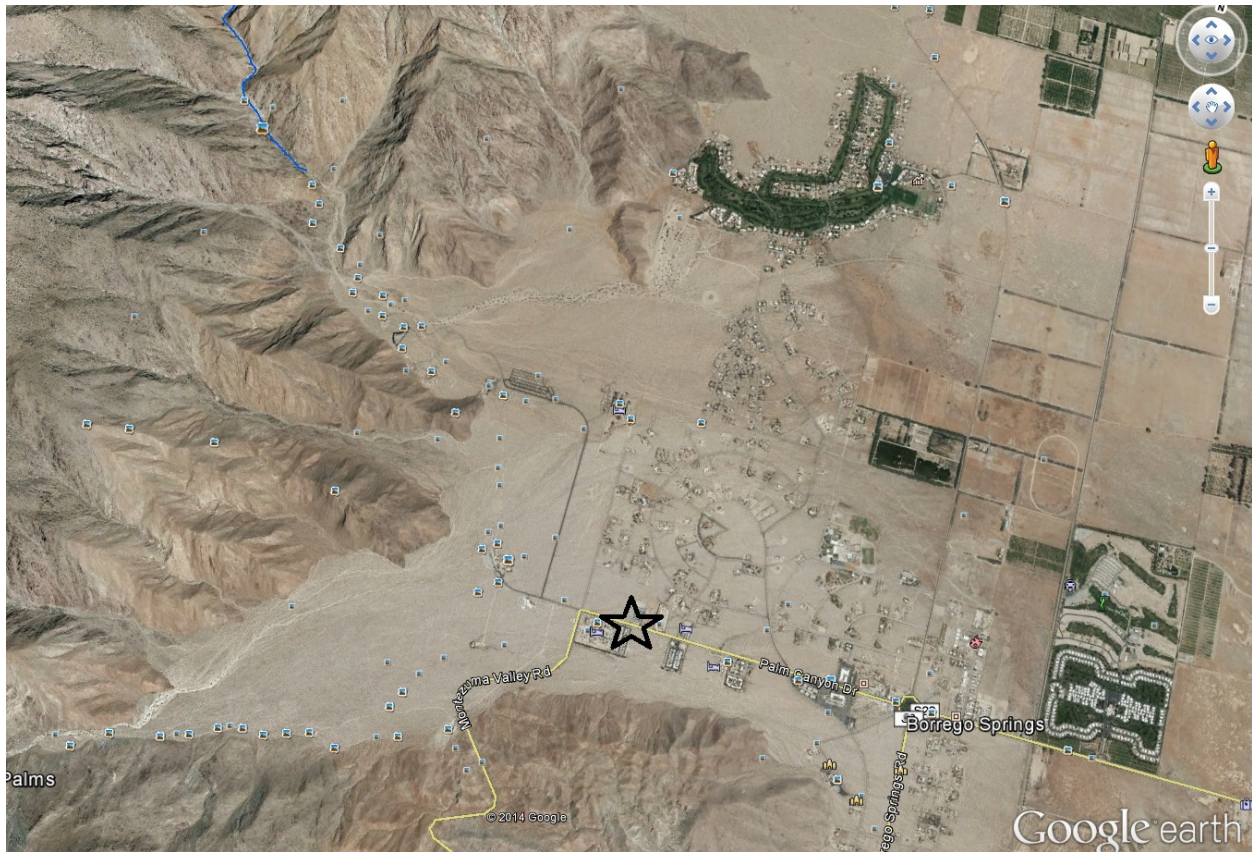
Figure 9. Google Earth image. The outlet point for the model is shown by the downstream terminus of the light blue line located in the top left portion of the image. The black star identifies the location of Palm Canyon Drive.

The Borrego Palm Canyon tipping bucket rain gage operated by San Diego County Flood Control District recorded 2.01 inches of rain on the 21<sup>st</sup>. There were no reports of flooding in Borrego Palm Canyon proper. There was a reference of flooding along Palm Canyon Drive from a blog posting made by the innkeeper at the Borrego Valley Inn (Marie, 2013). Portions of Palm Canyon Drive were covered by 7 to 8 inches of water, but flood damage was minimal. Palm Canyon Drive is located 2.3 miles southeast of the model outlet point for Borrego Palm Canyon (Figure 9).

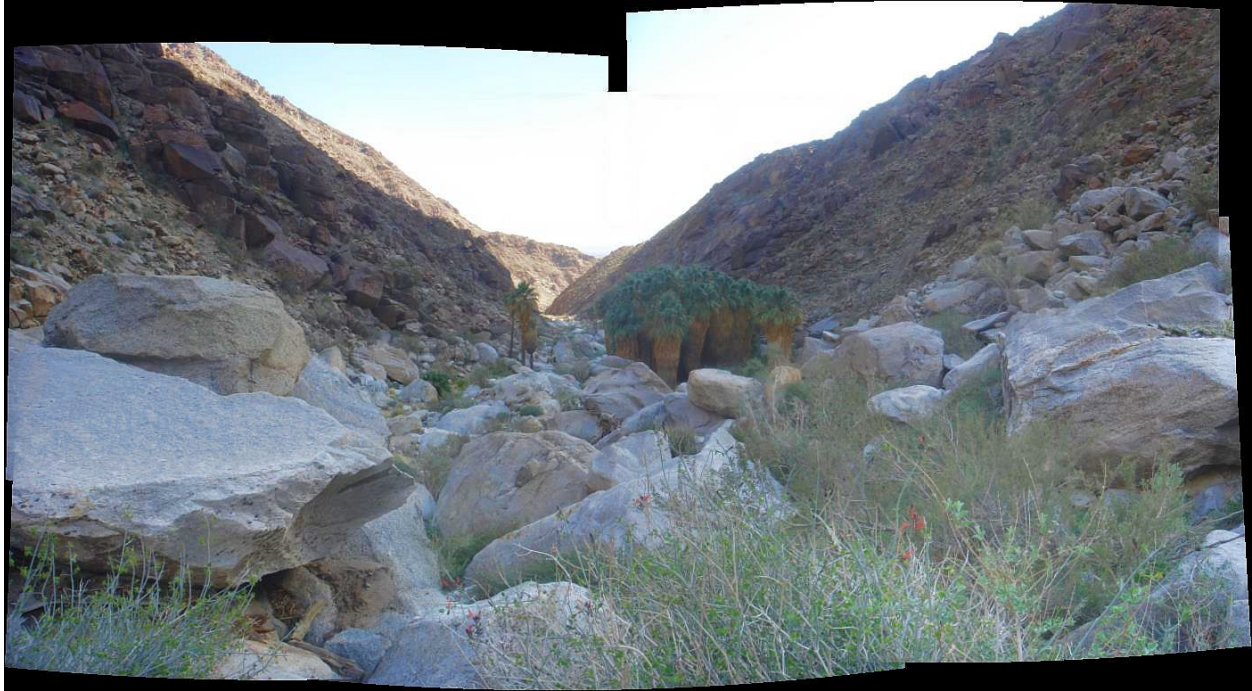
Figure 11. Panorama of five pictures taken on January 31, 2010 from just above the first palm grove looking downstream toward the mouth of Borrego Palm Canyon. Image source:

Google Earth was used to measure channel widths for each channel element, and was used to evaluate the Manning's roughness coefficient by viewing pictures that were geocoded based on their latitude and longitude. Google Earth imagery dated from 2010 and 2011. Manning's roughness values of 0.043 to 0.045 were assigned to the main channel sections of Borrego Palm Canyon (mainstem, South Fork, and Middle Fork). Smaller headwater tributary streams were given roughness values as high as 0.046. The authors view the Manning's roughness values as some of the highest they have ever seen (Figure 11).
