**WESTERN REGION TECHNICAL ATTACHMENT
NO. 01-11
September 4, 2001**

**USING RADARSAT TO MONITOR AND FORECAST
RIVER ICE MOVEMENT IN NORTHEAST MONTANA**

**Tom Wright and Andrew Pohl
Weather Forecast Office, Glasgow, MT**

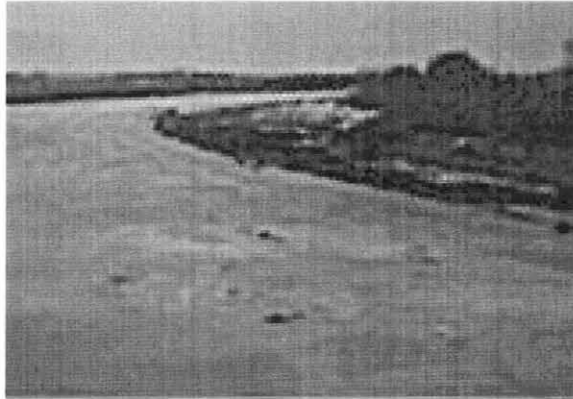
Figure 3. Photograph from March 9, 2001, of the Yellowstone River looking upstream of the Highway 23 bridge, near Sidney.

On March 9, the Richland County DES Coordinator provided us with some digital photographs taken of the Yellowstone River from the Highway 23 bridge in Sidney, Montana. (See Fig. 1 for location of Sidney.) The photos were taken both upstream and downstream (Figs. 3 and 4, respectively) and showed continuous ice in both directions. The DES Coordinator concluded that there was no open water on the Yellowstone River in the vicinity of Sidney.

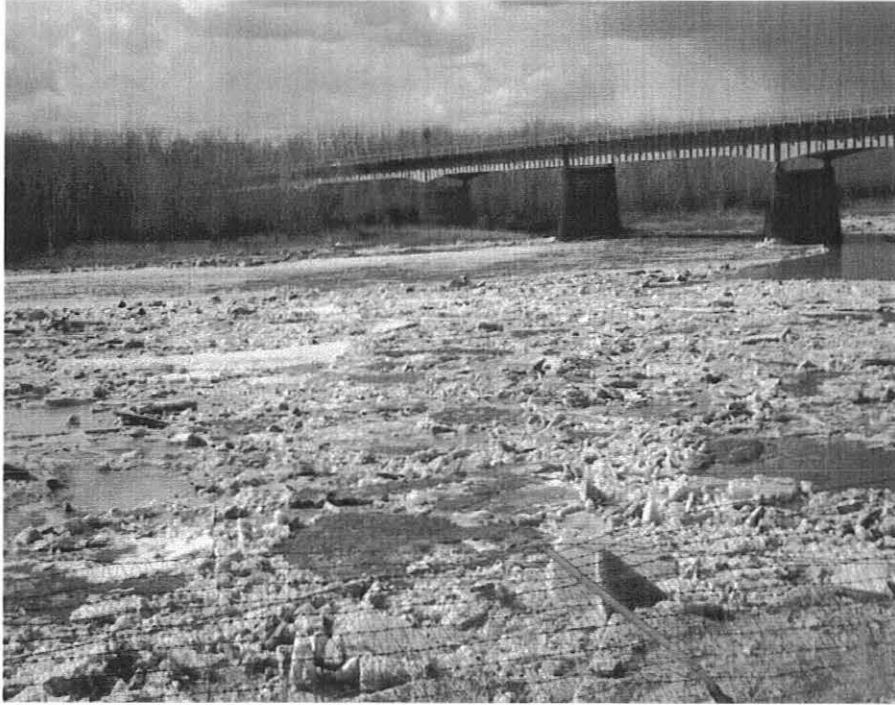
Figure 8. Photograph of the Yellowstone River on March 20, looking northwest from near the Bell St. bridge (not shown in photograph) toward the Business 94 bridge in Glendive.

On March 20, 2001, RADARSAT imagery (Fig. 7) indicated an ice field on the Yellowstone in Glendive (see Fig. 1) near the Bell Street bridge. The ice appeared to be decaying due to the grayish color of the river in the area. A comparison with subsequent photographs obtained from Dawson County DES (Figs. 8 and 9) confirmed that ice was beginning to decay.

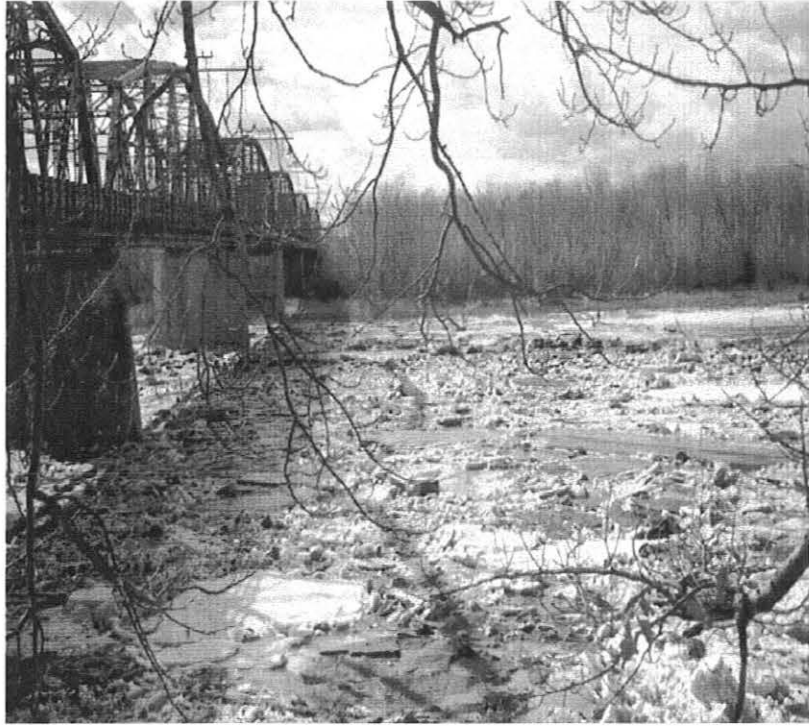
Figure 9. Photograph of the Yellowstone River on March 20, looking west along the Bell St. bridge (at left of photograph) in Glendive.

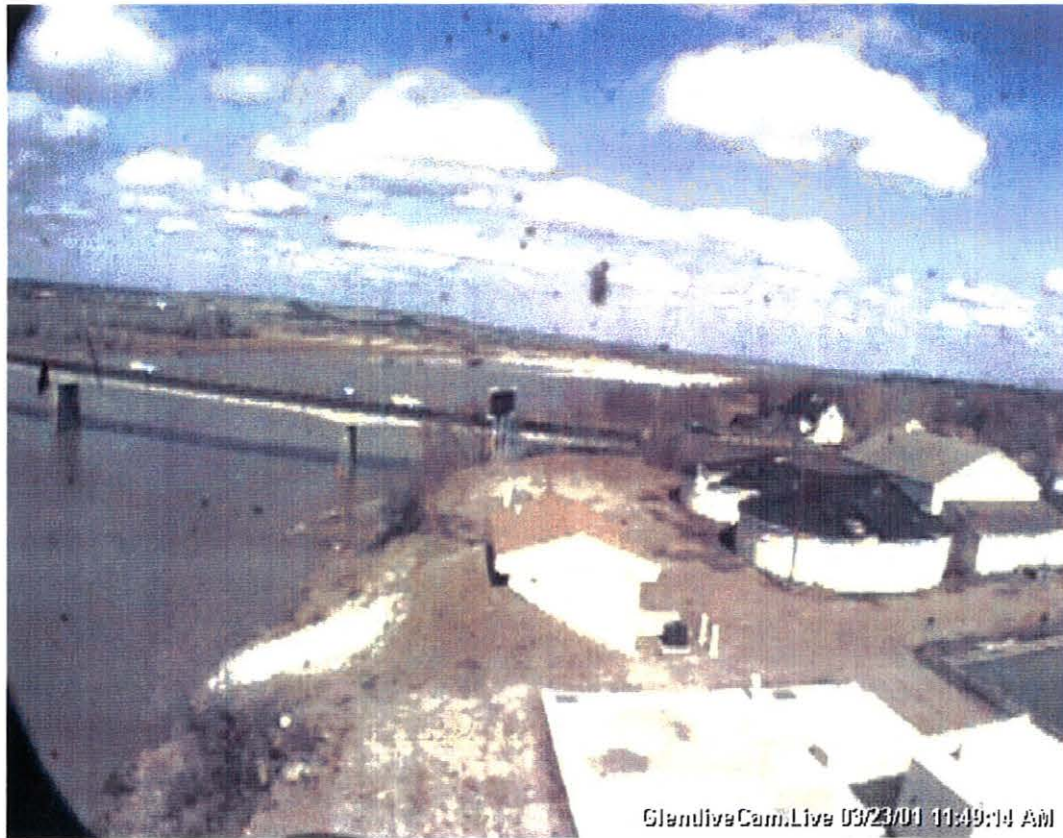
Figure 12. Photograph of the Yellowstone River from the "Glendive Camera" on March 23 at 11:49 a.m. MST looking north. The Business 94 bridge is in the foreground. Note the ice upstream at the top of the photograph. The ice is the back edge of the ice jam seen in Figure 11.

Further upstream in Glendive, we were able to see an ice jam between the Business 94 bridge and the Interstate bridge (Fig. 11). An apparent widening of the channel was observed just upstream of the ice jam, indicating that a lot of water was being backed up there. A digital photograph (Fig. 12) taken from a camera at Glendive was used for comparison. The Business 94 bridge is in the foreground of Fig. 12 and the back edge of the ice jam just downstream can be seen in the figure; thus confirming the RADARSAT image.
