**Western Region Technical Attachment
NO. 04-07
July 14, 2004**

**The Rucker Canyon Flash Flood of July 21, 2002:
Estimating Discharge for an Ungaged Site**

Mike Schaffner, NOAA/NWS Weather Forecast Office, Tucson, AZ

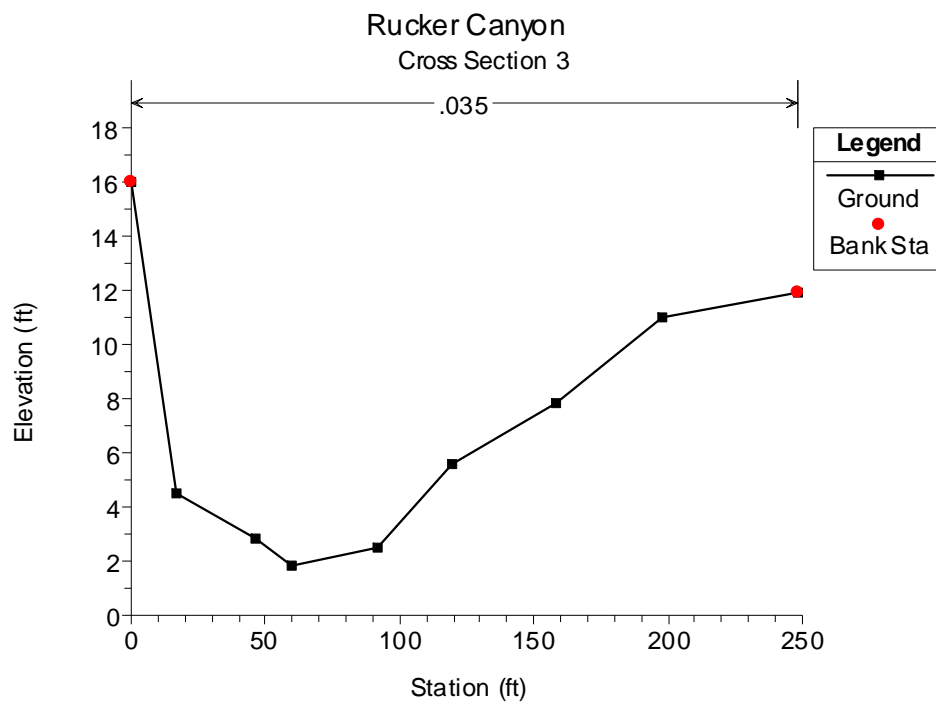
Figure 5: Cross section 3. Cross section is located 10.5 feet downstream from cross section 4 and 12.25 feet downstream from the bridge structure. Cross section view is from upstream looking downstream.

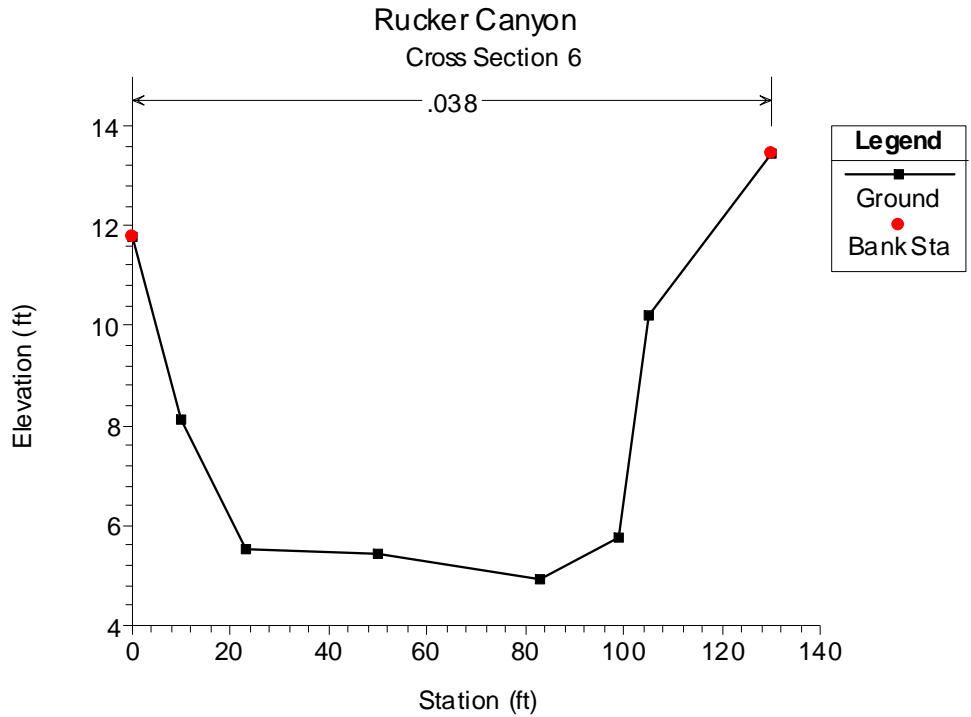
Figure 6: Cross section 6. Cross section is located 14.5 feet upstream from cross section 5 and 16.25 feet upstream from the bridge structure. Cross section view is from upstream looking downstream. The near-vertical slope on the right bank is an area of rip rap bank protection.

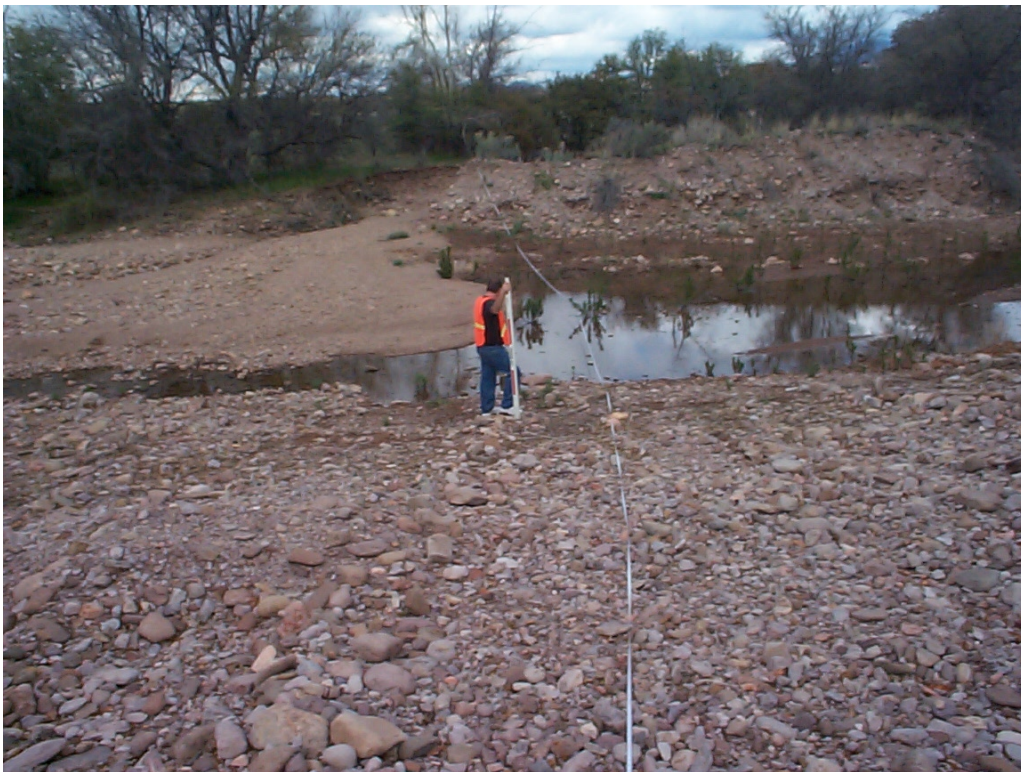
Figure 11: Cross section 1 as viewed from top of left bank looking north. While not taught at the time, tape measure shows approximate position of cross section. Small tributary seen entering just downstream of cross section at right bank. Tucson WCM Tom Evans in foreground for scale.

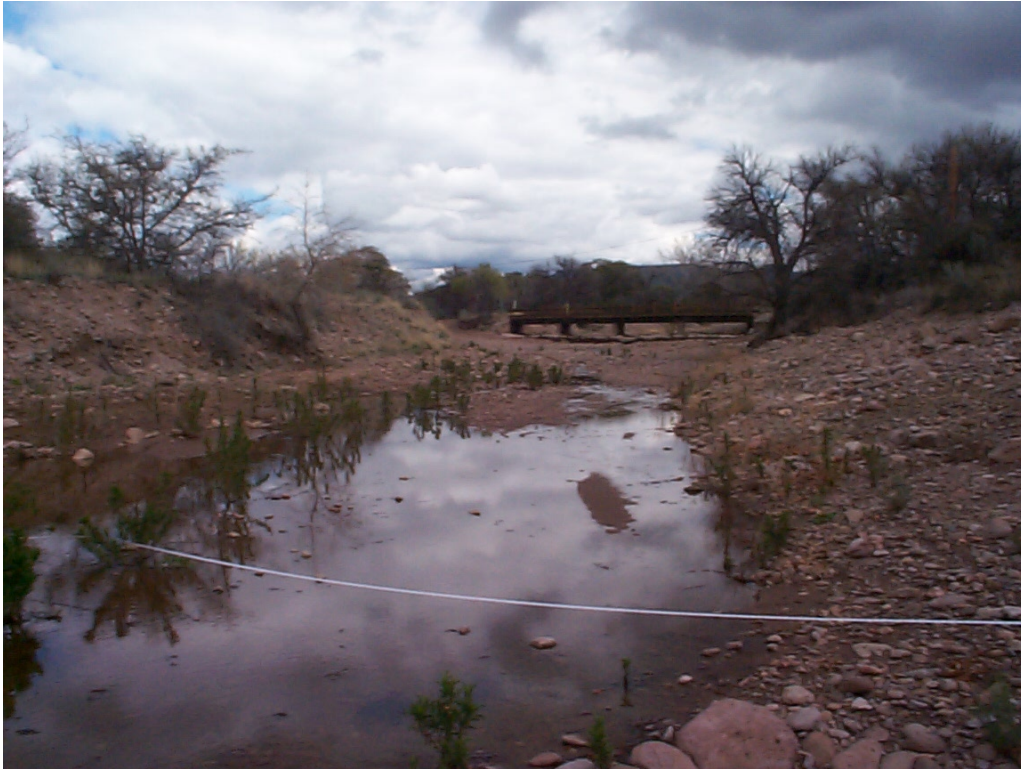
Figure 12: Cross section 1 looking upstream. Tape measure shows approximate position of cross section. Cross section 2 was located upstream near tree along right bank. Rucker Bridge and adjacent low water crossing seen in distance.

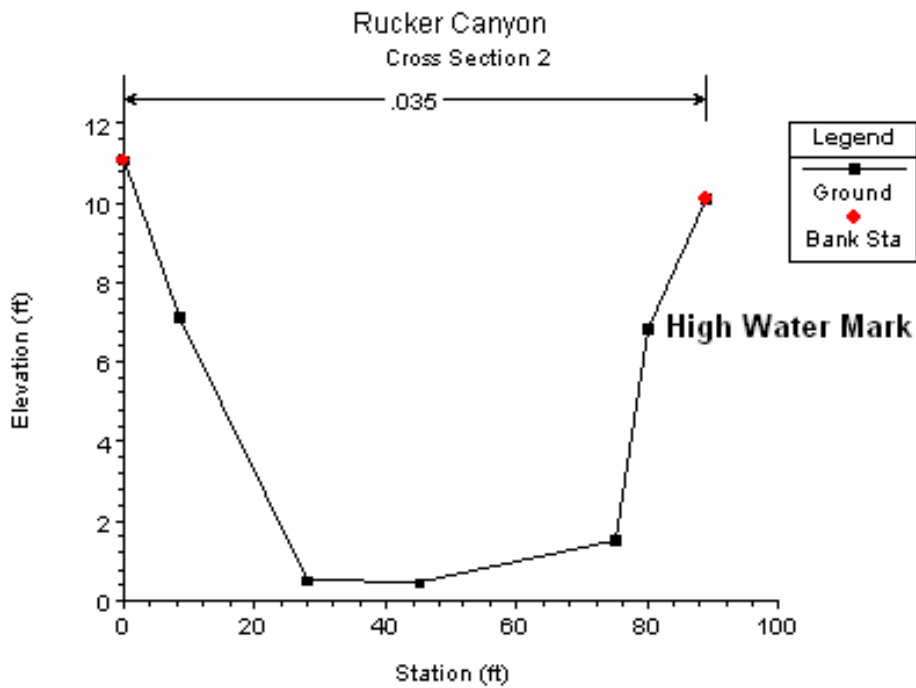
Figure 13: Cross section 2. Cross section is located 86 feet upstream from cross section 1 and 193 feet downstream from cross section 3. Cross section view is from upstream looking downstream.

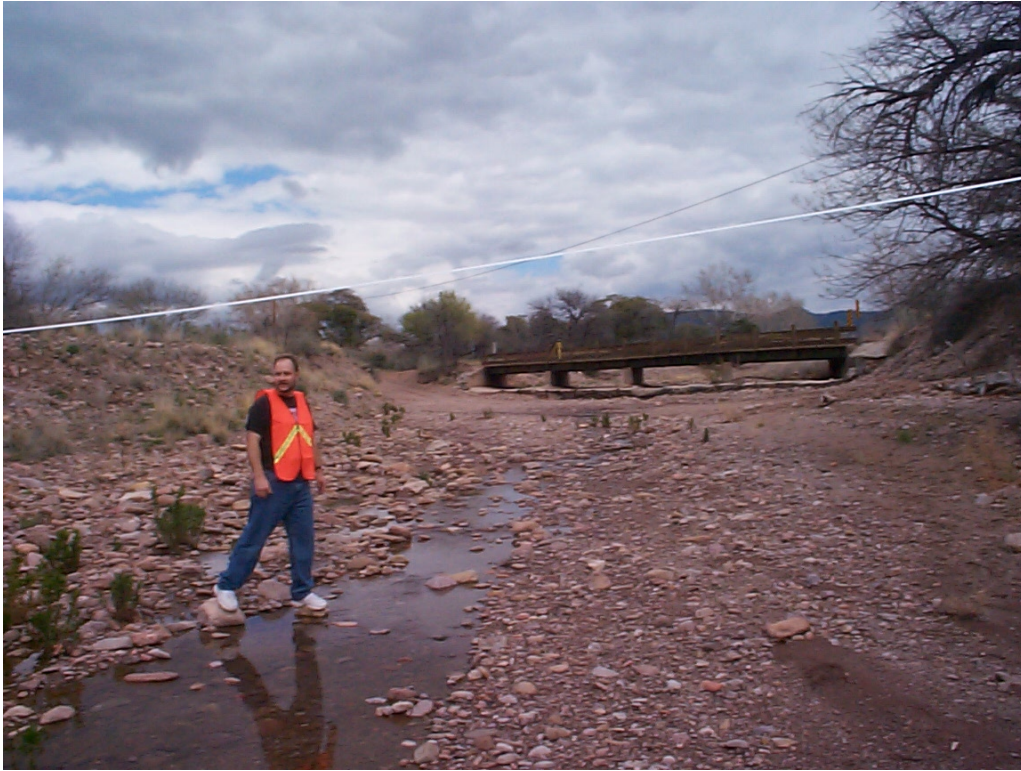
Figure 14: Cross section 2 looking upstream. Tape measure shows approximate position of cross section. Rucker Bridge and adjacent low water crossing seen in distance.

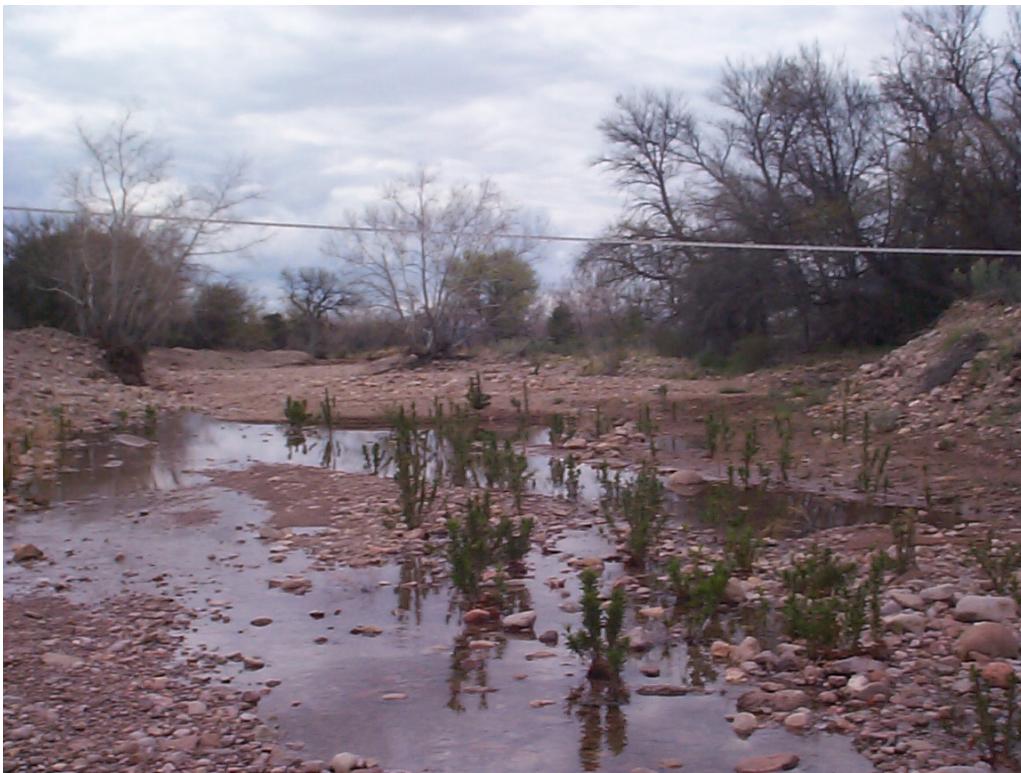
Figure 15: Cross section 2 looking downstream. Tape measure shows approximate position of cross section. Cross section 1 located in distance where in-channel vegetation ends.

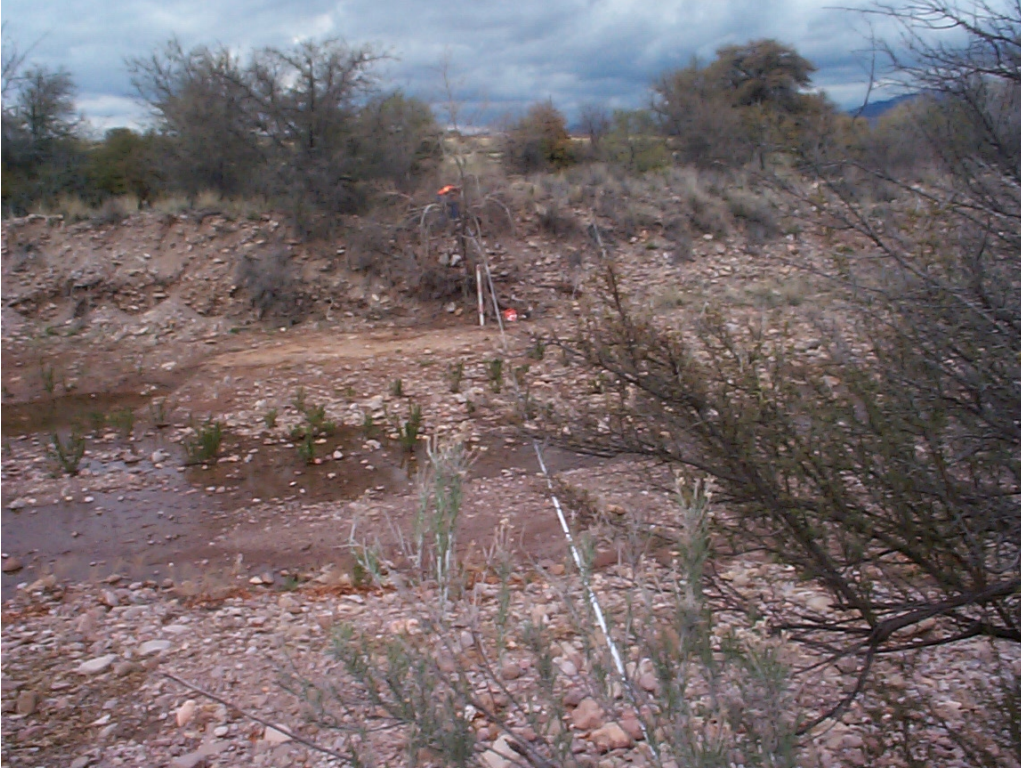
Figure 16: Cross section 2 as viewed from top of left bank looking north. Tape measure shows approximate position of cross section. High water mark located just above top of survey rod leaning against tree on right bank.

Besides cross sections 3 through 6 used to define the bridge, cross sections 1 and 2 were placed downstream. Cross section 1 was placed several feet upstream from a small side tributary (figure 10, 11, 12). Cross section 2 (figure 13, 14, 15) was placed upstream of cross section 1 and downstream of Rucker Bridge and its adjacent low water crossing. Cross section 2 coincides with the only well-defined high water mark (figure 16, 17).

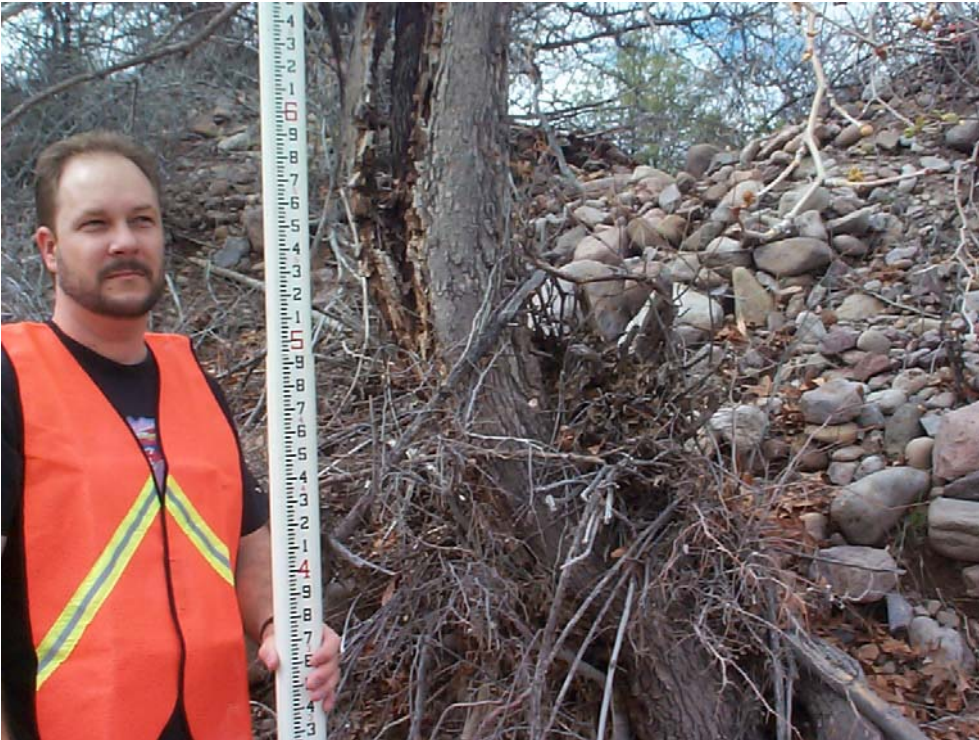
Figure 17: High water mark located at right bank of cross section 2. Debris, including a metal arrow bent by the flow, was discovered within.

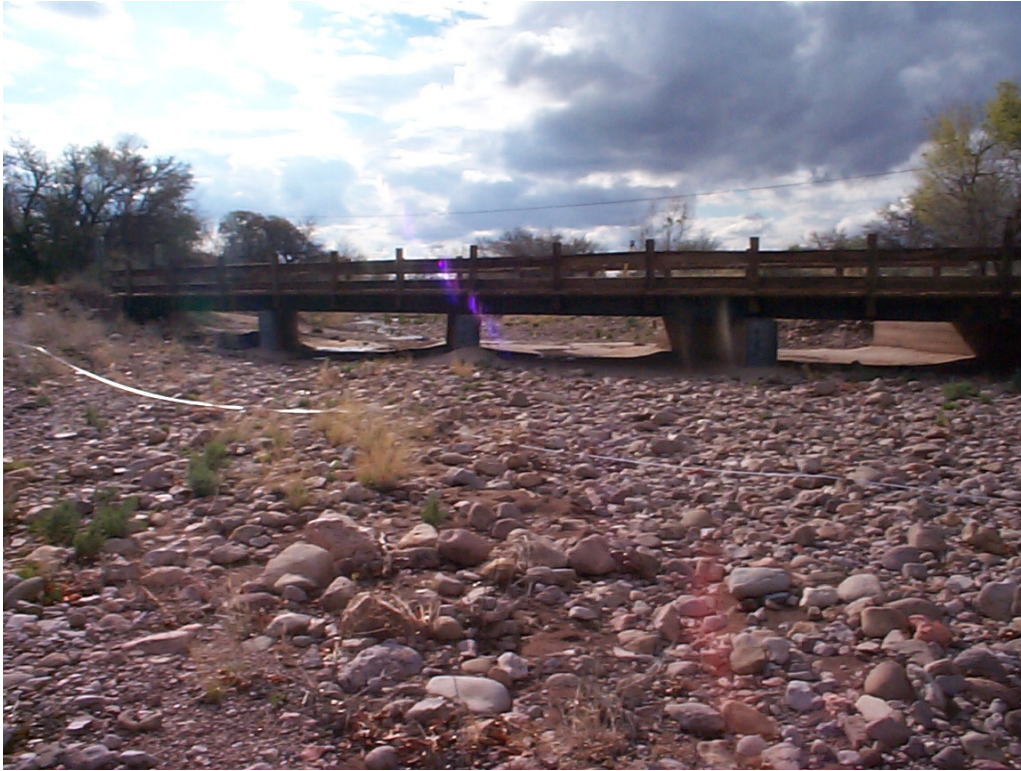
Figure 18: Cross section 6 looking downstream towards Rucker Bridge. Cobbles dominate channel bottom as well as banks.

The n value at cross section 6 was estimated to be 0.038 excluding vegetation which was minimal (figure 18). At cross section 4 (figure 19) n values were slightly lower due to the presence of concrete bridge piers and concrete channel bottom directly below the bridge. The channel downstream of Rucker Bridge (cross sections 1 and 2) was composed of cobble banks and less coarse channel bed material. A reasonable n value for cross sections 1 and 2 is 0.034 or 0.035 respectively.

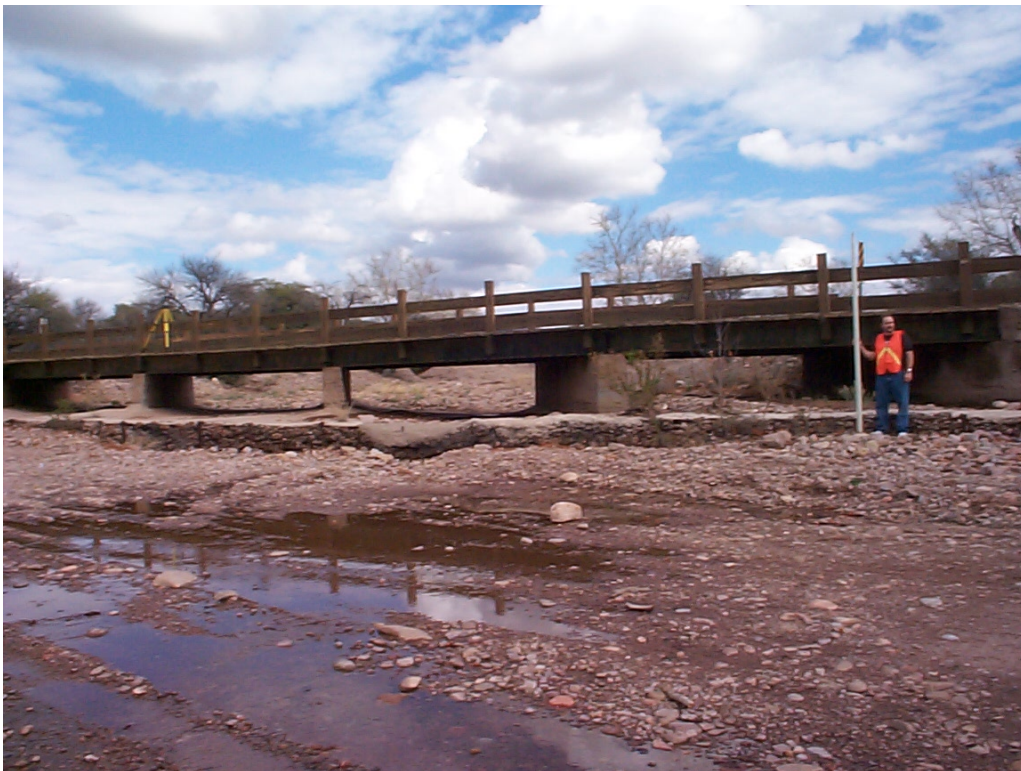
Figure 19: Rucker Bridge as seen from low water crossing just downstream of bridge. Yellow survey tripod seen on downstream-north side of bridge.

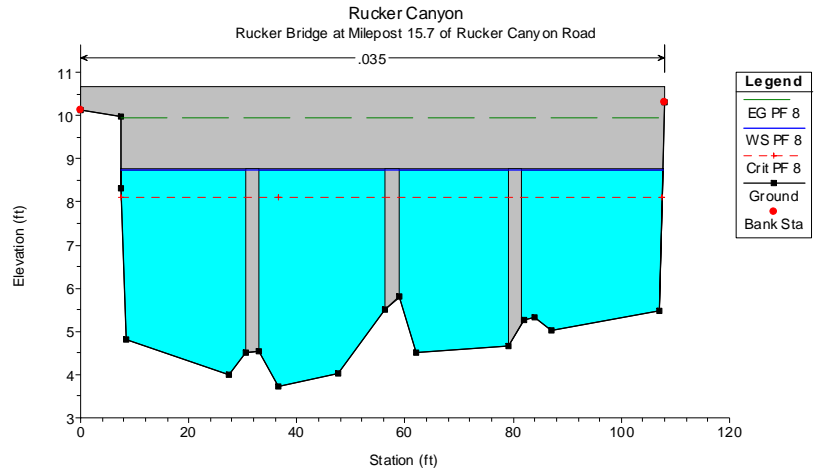
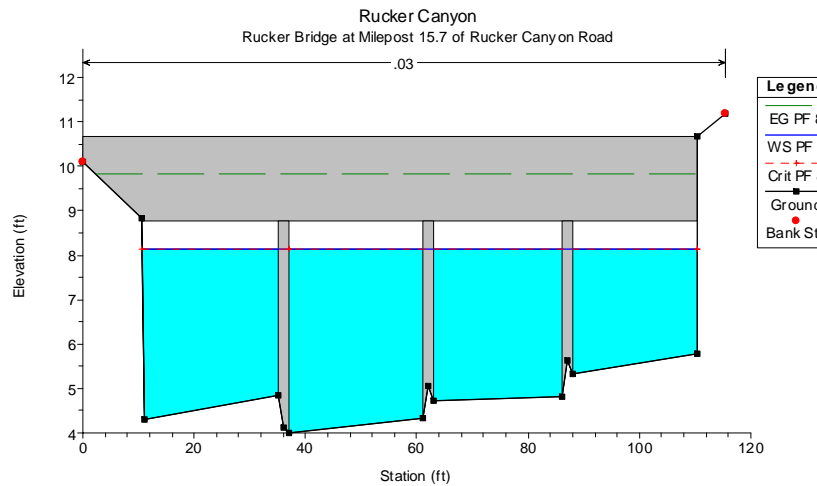
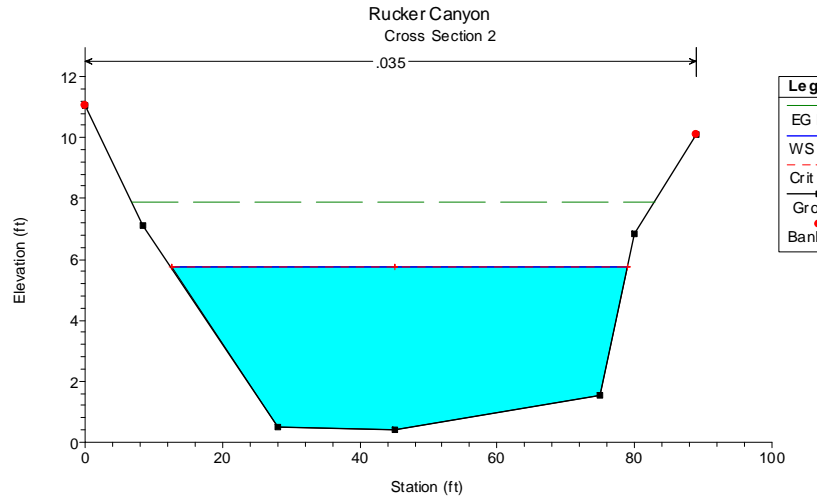
Figure 20: Water surface elevations at 3300 cfs for bridge cross section upstream, downstream, and 205 feet downstream from the bridge structure (cross section 2). Water surface elevation profile represented by solid blue line, water surface critical flow profile represented by dashed red line (coincides with water elevation profile for downstream bridge cross section and cross section 2), and energy profile represented by dashed green line. Cross section view is from upstream looking downstream.

Solution results for 3300 cfs show water reaching low steel on the upstream side of the bridge ([figure 20](#)). Solution results for 4000 cfs show water reaching just above low steel on the upstream side of the bridge, low steel at the downstream side of the bridge, and just below the high water mark along the right bank of cross section 2 ([figure 21](#)). Solution results for 4500 cfs show water almost overtopping the bridge on the upstream side, just above low steel on the downstream side, and at the elevation of the high water mark in cross section 2 ([figure 22](#)).

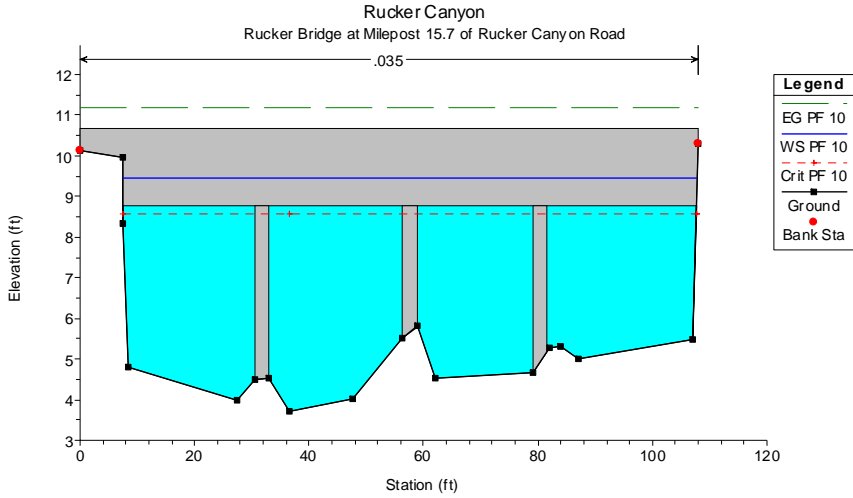
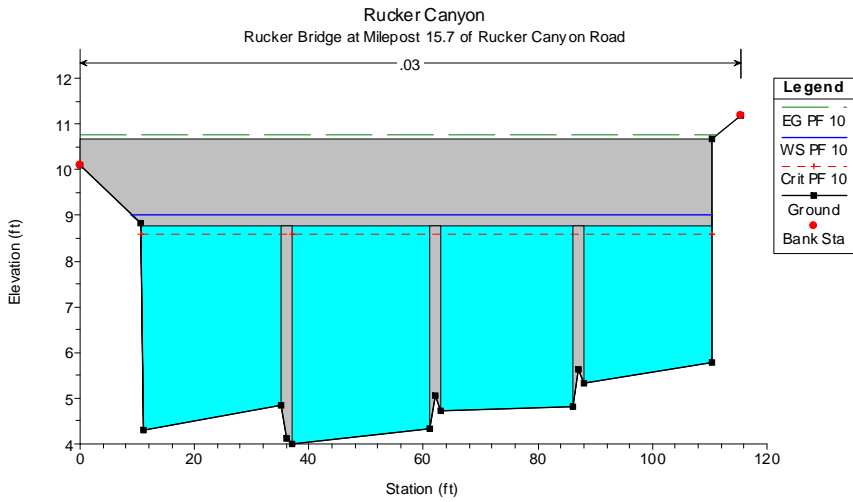
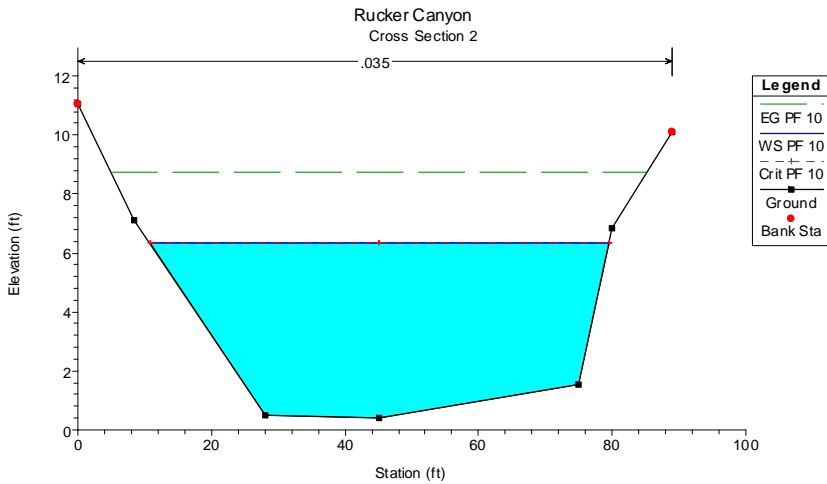
Figure 21: Water surface elevations at 4000 cfs for bridge cross section upstream, downstream, and 205 feet downstream from the bridge structure (cross section 2). Water surface elevation profile represented by solid blue line, water surface critical flow profile represented by dashed red line (coincides with water elevation profile for cross section 2), and energy profile represented by dashed green line. Cross section view is from upstream looking downstream.

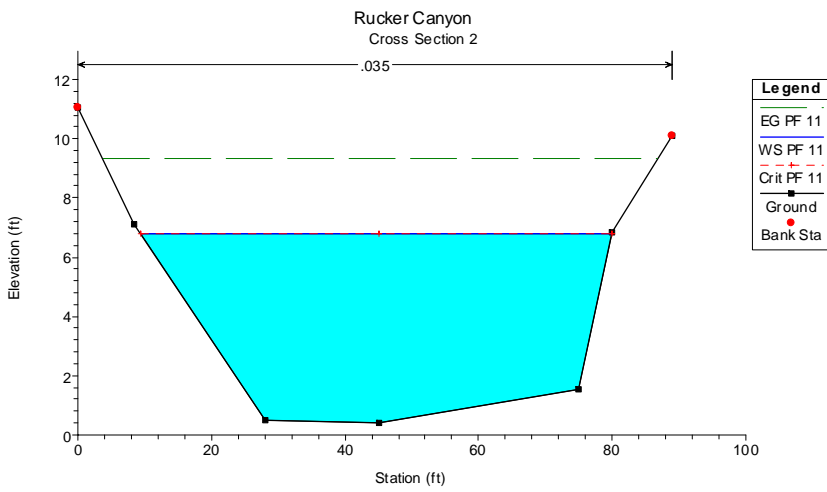
Figure 22: Water surface elevations at 4500 cfs for bridge cross section upstream, downstream, and cross section 2. Water surface elevation profile represented by solid blue line, water surface critical flow profile represented by dashed red line (coincides with bridge low steel for bridge cross sections and water elevation profile), and energy profile represented by dashed green line. Cross section view is from upstream looking downstream.

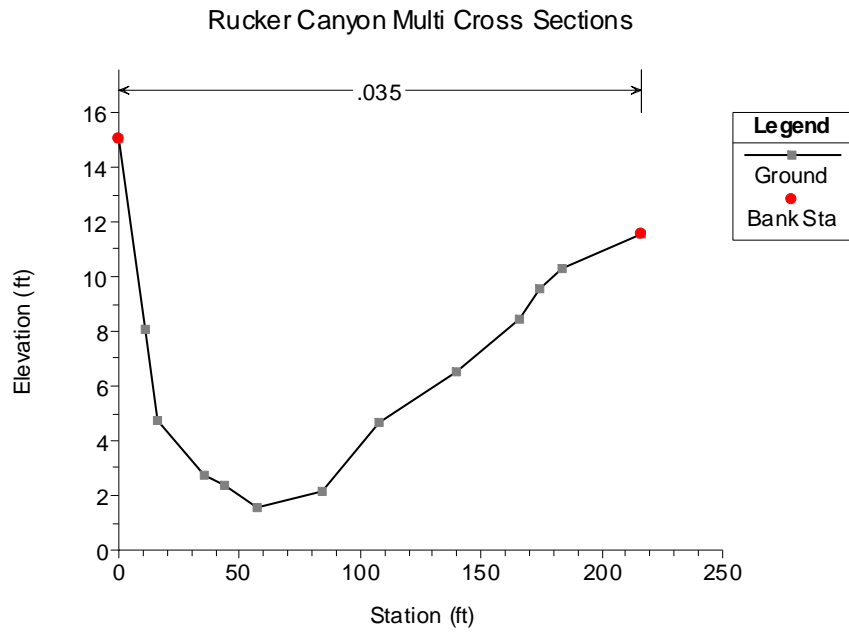
Figure 24: Scour hole added to cross section 2.8. Cross section prior to scour and including scour whole shown on top and bottom of figure respectively. Cross section view is from upstream looking downstream.

In order to evaluate the effect of scour just downstream from the bridge, as reported by an eyewitness, a scour hole several feet deep was placed in the simulation (figure 24). Solution results were comparable to those without the scour hole.

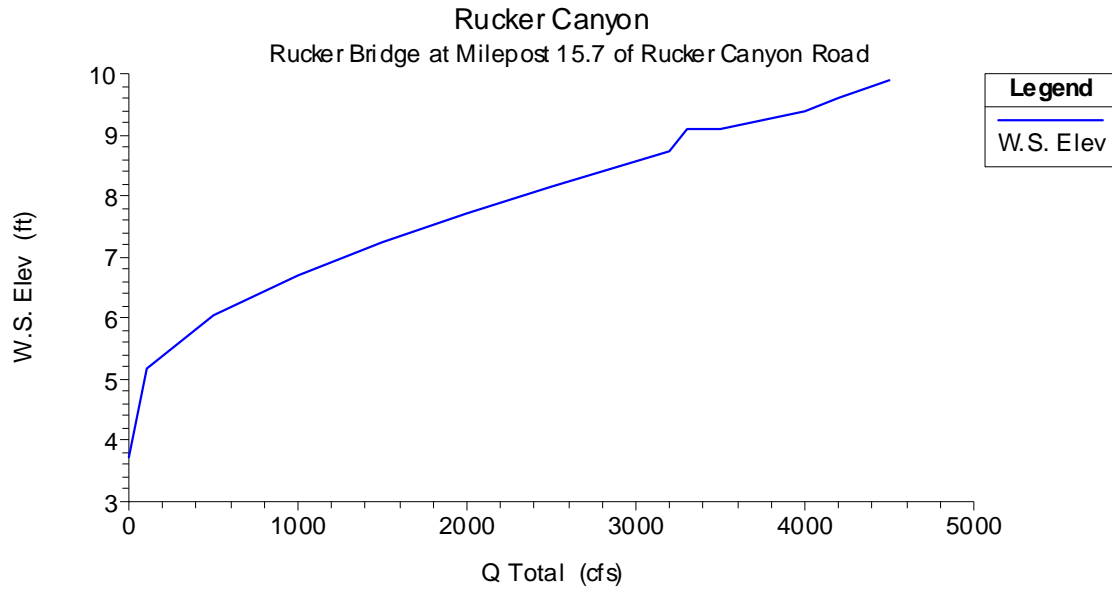
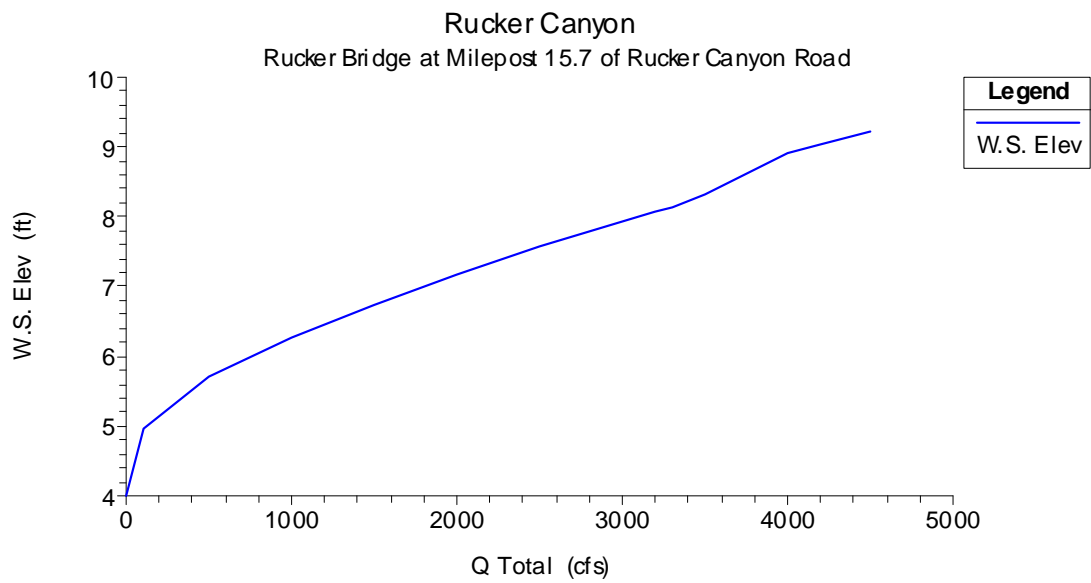
Figure 26: Theoretical rating curve for upstream (top) and downstream (bottom) side of Rucker Bridge at milepost 15.7 of Rucker Canyon Road. Bump in upstream rating curve appears to be a reaction to the water first coming into contact with bridge low steel.

HEC-RAS can generate a theoretical rating curve for each cross section. A theoretical rating curve is only as good as to how well the channel geometry is defined. Channels with shifting sand, as is quite common in southern Arizona, make poor sites to develop theoretical rating curves. Every time a flow event occurs, channel geometry is modified thus making the previous theoretical rating less accurate if not obsolete. Theoretical rating curves in stable channels (such as those lined with clay or coarse bed material) tend to have a longer life span. Those in concrete channels tend to be as good as those defined through human collected flow measurements and require little if any modification through time. The USGS, in Arizona, use HEC-RAS to create a theoretical rating curve for their new stream gauging sites. This is used as a starting point. Flow measurements are then used to verify and if needed modify the original theoretical rating curve (Saeid Tadayon, USGS AZ, Personal Communication). The USGS has recently reported that their theoretical rating curve for Gila River at Duncan Arizona was excellent when compared to their flow measurements from the winter of 2003-2004 (Dan Evans, USGS AZ, Personal Communication). With any hydraulic model, output is only as good as the input parameters. If good channel geometry, Manning n values, and channel slope are used as input, the model should output a fairly good theoretical rating curve that is representative of the site (Bill Reed, CBRFC Senior Hydrologist, Personal Communication).

The theoretical rating curve developed in this study can be helpful to estimate flows for future flow events at the site. It can be useful if the site is ever to be modeled using a site specific or distributed model that has shown skill in forecasting for ungauged basins. A rating curve was produced for the upstream and downstream sides of Rucker bridge (figure 26). Since the bridge is underlain with concrete, the rating curve should provide a relatively accurate depiction of the stage-discharge relationship at the site.
