Effects of Wildfire in the Mountainous Terrain of Southeast Arizona: Post-Burn Hydrologic Response of Nine Watersheds

ABSTRACT:

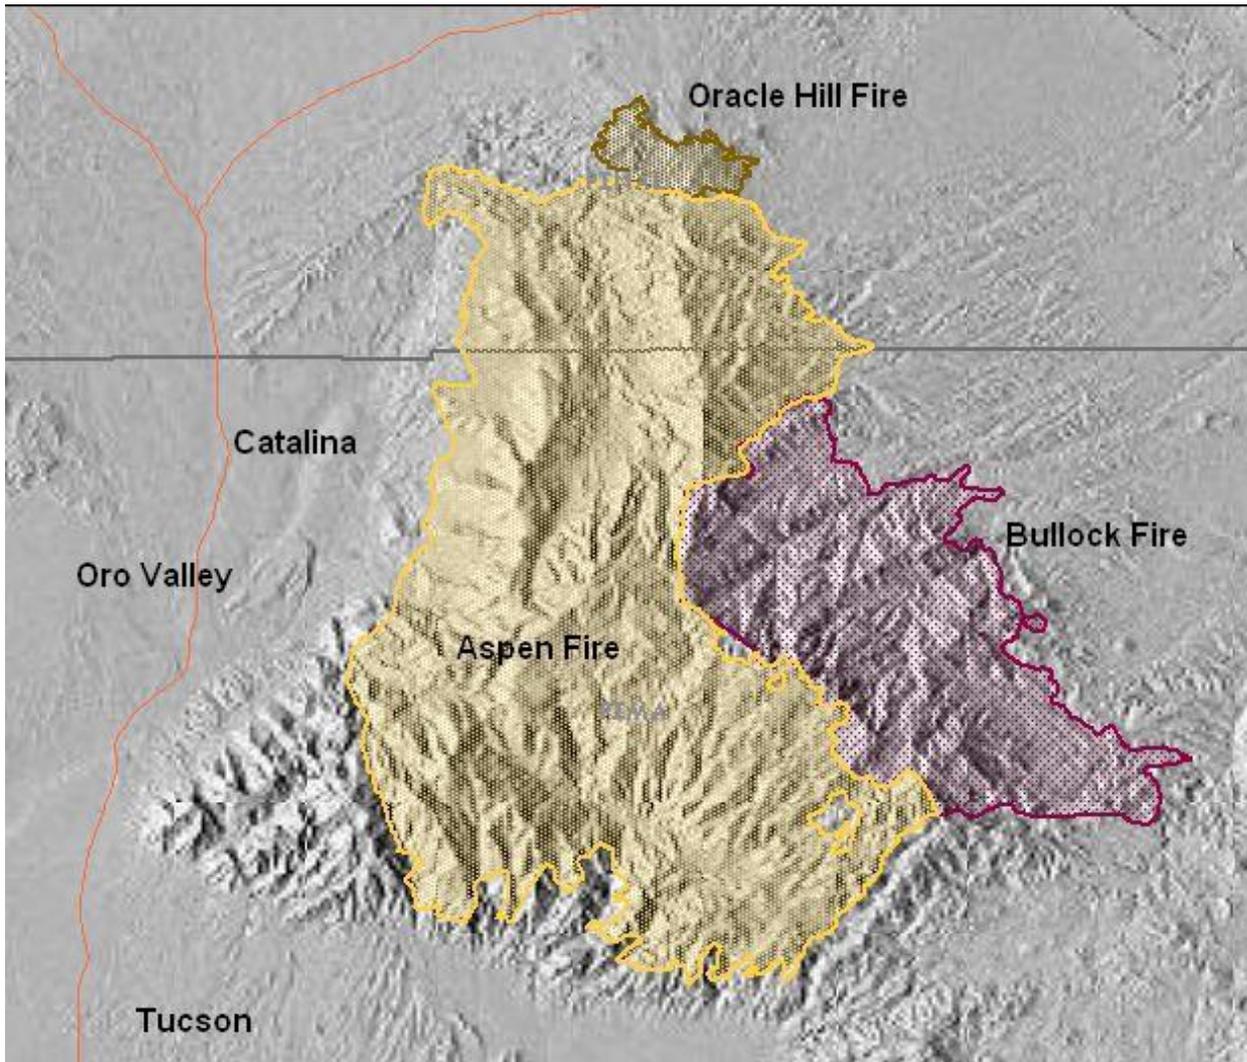
Figure 1: Hillshade image of the Santa Catalina Mountains overlaid with fire shapefiles. Image courtesy of Pima County Flood Control.

Southeast Arizona has been impacted by several large wildfires. These include the Oracle Hill Fire (2002), Bullock Fire (2002), and Aspen Fire (2003) on the Santa Catalina Mountains ([figure 1](#)) and the Nuttall Fire (2004) on the Pinaleno Mountains ([figure 2](#)). After these wildfires, significantly increased runoff from the burn areas has occurred. Rainfall amounts and intensities that normally would have caused little if any flooding now have the potential to produce dangerous flash floods.

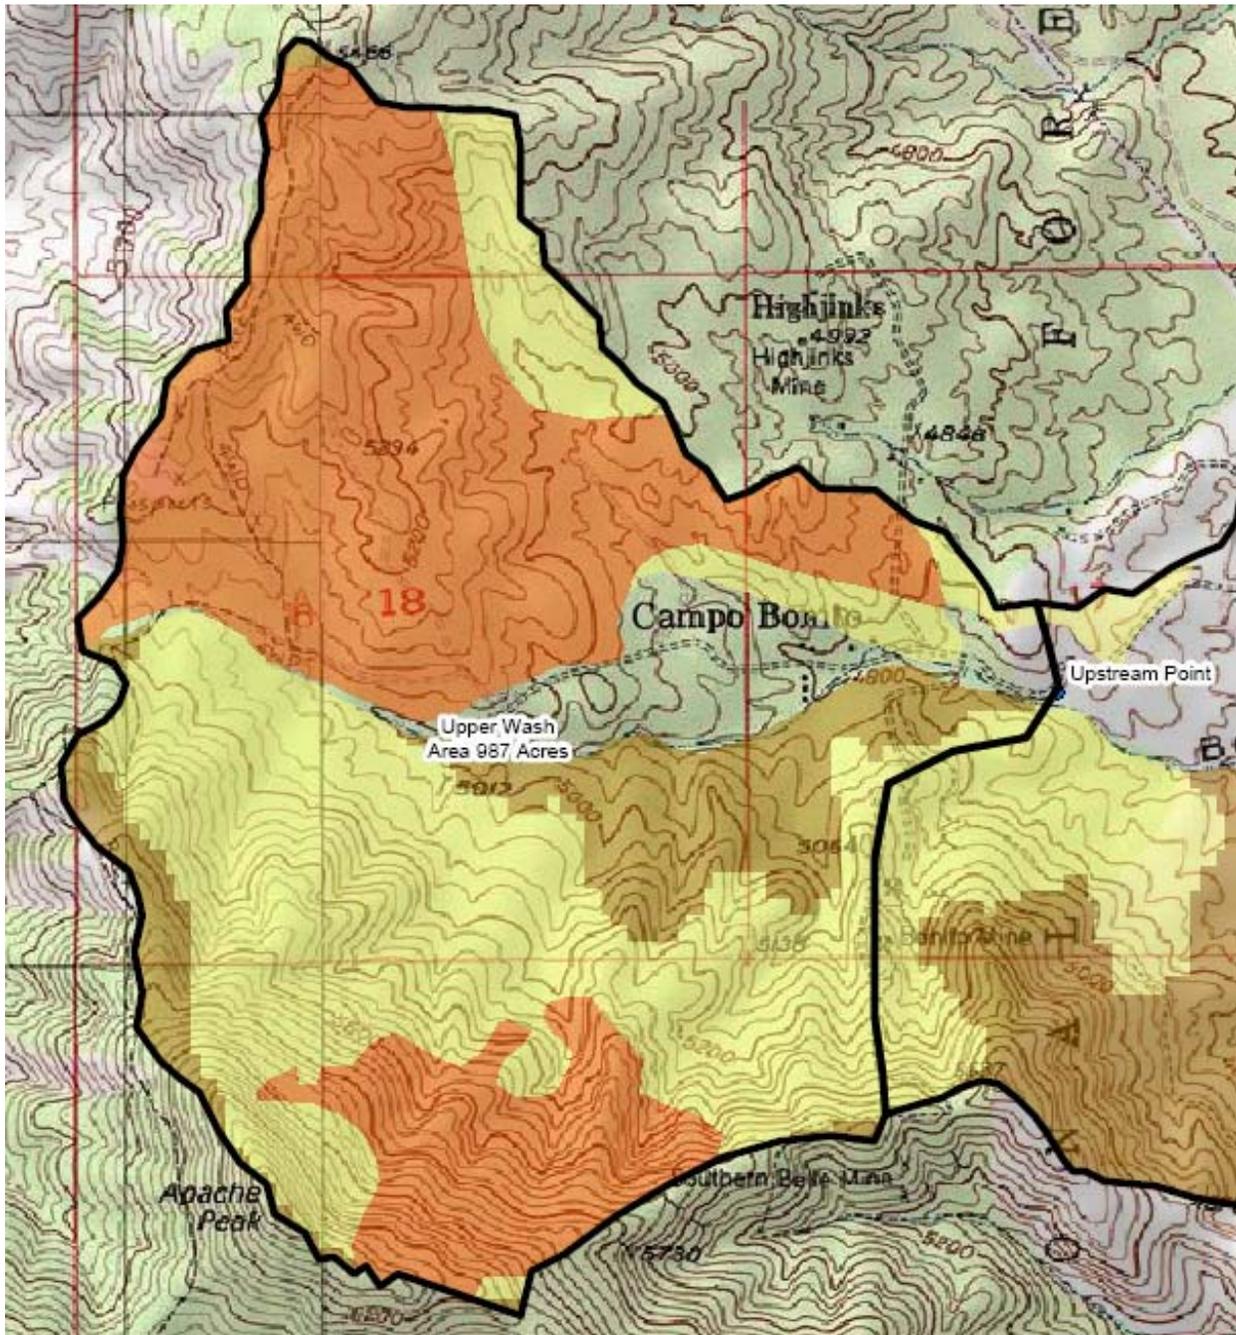
Figure 3: Upper Campo Bonito Watershed. Watershed shown with their burn severity and location of upstream slope-area reach. Image created on October 8, 2004 and courtesy of Barry Scott of AZ DEM using data from US Forest Service.

On August 14, 2003, a rainfall event and resultant flash flood occurred on the upper Campo Bonito watershed ([figure 3](#)). The upstream site drains a 1.5 square mile watershed, has a mean basin elevation of 5,600 feet, and contains 42% high severity and 38% moderate severity burn. The peak discharge was estimated, by the USGS using the slope area method, at 1,900 cfs +/- 20%. This equates to a 100-year pre-burn flood. This amounts to a burn area post-burn runoff 2.5 times greater than runoff during pre-burn conditions ([table 1](#)).

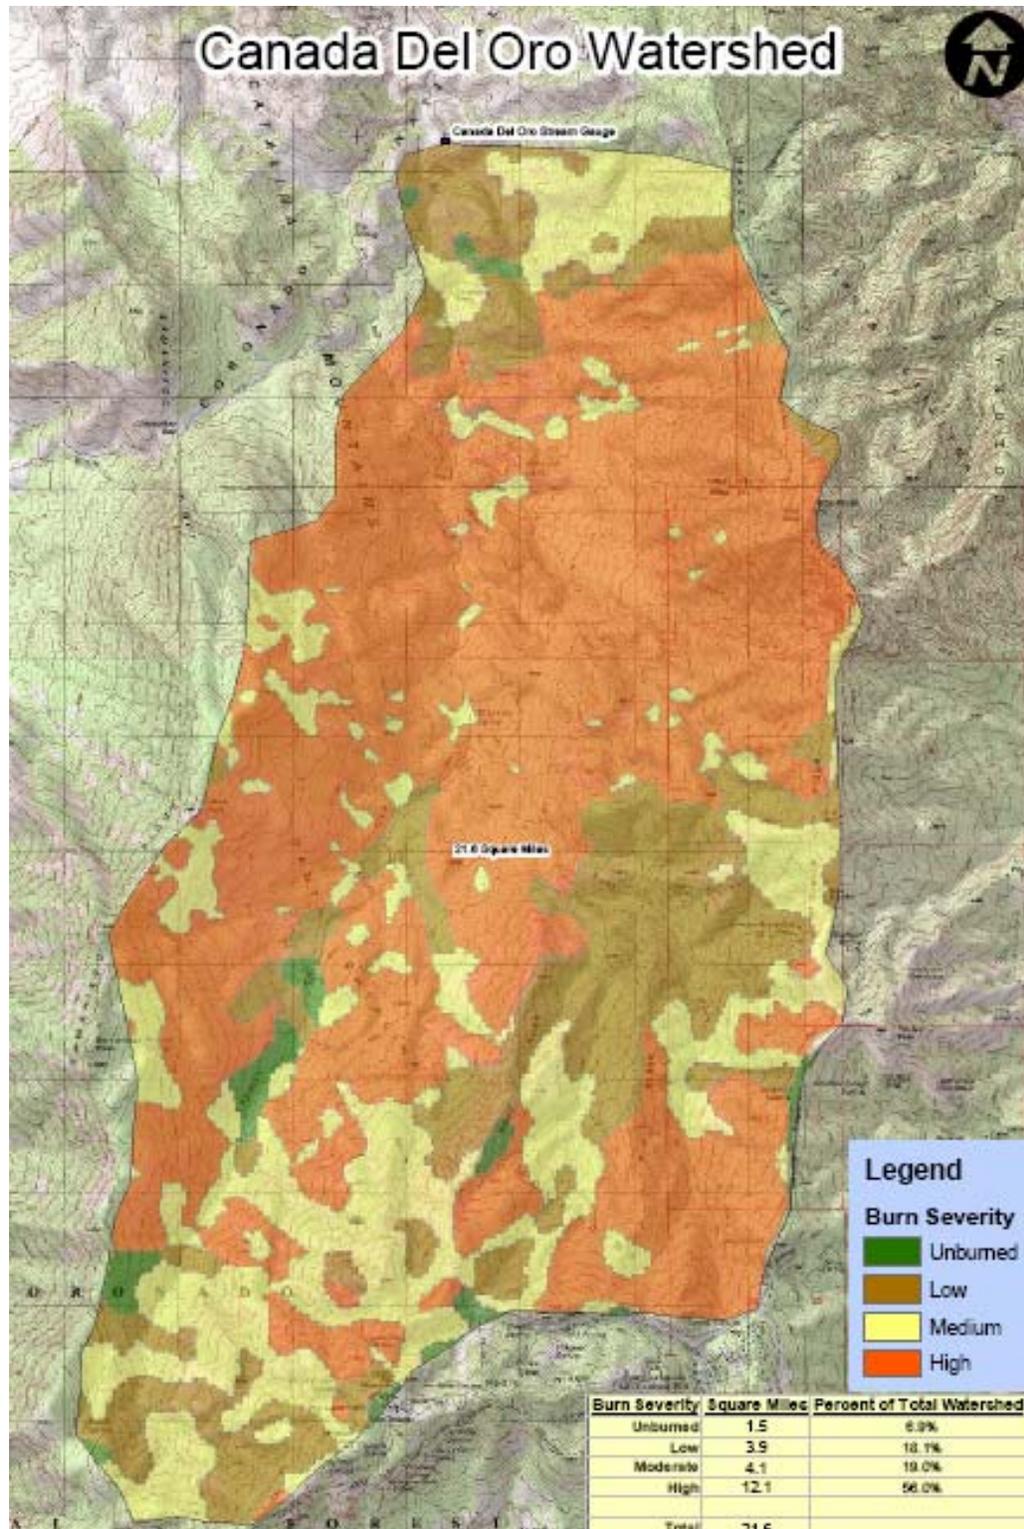
Figure 4: Cañada del Oro Watershed. Watershed shown with their burn severity and location of Pima County Flood Control stream gauge at outlet. Image created on October 7, 2004 and courtesy of Barry Scott of AZ DEM using data from US Forest Service.

On July 23, 2004, 1.14 inches fell within an hour in the Cañada del Oro near Coronado Camp watershed ([figure 4](#)). This is a 21.6 square mile watershed with a mean basin elevation of 6,675 feet, which contains 56% high severity and 19% moderate severity burn. A Pima County Flood Control ALERT stream gauge located on Cañada del Oro near Coronado Camp recorded 1,450 cfs ([table 3](#)). According to the NOAA Atlas 14 (2004), the rainfall had a frequency of a 2-year one-hour event. The resultant flash flood equates to approximately a 40-year pre-burn flood. This amounts to a burn area post-burn runoff 6.5 times greater than runoff during pre-burn conditions.

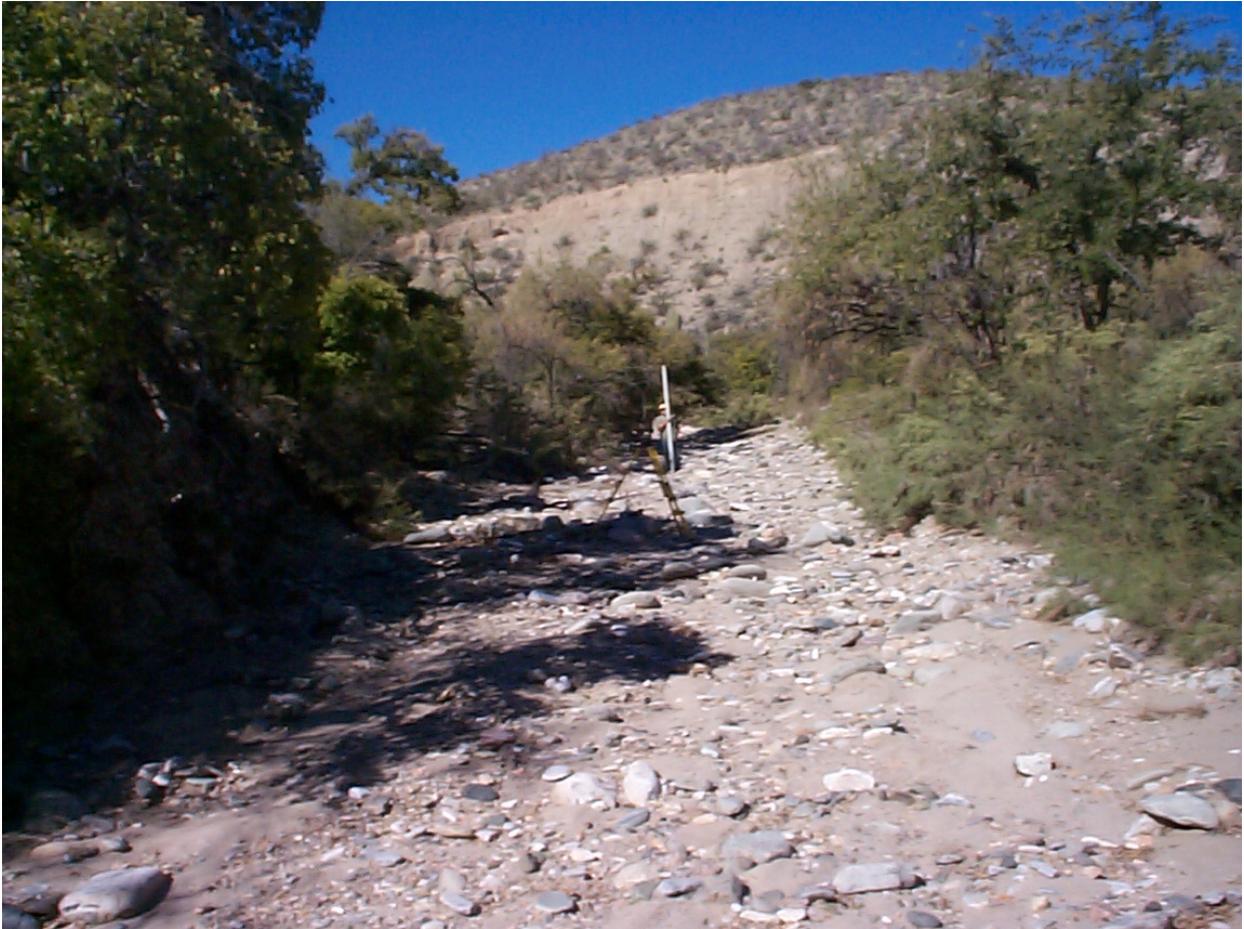
Figure 5: Alder Canyon near Ventana Windmill. Photo taken in center of channel in slope conveyance cross section looking upstream. William Reed holding survey rod 100 feet upstream for scale.

Alder Canyon near Ventana Windmill is a 15 square mile watershed with a mean basin elevation of 5,980 feet. On July 29, 2003, 1.60 inches fell in about an hour. The authors conducted a slope conveyance along Alder Canyon near Ventana Windmill ([figure 5](#)). A slope conveyance is a simple indirect discharge measurement. Unlike a slope-area measurement where multiple cross sections are used, slope conveyance utilized one cross section and the slope of the channel. The survey was conducted on November 2, 2004. The peak flow was calculated as 3,103 cfs +/- 10 percent. According to the NOAA Atlas 14 (2004), the rainfall had a frequency of a 5-year one-hour event. The resultant flash flood equates to approximately a 25-year pre-burn flood ([table 4](#)). This amounts to a burn area post-burn runoff 2.5 times greater than runoff during pre-burn conditions.

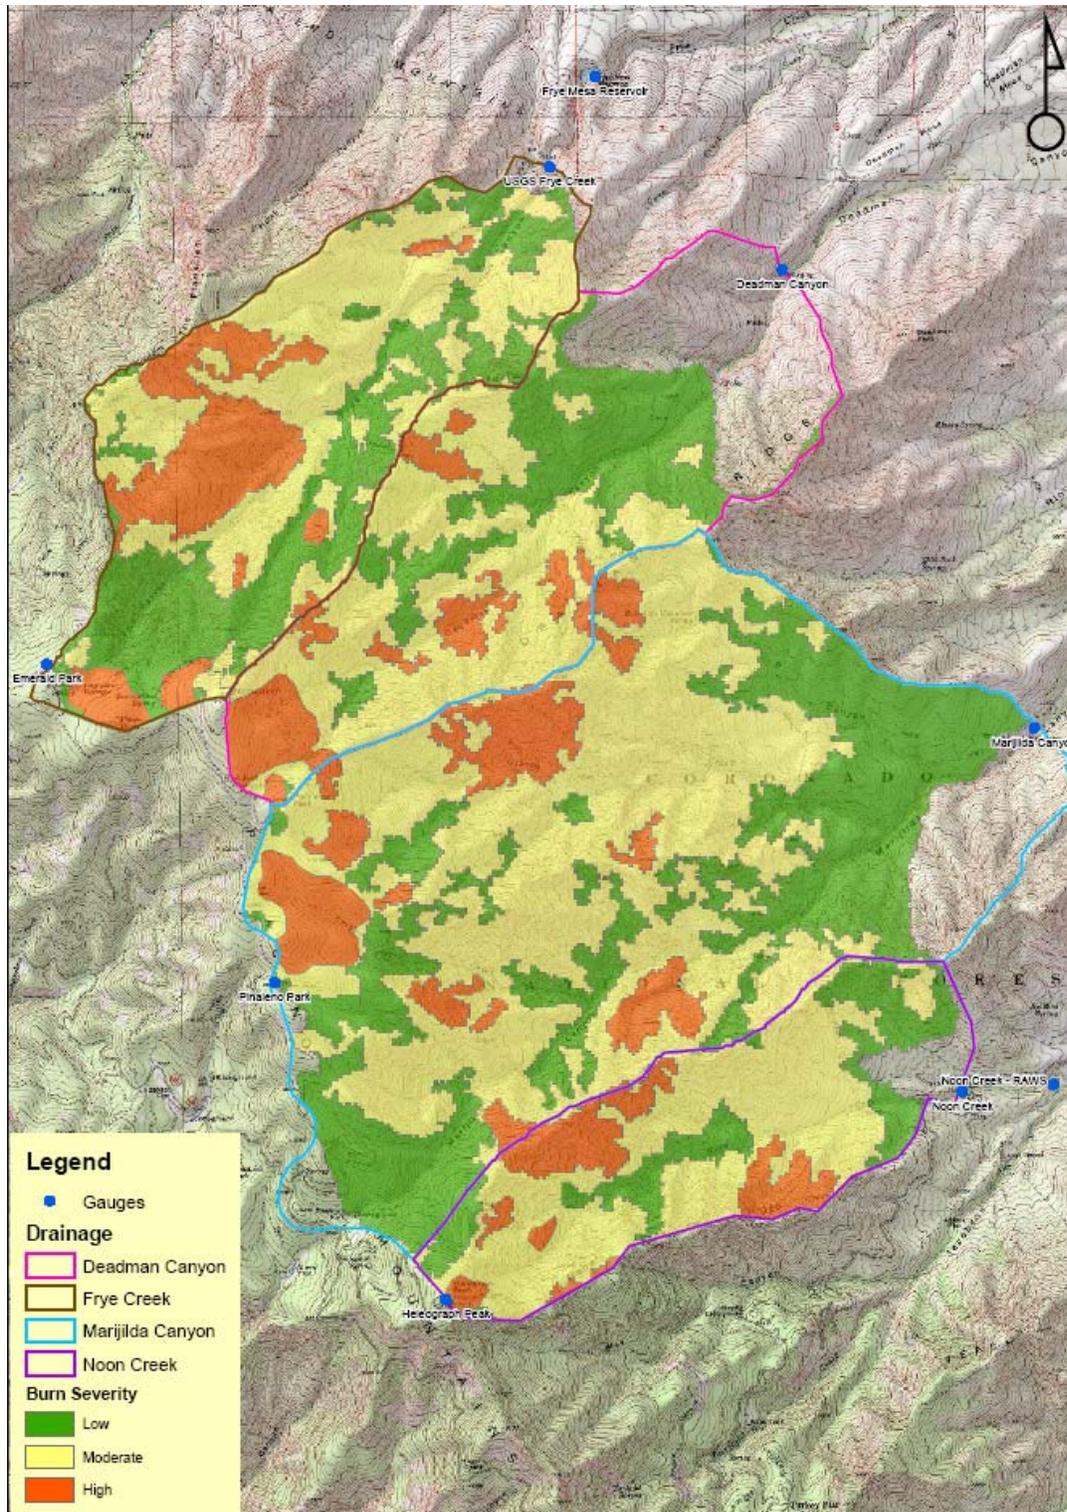
Figure 6: Southern half of the Nuttall Complex burn area. Several study watersheds are shown with their burn severity and gauge locations. Image created on September 21, 2004 and courtesy of Barry Scott of AZ DEM using data from US Forest Service.

During late June and early July 2004, the Nuttall and Gibson Fires began on the Pinaleno Mountains in Graham County. They merged into what is known as the Nuttall Complex Fire that burned 29,725 acres ([table 5](#)). The Nuttall Complex burned the majority of four watersheds ([figure 6](#)) and the upper reach of Wet Canyon south of Noon Creek. All of these are relatively small watersheds and are located on a northward facing flank of the Pinaleno Mountains. Burn severity is a patchwork with moderate burn severity dominating ([table 6](#)).

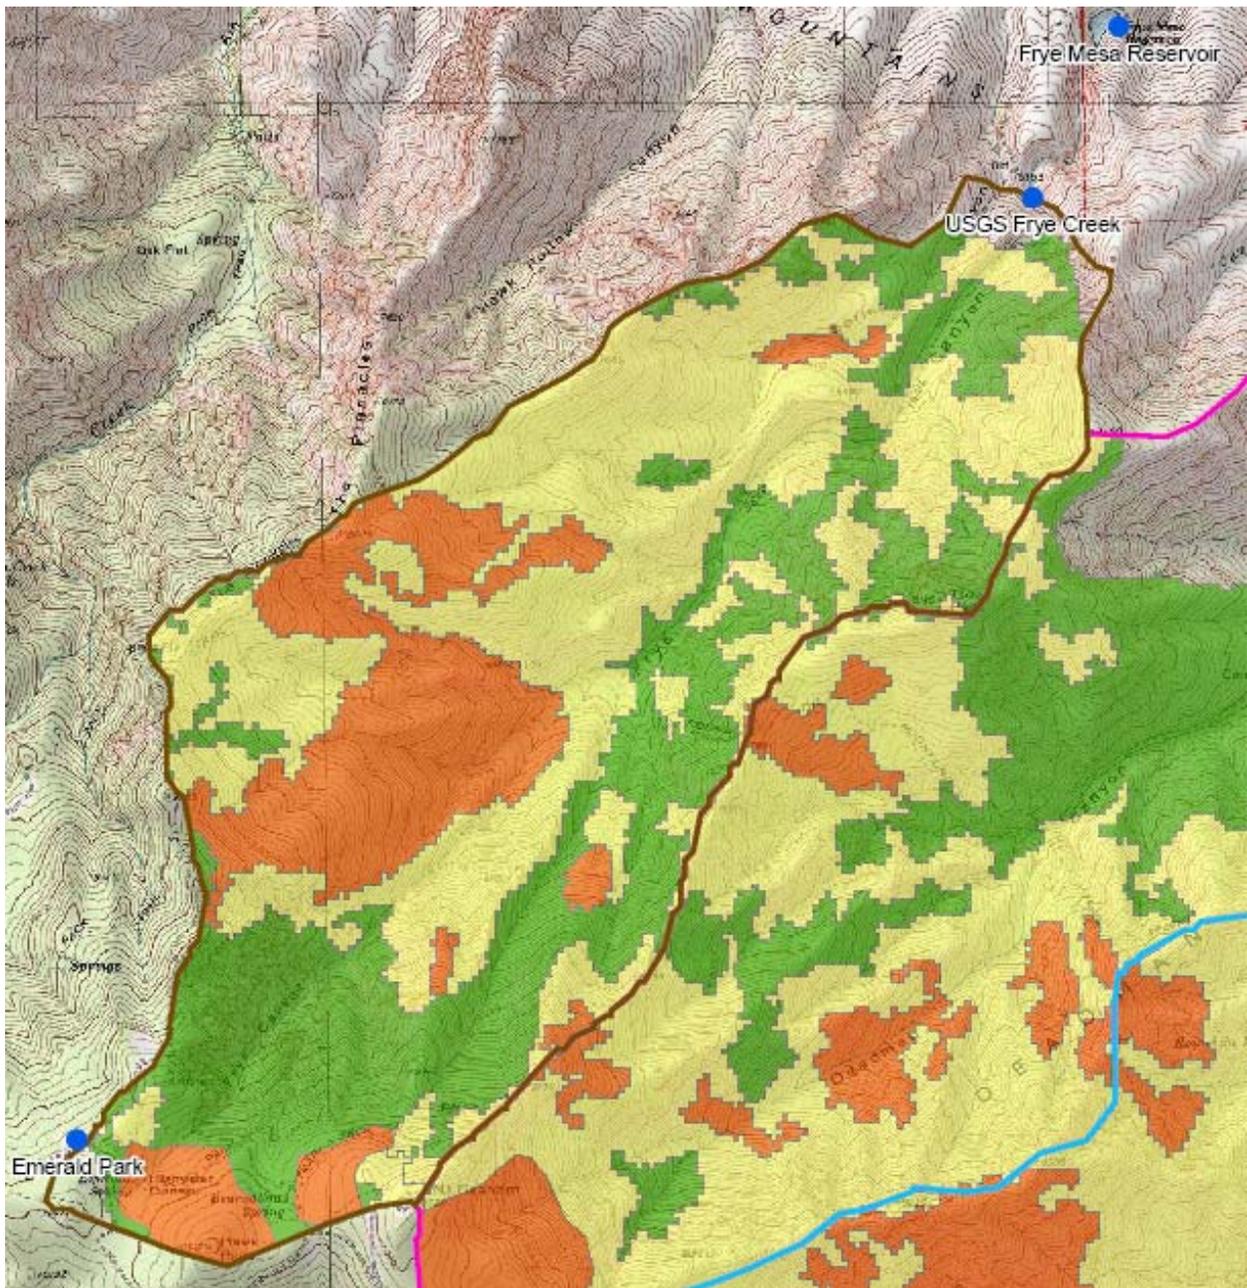
Figure 7: Close-up of Frye Creek watershed outlined in brown. Location of Emerald Park rain gauge and USGS stream and rain gauge shown as blue dots.

Frye Creek is a 4.02 square mile watershed with a USGS stream gauge situated at an elevation of 5,580 feet ([figure 7 and 8](#)). It has a mean basin elevation of 8,400 feet. Close to its headwaters is an automated rain gauge at Emerald Park situated at an elevation of 10,350 feet. Events occurred on July 27, 2004, August 4, 2004, and August 17, 2004 ([table 7](#)). These events were characterized by a significant amount of debris entrainment and characteristic dark grey to black color from ash ([figure 9 and 10](#)). Analysis of precipitation frequencies for each event in comparison to USGS return flows shows that events with rather typical precipitation frequencies are capable of producing significant return flows many orders of magnitude greater than would have been expected in pre-burn conditions ([table 8 and 9](#)).

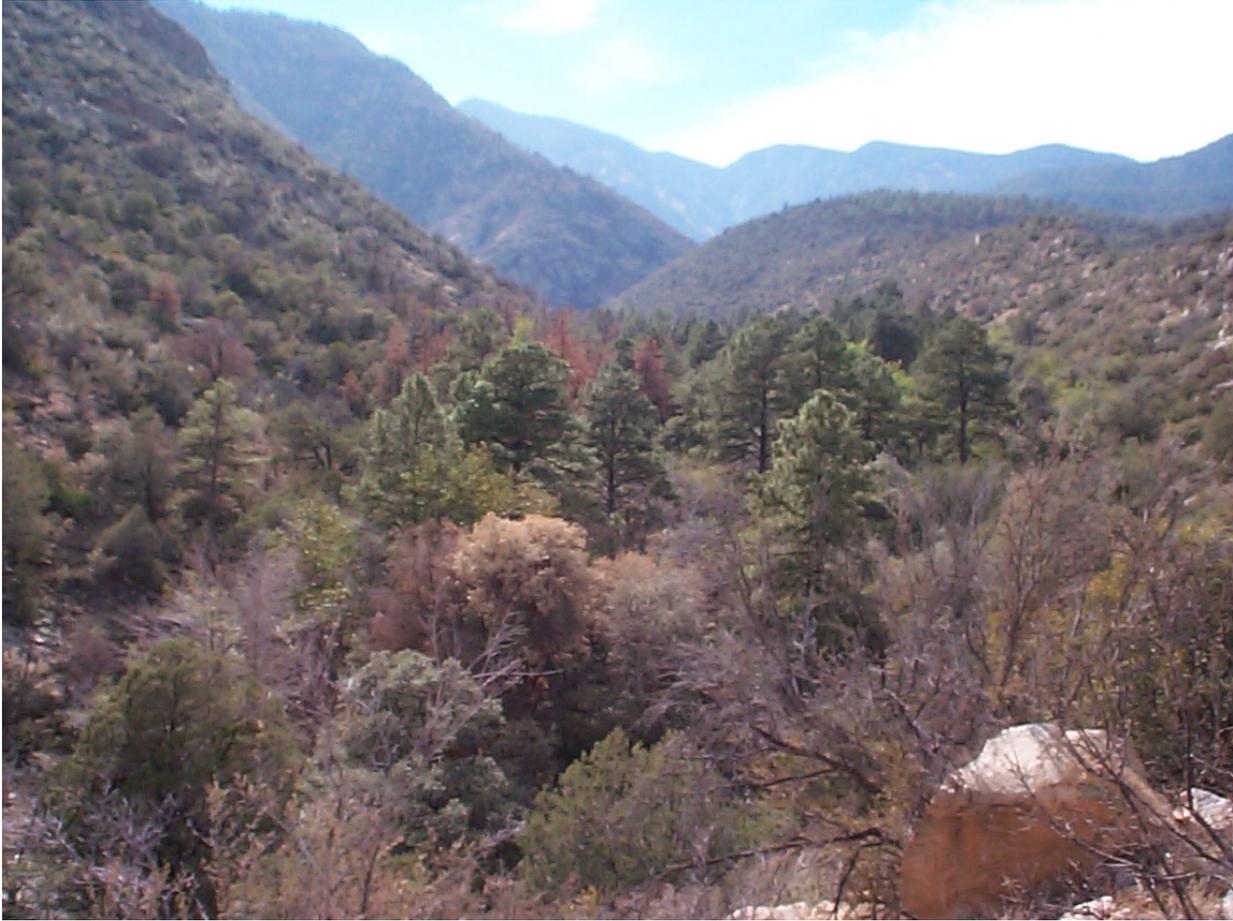
Figure 8: View above gauge looking upstream towards headwaters. Rugged and steep terrain of the Pinaleno Mountains is clearly visible. Photo taken prior to fires in 2003.

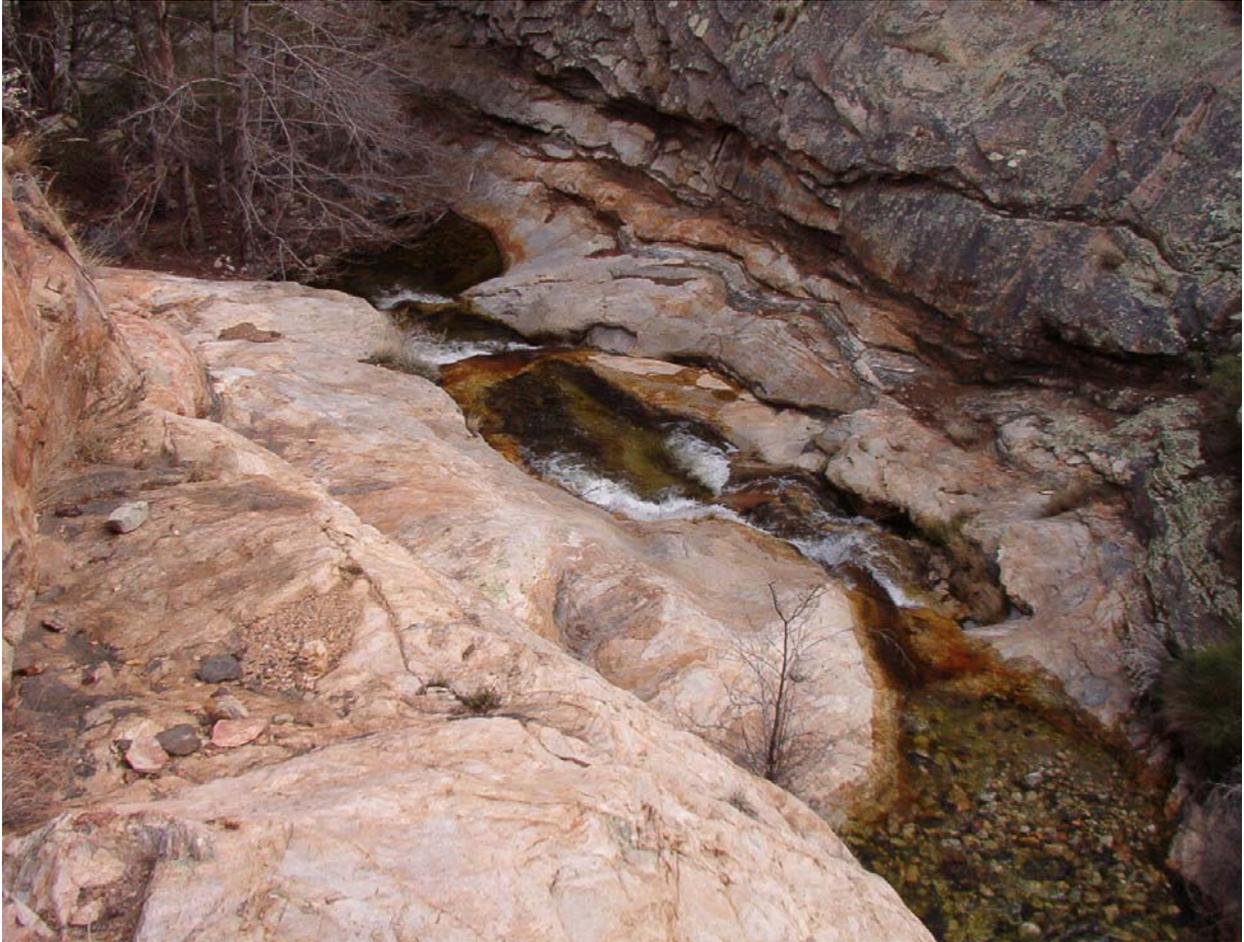
Figure 9: Frye Creek just downstream of gauge. Photo taken on the morning of August 4, 2004 prior to flow event. Note clear water. Photo courtesy of USGS.

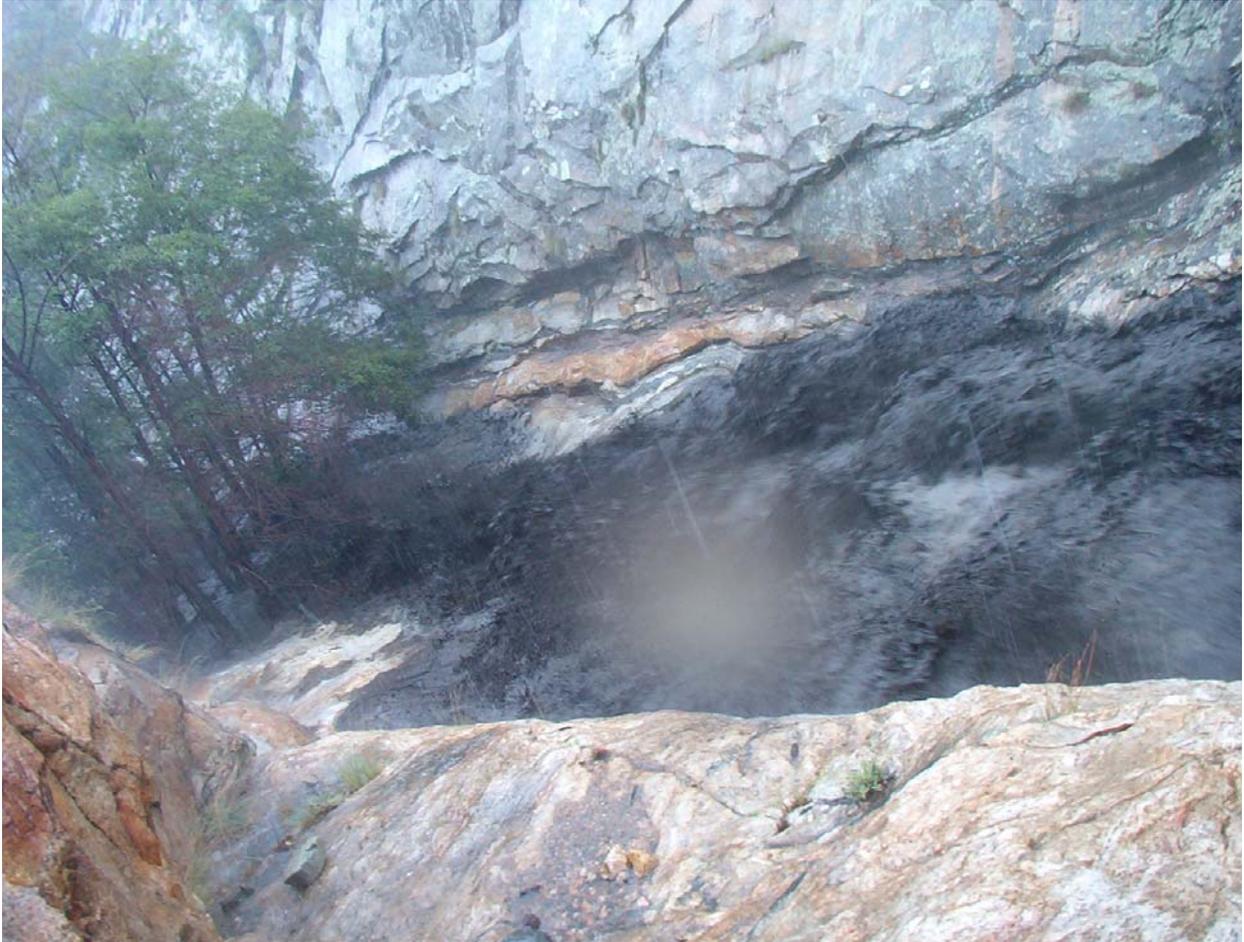
Figure 10: Frye Creek just downstream of gauge. Photo taken during August 4, 2004 flow event. Note black color of water due to ash. Photo courtesy of USGS.

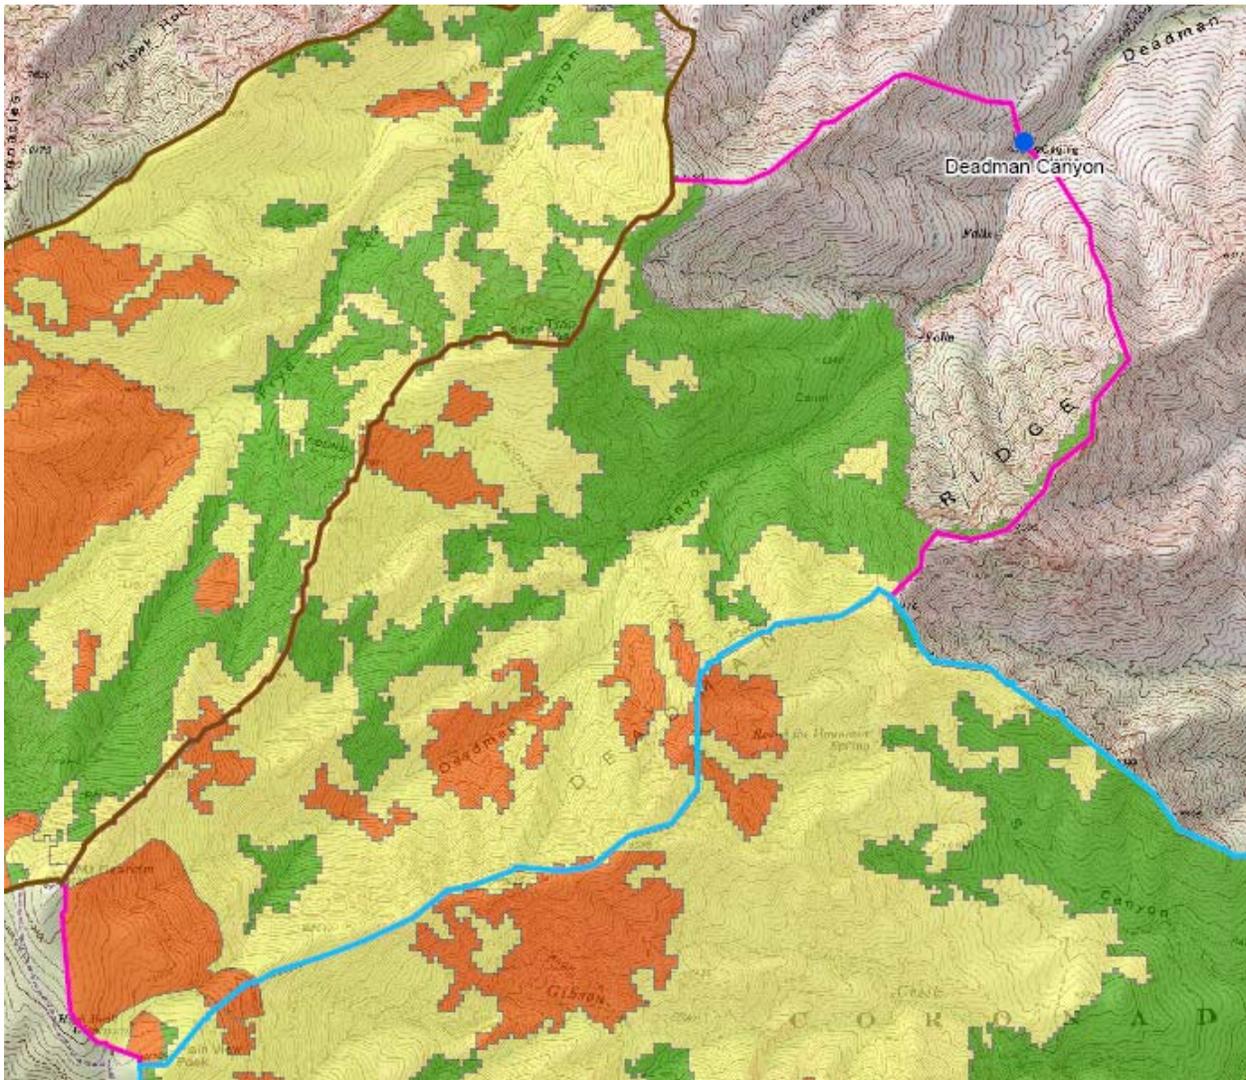
Figure 11: Close-up of Deadman Canyon watershed outlined in pink. Location of ALERT stream gauge shown as blue dot.

Deadman Canyon is a 4.78 square mile watershed with a discontinued USGS stream gauge situated at an elevation of 4,950 feet ([figure 11 and 12](#)). It has a mean basin elevation of 7,500 feet. The site was reoccupied as an ALERT stream and rain gauge following the fires.

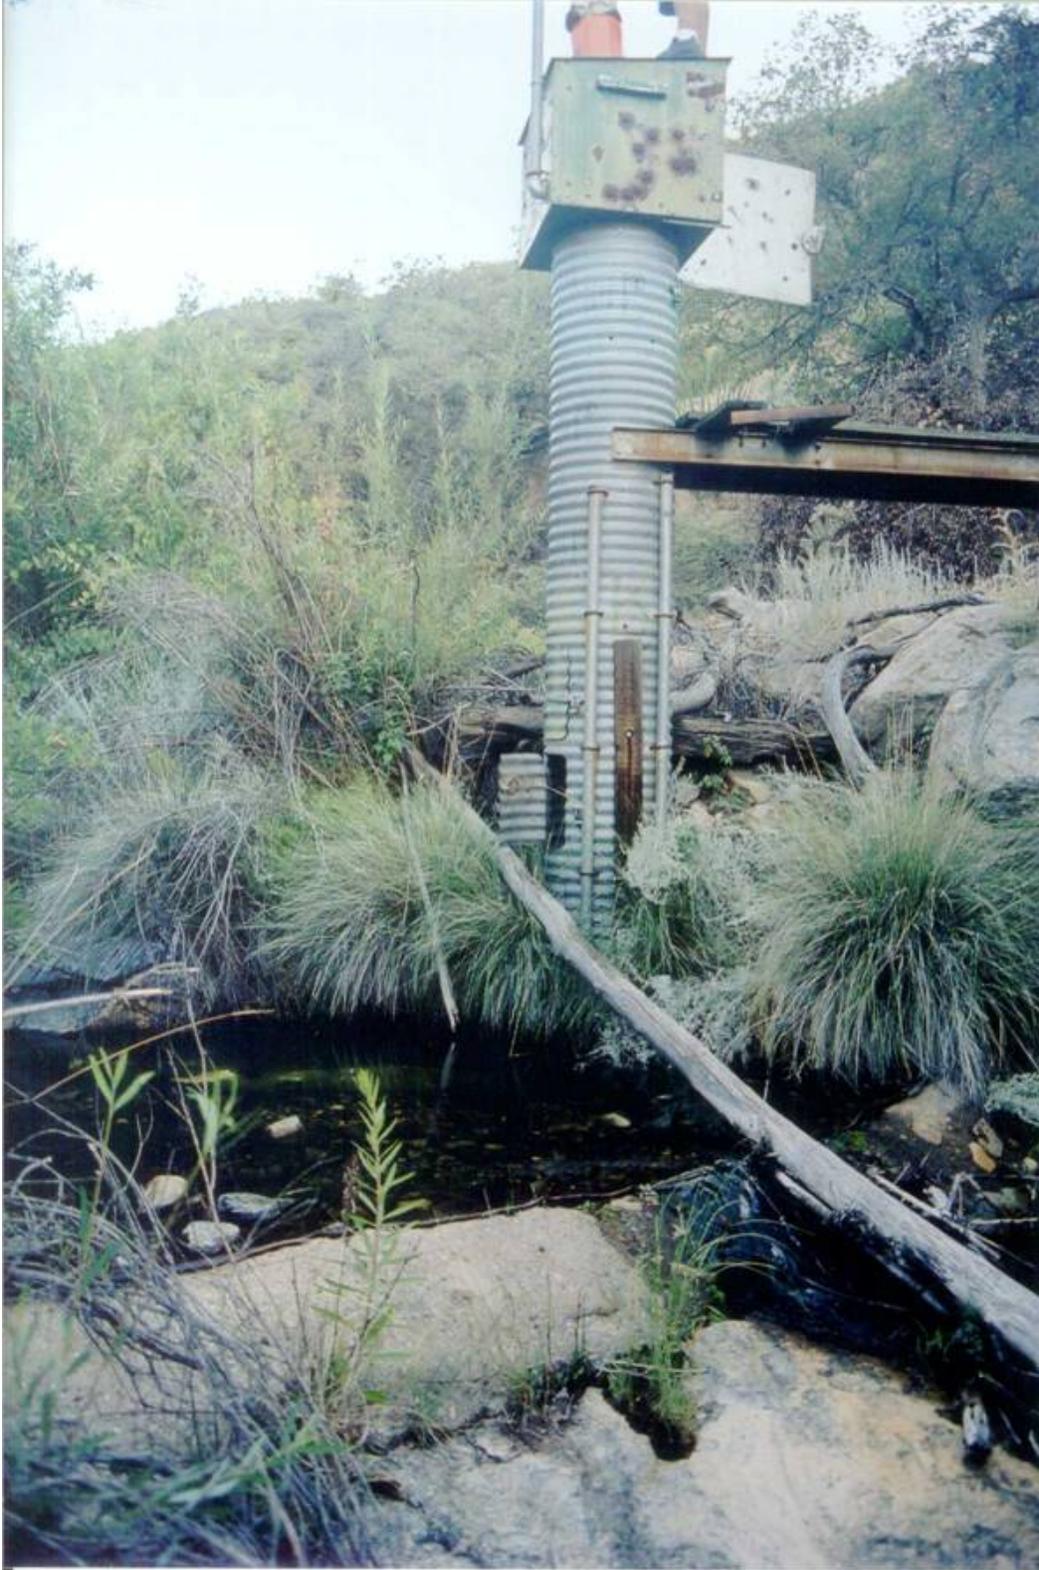
Figure 12: Discontinued USGS site on Deadman Canyon being reactivated as an ALERT gauge. Photo taken on June 26, 2004. Photo courtesy of JE Fuller Hydrology.

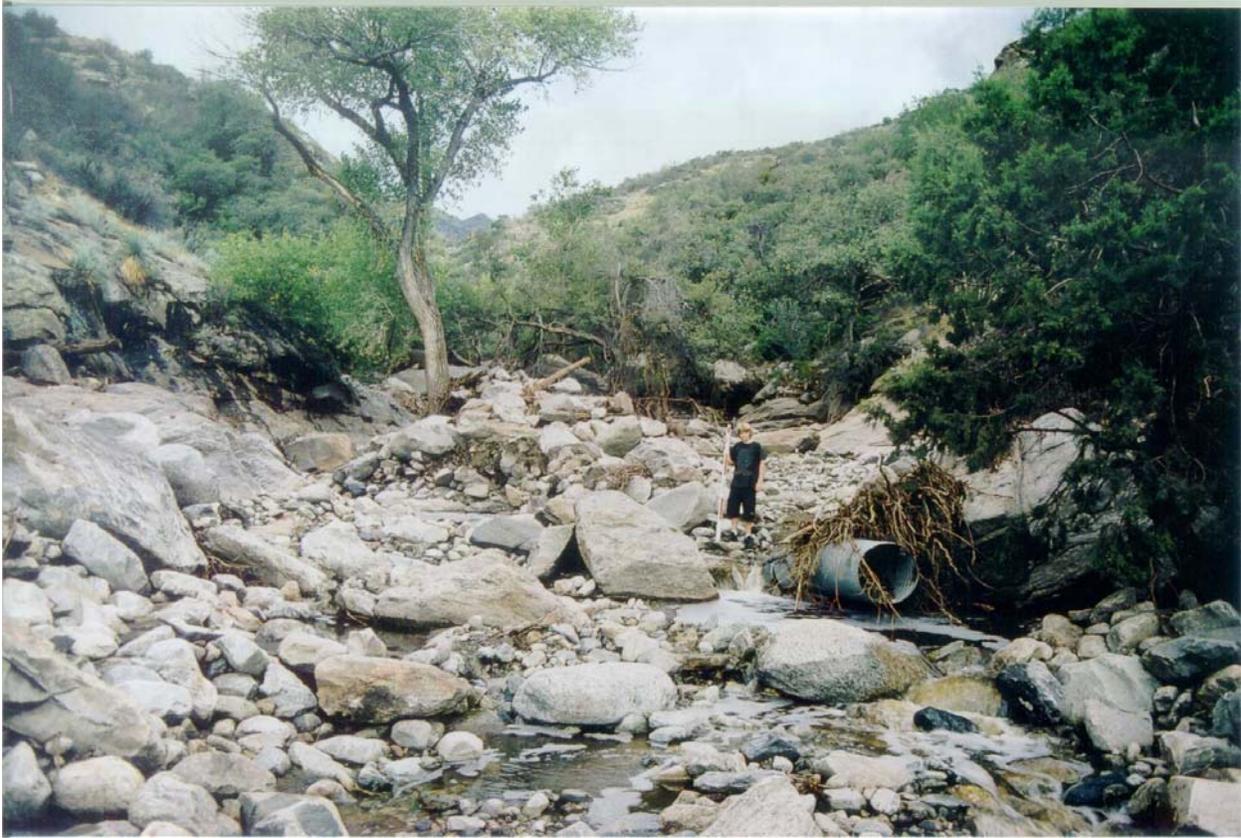
Figure 13: Looking up Deadman Canyon from USGS gauge site. One right is portion of the stilling well. Photo taken on August 27, 2004. Photo courtesy of JE Fuller Hydrology.

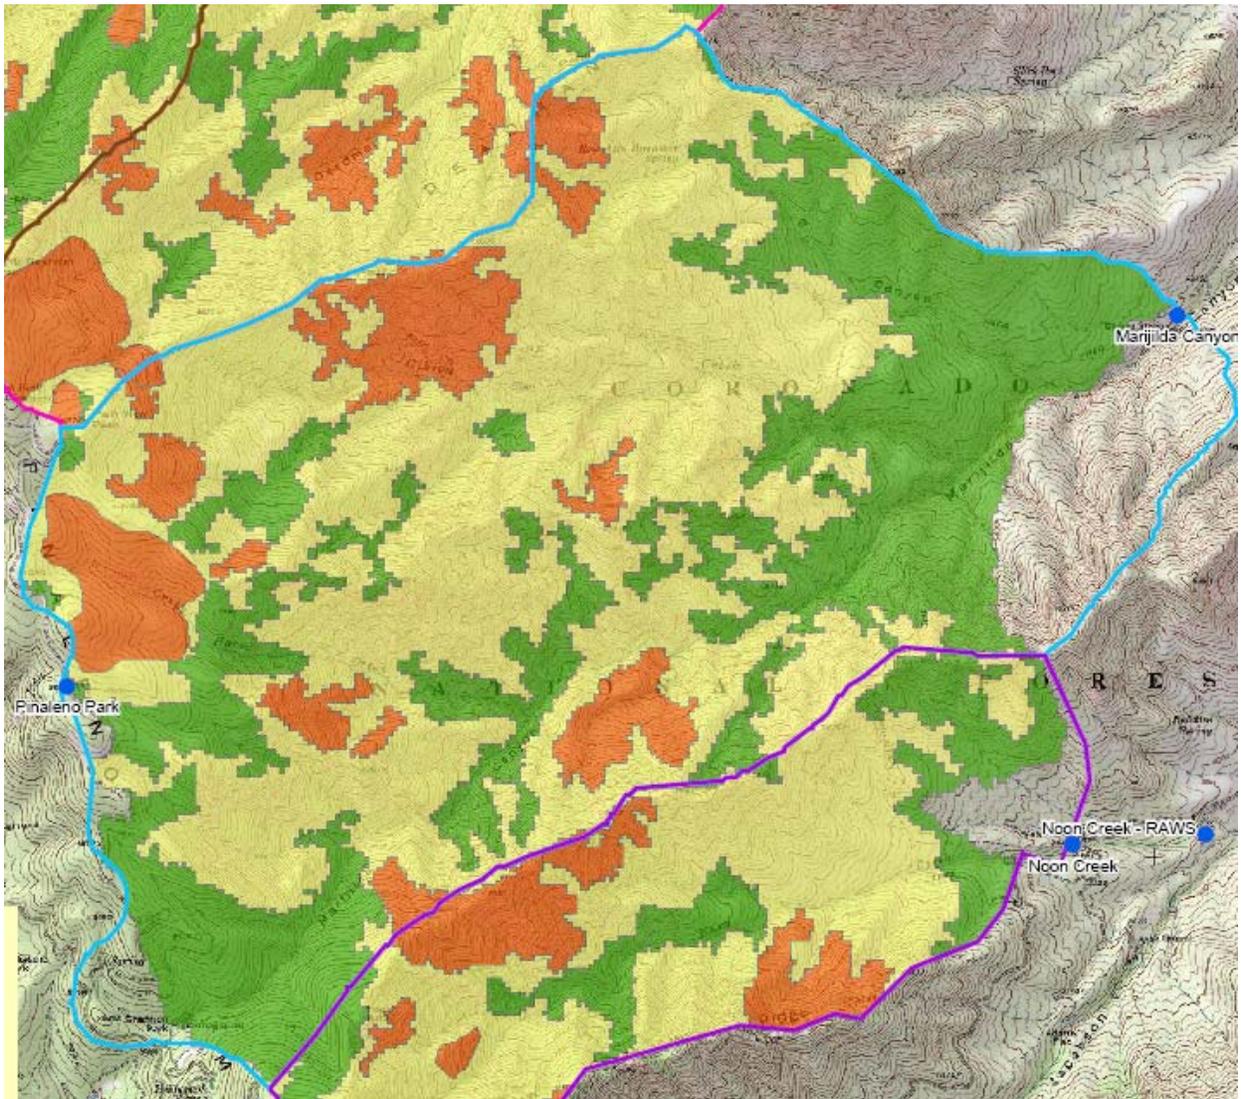
Figure 14: Close-up of Marijilda Canyon watershed outlined in light blue. Location of ALERT stream gauge and former USGS site shown as blue dot labeled Marijilda Canyon. Pinaleno Park is an ALERT rain gauge located at the headwaters.

Marijilda Canyon is an 11.00 square mile watershed with a discontinued USGS stream gauge site situated at an elevation of 4,400 feet ([figure 14](#)). It has a mean basin elevation of 6,500 feet. An ALERT stream and rain gauge was placed several hundred feet downstream of this site following the fires. An ALERT rain gauge was placed in the headwaters at Pinaleno Park situated at an elevation of 10,117 feet.

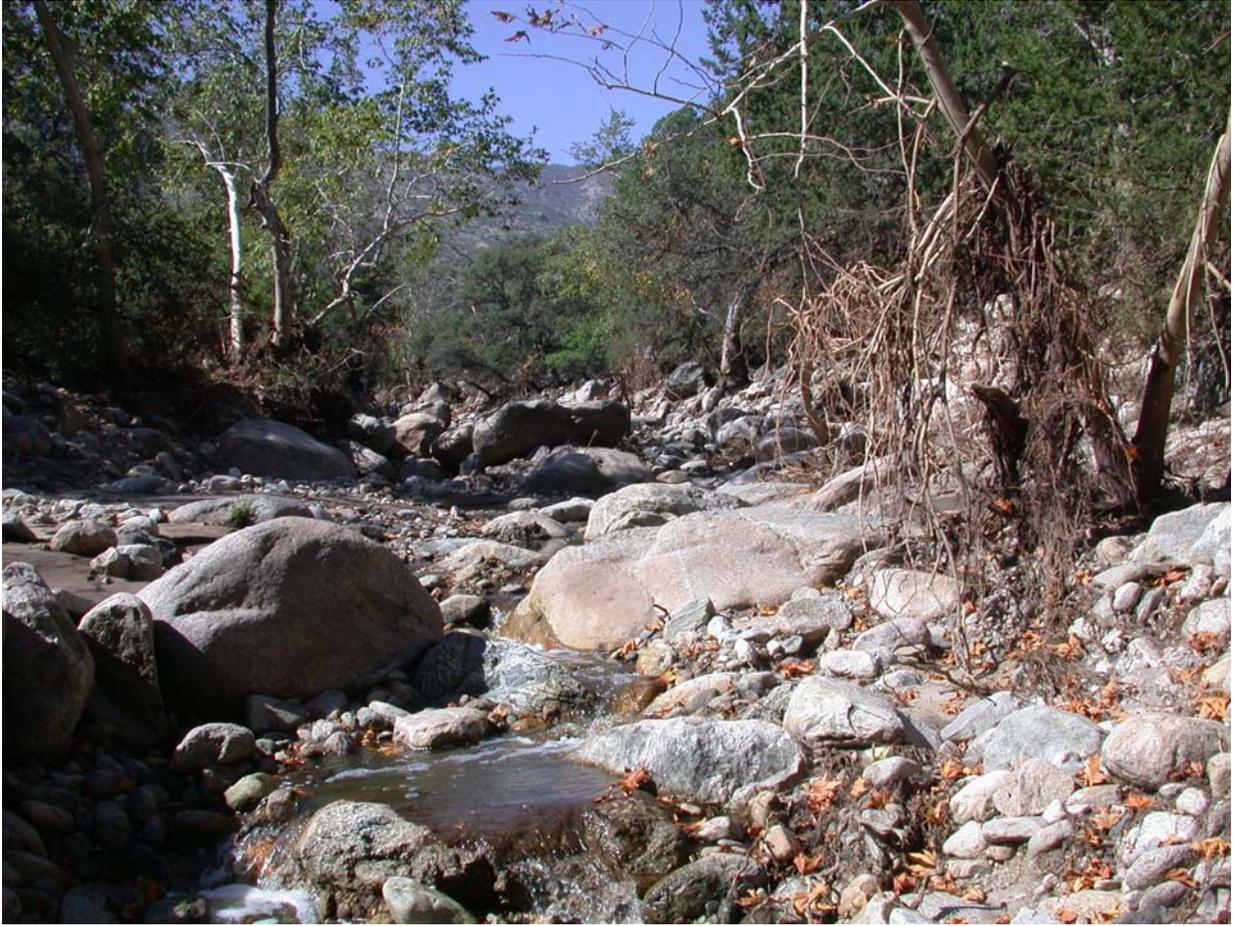
Figure 15: Marijilda Canyon slope area reach looking upstream. Photo taken on August 31, 2004 and courtesy of USGS.

Shortly after the flash flood event, NWS Tucson partnered with the USGS to perform a slope-area measurement. Slope-area is an indirect discharge measurement used by the USGS when it is impractical to directly measure peak discharge. Slope-area has been used before, by the USGS, to document post-burn flow events in southeast Arizona (Schaffner, 2003). The slope-area reach was located a quarter mile downstream from the ALERT gauge at an elevation of 4,200 feet ([figure 15](#)).

The drainage area is approximately the same since ridges border the canyon on either side with no significant tributaries in between. The reach selected was about 300 feet long and contained five surveyed cross-sections. The channel is steep and rocky with 15 to 20 feet of fall within it. Numerous trees were bent over by the force of the flow. Several trees withheld and collected debris. At least one tree was removed by flood waters. Only the stump remains. High water marks were generally well defined by

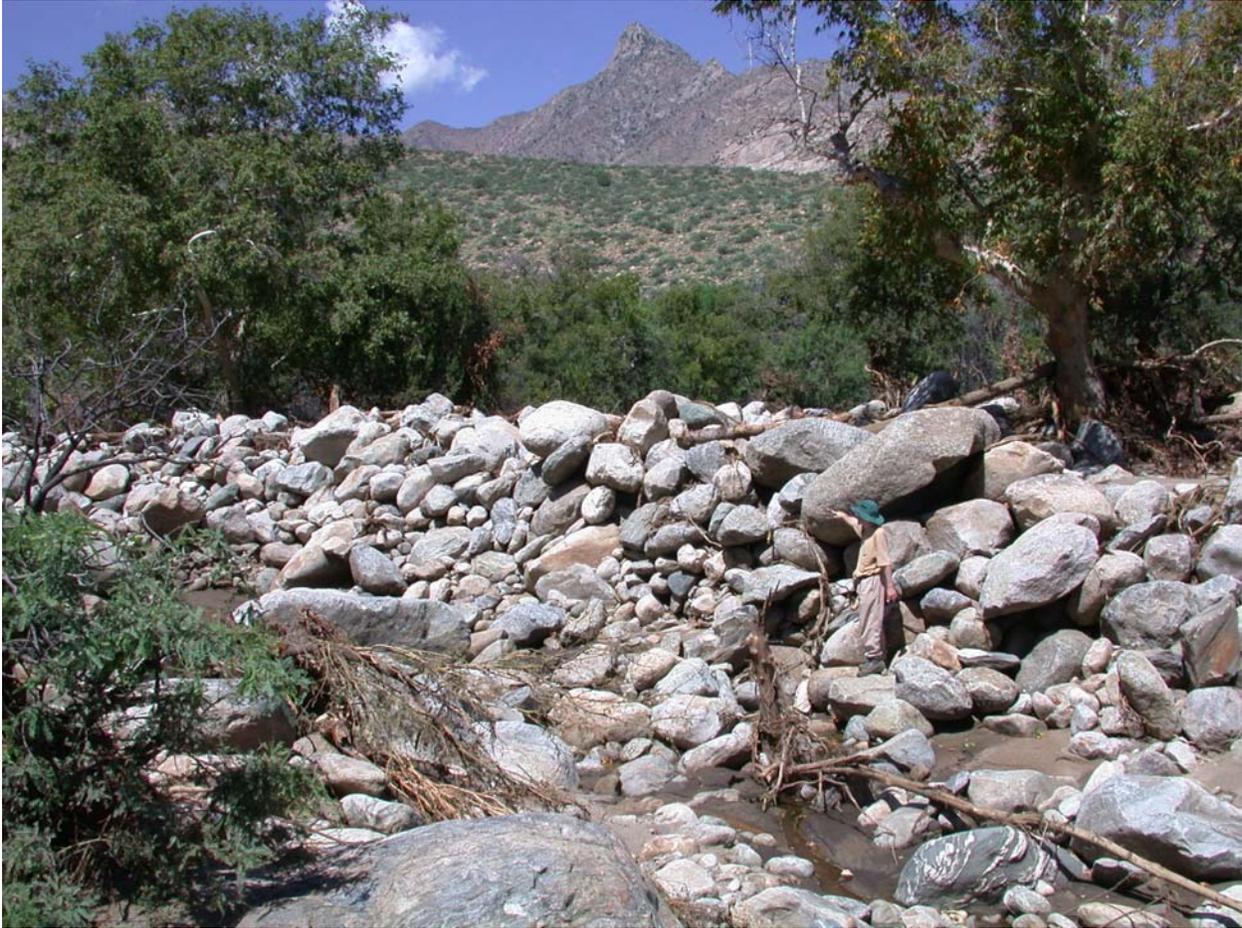
Figure 16: View of boulder deposit in Marijilda Canyon about a quarter mile downstream from slope area reach. Photo taken on August 30, 2004 and courtesy of USGS. Tucson WFO Service Hydrologist, Mike Schaffner, for scale.

debris. The main channel contained 8 to 10 feet water depth. An overflow channel on right bank was up to three feet deep. Those cross sections that had both main channel and an overflow channel were subdivided. Another quarter mile downstream from the slope-area reach, an impressive pile of boulders was seen (figure 16). In the same area, large debris piles were noticed.
