Effects of Wildfire in the Mountainous Terrain of Southeast Arizona: Post-Burn Hydrologic Response of Nine Watersheds

ABSTRACT:

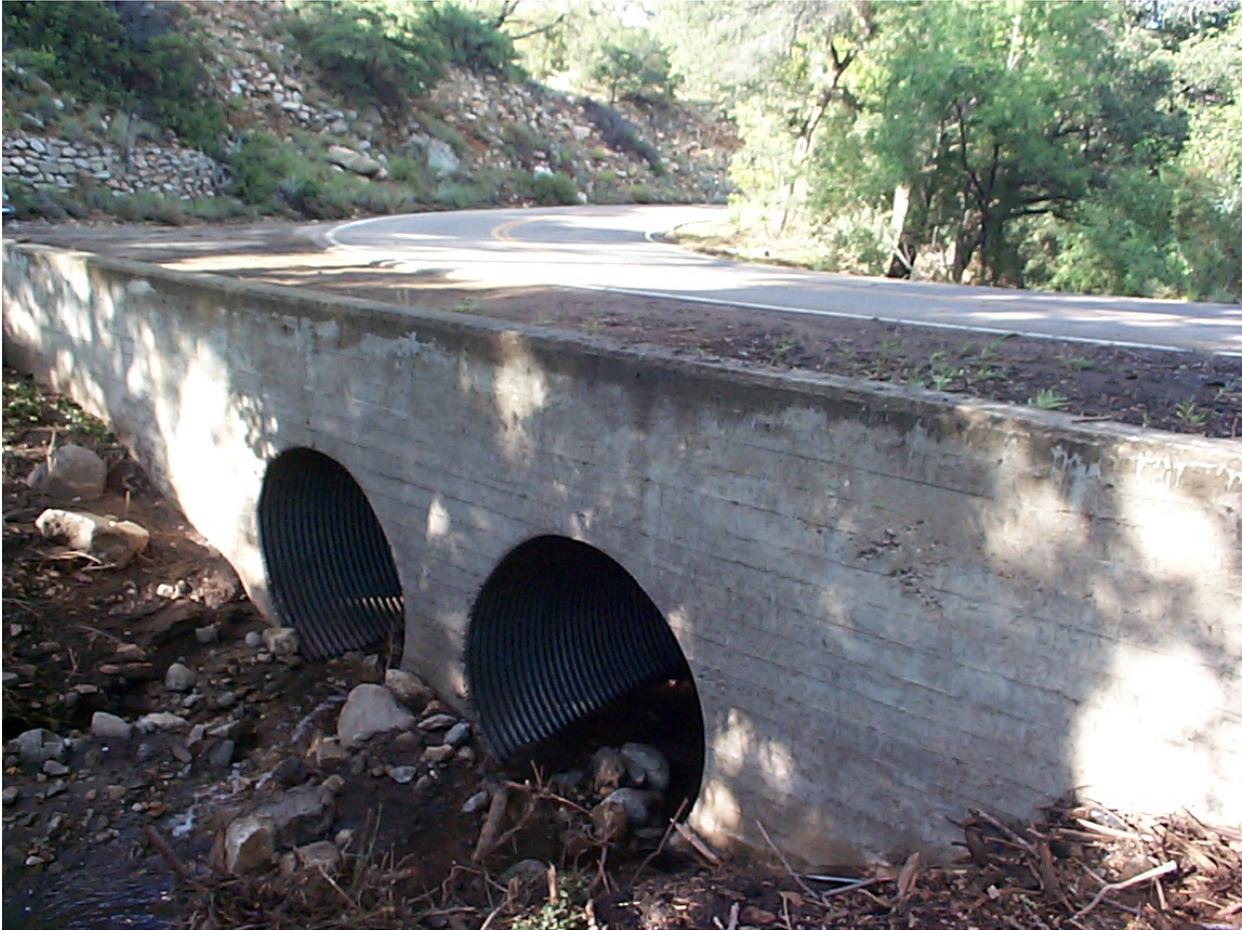
Figure 18: Noon Creek at Highway 366. ALERT pressure transducer located near base of right culvert.

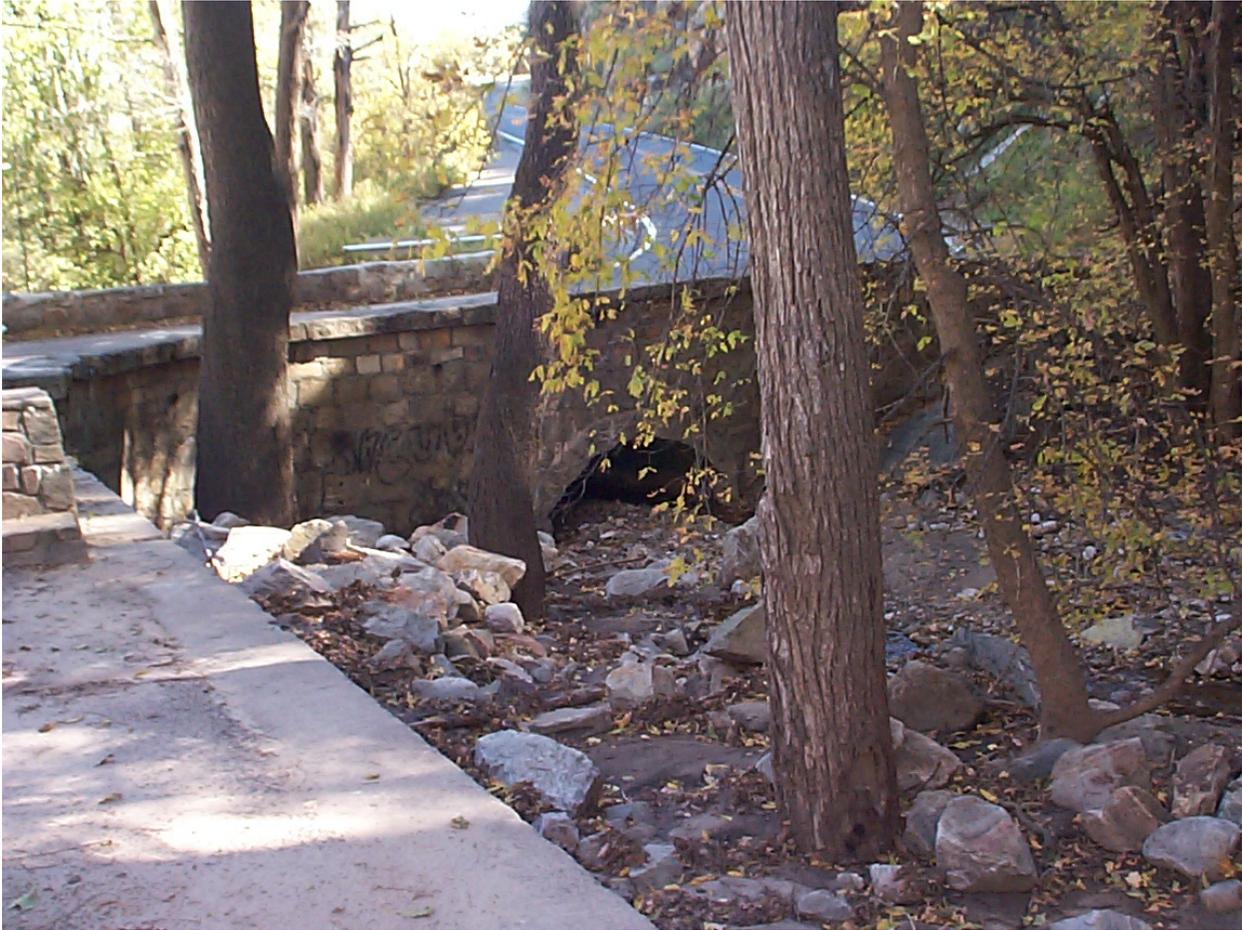
Figure 19: Wet Canyon at Highway 366. Photo taken upstream on left bank looking downstream towards Highway 366 bridge.

Wet Canyon is a 1.57 square mile watershed where it crosses Highway 366 at an elevation of 6,170 feet (figure 19). On August 17, 2004, 0.80 inch basin average precipitation fell in about an hour. On November 4, 2004, the authors conducted a slope conveyance where Wet Canyon crosses Highway 366. The peak flow for the August event was calculated as 1,490 cfs +/- 10 percent. Such a flow would be in the range of a 100-year return flow (table 13). Basin average precipitation frequency for Wet Canyon event amounts to a 2-year event. This is a post-burn peak discharge increase of at least 146 times greater than pre-burn peak discharge.

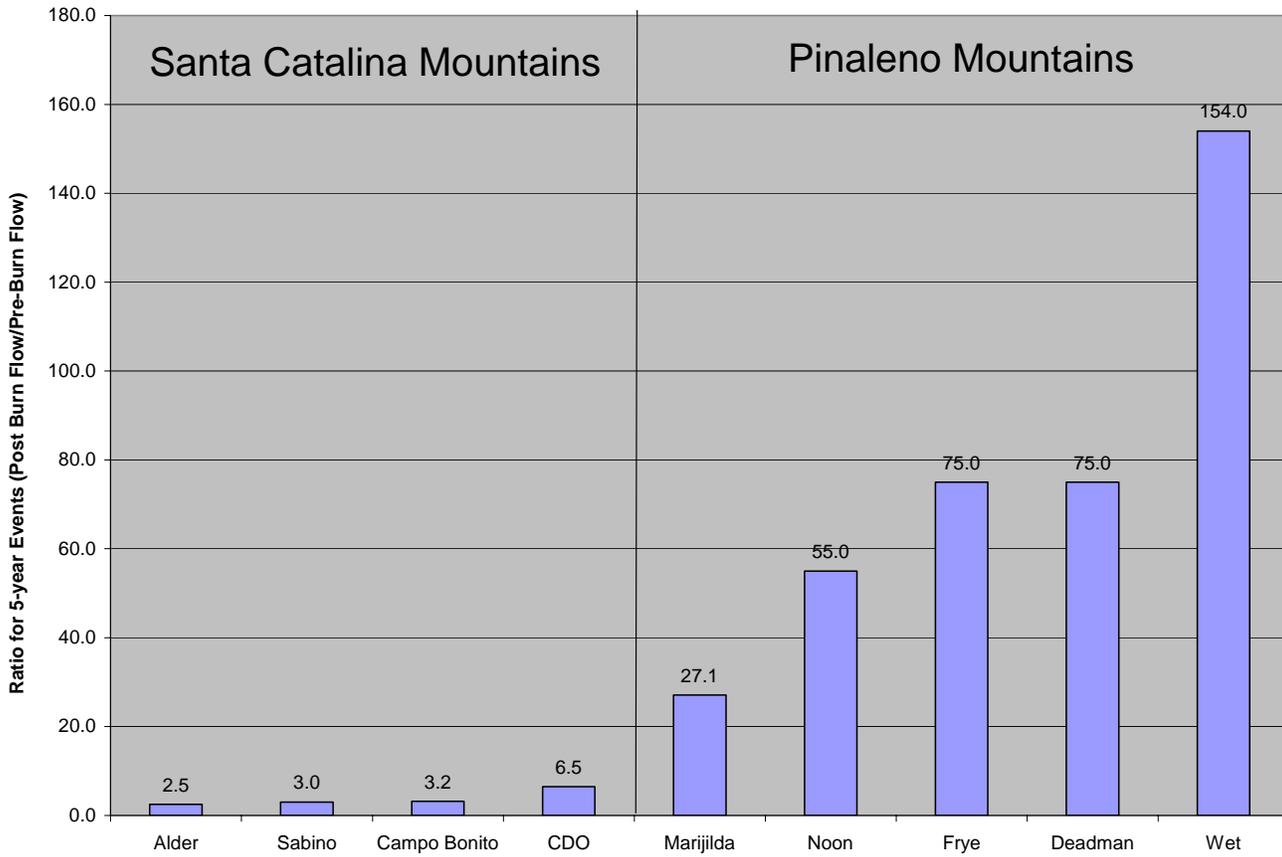
Graph 1: Basin Response under burn conditions for various watersheds in the Santa Catalina and Pinaleno Mountains.

to 3 times greater for the watersheds in the Pinaleno Mountains. This has produced post-burn flows originating from the Pinaleno Mountains 5 to 18 times greater than those of the Santa Catalina Mountains ([graph 1](#)).
