Western Region Technical Attachment
No. 07-06
May 14, 2007

**Flood and Precipitation Frequency of the September 13, 2006 Flash
Flood in Railroad Wash through Indirect Discharge Estimates**

Glenn Lader, NOAA/NWS Forecast Office Tucson, Arizona

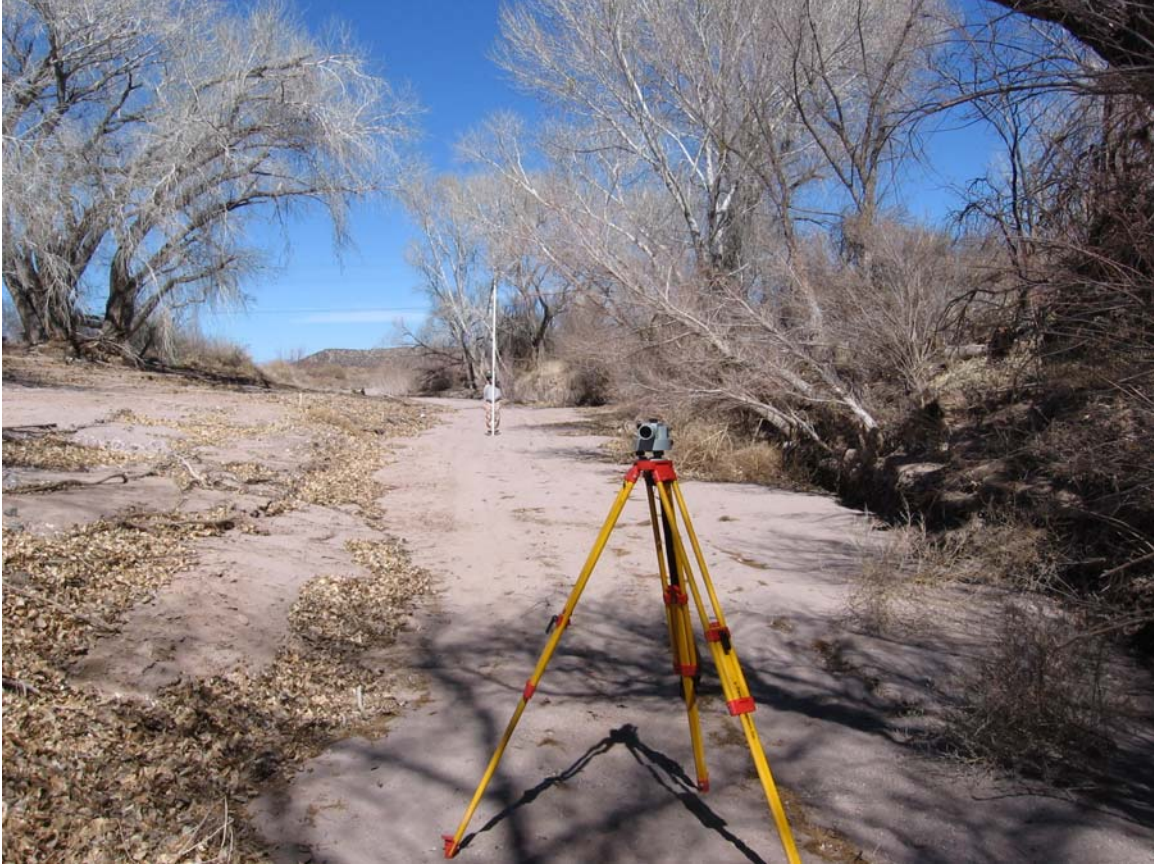
Figure 6: View looking downstream in low flow channel of Railroad Wash. Distance between cross sections was 100 feet, the same distance between the survey equipment as shown in the foreground and the survey rod in the distance. This was also the methodology used to determine channel slope.

Since a suitable reach was found with useful high water marks, the USGS slope-area method was used to compute a peak discharge for this flash flood event (Dalrymple and Benson, 1967). At Railroad Wash, appropriate locations were first determined to use as cross sections. Using the slope-area method, the distance between each cross section should be at least as wide as the channel. In this case an estimate was made that the channel reach was 400 feet long and 100 feet wide. As a result, there were four cross sections placed 100 feet apart (Figure 6.) Once the cross sections are determined a common benchmark should be found and used as a reference point for all the cross sections. This enables the surveyor to determine the height difference between the high

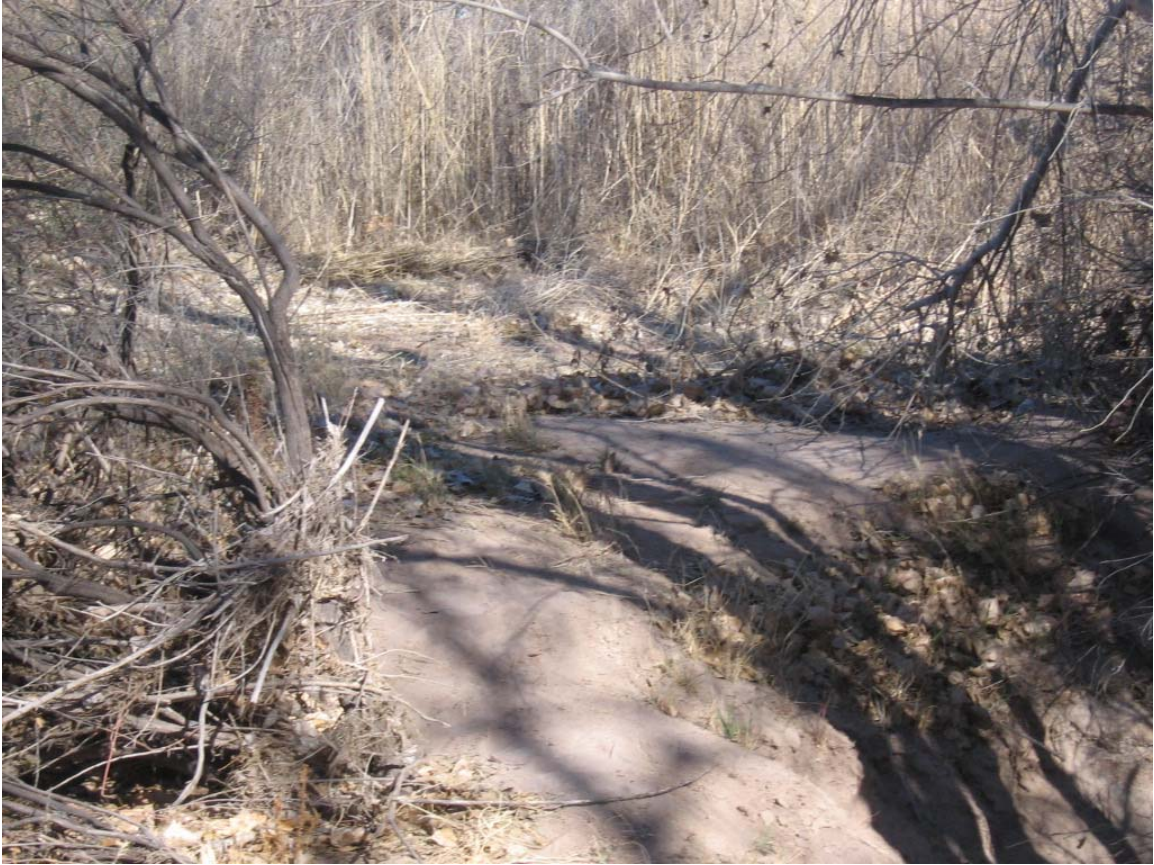
Figure 7: Example of high water mark on right bank of Railroad Wash. Note debris pushed up against tree on left side of picture.

water marks which also approximates the water surface slope at peak discharge. Within each cross section, the wetted perimeter, or distance between high water marks (Figure 7) averaged 125 feet. It is best to take distance measurements relative to the high water mark along the channel bed often, especially at natural breaks in the channel (Figure 8). Depth at each break in the channel is calculated using survey equipment. The high water marks were generally 10 feet above the low flow channel at each cross section with a gentle slope of 0.3 feet/100 feet distance between cross sections. A determination of Manning's Roughness Coefficient must also be determined at each cross section. Given that the channel characteristics were nearly identical at each cross section, with 80% mostly sand and small cobble matrix with the other 20% consisting of denser vegetation, a weighted Manning's Roughness value (N) of 0.037 was used at all cross sections (Phillips and Tadayon, 2006).

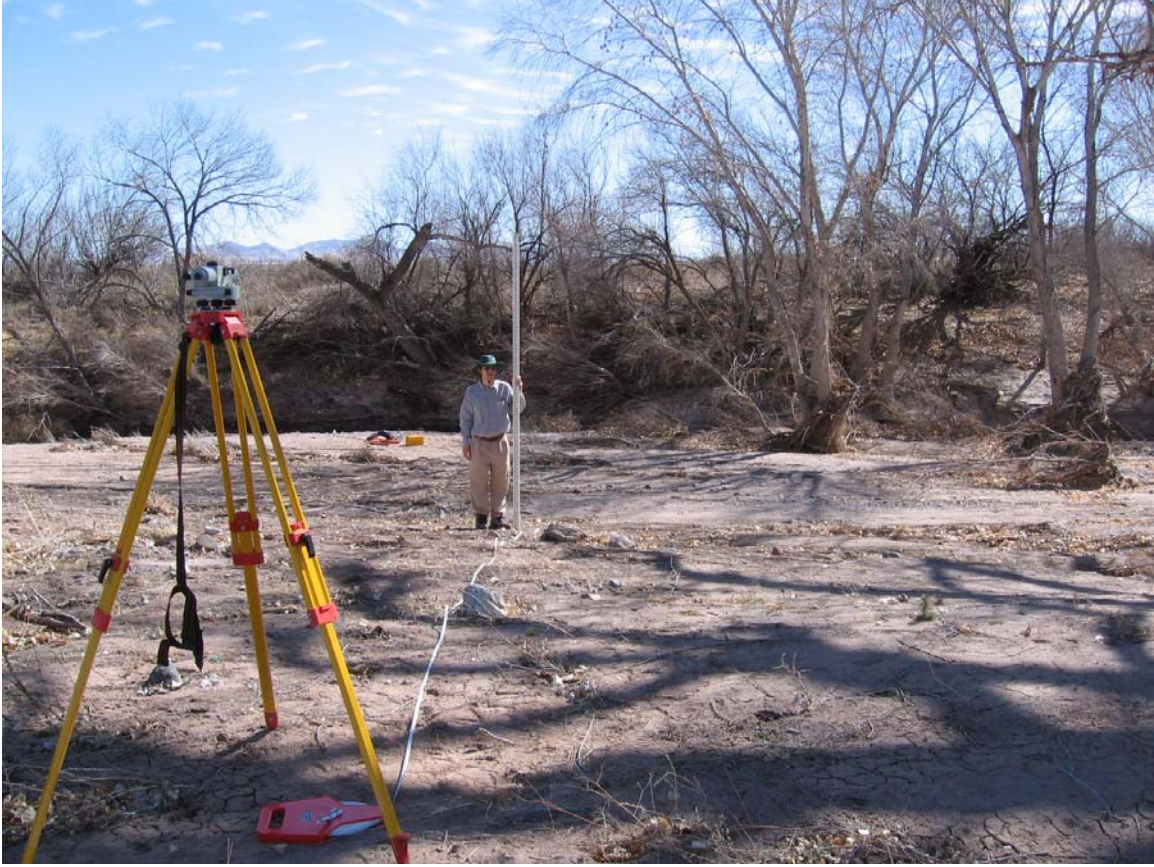
Figure 8: Survey equipment placed at high water mark on left bank of Railroad Wash. There were numerous breaks in the channel where distance measurements were made. The right bank featured a steep embankment on which the high water marks were above the bank at each cross section.

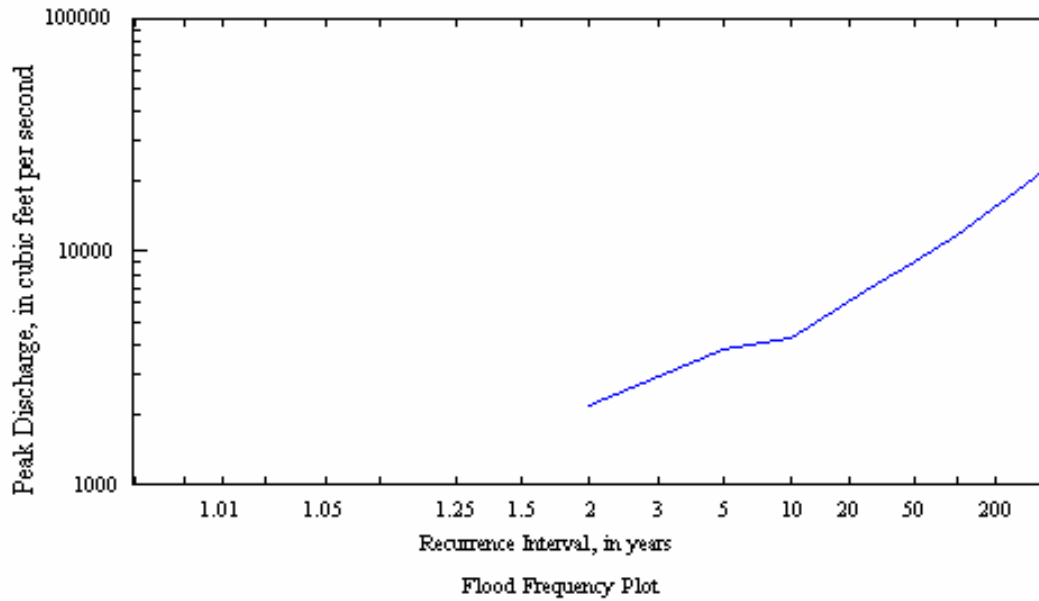
Figure 9: Flood Frequency plot using appropriate USGS regression equation for the Railroad Wash watershed.

Regression equations to determine flood frequency in ungaged watersheds have been developed by the USGS for every state and for the different hydrologic regions within each state. Watershed size is input into the National Flood Frequency visual basic program which uses the regression equations to determine a recurrence interval (USGS Fact Sheet 111-98, June 1999). In this case, 6916 cfs for Arizona in USGS Hydrologic region four, the recurrence interval is about 27 years (Figure 9). Since part of the Railroad Wash watershed is in New Mexico, the data was compared to the proper New Mexico regression equation and the results were nearly identical. Even assuming up to a 20% plus or minus error on the determination of peak discharge the recurrence interval would range from 15 years to 40 years, thus signifying that this flow was significant.

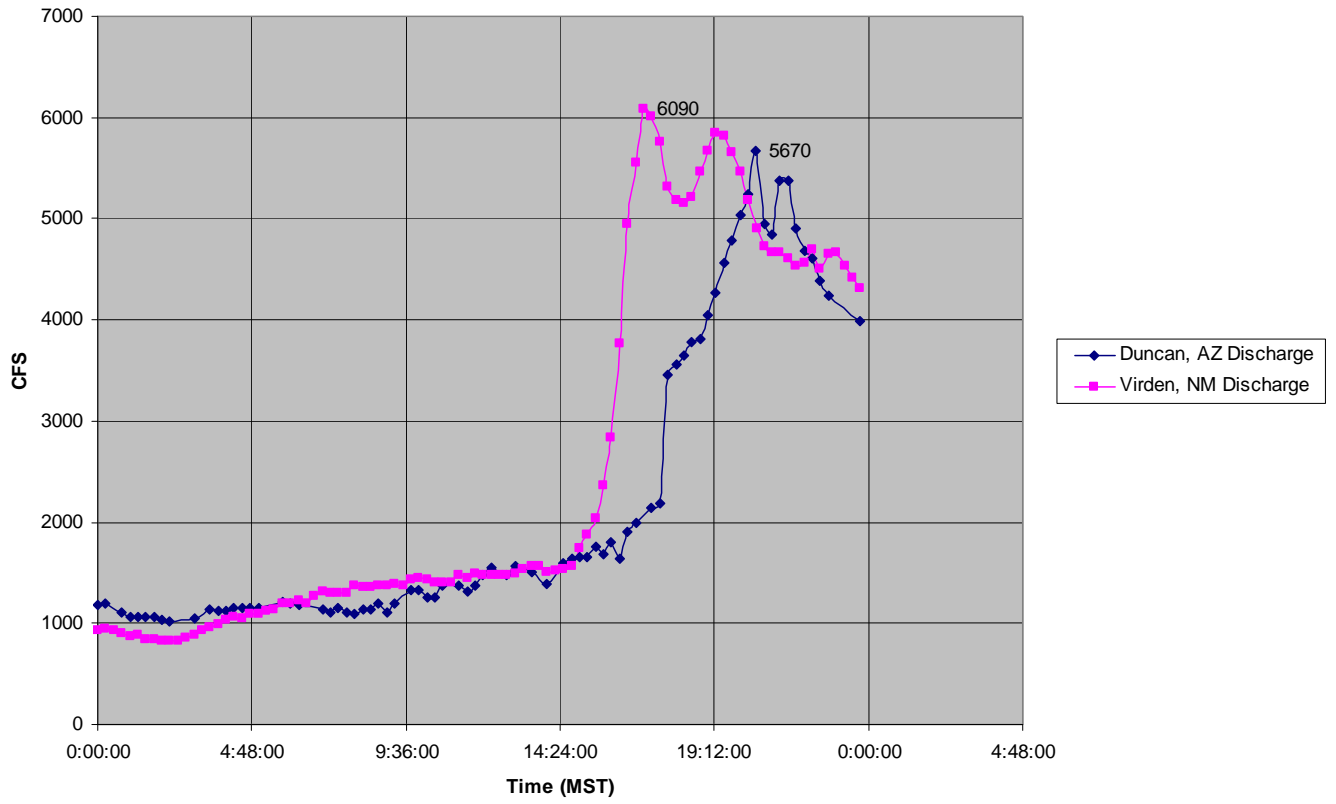
September 13, 2006 Discharge

Figure 11: Stream discharge on September 13th, 2006 from USGS gages on the Gila River at Duncan, Arizona and Virden, New Mexico.

About 3 miles downstream from the mouth of Railroad Wash at the Gila River, there is a USGS stream gage on the Gila in Duncan, Arizona. Hydrograph data from the stream gage at Duncan was examined to determine whether a spike from the flash flood in Railroad Wash could be seen (Figure 11). The Duncan hydrograph did indeed show a clear rise after 5 PM MST jumping from 2180 cfs to 3450 cfs in a 15 minute time period between 5:30 PM and 5:45 PM. It is likely that this was a rise partially attributed to Railroad Wash. The attenuation of the hydrograph from the Railroad Wash site to the USGS Gage on the Gila River at Duncan is the primary reason that the rise on the Gila was much reduced compared to the 6916cfs estimated flow at Railroad Wash. The peak discharge at Duncan was 5670 cfs at 8:30 PM MST. Much of this peak flow on the Gila came from upstream as a typical flow takes 4-6 hours to reach Duncan, Arizona, from the Virden, New Mexico, gage upstream.
