National Weather Service Austin-San Antonio TX

Tornado hits San Antonio...South Central Texas Soaks Up Some Much Needed Rain

...UPDATE...EF1 TORNADO RATING FOR SAN ANTONIO TORNADO...

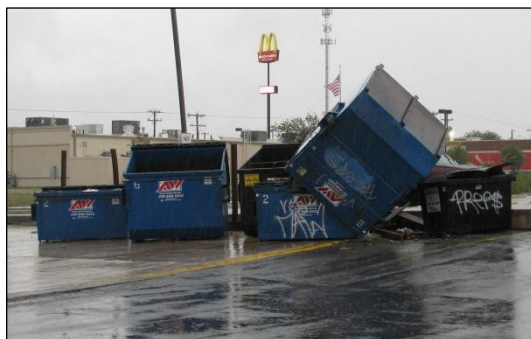
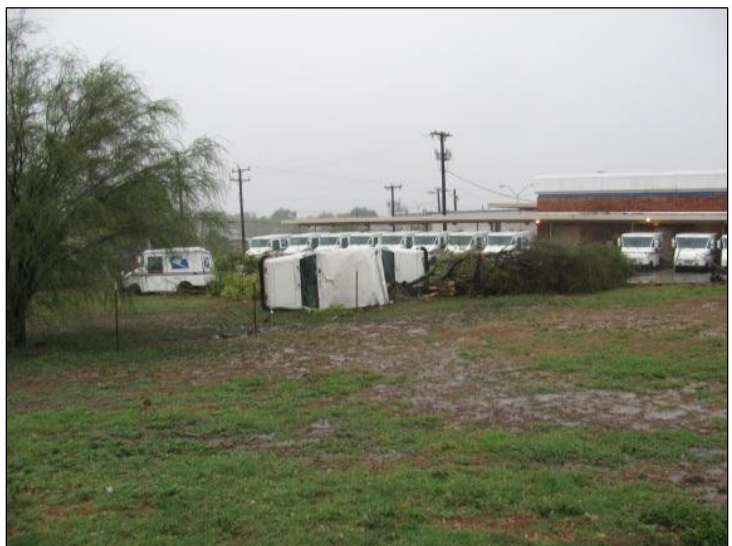
The tornado continued to head north, crossed Aldrich Drive and went behind the U.S. Post office (5510 SW Loop 410) near the corner of Loop 410 and Valley Hi Drive. This corner has several businesses along with an H.E.B. grocery store. Several eyewitnesses at H.E.B. saw the tornado move through the parking lot and cause subsequent damage to over 20 postal trucks that

were parked in the back of the Post Office. While several trucks were untouched, an entire row of vehicles were thrown up to 30 yards into another adjacent parking lot and grassy field. Fifteen postal trucks were a total loss. The postal building itself sustained little damage. The postal trucks weigh 2200 pounds each, showing the strength of wind associated with the tornado. This is where the tornado likely reached its peak intensity. The assessment of wind speed is still part of the ongoing investigation with this tornado track.

THE TORNADO CONTINUED NORTH NORTHWEST AND HIT NEAR THE US POST OFFICE (5510 SW LOOP 410) POSTAL TRUCKS WERE TOSSED FROM THE PARKING LOT BEHIND THE POST OFFICE. 22 TRUCKS WERE DAMAGE AT THE FACILITY WITH 15 OF THE TRUCKS BEING A TOTAL LOSS. THIS DAMAGE IS AN INDICATOR OF WHERE THE TORNADO LIKELY REACHED ITS PEAK INTENSITY. THERE WERE SEVERAL WITNESSES TO THE TORNADO INCLUDING EMPLOYEES AT THE NEARBY HEB GROCERY STORE...ALONG WITH SAN ANTONIO FIRE DEPARTMENT.

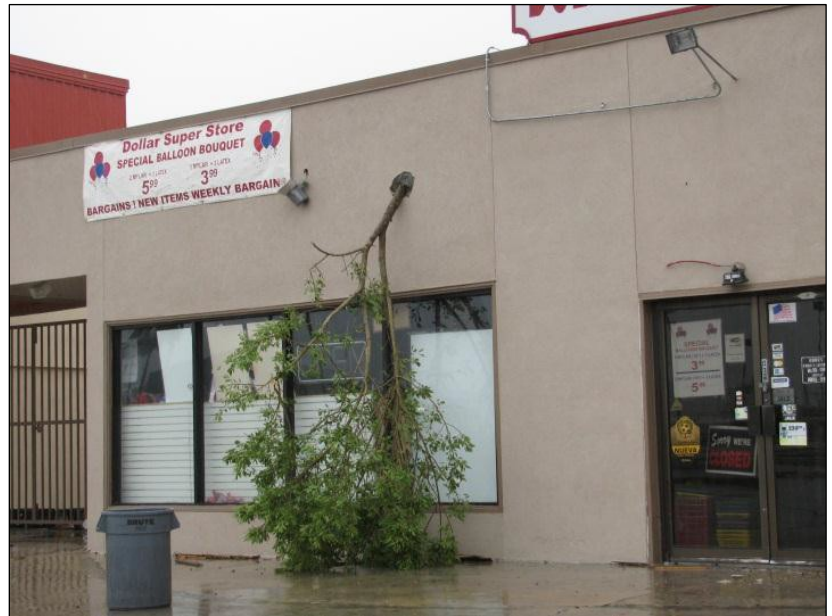
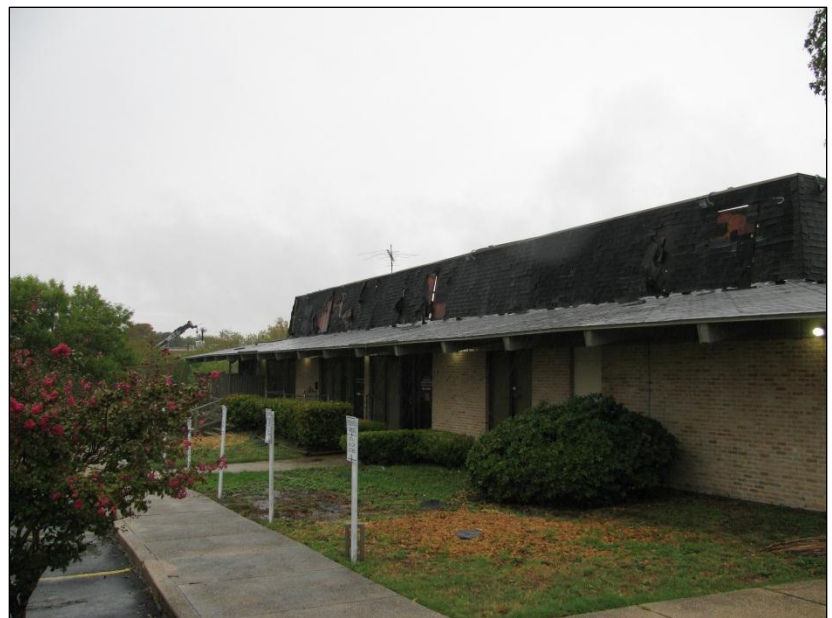
The tornado flipped over a garbage dumpster and sent a tree limb into the side of a business before crossing Valley Hi Drive. Flying debris is what typically kills people in tornadoes. Even winds as little as 50 mph can send items through the air, projectiles that will act like deadly missiles...don't get caught outside. Seek shelter indoors away from windows. There were several examples along this tornado track of projectiles penetrating roofs, cars, and windows.

The tornado crossed Valley Hi Drive where it produced mainly shingle and roof damage to two office buildings before moving over or very near the Sam Rayburn Middle School. While the school itself only suffered minor roof damage, there was damage to the construction site where a new school addition was being built.

Roof damage at a business along Valley Hi Drive

THE TORNADO CROSSED VALLEY HI DRIVE WHERE IT DID SOME DAMAGE TO TWO OFFICE BUILDINGS ALONG VALLEY HI DRIVE BEFORE MOVING OVER OR VERY NEAR THE SAM RAYBURN MIDDLE SCHOOL. THE SCHOOL ITSELF SUFFERED ONLY MINOR ROOF DAMAGE...WITH MORE DAMAGE BEING SEEN BEHIND THE SCHOOL WHERE A NEW SCHOOL BUILDING IS UNDER CONSTRUCTION. JUST NORTH OF THE SCHOOL...A HOME LOST A SECTION OF ROOF AT THE CORNER OF CEDARHURST AND GAGE DRIVES. THE TORNADO APPEARS TO HAVE THEN SHIFTED A LITTLE MORE TO THE RIGHT AS IT TRAVELED ANOTHER ONE HALF MILE THROUGH A NEIGHBORHOOD WITH ADDITIONAL TREE DAMAGE AND DAMAGE TO PORTABLE BUILDINGS AND ROOFS. THE TORNADO APPEARS TO HAVE LIFTED OR DISSIPATED NEAR THE INTERSECTION OF SPRINGVALE DRIVE AND ALLENHURST DRIVE.

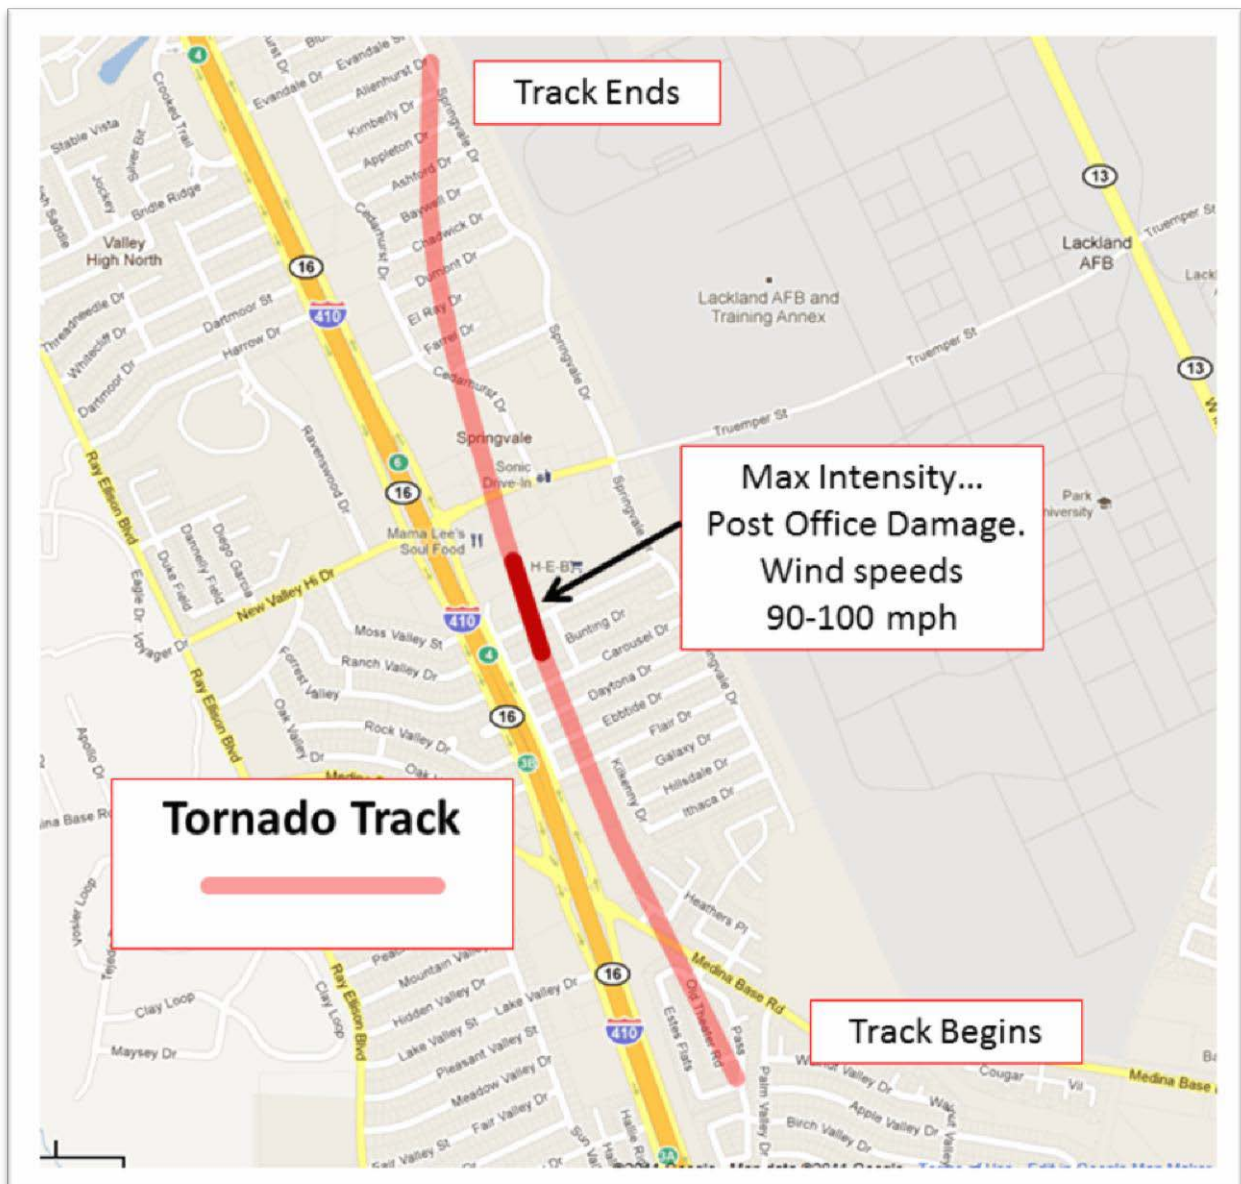
The Track...

- * Location ...1 to 1.5 miles west of Lackland AFB
- * Beginning Lat/Lon...29.366 N / -98.632 W
- * Ending Lat/Lon.....29.392 N / -98.642 W
- * Path Length.....2 MILES
- * Maximum Width.....50 YARDS
- * Injuries/deaths.....None
- * Estimated Start Date/Time...112 am October 9 2011
- * Estimated End Date/Time.....117 am October 9 2011
- * Maximum Winds/EF Scale.....EF1...peak winds 90-100 mph. Majority of damage path was 70-85 mph (EF0).
