Tornado - July 19th, 2019 Preliminary Summary

Summary of Carter County Tornadoes

July 19, 2019

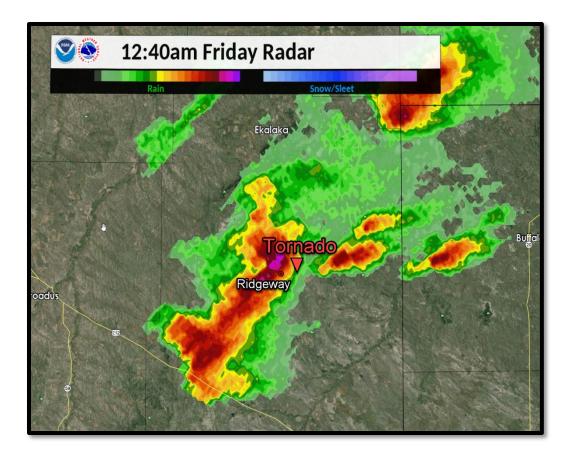
The tornado was approximately 50 yards wide and on the ground for nearly 200 yards. The tornado was classified as an EF-1 (winds 86-110mph).

There was considerable damage to buildings on a local ranch. A shop building had 2 doors blown in and roof damage. Two other sheds had significant roof damage. Several metal rooftops were torn off and peeled back. A small garage was destroyed with a vehicle displaced inside, turned and moved by a couple feet. Several trees were snapped (approximately 1 foot diameter), with other smaller trees blown over or uprooted.
