National Weather Service Des Moines

June 12, 2013 Tornado Event Summary

Updated on February 23, 2014

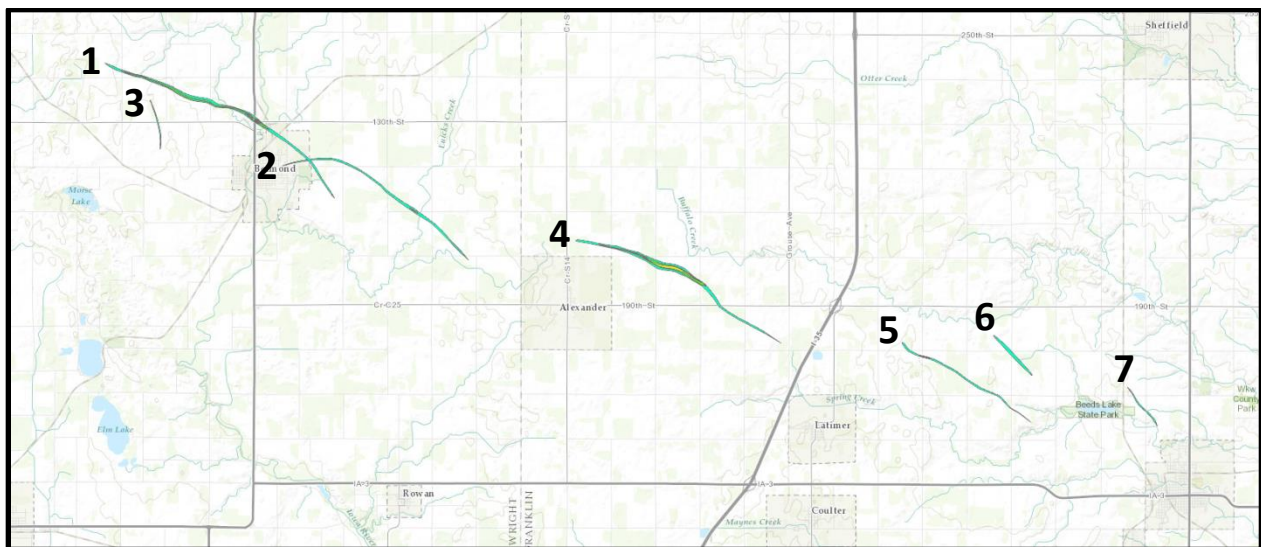
Overview map with the tornado tracks

Number of Tornadoes across North Central Iowa: 7

EF-0 Tornadoes: 3 EF-1 Tornadoes: 2 EF-2 Tornadoes: 1 EF-3 Tornadoes: 1

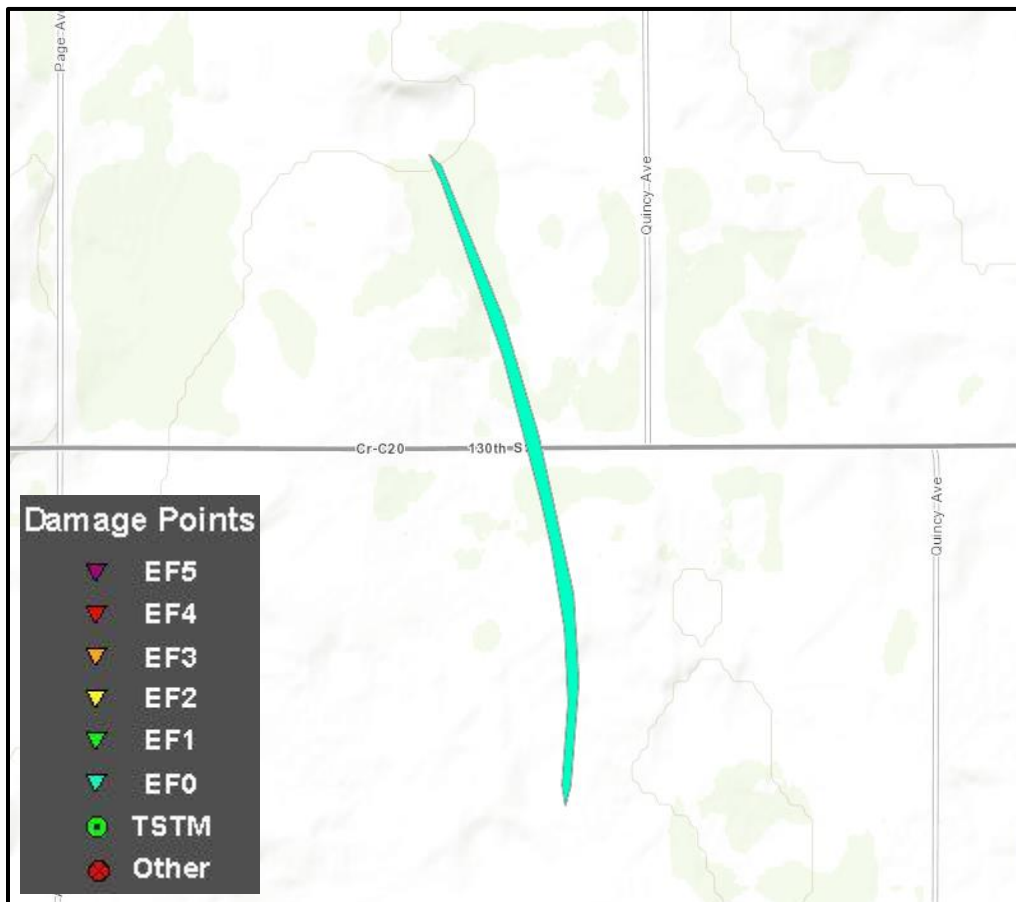
Tornado 3 Path Map:

This tornado formed as a larger EF-3 tornado was passing through the NE side of Belmond. This tornado tracked to the SSE across open farm land before dissipating. The track was determined based on photographs of the tornado and satellite imagery of the area. The location of the tornado in the storm, track direction, and streaks in satellite imagery suggest that this tornado rotated anti-cyclonically.

Tornado Strength: EF-0

Peak Wind Speed: 70 mph
