Tornado and Hail Event

October 18th, 2004

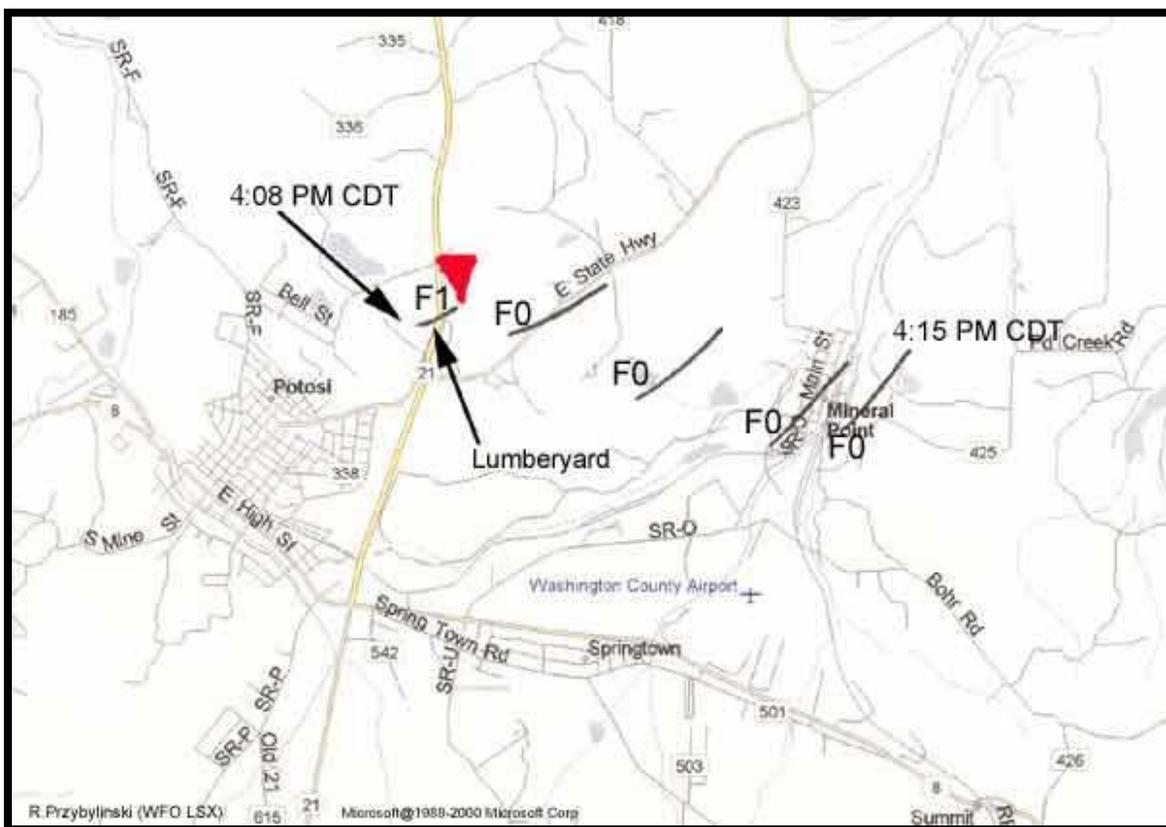
Map of the tornadic damage tracks associated with the Washington County supercell. Five tornadic damage tracks were uncovered during the survey. We wish to extend our appreciation to Mr. Paul Merrill (EMA - Washington County) for his assistance.

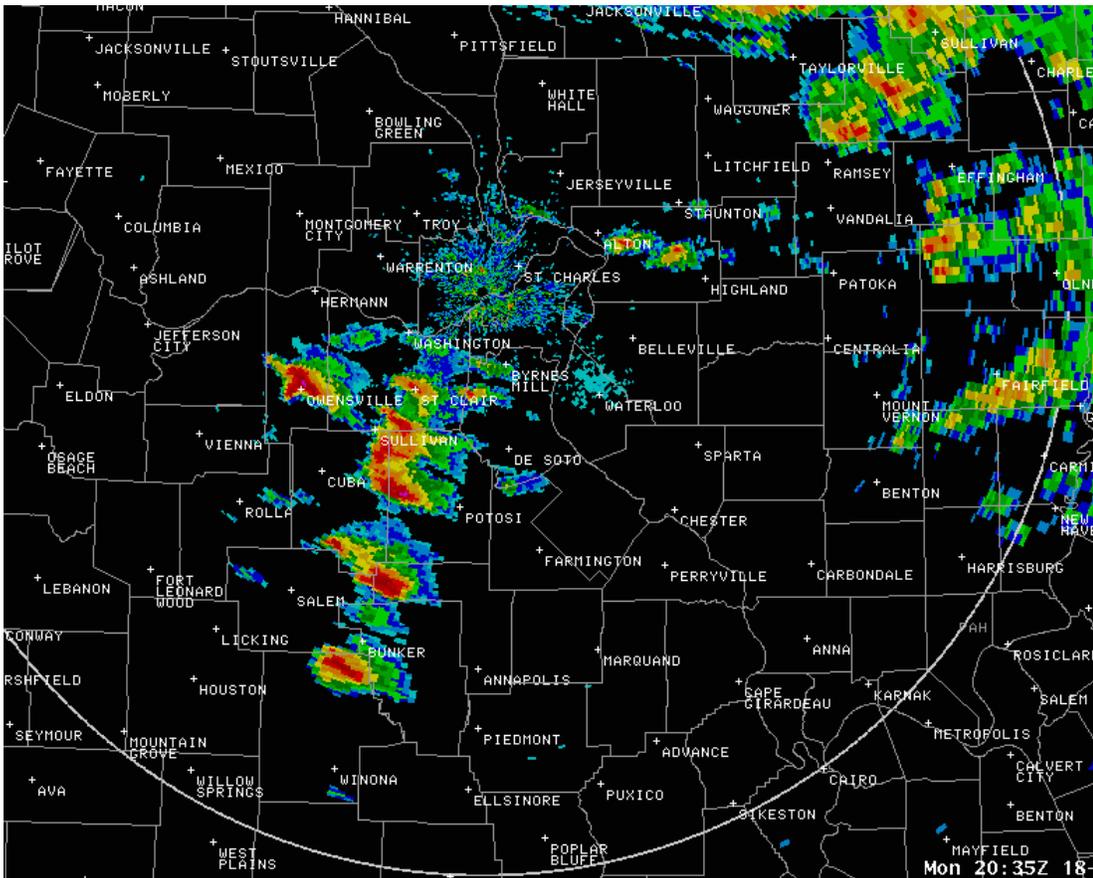
3:30 PM CDT - Supercells began to develop with the mid afternoon heat and increased in size and intensity as they moved across the southern portion of our area producing large hail and damaging winds.

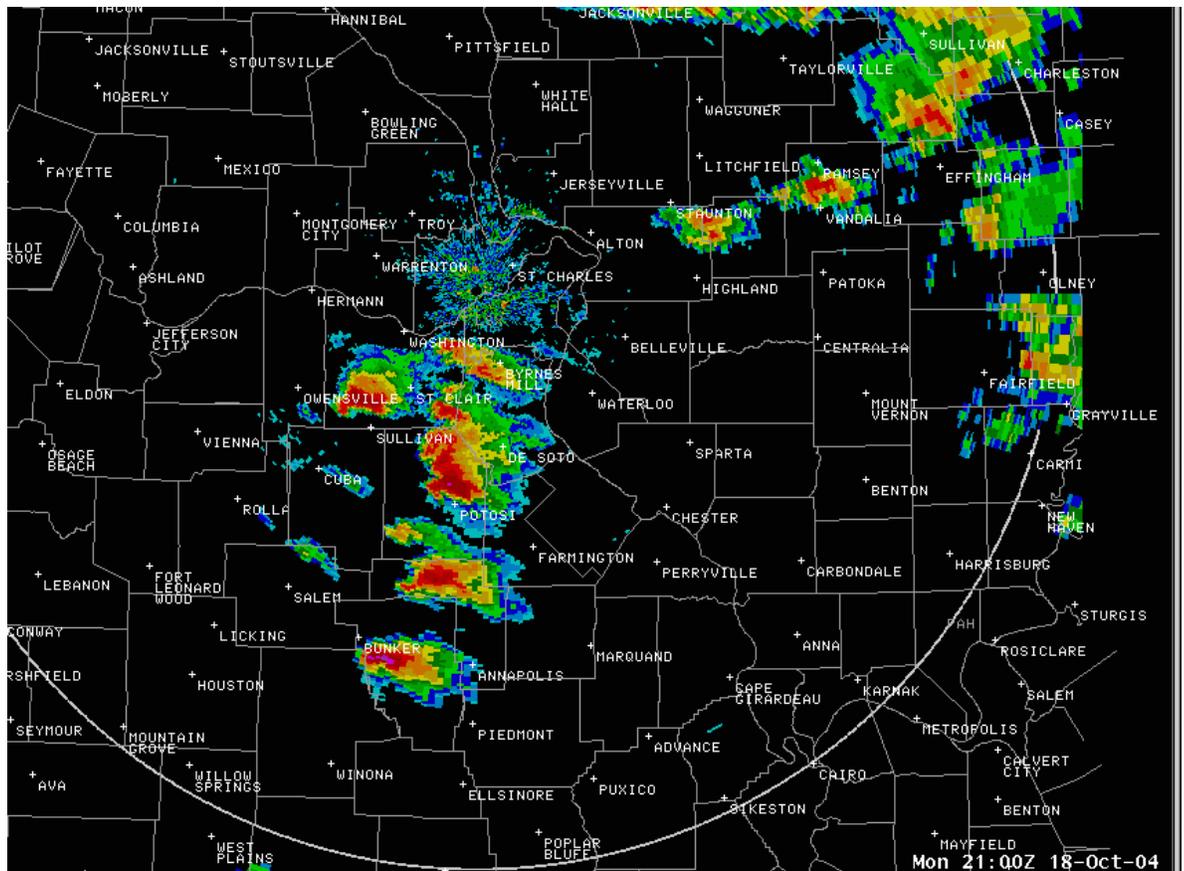
4:00 PM CDT - The strongest cell moves through Washington county producing hail the size of hen eggs and spawning several small tornadoes shortly after 4:00 PM

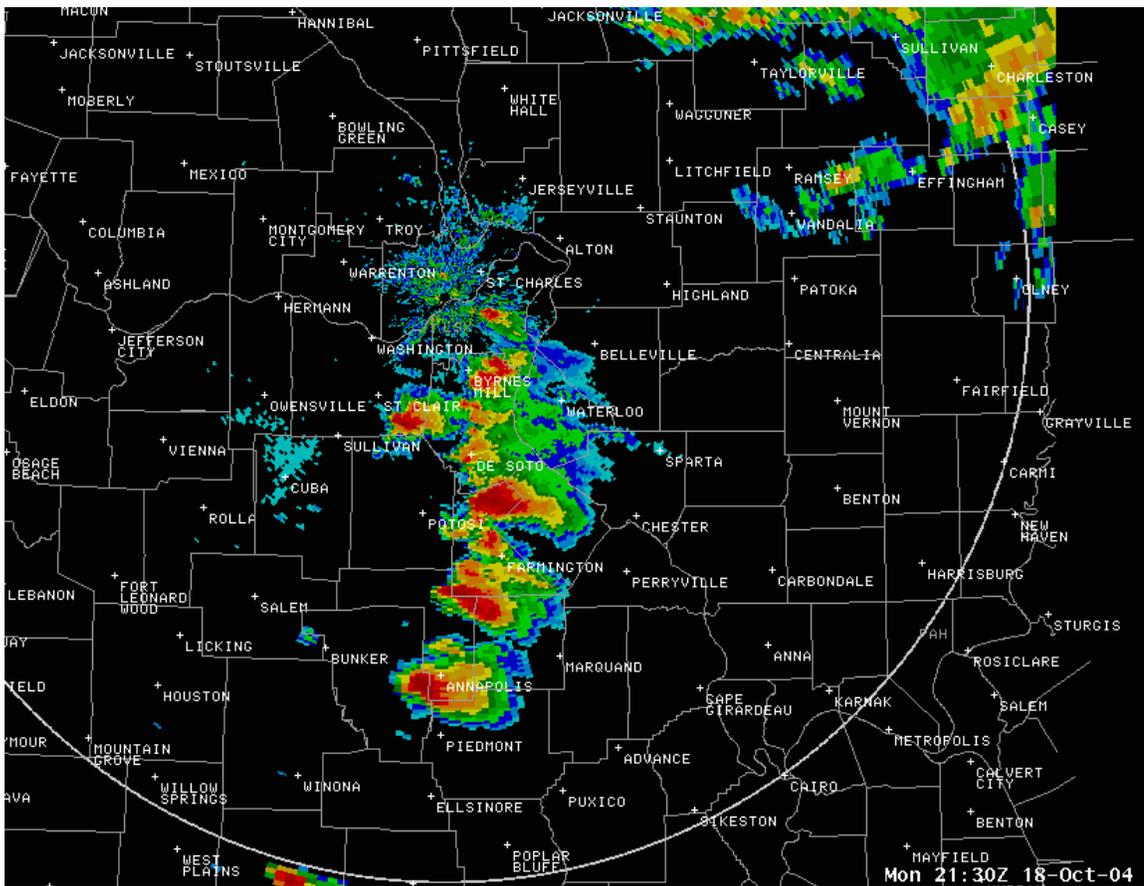
4:30 PM CDT - The cluster of cells continues to dump large hail over portions of St. Francois county, eastern Iron and Madison counties. Tornado damage was reported in Ironton.

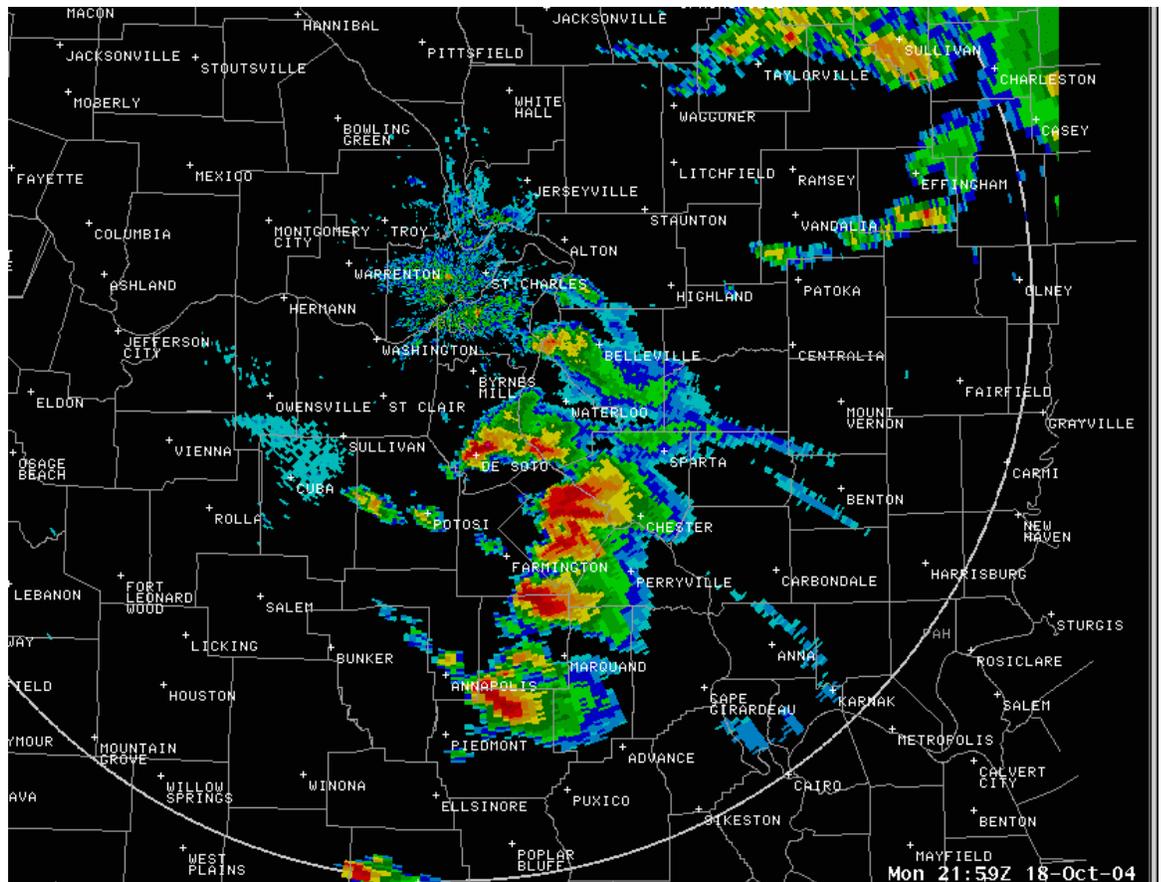
5:00 PM - St. Genevieve and Madison counties bear the brunt of the storms with large hail, damaging winds and a tornado touchdown.
