Tornadoes - June 28th 2018

Damage Survey Results from Carter County, MT and Harding County, SD

Summary of Carter County Tornadoes

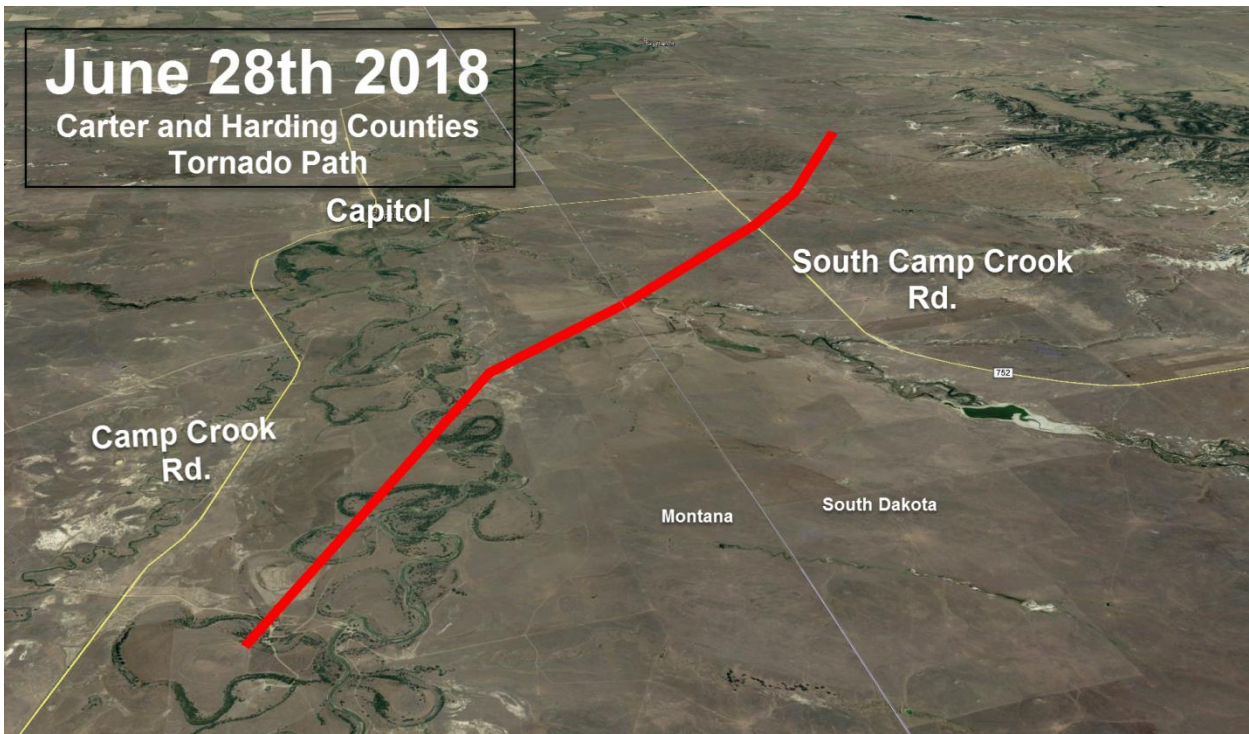
Tornado 1 (EF-0):

Start: 45.3219, -104.4806 (717pm)
End: 45.3548, -104.2803 (735pm)

Tornado on the ground for 10 miles. No damage visible from tornado. EF-0 microburst damage to the south of the tornado due to RFD included; 2 trees uprooted, barn roof blown off, shed destroyed, and a horse trailer flipped over.

Tornado 2 (EF-0):

Start: 45.3503, -104.2066 (744pm)
End 45.3573, -104.1321 (750pm)

Tornado on the ground for 4 miles (6 minutes). Rural areas. No reports of damage.

Tornado 3 (EF-0):

Start/End: 45.3675, -104.0981 (801pm)

Brief touchdown. No reports of damage. Reports indicate anti-cyclonic rotation.

Tornado 4 (EF-2 in MT, EF3 in SD):

Start: 45.3753, -104.0813 (806pm)

Exit to SD: 45.4092, -104.0406 (820pm)

End: 45.4475, -103.9904 (830pm)

Tornado on the ground for 7 miles (24 minutes) from south of Capitol, MT northeast into SD.

In MT: 3 mile long path, 200 yards wide. Damage ranged from EF-1 at the initial touchdown, increasing to EF-2 just before the SD border. Large tree limbs down and trees being snapped off, becoming more widespread as the path approached the Little Missouri River.

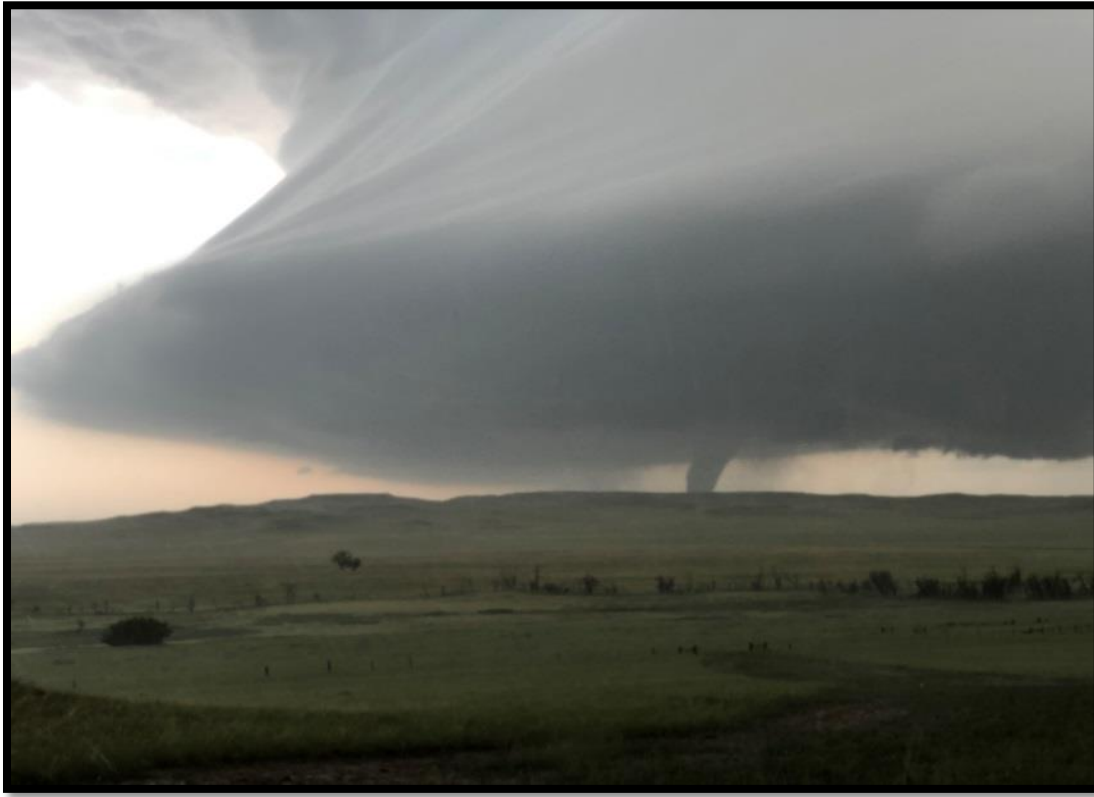
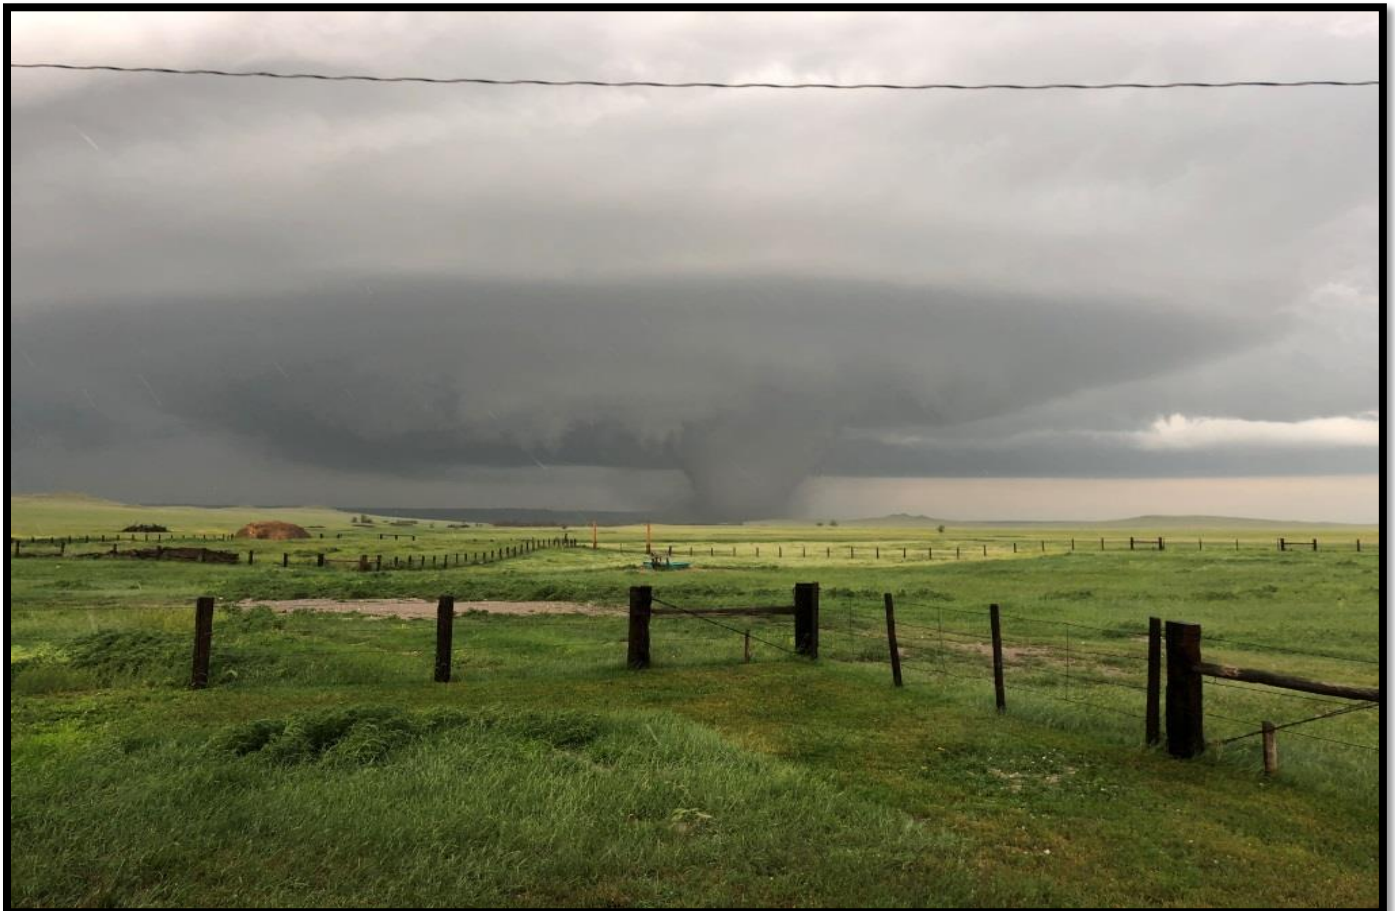
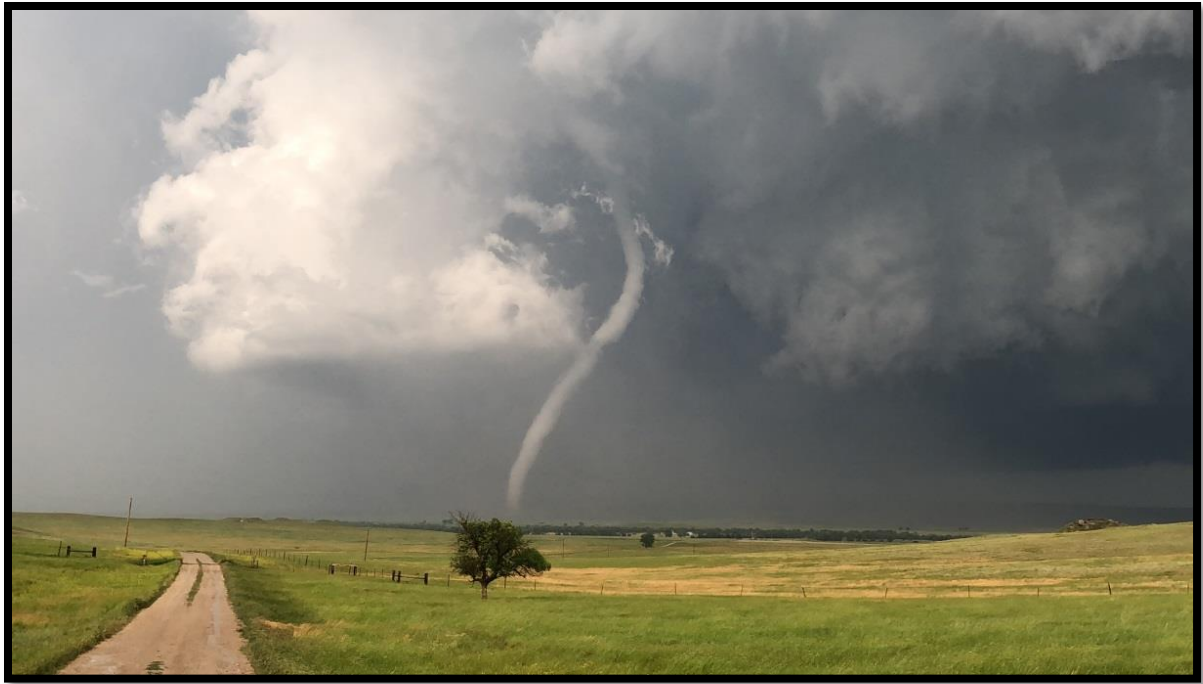
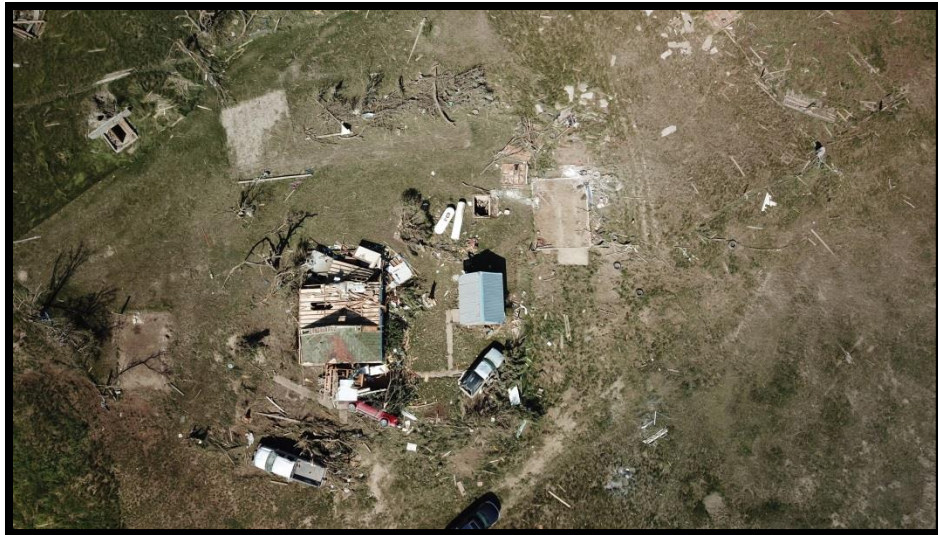
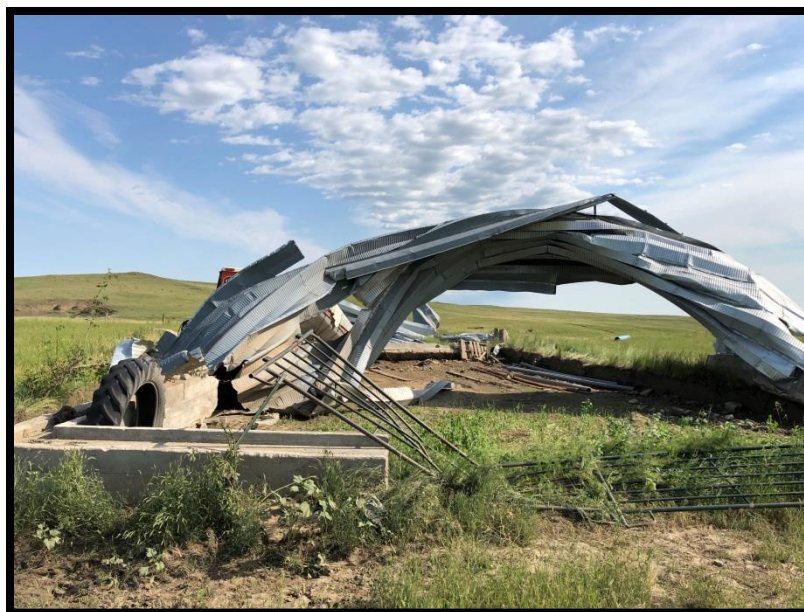
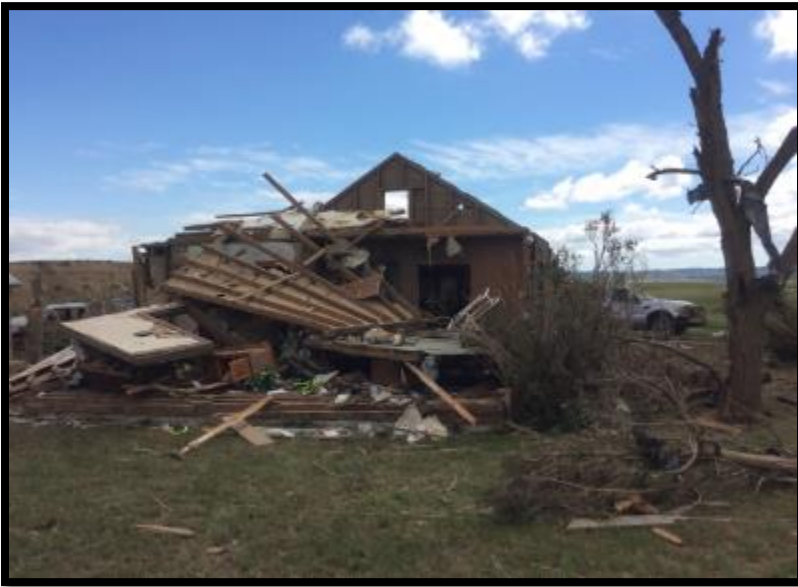
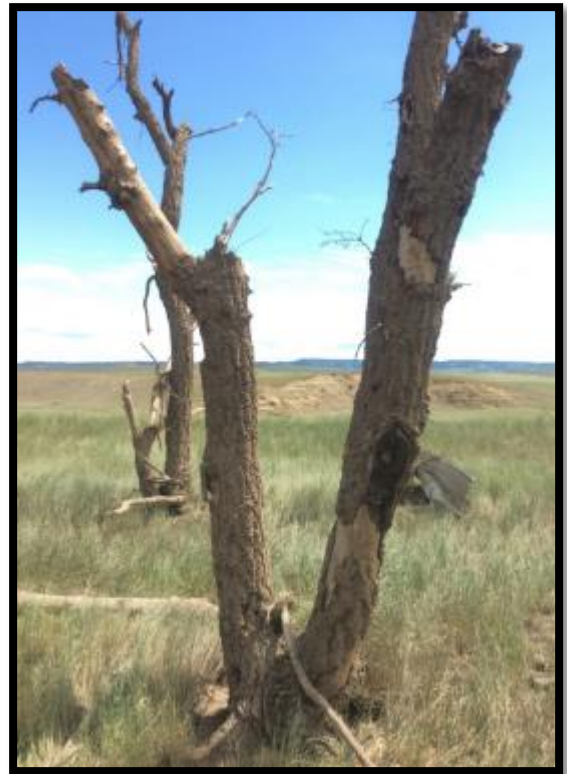
Photos and Video Courtesy of Daniel Kalbach

Damage survey and eye witness accounts confirm the tornado initially moved north-north-east along the Little Missouri River. As it approached the river it intensified to 120 mph (EF-2) producing an increasingly wider swath of snapped trees several hundred yards wide. The tornado started to turn more to the east at this time, moving on a northeasterly track as it crossed the Little Missouri and moved across the Montana/South Dakota border.

In South Dakota, this storm increased to an estimated $\frac{1}{2}$ mile wide and damage observed was consistent with an EF-3 tornado rating, with winds estimated at 136 mph. Preliminary damage in South Dakota included one home destroyed, shed destroyed, trailer toppled over, heavy hay bales moved, along with tree damage (even debarked in some cases). Local residents reported finding numerous dead deer in the debris along the river where the tornado crossed the tree line. Damage in South Dakota is assessed by the National Weather Service in Rapid City and further updates to this information can be found at weather.gov/rapidcity.
