July 8, 2013
Severe Weather
Damage Assessment Report

National Weather Service
Billings, MT

Event Overview

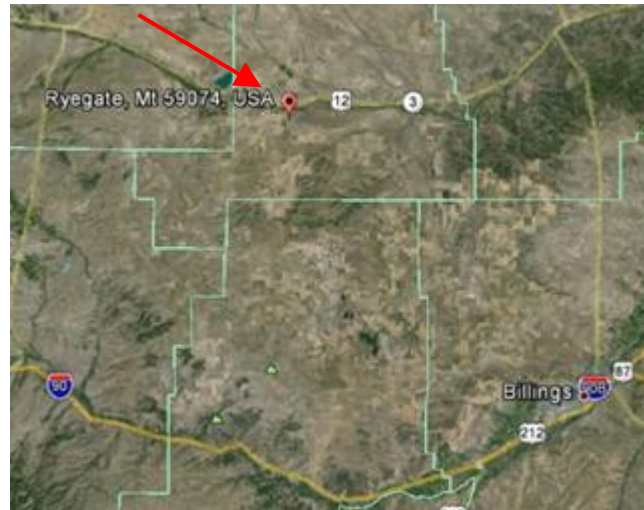
- Event
 - Microburst winds approx 4:00 pm MDT (Estimated speeds upwards of 75 mph)
- Extent
 - Majority of damage in the town of Ryegate, MT
 - Quarter mile wide and a mile long path
- Structural
 - Several structures impacted with mostly minor roof damage
 - Large tree limbs landed on several structures
- Tree
 - Numerous trees impacted with large tree limbs down
 - Several large pine trees were uprooted

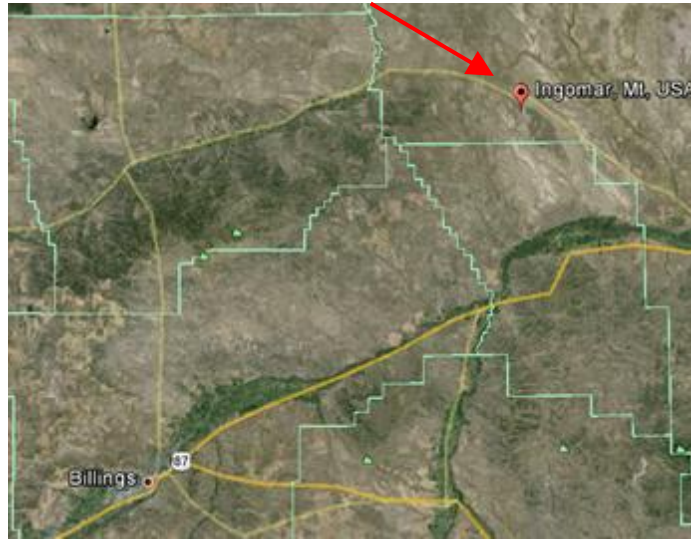
- Event
 - Microburst winds approx 5:15 pm MDT (Estimated speeds upwards of 75 mph)
- Extent
 - In the town of Ingomar, MT
 - Quarter mile wide and a mile long path
- Structural
 - Numerous structures impacted with some damage
 - Corner roof on one house tore off
 - Metal shed destroyed
 - RV rolled

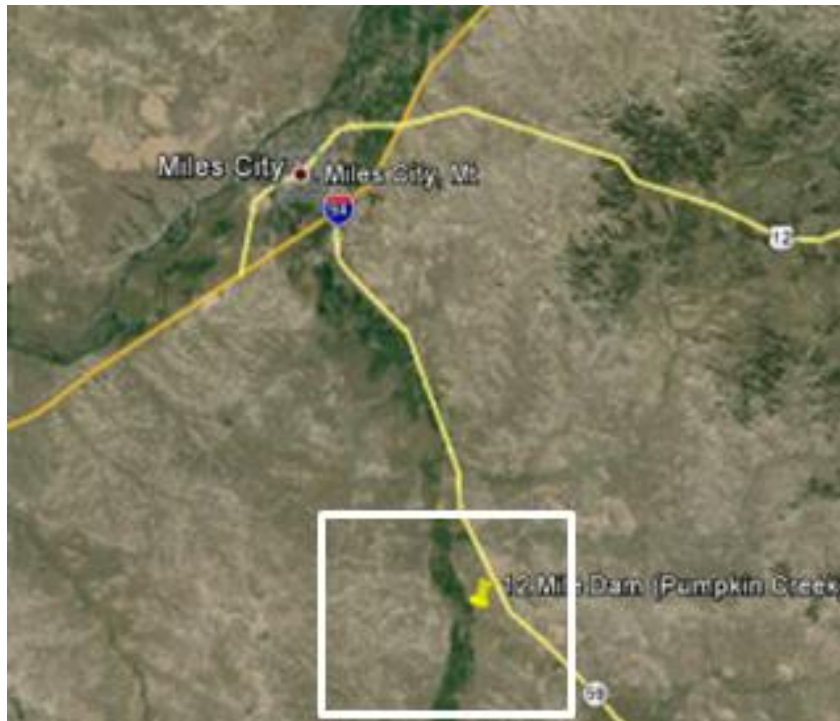
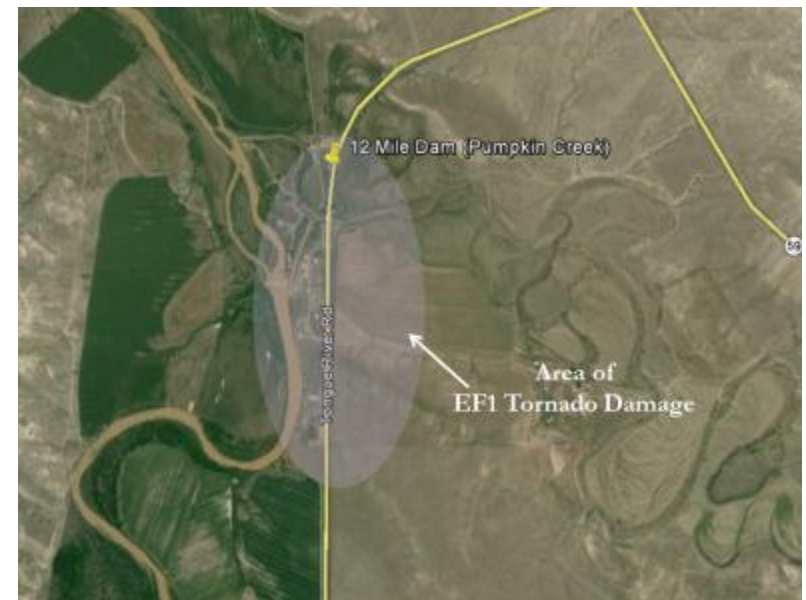
Damage Location

- Extent
 - Areal coverage of about one square mile along MT State Road 332 about 13 miles south of Miles City
 - Debris thrown in all directions several hundred yards from point of origin
- Structural
 - Several structures impacted by high winds due to short lived EF1 tornado
 - Parts of several roofs blown off
 - Side of one house blown off
- Tree
 - Dozens of large trees 12-16 inches in diameter uprooted
 - Large tree limbs thrown long distances
- Miscellaneous
 - ~12 power poles knocked down
 - Irrigation pipe system thrown several hundred feet
 - Large camper overturned
- Impacts
 - Tree limbs blocking roads
 - Power outage(s)
 - Campers at 12 Mile Dam (no known injuries)
 - Major structural damage to homes/barns/garages

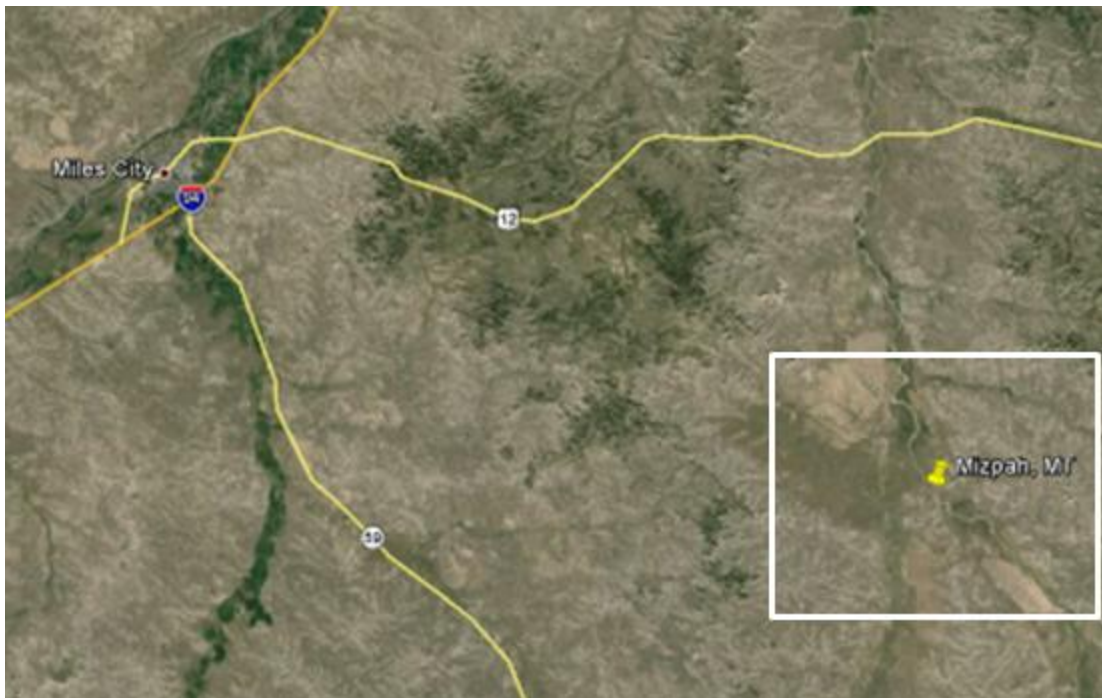
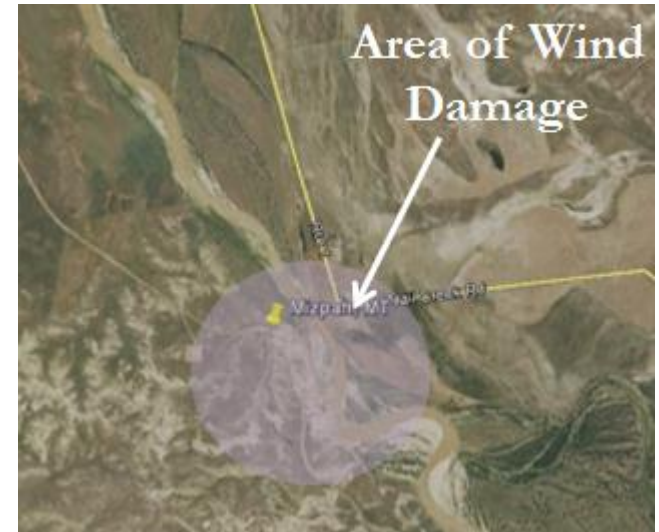
Damage Location

- Extent
 - Areal coverage of about two square miles, along Mizpah Road (30 miles southeast of Miles City)
 - Debris thrown in the southeasterly direction several hundred yards from point of origin
- Structural
 - Several structures impacted by high winds
 - Grain silos indented
 - Several large barn / storage structures completely destroyed
 - Roof of local school house severely damaged
- Tree
 - Large tree limbs thrown long distances
- Miscellaneous
 - Several automobiles within barn structure damaged
 - Large semi-trailer knocked over
- Impacts
 - No known injuries
 - Major structural damage to homes/barns/garages

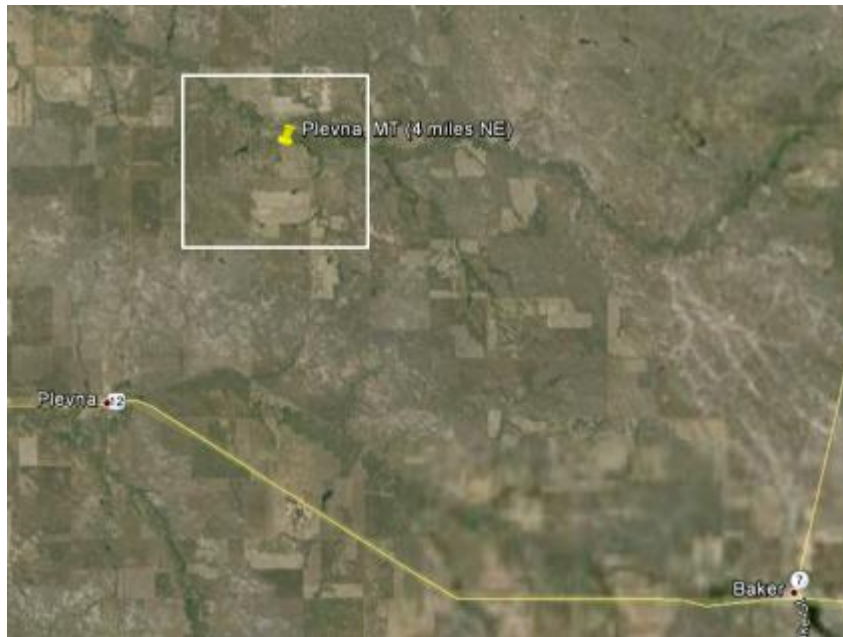
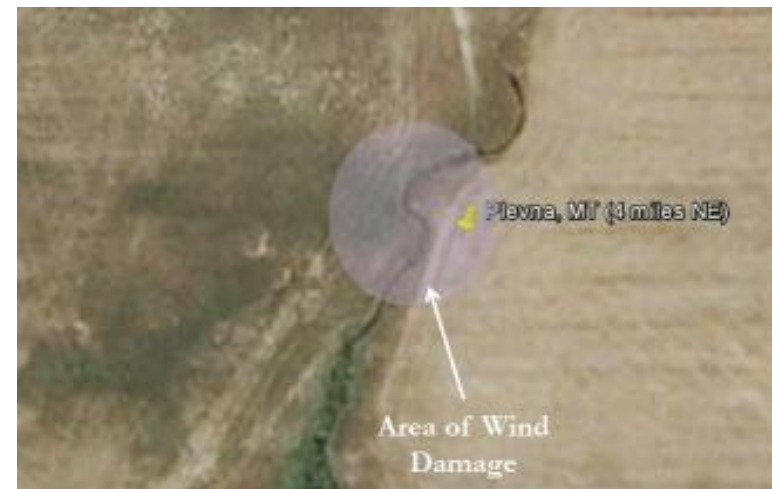
Damage Location

- Extent
 - Areal coverage of about one square mile
 - Debris thrown eastward several hundred yards from point of origin
- Structural
 - Several structures impacted by high winds
 - Large silo separated from tie down
 - Large garage door and roof of structure severely damaged
- Tree
 - Large tree limbs down on back deck of home
- Impacts
 - Major structural damage to barn/garage/silo
