# Straight-line Wind Damage South-central Iowa May 17, 2004

NWS WFO Des Moines/Johnston

The National Weather Service in Des Moines Conducted a storm survey on wind damage in Mahaska, Wapello, and Monroe counties on May 18, 2004. The damage was produced by a microbursts in thunderstorms on the evening of May 17. A summary of damage at various sites follows along with representative photographs of the damage.

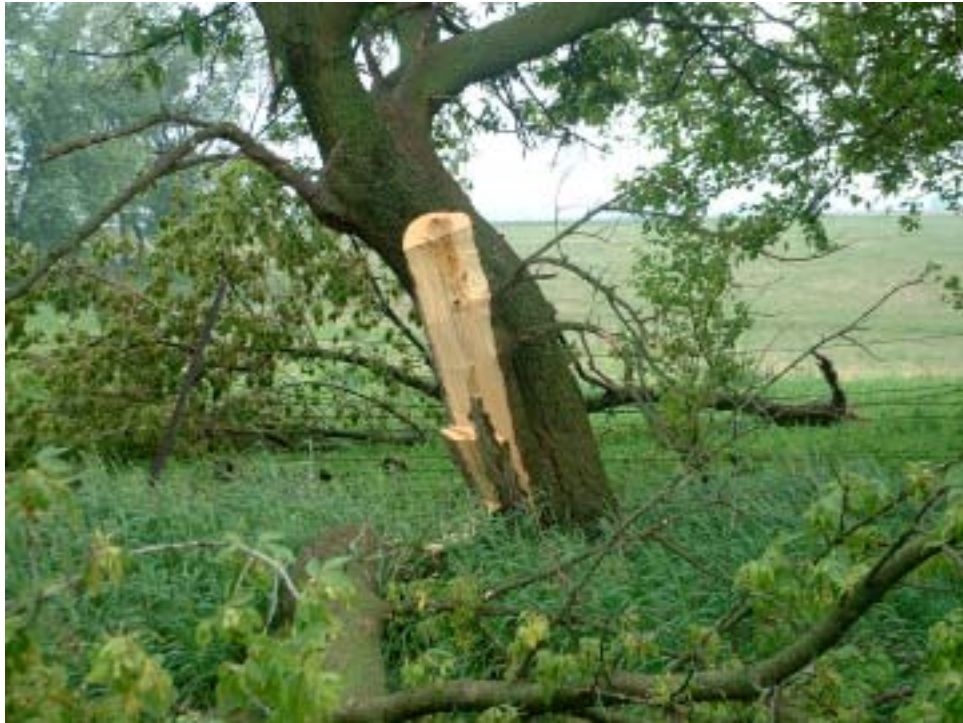
A line of thunderstorms first produced damage in Bussey around 8:55 p.m. Sporadic tree and powerline damage continued eastward across extreme southeast Marion county, southwest Mahaska county, and extreme northern Monroe county. This damage is likely due to straight-line winds. Following extensive damage one mile east of Eddyville around 9:15 p.m., winds diminished rapidly below severe criteria (58 mph or greater).
