# PARKERSBURG - NEW HARTFORD, IOWA EF-5 TORNADO

May 25, 2008

43 Mile Damage Track

National Weather Service - Des Moines, Iowa

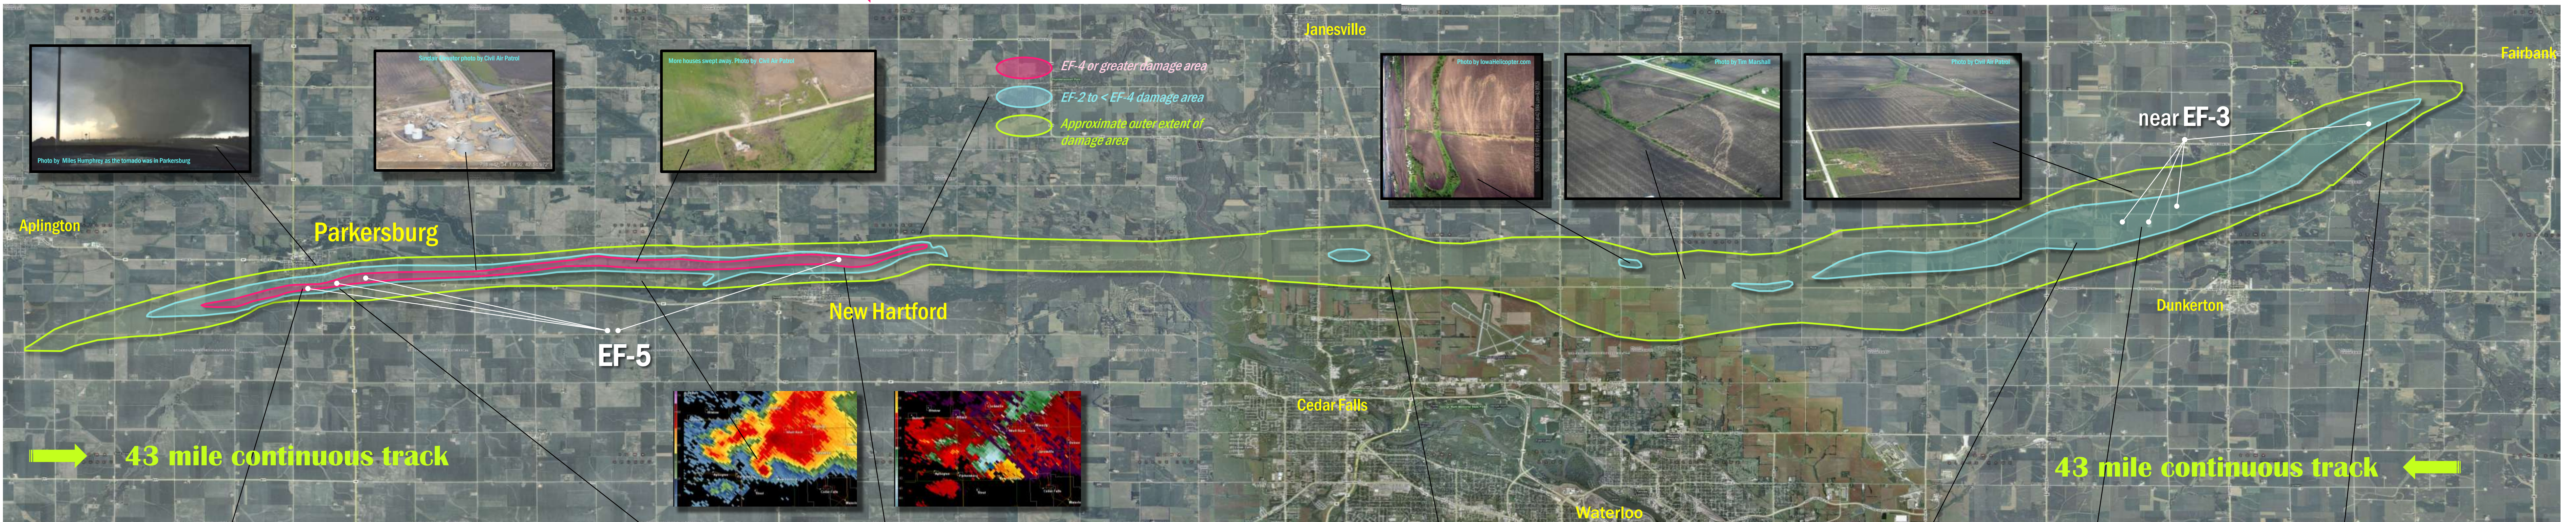
43 mile continuous track

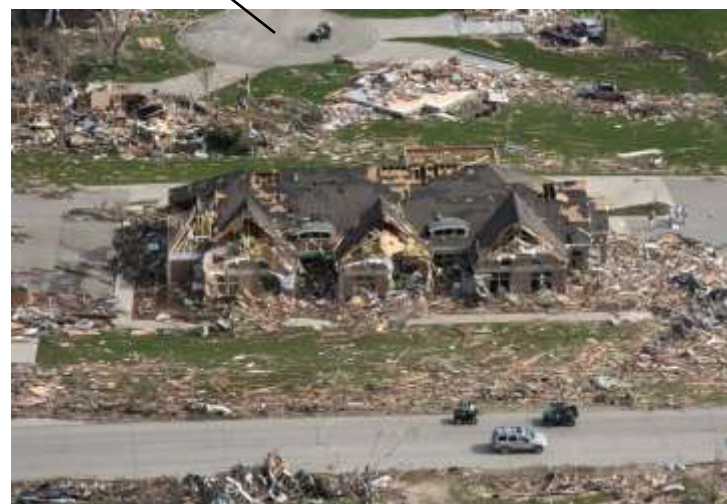
The most severe destruction in Parkersburg occurred south of the tornado core, which tracked directly over the First State Bank (left photo). Several fatalities occurred in the neighborhood of the center photo, as floors were swept away exposing basements. Mature trees were reduced to debarked stubs. The high school (right photo, Getty Images) received EF2-3 damage.
