National Weather Service Des Moines

May 11, 2014 Storm Survey for Guthrie, Dallas, and Boone Counties

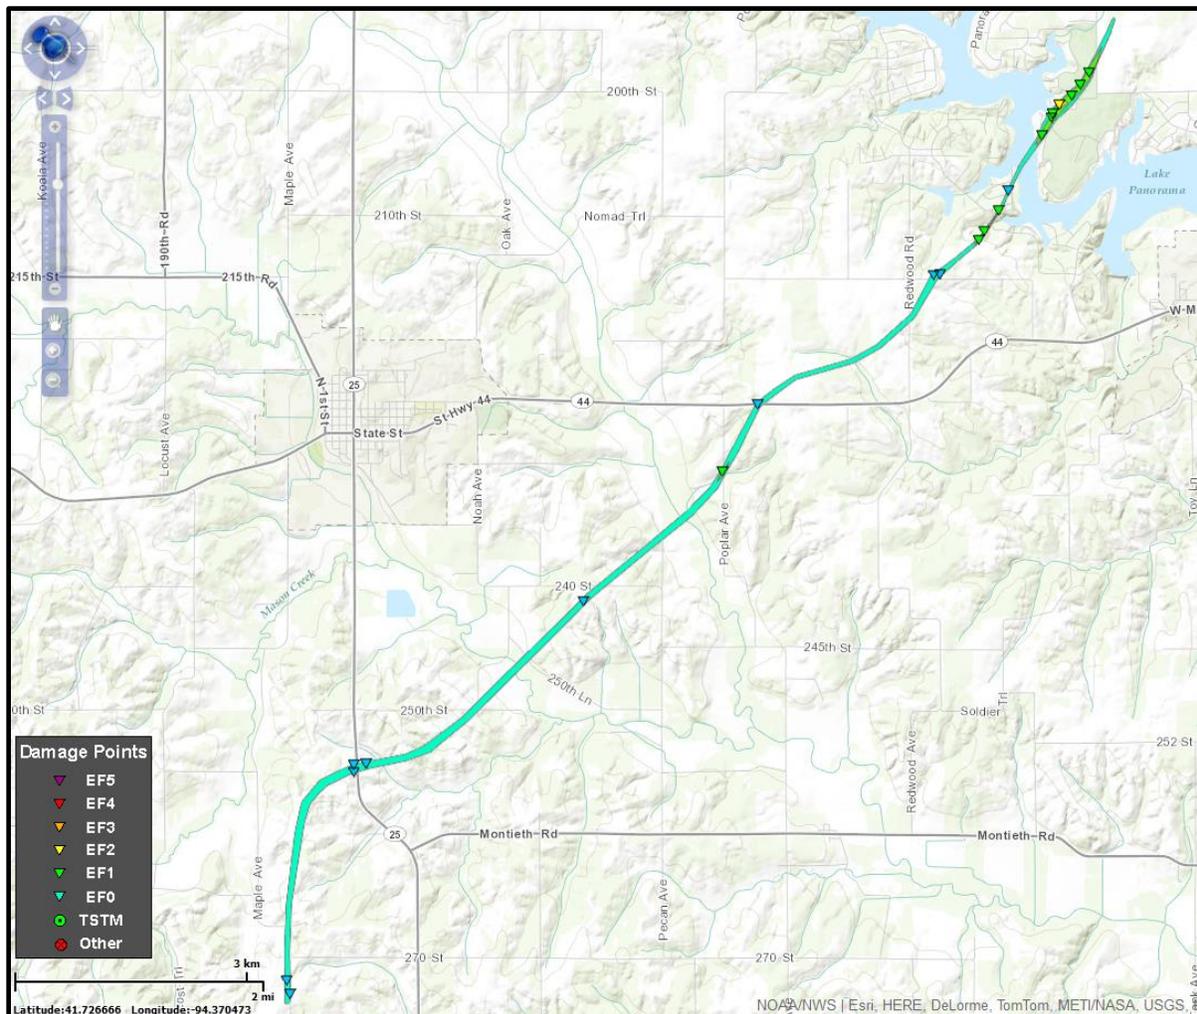
Tornado 1 Path Map:

This tornado formed 4.5 miles south of Guthrie Center and tracked northeastward, producing EF-0 to EF-1 damage east of Guthrie Center. The narrow tornado then strengthened as it reached Lake Panorama, where it briefly reached low EF-2 intensity and damaged several homes and condos, along with dozens of trees. The tornado was overtaken by downdraft winds and dissipated shortly after crossing Lake Panorama.

Tornado Strength: EF-2

Event Location: 4.5 miles S of Guthrie Center to 2.6 miles NW of Panora

Peak Wind Speed: 115 mph

Path Length: 10.98 miles

Average Path Width: 100 yards

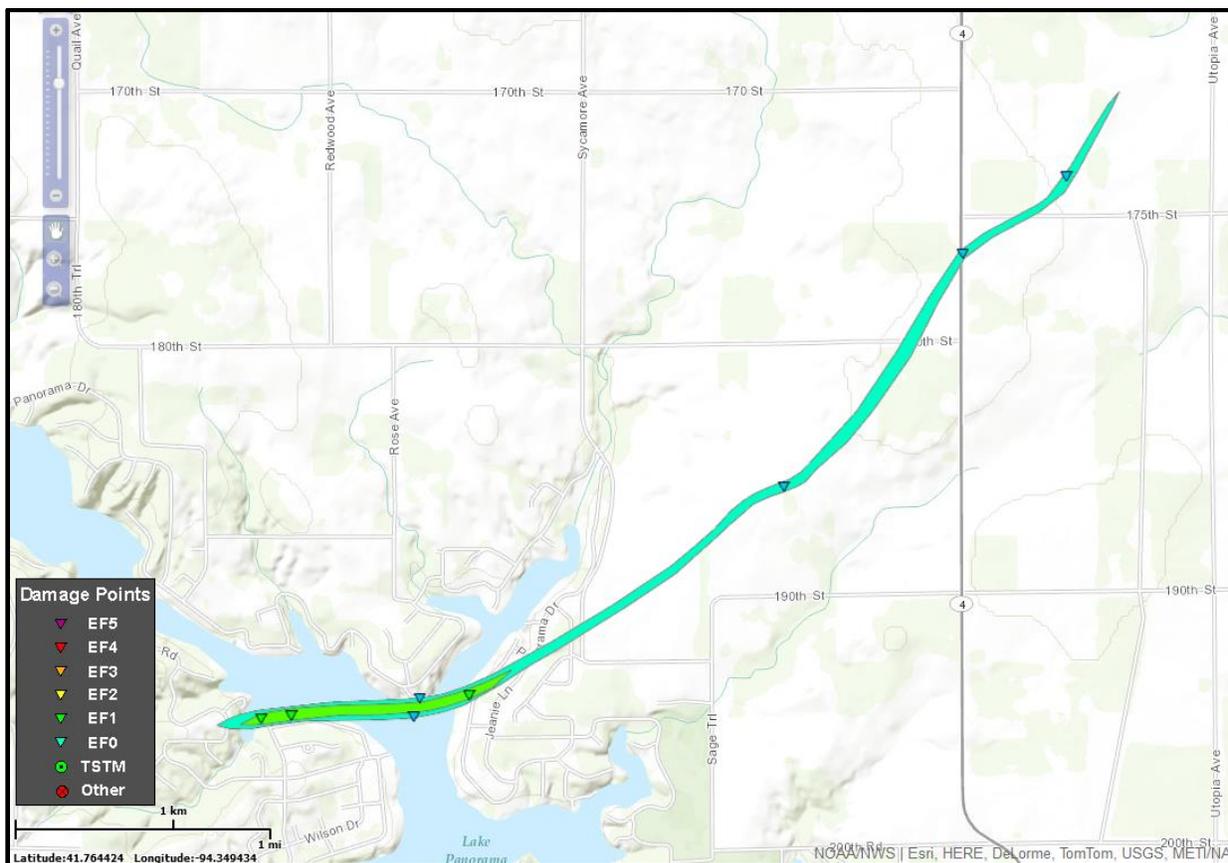
Tornado 2 Path Map:

As Tornado #1 was crossing Lake Panorama, a second tornado took shape a couple of miles further north on the west side of the lake. This tornado quickly strengthened to an EF1 and damaged a number of properties along the lake. The tornado then turned to the northeast and eventually dissipated a mile south of Yale as downdraft winds overtook the vortex.

Tornado Strength: EF-1

Event Location: 3.8 miles NW of Panora to 1.2 miles S of Yale

Peak Wind Speed: 100 mph

Path Length: 4.57 miles

Average Path Width: 110 yards

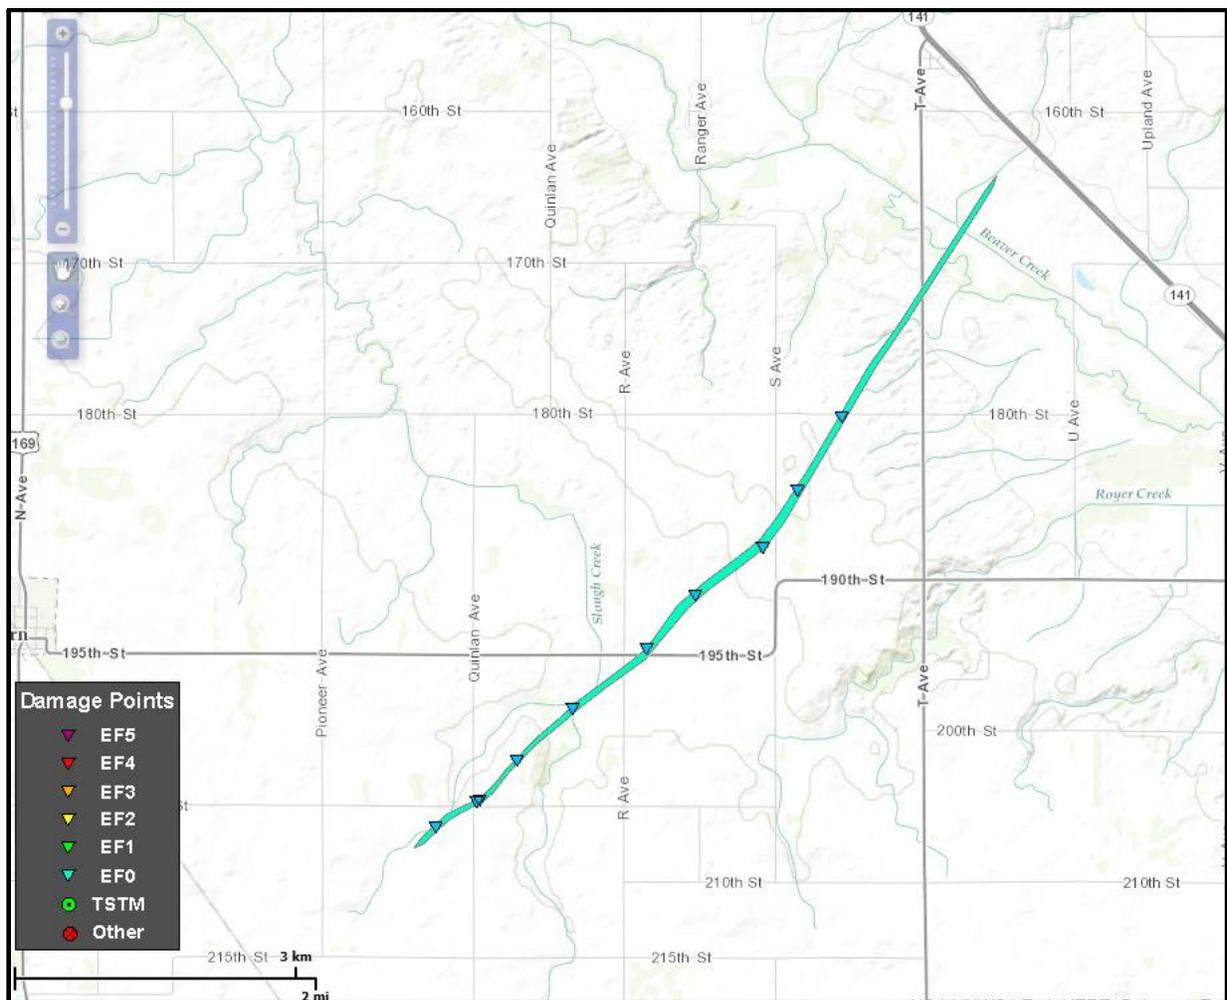
Tornado 3 Path Map:

A combination of radar imagery, a ground survey, and aerial photography revealed that a third tornado touched down in rural Dallas County north of Dallas Center and tracked northeastward for 6 miles. This tornado was accompanied by strong RFD winds and damage was confined to farm outbuildings. A special thanks to John McLaughlin for aerial photos of this track.

Tornado Strength: EF-0

Event Location: 3.5 miles NNW of Dallas Center to 4.8 miles NW of Granger

Peak Wind Speed: 85 mph

Path Length: 6.0 miles

Average Path Width: 100 yards

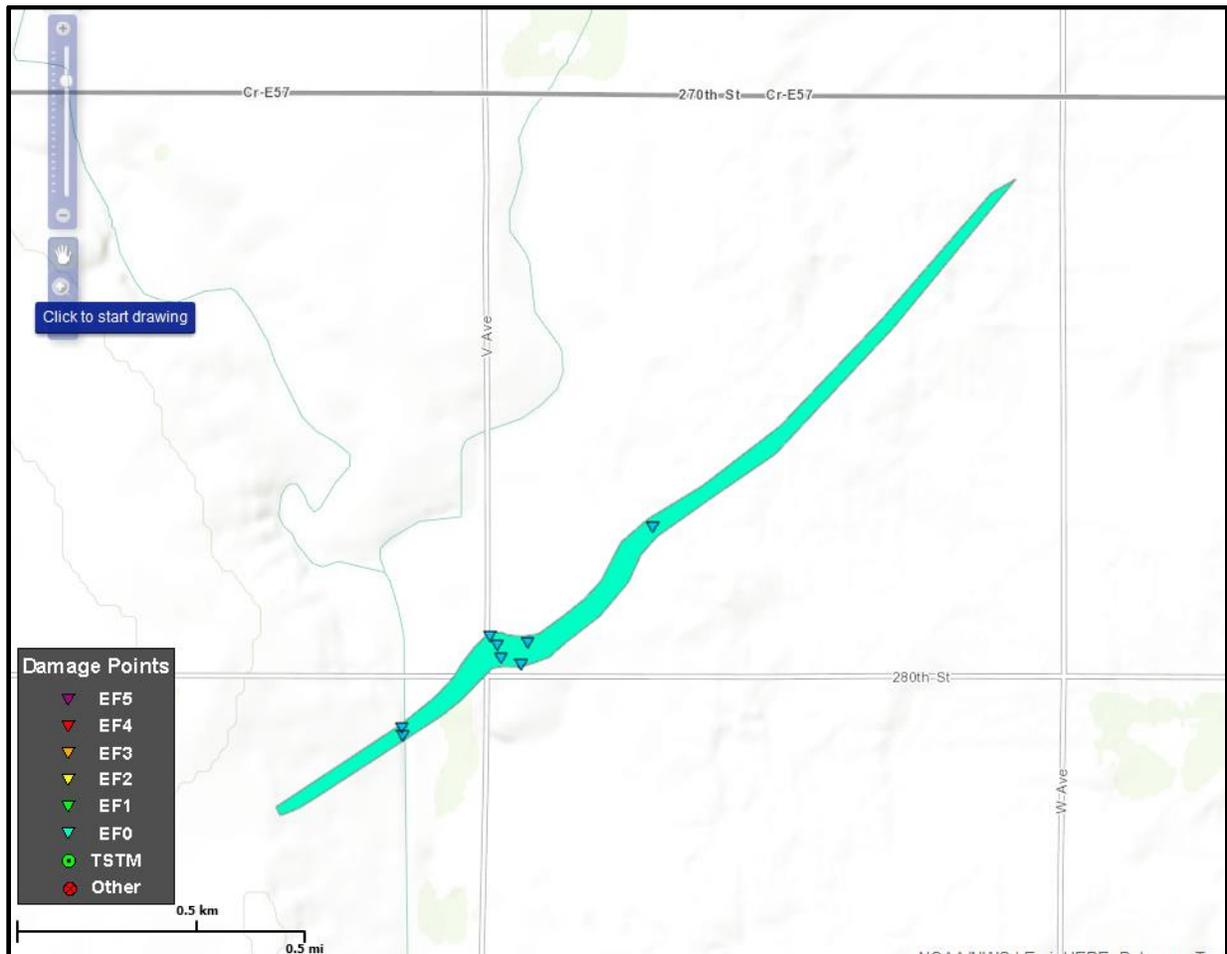
Tornado 4 Path Map:

This brief tornado formed in rural southeast Boone County and damaged a shelterbelt and farmstead. Damage at the farmstead was confined to trees, with damage to structures coming from falling tree debris.

Tornado Strength: EF-0

Event Location: 3.0 miles SE of Luther to 1.7 miles SW of Napier

Peak Wind Speed: 85 mph

Path Length: 1.71 miles

Average Path Width: 100 yards
