NWS Damage Survey

Cloudcroft Wind Event (March 13, 2019)

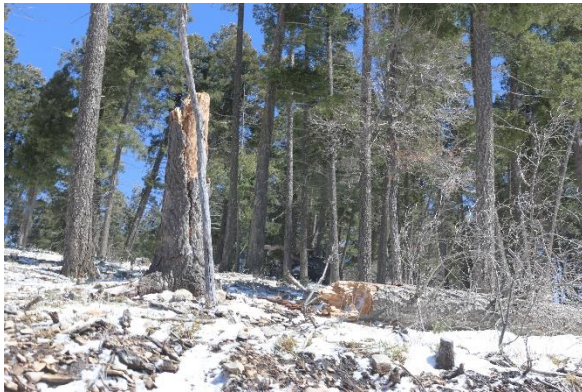
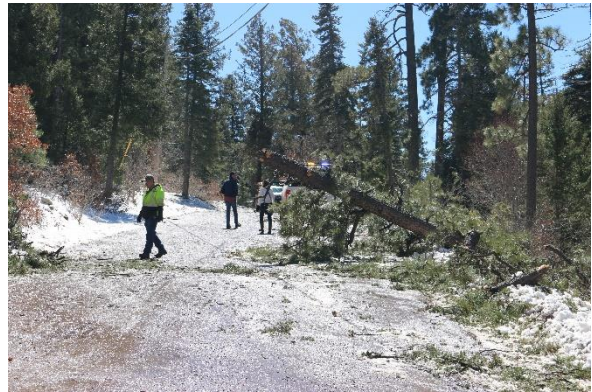
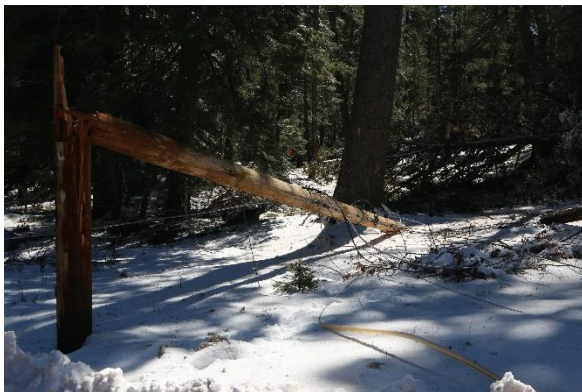
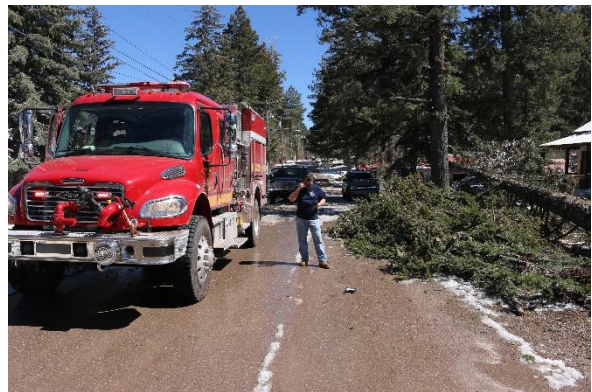
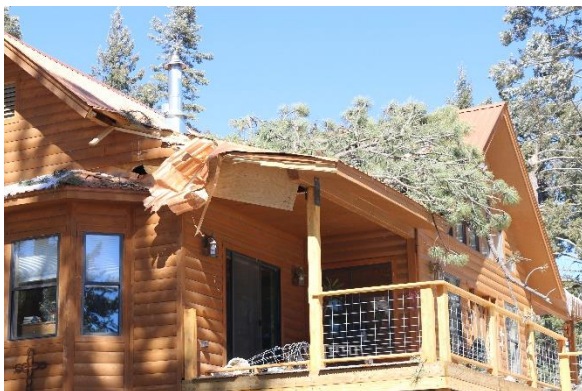
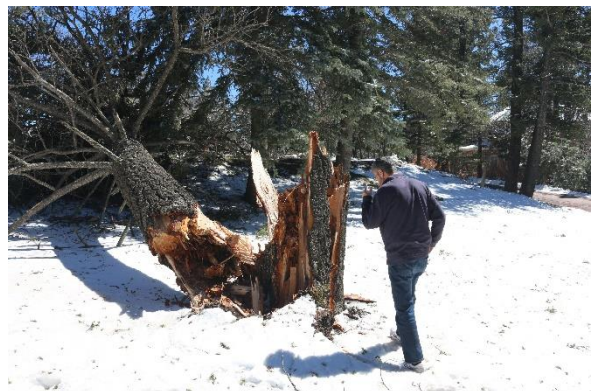
Additional Images...

This damage survey was conducted in the Village of Cloudcroft in Otero county following public reports of over 100 MPH wind gusts and reports of extensive damage within Cloudcroft and nearby areas. Extensive tree damage was observed including both uprooted ponderosa pines as well as pines snapped either at their bases or midsections. The Cloudcroft Fire Department escorted three meteorologists from NWS El Paso to multiple locations where both tree and property damage were located. Wind speed estimates based on the damage done to these hardwood trees suggested an extended period of stress due to sustained winds of near 70 MPH. The most significant tree damage appeared to have been caused by wind gusts exceeding 90 MPH with the highest estimated wind speed estimated to be around 107 MPH.

Meteorological conditions at the time included very strong gradient winds (blowing primarily from the west) across the area extending from the surface to well above mountain top levels. Light to moderate frozen precipitation combined with the strong winds led to excessive rime ice build up on the windward side of the exposed trees. This ice accumulation likely caused the trees to become top-heavy, thus increasing their vulnerability to the strong wind.

The majority of the significant damage surveyed was located on a north to south exposed ridge line on the windward side of the mountain. Most of the damage also appeared to be located at the edge of canyons, where funneling of up-canyon winds resulted in the higher wind gusts that were ultimately responsible for the most extensive damage.
