Event Overview:

Shelby and Macon County Tornadoes of 10/13/2014

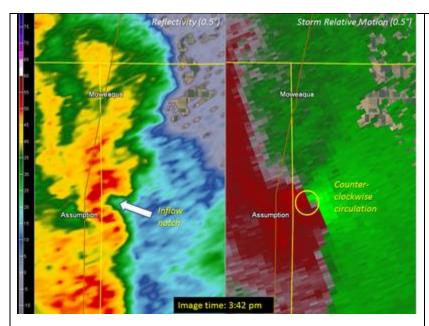
These radar images were taken at 3:42 pm, a few minutes after the tornado warning was issued for northwest Shelby County. On the left is the regular reflectivity image, which shows what meteorologists refer to as an "inflow notch" (area of low precipitation intensity, which shows an area of strong inflow winds). On the right is the storm relative motion product from the radar, which shows the wind flow. Green colors are indicating winds moving toward the radar (located off the northwest corner of the image), and red colors are moving away from the radar. The area inside the circle, with the red and green immediately adjacent to each other, shows a circulation is developing.

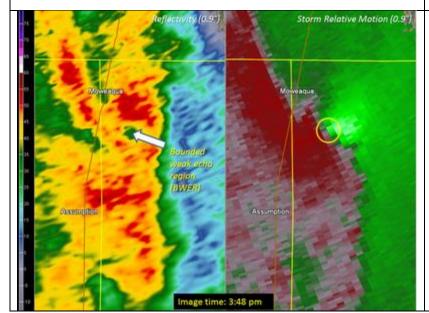
These images were taken at 3:48 pm, and are a bit higher in elevation (0.9 degrees vs. 0.5 degrees on the previous picture). The notch has filled in, but there is an area of lower reflectivity (green shades) completely surrounded by high reflectivity (yellow/red shades). This is referred to as a "bounded weak echo region", which is indicative of potential tornadic activity. The circulation on the right side continues to intensify, as indicated by the brighter greenish-white shades.

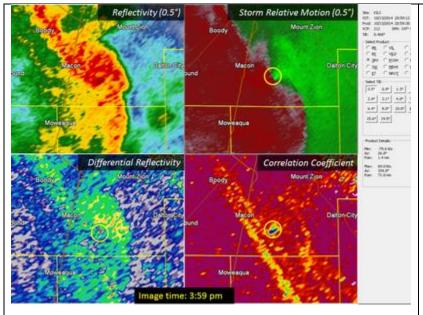
This image from 3:59 pm shows the storm about halfway between Moweaqua and Mount Zion. It shows 4 different radar products. The top left and top right are the reflectivity and storm relative motion products, as we have been discussing. The two lower panels are products resulting from the dual polarization upgrade to our radar a couple years back. The lower left image is called "differential reflectivity" (ZDR), and is a ratio of the reflected horizontal and vertical parts of the radar beam. The lower right image is called "correlation coefficient" (CC), and is a measure of how the horizontal and vertical pulses of the radar beam are behaving. Low values of CC are an indication of nonprecipitation targets detected by the radar beam. The location of the lower CC values line up with the location of the circulation, helping to give confidence to the radar operator that a tornado is on the ground.

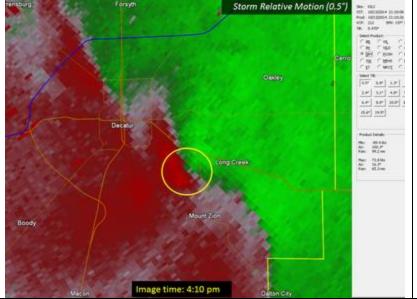
Storm relative motion image from 4:10 pm This storm relative motion image from 4:10 pm shows the storm coming into the Long Creek area. The intensity of the circulation is weaker than it had been, but it is still present. A brief touchdown of a tornado was reported a minute or two later.
