Urgent Survey for 2011 Great East Japan Earthquake and Tsunami Disaster in Ports and Coasts – Part I (Tsunami)

Yasuhiro KAWAI, Taro ARIKAWA, Daisuke TATSUMI, Port and Airport Research Institute (PARI)

The Port and Airport Research Institute is conducting investigations including field surveys just after the earthquake, for recover the ports and coasts in the regions for the Ministry of Land, Infrastructure, Transport, and Tourism (MLITT) .

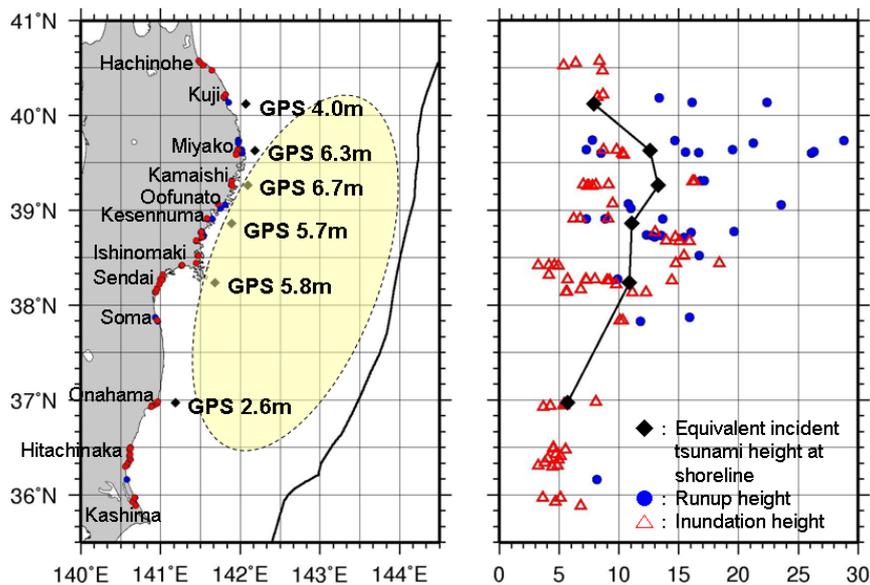
Fig.1 Source region and GPS wave meters(left)
and Estimated Incident Tsunami and Measured Tsunami water marks(right)

Huge tsunami waves were generated by the M9.0 earthquake. The left figure of Fig. 1 shows the source region, which ranges 400km from north to south and 200km from east to west. The sea bottom of the region rose and dropped, causing the initial tsunami. The Port and Harbour Bureau of the Ministry of Land, Infrastructure, Transport and Tourism had installed a number of GPS wave meters (GPS mounted buoy) along the Japanese coast, that measured the tsunami directly. For example a GPS wave meter 18km off the coast of Kamaishi at a depth of 204m measured a 6.7m high tsunami at 15:12. Another GPS wave meter off the coast of

The GPS data are very important for the disaster analysis. For example the incident tsunami can be estimated from the GPS data. The right figure of Fig.1 shows 'Equivalent Incident Tsunami Height at Shore' which is evaluated considering shoaling coefficient assuming perpendicular incidence and parallel contours. The estimated tsunami height at shore η (defined here as equivalent incident tsunami height at shore) is evaluated by $\eta = (h_G \eta_G^4)^{0.2}$ where the water depth h_G and the GPS tsunami height η_G . As mentioned above the equivalent incident tsunami height at shore is two or three times the GPS values -- 7.9m at Kuji, 12.6m at Miyako, 13.3m at Kamaishi, 11.1m at Hirota Bay (Rikuzen-Takada), 10.9m at Kinkazan, and 5.7m at Onahama.

The right figure of Fig.1 shows the measured water mark heights. Although the teams of Japan Society of Civil Engineers also measured the water marks, the figure shows only the authors' data due to the urgency of this report. The water mark heights are the heights above the sea level when the tsunami arrived and include those of inundation heights and run-up heights. The data scatters significantly. The run-up heights exceed 15m and the inundation heights vary from 5 to 15m approximately. The equivalent incident tsunami height at shore agrees with the average of the measured inundation heights which exceed 10m in Miyagi and Iwate Prefectures.

It is well-known that the tsunami height increases at sawtooth coastlines with decreasing width and resonant effects and the heights increases with refraction effects, while the heights decrease with the sheltering effects due to natural islands, artificial breakwaters, and seawalls. These are the reasons of the wide scattering of the measured data in Fig.1. It should be noted that the tsunami ran up rivers and overflowed from the rivers.

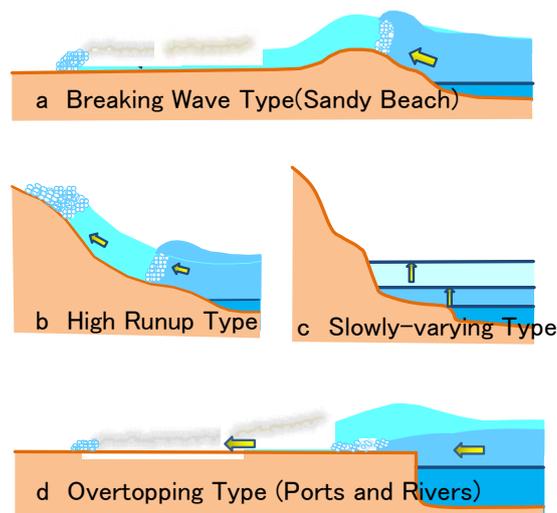
Fig.2 Typical cross sections of shores and intrusion of a huge tsunami

Tsunami height changes significantly due to the shore profile. Figure 2 shows a schematic diagram of typical cross sections of the shores to explain the intrusion of tsunami more than 10m. Videos and photos that were taken during the tsunami attacks will be analyzed further to reveal the tsunami behaviors at shore.

Tsunami fronts break and run up rapidly on a relatively steep slope. This type of rapid runup with breaking waves was seen at Omoe Peninsula and Ryori-Shirahama Bay where the runup heights were more than 20m. The sea bottom slope at Ryori-Shirahama is 1/100 at a depth of 10m and 1/10 on land. The tsunami runup heights are high at this type of shore in Fig. 1.

Since ports have a relatively large water depth and tsunami does not break. In Kamaishi port the tsunami overtopped the quaywalls and seawalls and intruded into the town with a very rapid current of 10 to 30 km/h. It should be noted that the tsunami heights exceeded those of 1896 Maiji-Sanriku Tsunami and the tsunami heights were more than two times higher in the southern areas from the border of Iwate and Miyagi Prefecture.

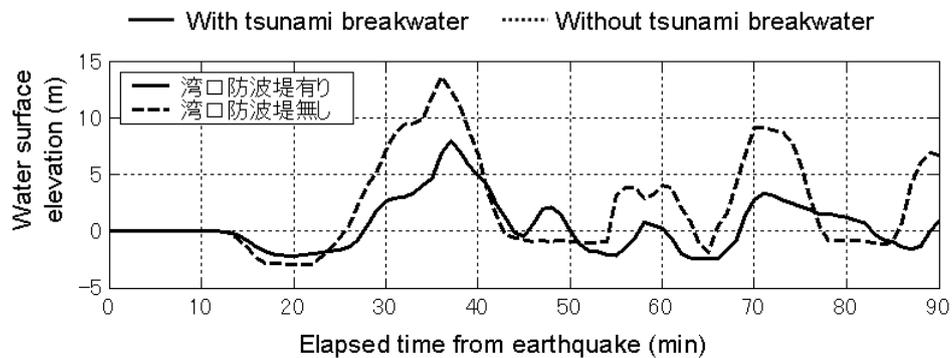
Fig. 3 Calculation results of tsunami profile at Suga in Kamaishi Port

Figure 3 shows a result of numerical simulation for the tsunami at Kamaishi. The tsunami measured by the GPS wave meter 18km off the Kamaishi coast was used as the boundary condition. The figure compares the effect of tsunami breakwater by the two time series of tsunami heights at a tide gauge station of Kamaishi Port with and without the breakwater. The tsunami height is 13.7m without breakwater while 8m with breakwater, reduced to 60 % by the breakwater. The measure value at Kamaishi was around 8 m which agrees with the calculation with the breakwater. It can be said that the breakwater maintained its function until the peak. However, the caissons of the breakwater gradually sunk down and slipped from the breakwater mound due to scouring by the strong current and due to the pressure difference between the front and back walls of the breakwater caissons (Photos 6 and 7)

It should be noted that the tsunami breakwater at Ofunato was designed against Chilean Tsunami and the caissons of that breakwater shifted before the first peak of the tsunami
