**ENGINEERING
ASPECTS OF THE
TORNADOES OF
APRIL 3-4, 1974**

KISHOR C. MEHTA, JOSEPH E. MINOR, JAMES R. McDONALD

Committee on Natural Disasters
Commission on Sociotechnical Systems
NATIONAL RESEARCH COUNCIL

1975

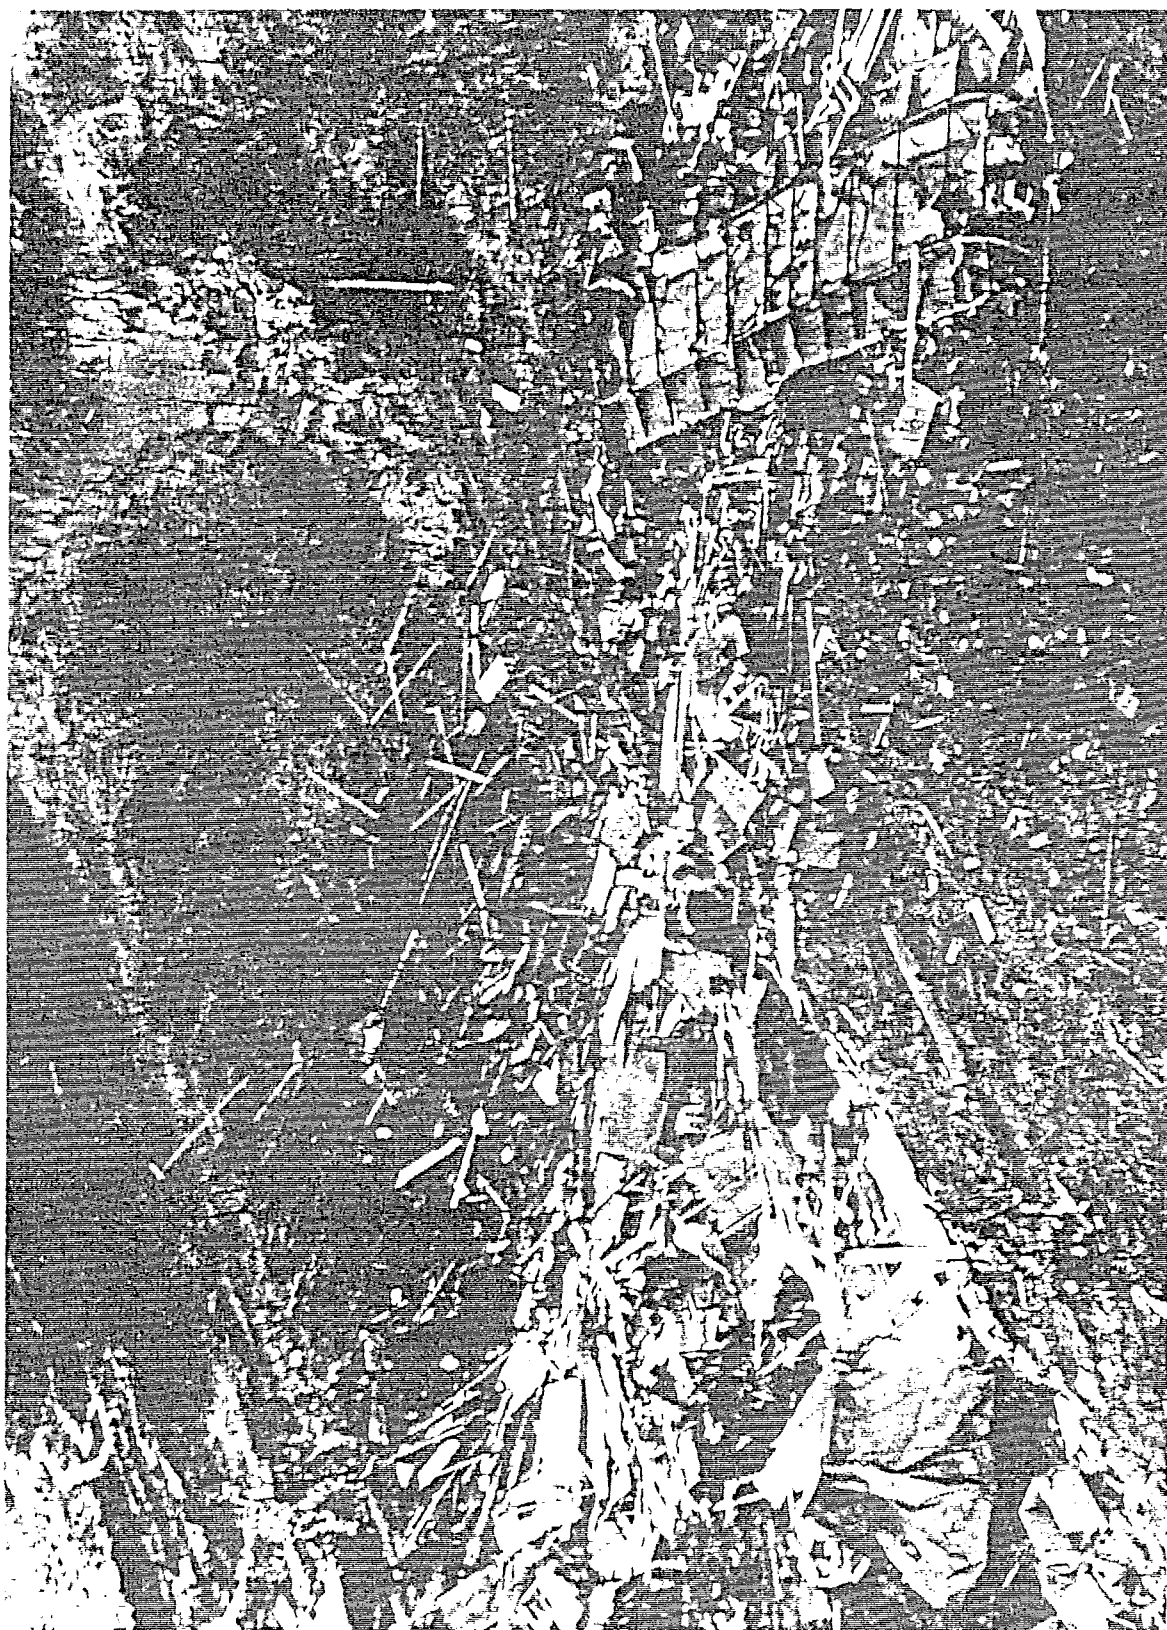
Deaths, injuries, and damage in Michigan occurred primarily in mobile homes. These types of residential units are susceptible to overturning and disintegrating in high winds if they are not properly anchored to the ground. Additional data should be obtained about these mobile homes and about standards for mobile home parks in Michigan. It would be informative to determine anchorage status of the mobile home units which overturned as well as for the ones which did not overturn. Damage and destruction of mobile homes in windstorms is a national problem, particularly in view of large percentages of mobile homes being used as new residential units. A detailed documentation of the behavior of anchored and unanchored mobile homes in tornadic windstorms will provide valuable information to improve design criteria of anchoring systems.

FIGURE 3. HILLSDALE, MICHIGAN. Debris of disintegrated mobile home (photograph courtesy Emergency Services Division, Michigan Department of State Police)

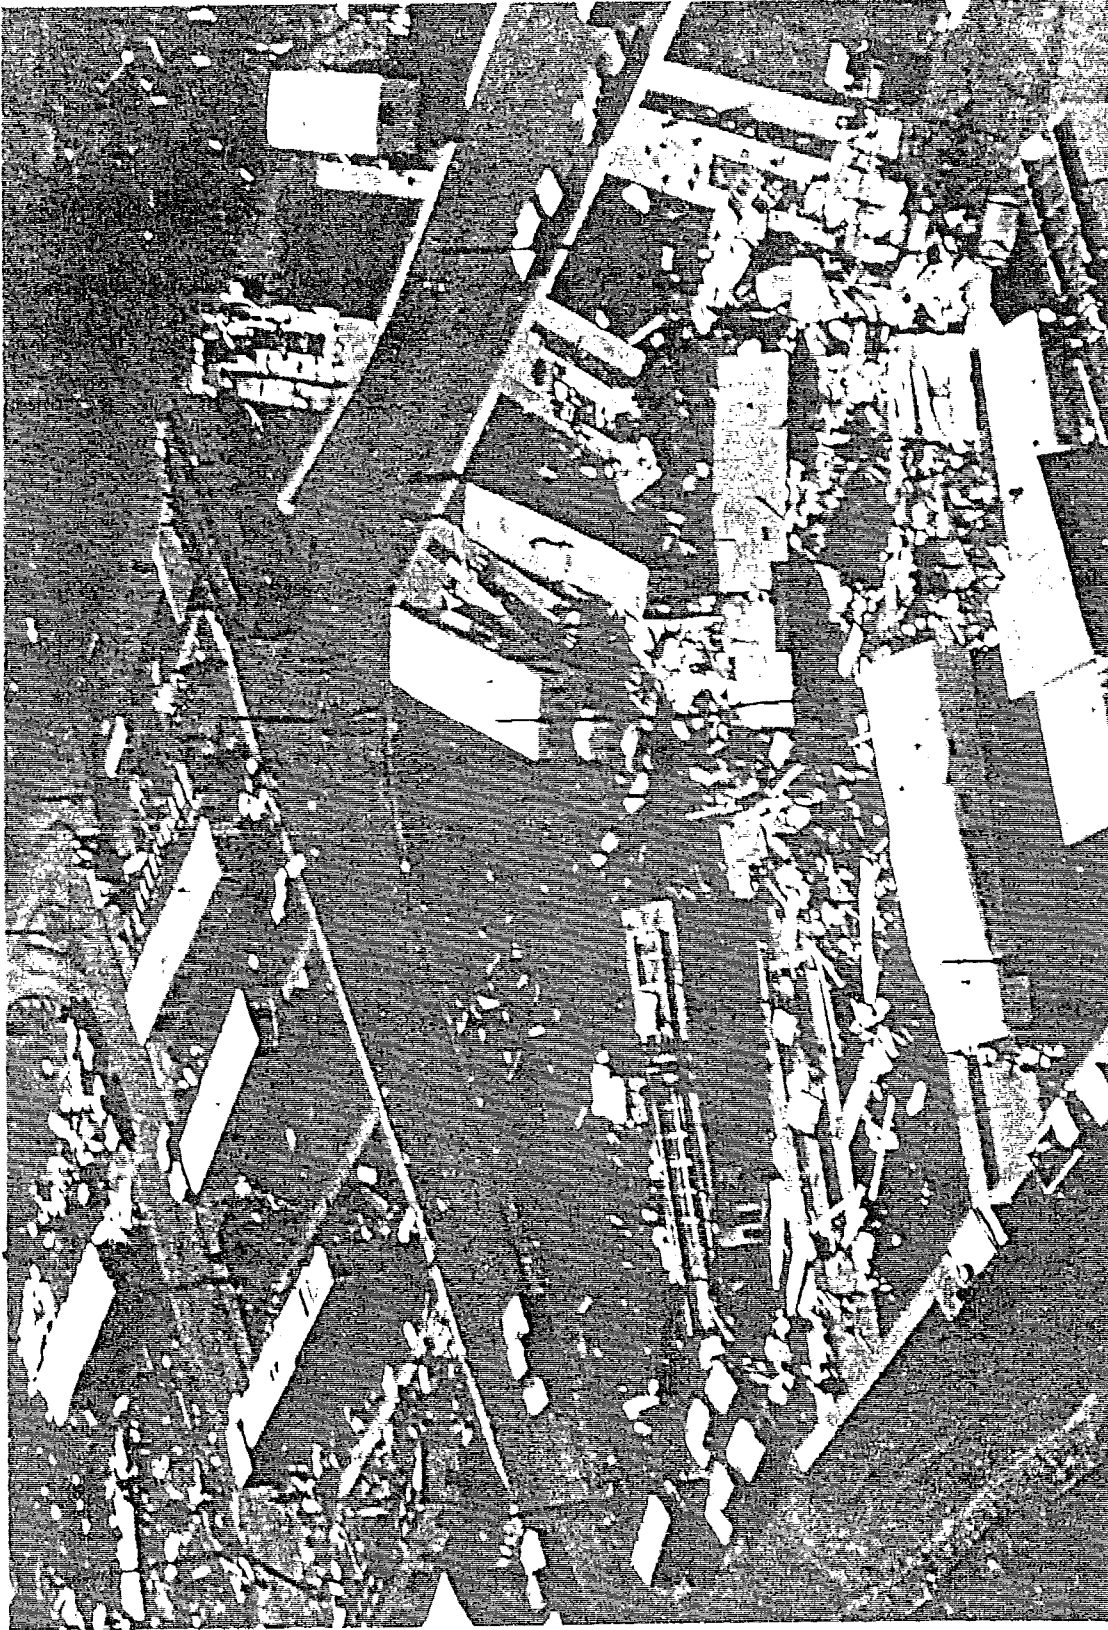
FIGURE 4. HILLSDALE, MICHIGAN. Riley's Mobile Home Park where mobile home units sustained varying degrees of damage. Some residents had taken shelter in the laundry building and outside of the park. (photograph courtesy Emergency Services Division, Michigan Department of State Police)

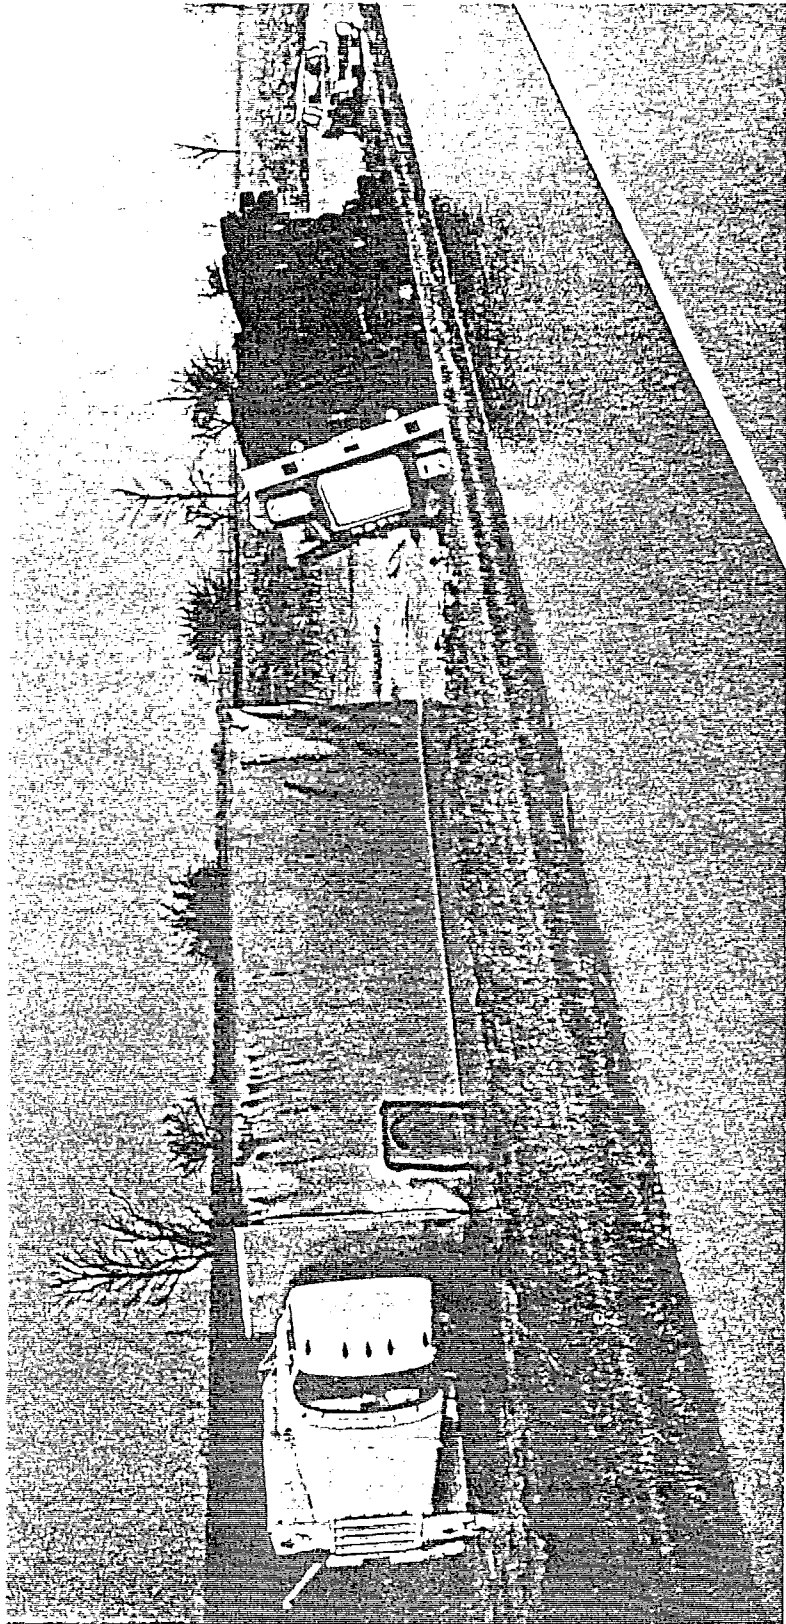
The town of Ogden is located approximately 12 miles east of Champaign, Illinois on Highway I-74. One person lost his life in this area. The tornado destroyed mobile homes, utility poles, and transmission line towers. Figure 8 shows a collapsed transmission line tower and a snapped utility pole. The tornado also overturned vehicles on I-74 as shown in Figure 9. The tornadoes in Illinois were of narrow paths and they seem to be less intense than tornadoes that occurred in other states on this day. The type of damage shown in Figures 8 and 9 could occur from maximum windspeeds in the 80-120 mph range.

FIGURE 9. OGDEN, ILLINOIS. Overturned vehicles on highway I-74. (photograph courtesy of Champaign News Gazette)

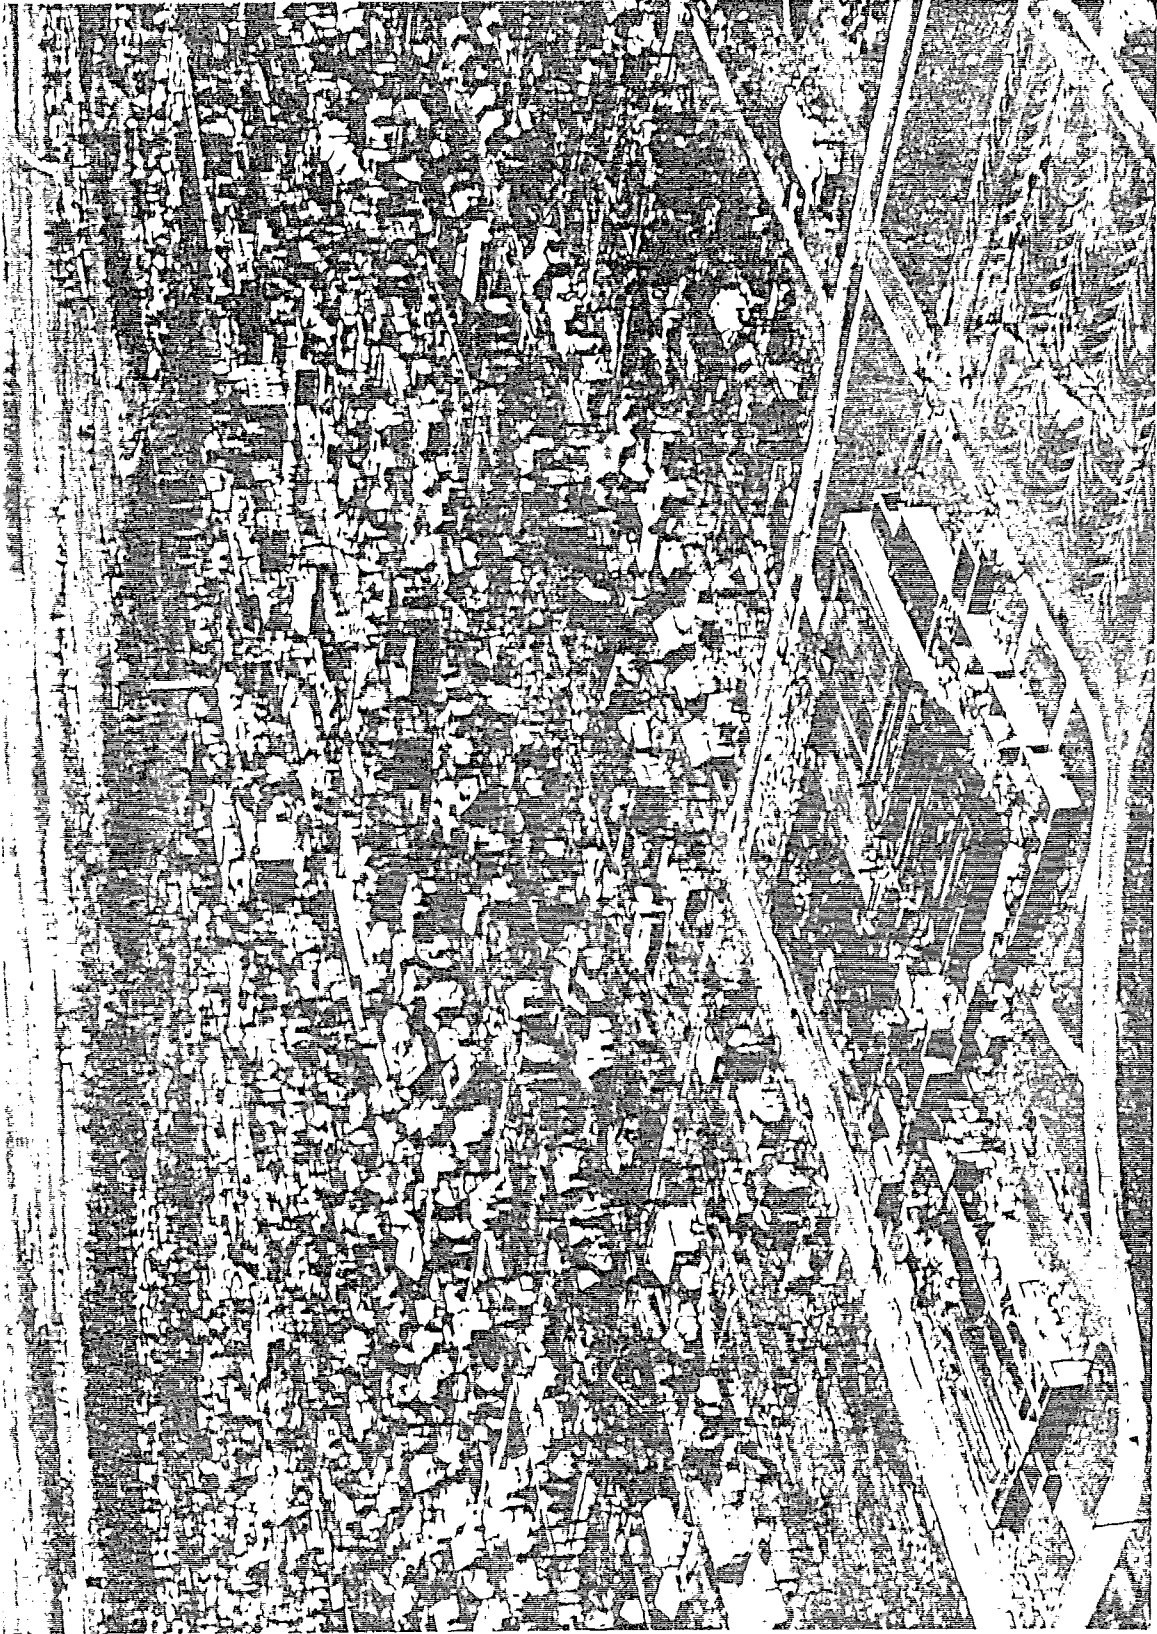
The tornado path through Monticello is illustrated in Figures 11 and 12. The storm crossed an open field as it approached the three schools located on the southwestern edge of the town. From the school complex it moved into a residential area, across an abandoned school, and into the central business district where the county courthouse was severely damaged (Figure 13). It then passed through another residential area to a bluff over the Tippecanoe River. Unusual events took place here: (1) the tornado followed the terrain closely by damaging houses and industrial buildings at the foot of the bluff (approximate elevation difference is 60 ft.) and (2) the winds pushed four spans of a Penn Central Transportation Company railroad bridge off their piers. The spans consisted of two 10 ft. deep plate girders 105 ft. in length carrying a single track. Damaged bridge piers are shown in Figure 14. Structural details of the bridge are available at Texas Tech University.

FIGURE 12. AERIAL VIEW OF DAMAGE PATH THROUGH MONTICELLO. View is toward northeast; Twin Lakes High School is in foreground and damaged railroad bridge is in background. (photograph courtesy U. F. Koehler, Ball State University)

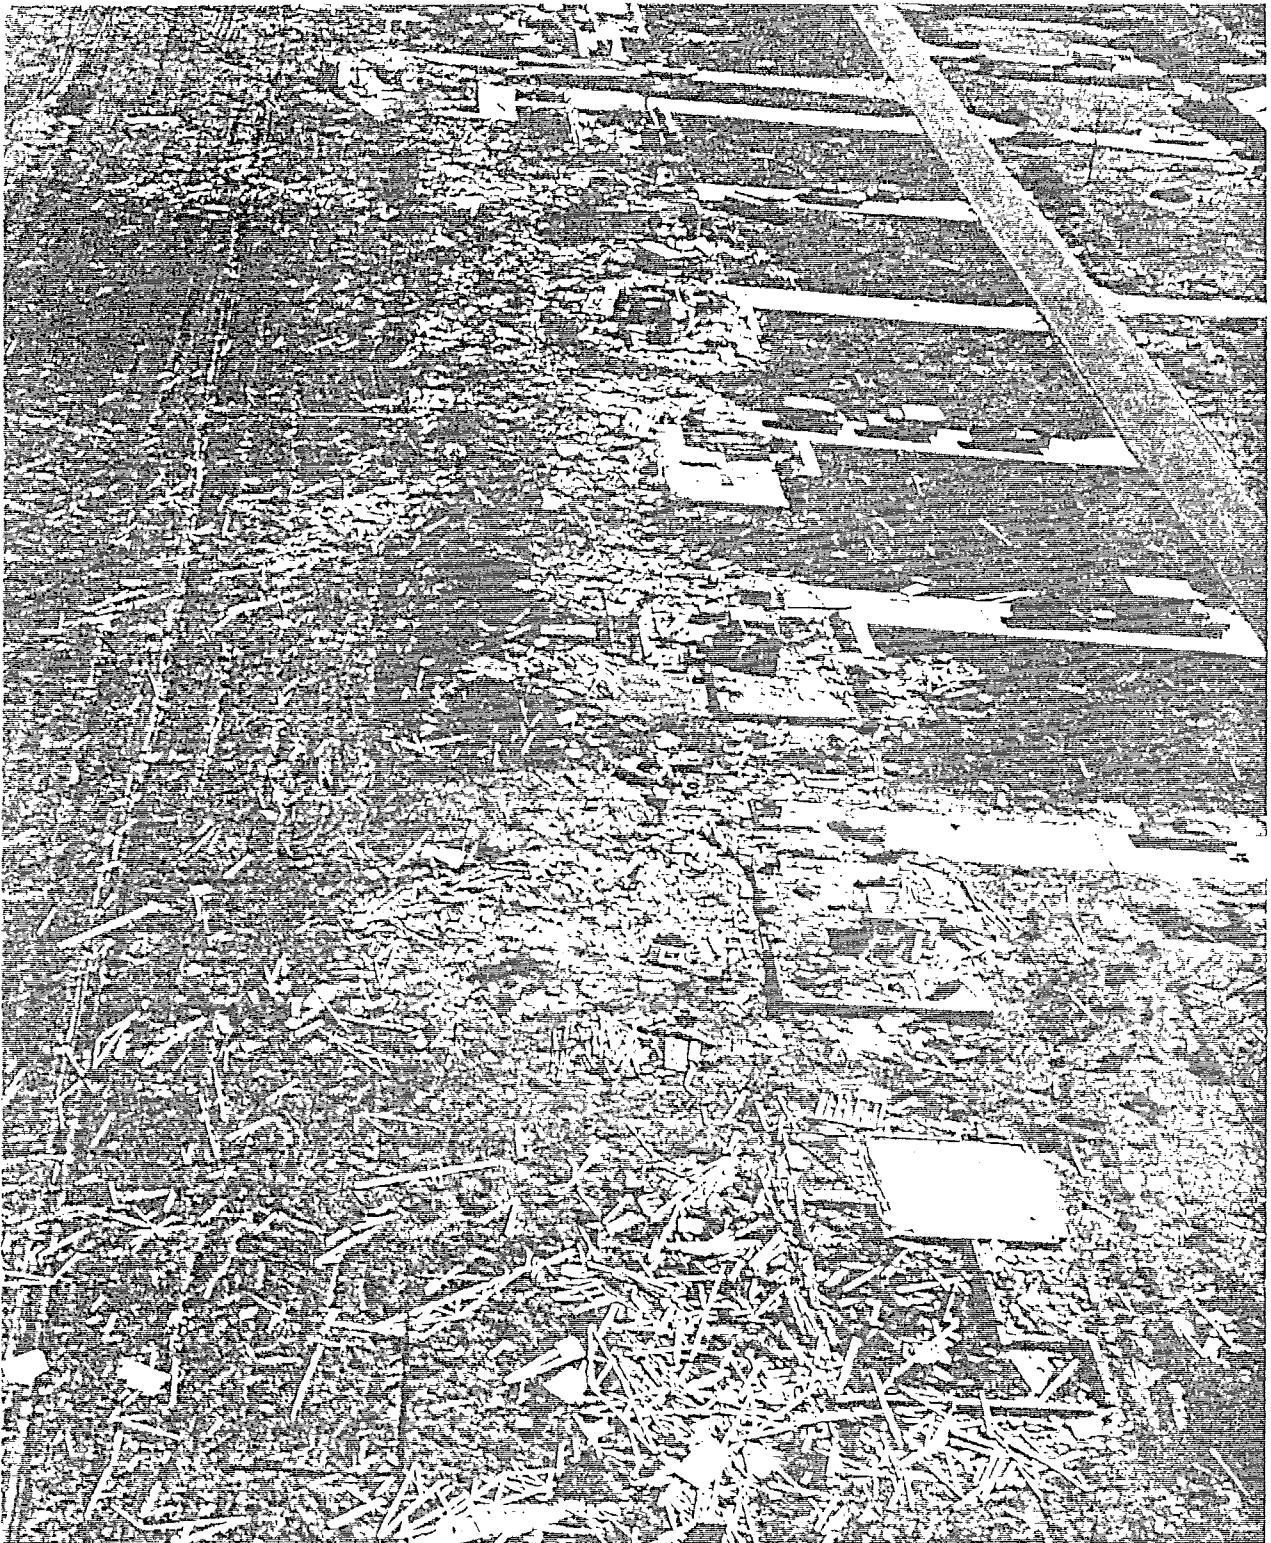
and damaged industrial buildings. Figure 16 includes nine houses in Rochester which were destroyed. Note that in five of these eight residences, a small portion of the interior of the residence survived.

FIGURE 16. DAMAGED RESIDENCES IN ROCHESTER, INDIANA. Note remaining interior portions of some residences. (photograph courtesy U. F. Koehler, Ball State University)

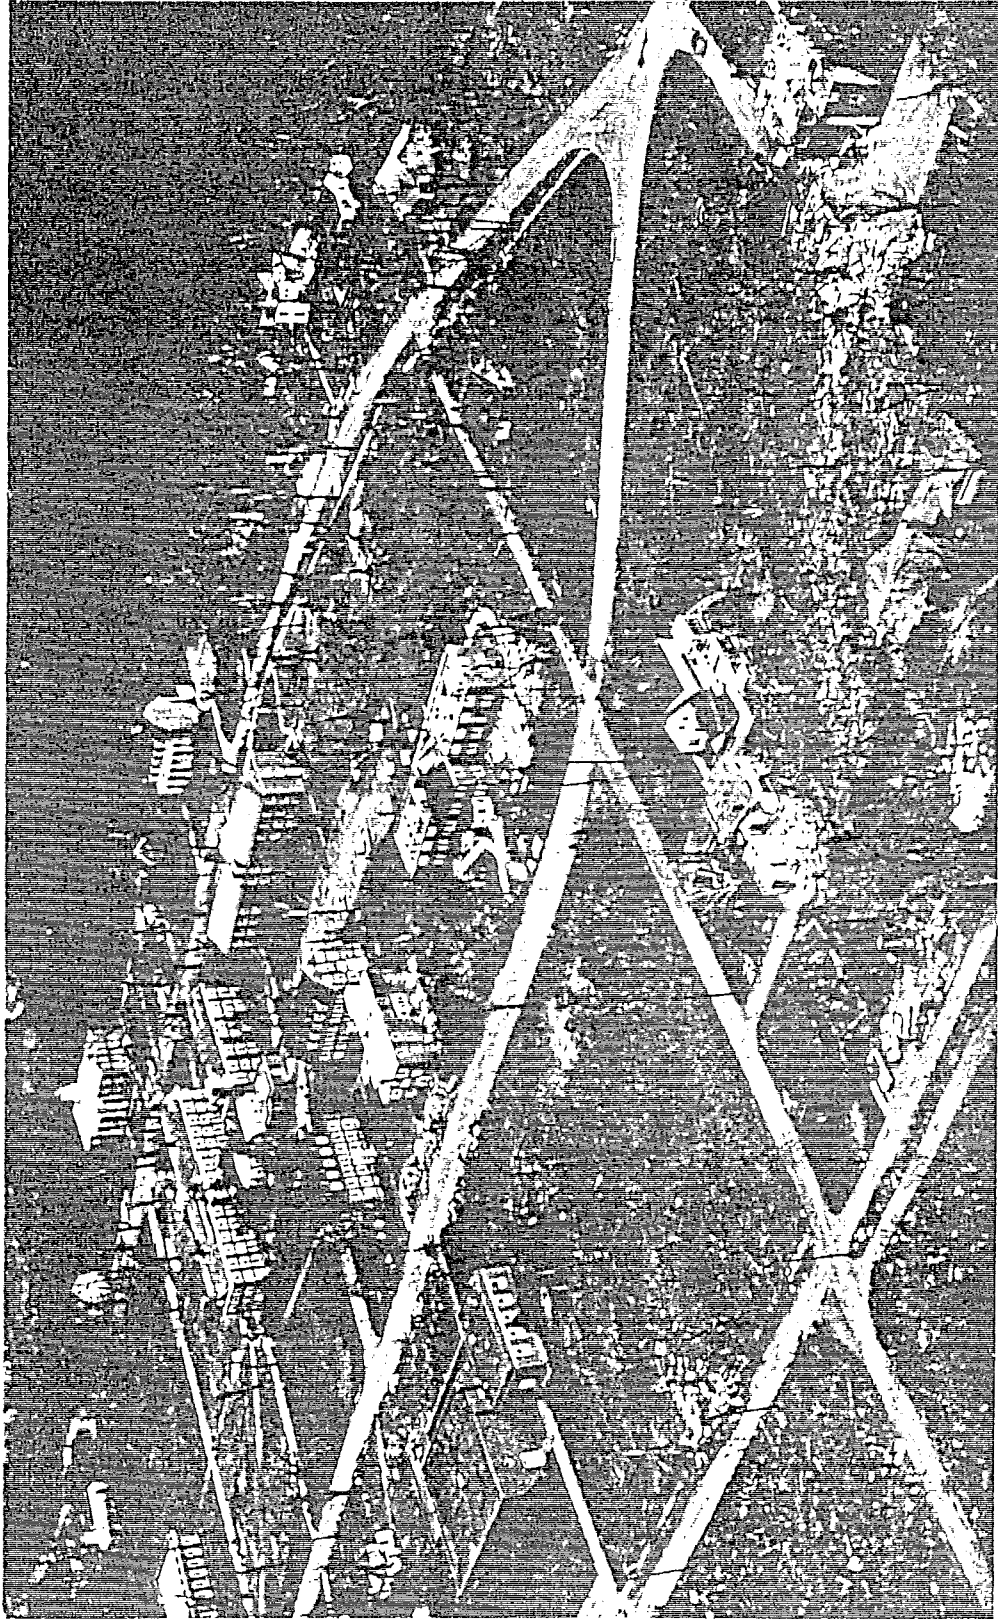
FIGURE 21. DAMAGE TO HANOVER COLLEGE, HANOVER, INDIANA. (photograph courtesy U. F. Koehler, Ball State University)

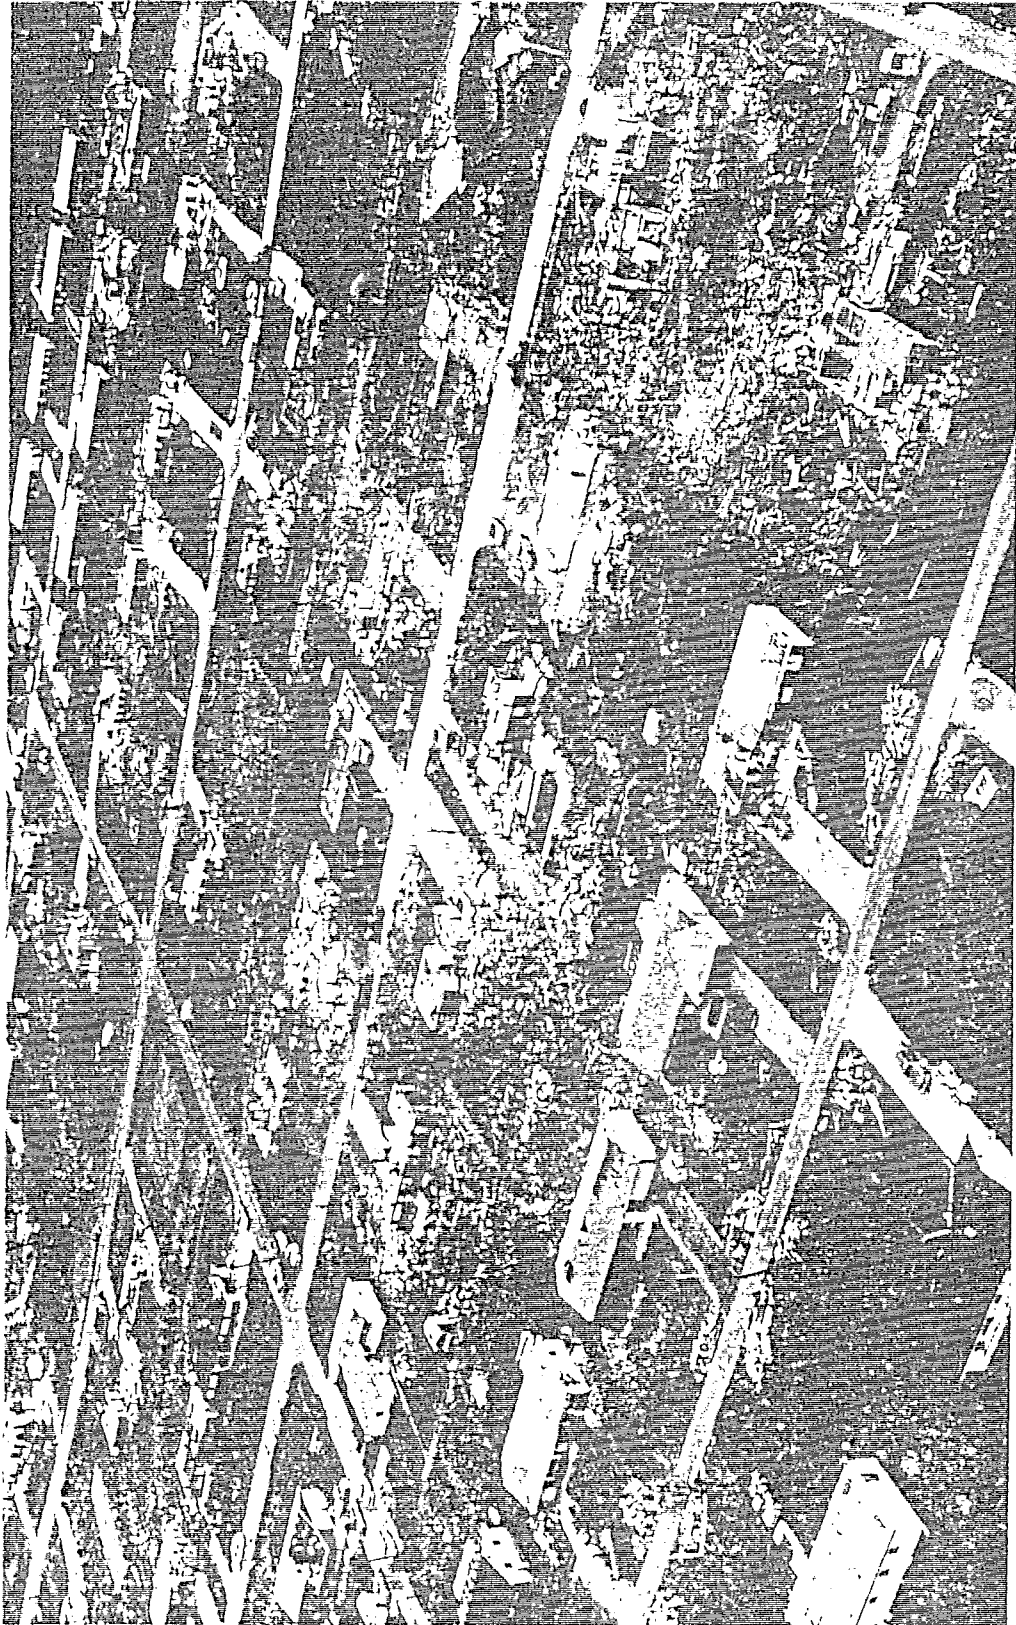
FIGURE 22. DAMAGE TO RESIDENCES IN HANOVER, INDIANA. Note interior portions of some houses which remained standing. (photograph courtesy U. F. Koehler, Ball State University)

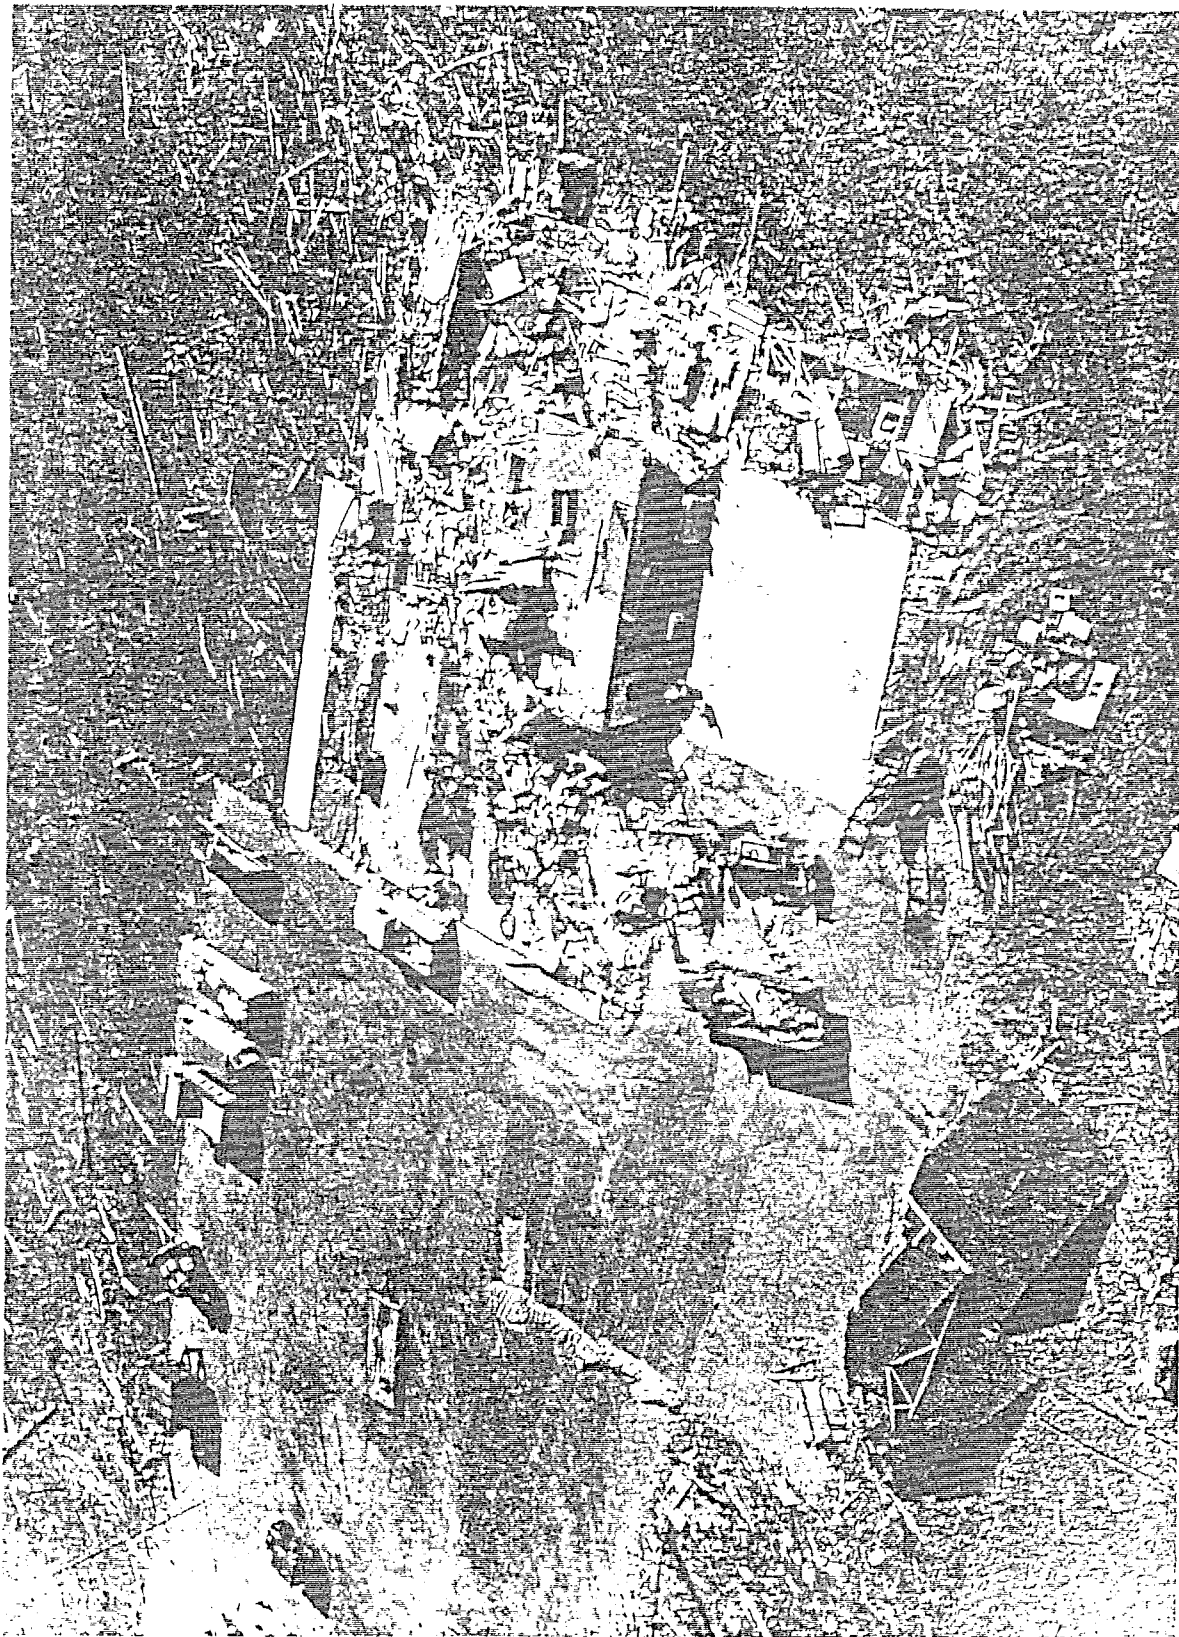
FIGURE 24. FUNERAL HOME DAMAGE, PARKER/FARMLAND, INDIANA. (photograph courtesy U. F. Koehler, Ball State University)

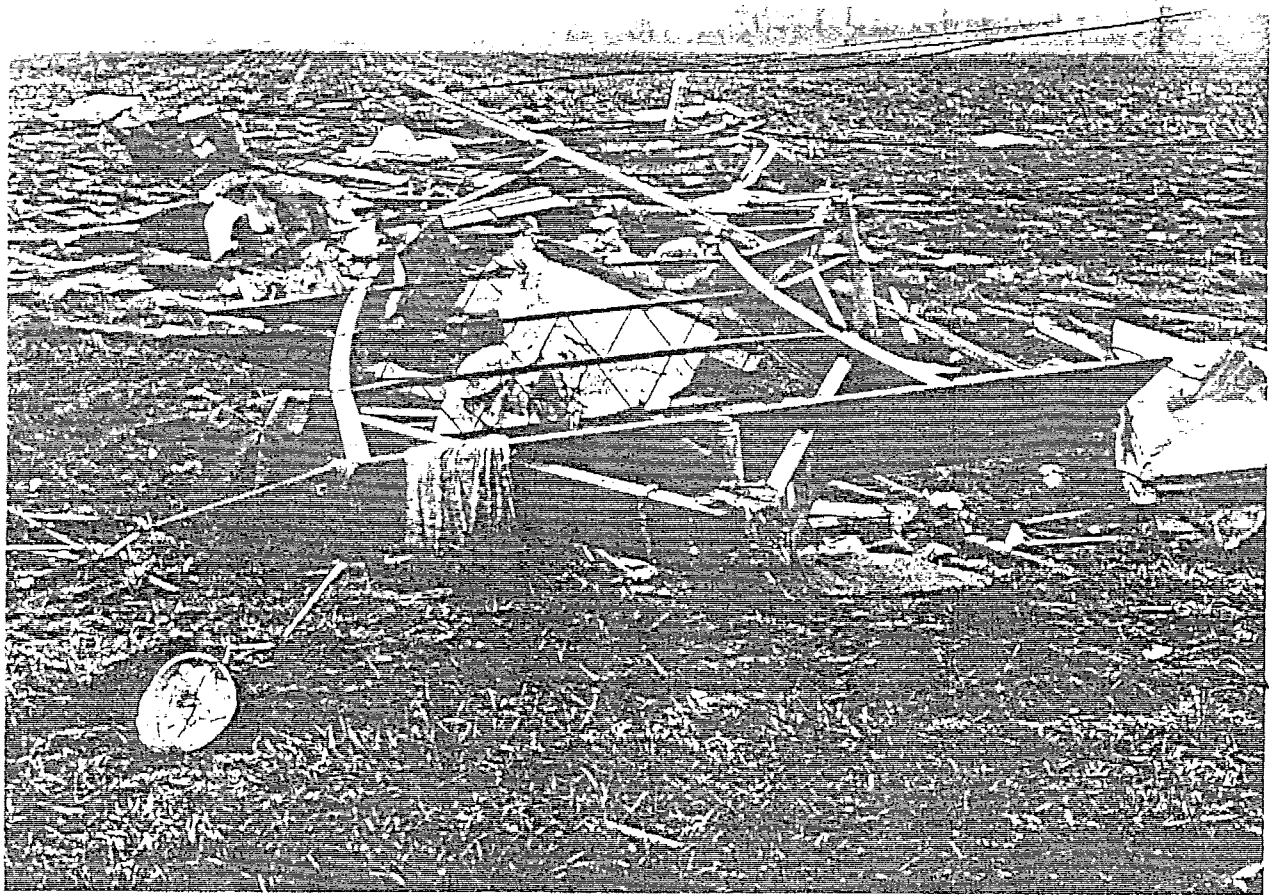
FIGURE 25. MOBILE HOME DAMAGE IN KENNARD DAMAGE PATH. (photograph courtesy U. F. Koehler, Ball State University)

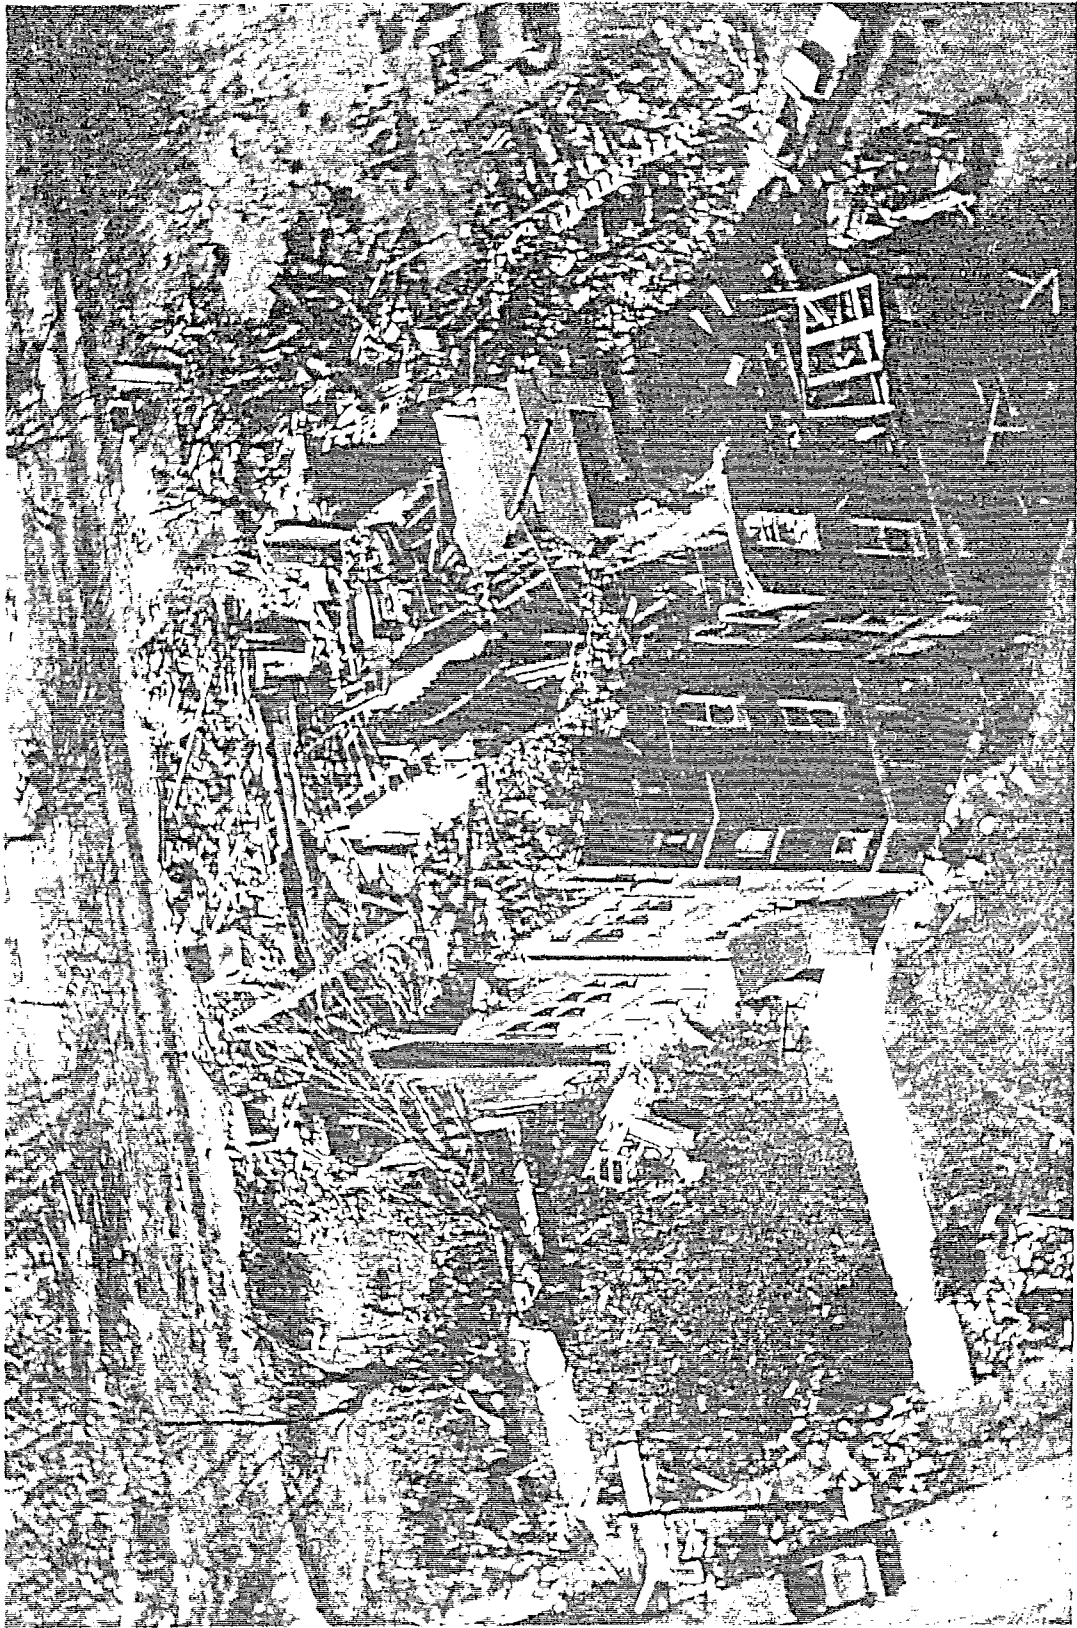
An old three-story elementary school at Kennard was heavily damaged (Ref. Figure 31). Although occupied by more than 100 persons at the time the tornado struck, no one was injured. Failures of loadbearing masonry walls provided the basic collapse mechanism (Ref. Figure 32). First floor interior hallways were havens of refuge in this structure.

FIGURE 31. KENNARD ELEMENTARY SCHOOL. One hundred people in the building were uninjured. (photograph courtesy U. F. Kochler, Ball State University)

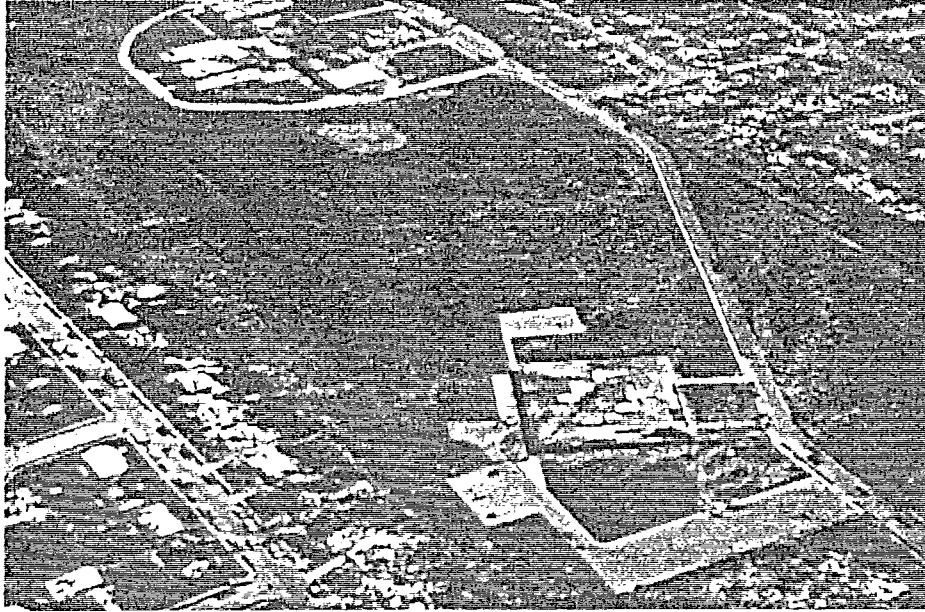
FIGURE 36. ARROWOOD ELEMENTARY SCHOOL. This school (foreground) sustained some damage to roof corners and roof ridges. Residences surrounding the school sustained very severe damage with many of them being totally destroyed.

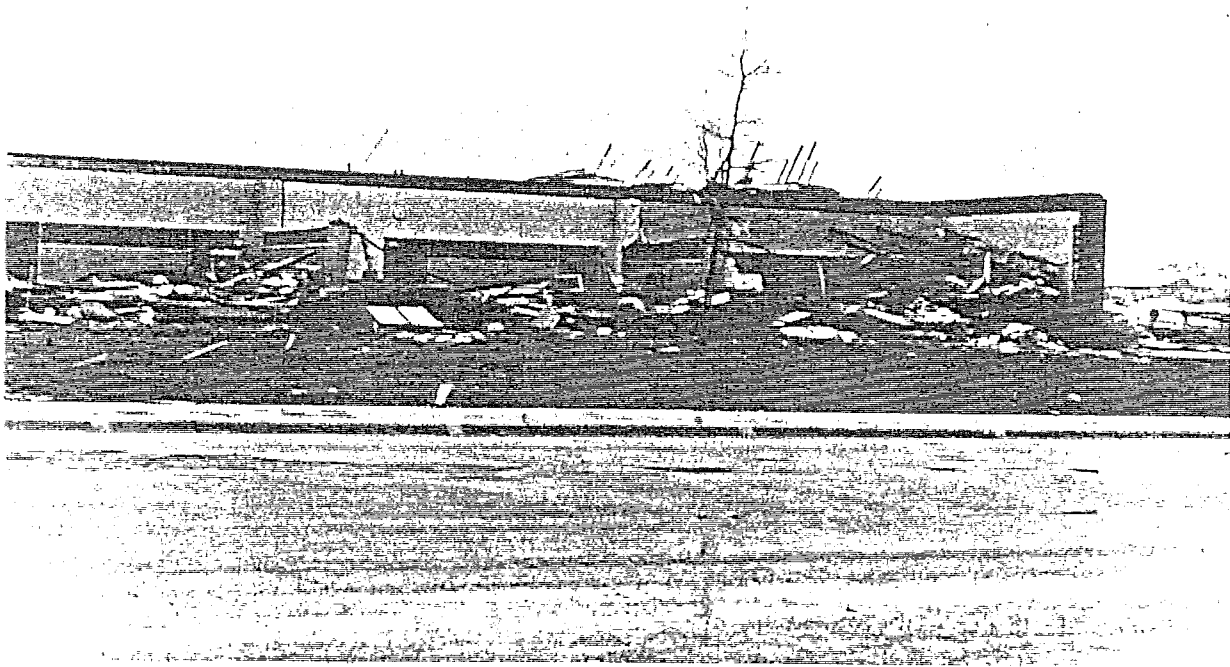
FIGURE 42. SIMON KENTON ELEMENTARY SCHOOL, CLASSROOMS. Exterior walls had collapsed and the roof was entirely uplifted.

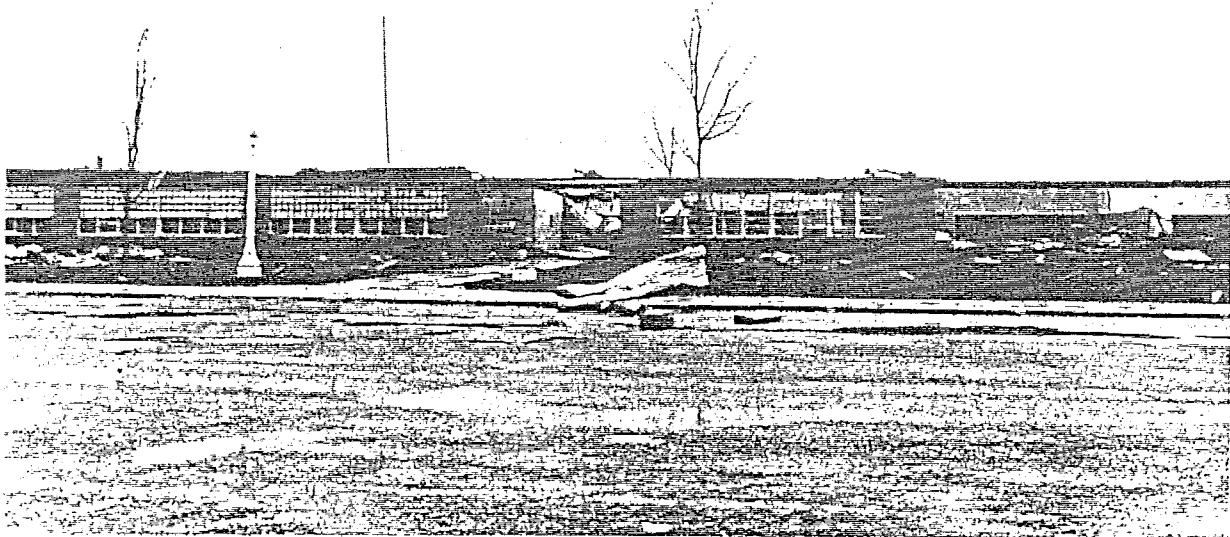
FIGURE 43. SIMON KENTON ELEMENTARY. Roofs over classroom and hallway were uplifted.

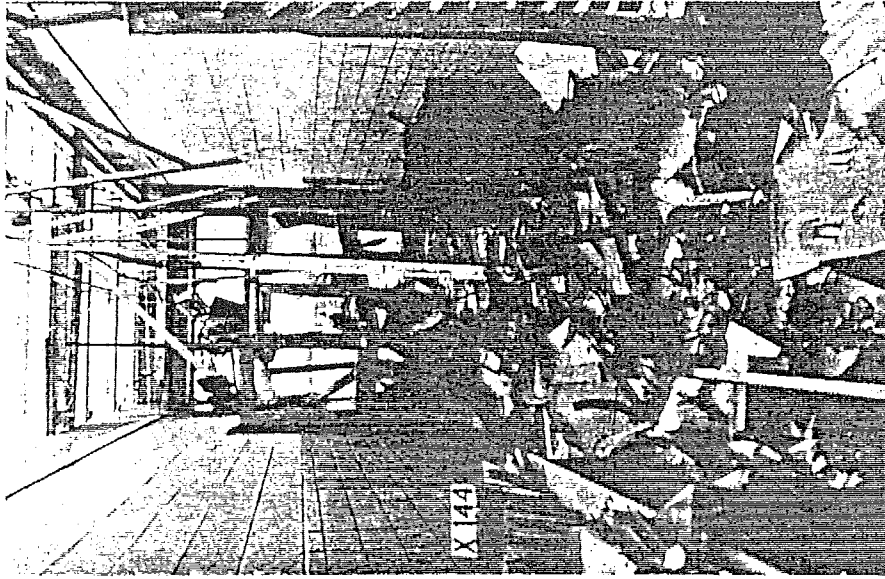
FIGURE 45. SIMON KENTON ELEMENTARY SCHOOL HALLWAY. Large amounts of debris entered through uplifted roof.

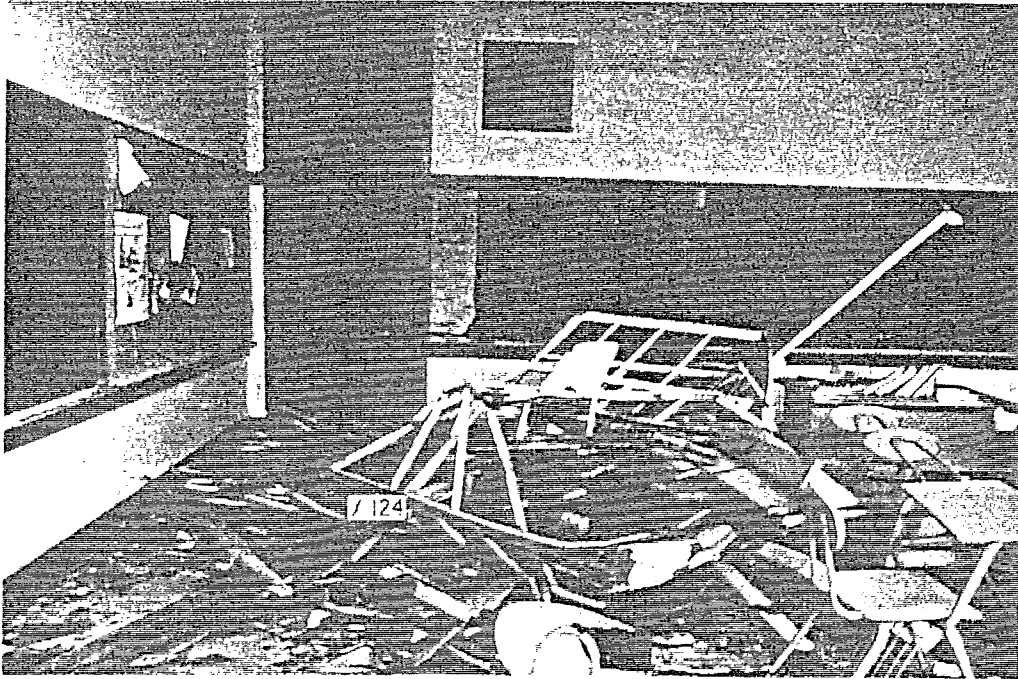
FIGURE 50. CENTRAL JUNIOR HIGH SCHOOL CLASSROOM. The second floor classroom contains a portion of a roof (approximately 40 sq ft in area) which flew in breaking the window frame. The roof and the window frame are visible.

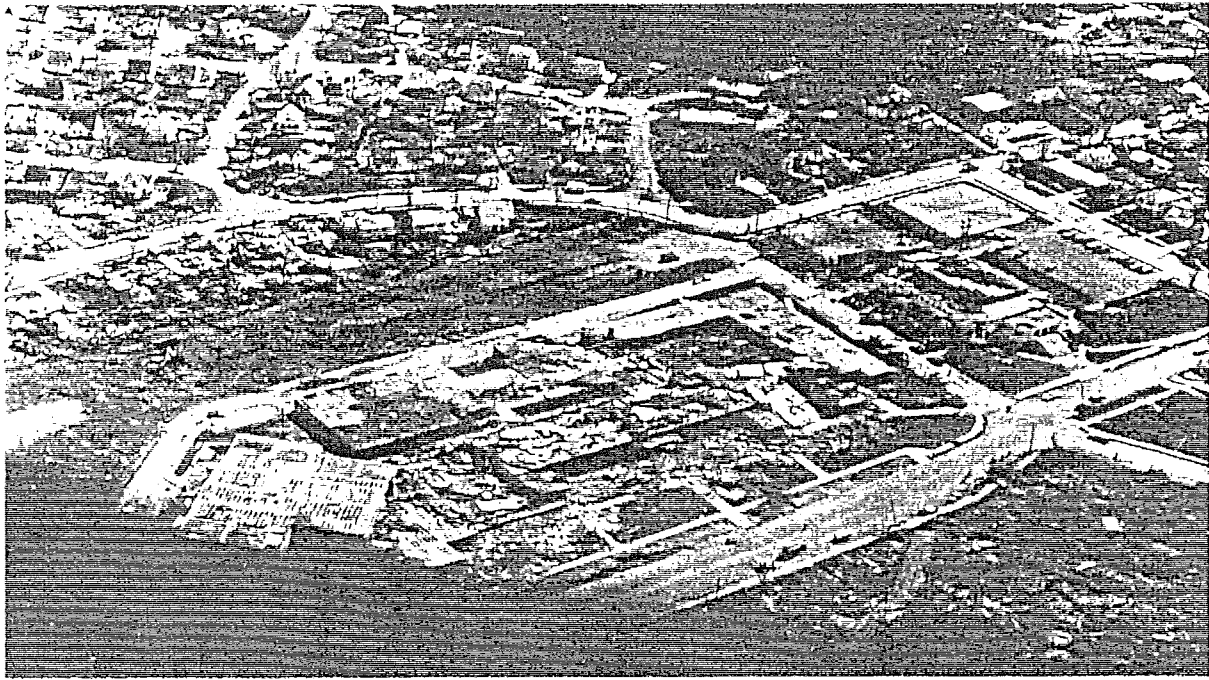
FIGURE 52. XENIA HIGH SCHOOL. Aerial view shows extensive damage to the school building and to the surrounding area. Tornado traveled from bottom right corner to top left corner of the photograph.

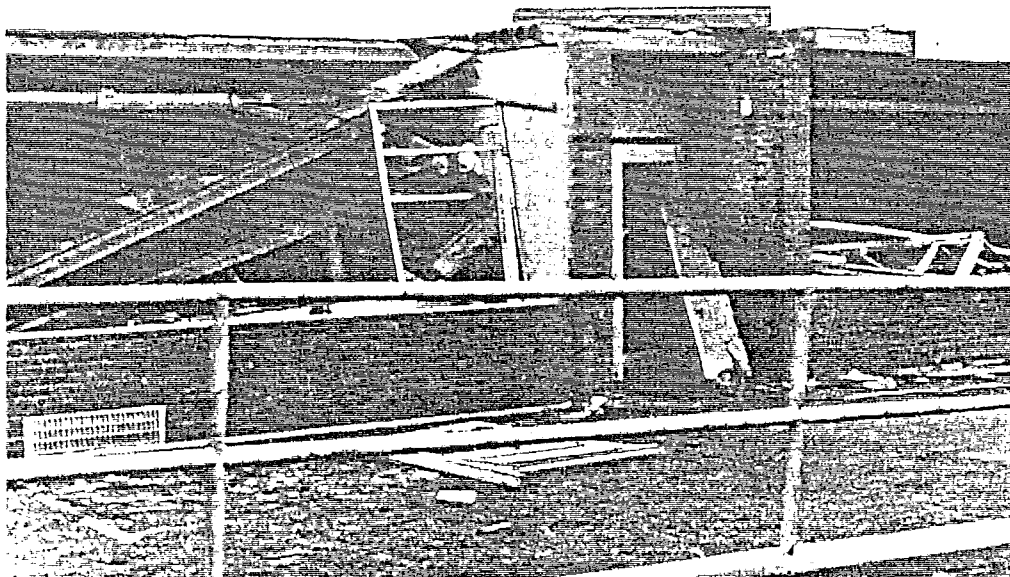
- (1) A utility pole approximately 20 ft. in length. The pole snapped 2 ft. above ground, and traveled 160 ft. This pole is seen in the foreground in Figure 57. All other utility poles in the

FIGURE 57. XENIA HIGH SCHOOL, ONE STORY CLASSROOM BUILDING. Hollow core roof slabs were uplifted.
