**ENGINEERING
ASPECTS OF THE
TORNADOES OF
APRIL 3-4, 1974**

KISHOR C. MEHTA, JOSEPH E. MINOR, JAMES R. McDONALD

Committee on Natural Disasters
Commission on Sociotechnical Systems
NATIONAL RESEARCH COUNCIL

1975

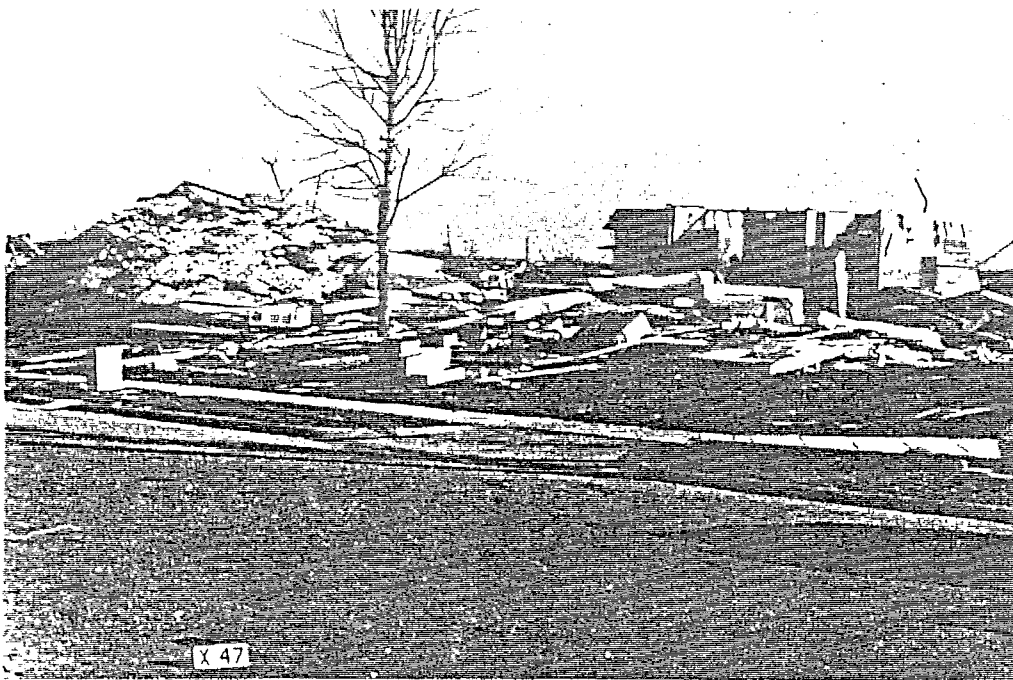
Single family residences which were in the path of the tornado sustained very heavy damage. Most of these can be considered to be total losses. However, even in the residences which can be considered totally destroyed, there was generally a central part of the residence which was still standing (Ref. Figures 61 through 64). The few walls which remained standing could provide a safe place of shelter in case the residence did not have a basement. The experiences in Xenia add to the credibility of having an in-residence shelter in the central part of the residence which would be economical and safe.

FIGURE 62. RESIDENCE. Exterior walls and the roof were blown away. The remaining room could have provided a shelter to the occupants.

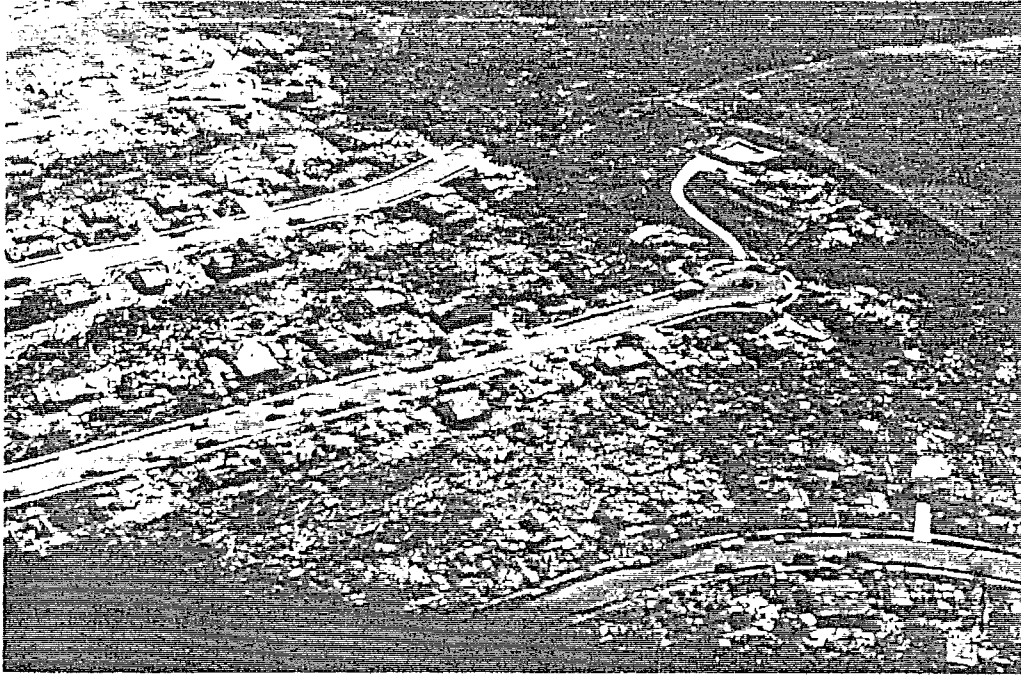
FIGURE 63. RESIDENCES IN NORTHEAST XENIA. The path of the tornado is from bottom right corner to the top left corner. Most of the homes were damaged beyond repair.

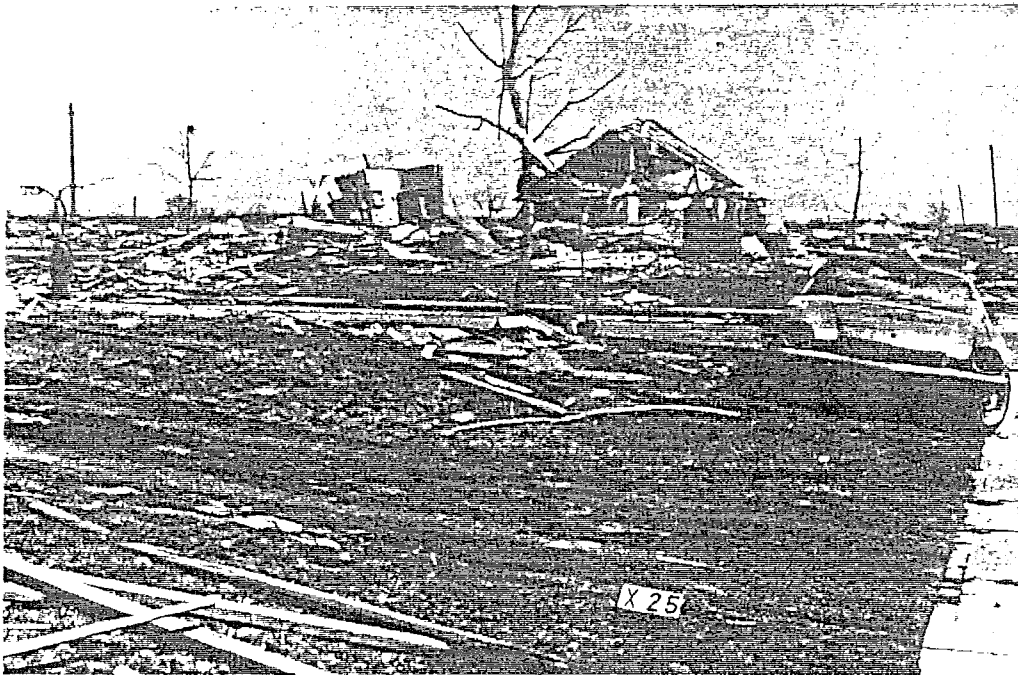
FIGURE 64. RESIDENCE IN SOUTHWEST XENIA. The residences were damaged beyond repair, although there remained some walls standing in most of them.

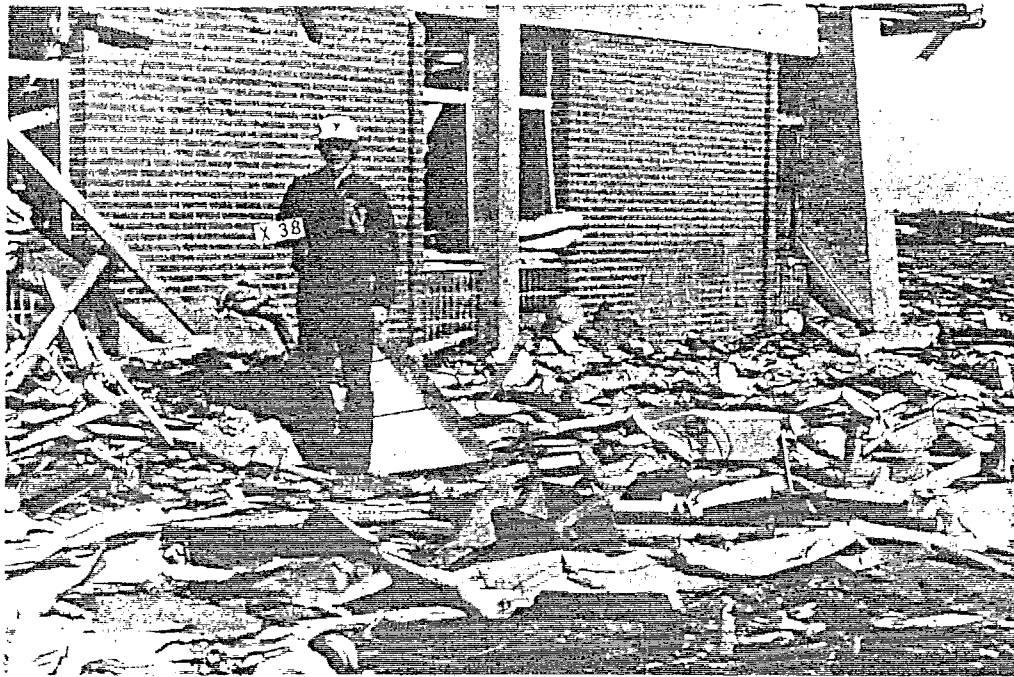
FIGURE 65. DEBRIS. Pieces of timber, roofing material, and other small items deposited at the corner of Arrowood Elementary School. This type of accumulation of debris was typical along the path of the tornado through residential areas.

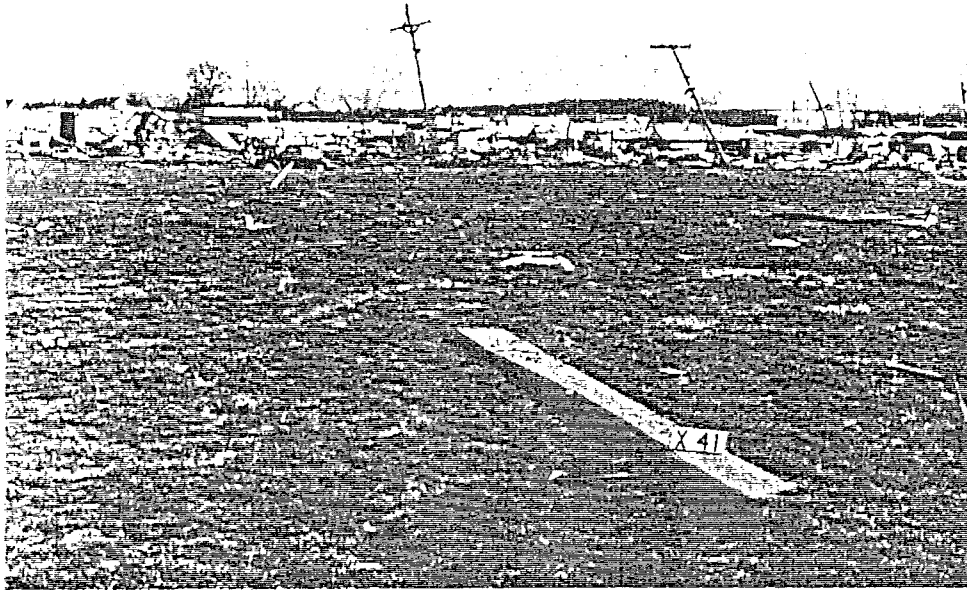
FIGURE 67. TIMBER BEAM. The beam, 3 x 13 in. in cross section and 20 ft long, was uplifted from the roof of the gymnasium of West Jr. High School (Ref. Fig. 41) and was deposited 450 ft from its original location.

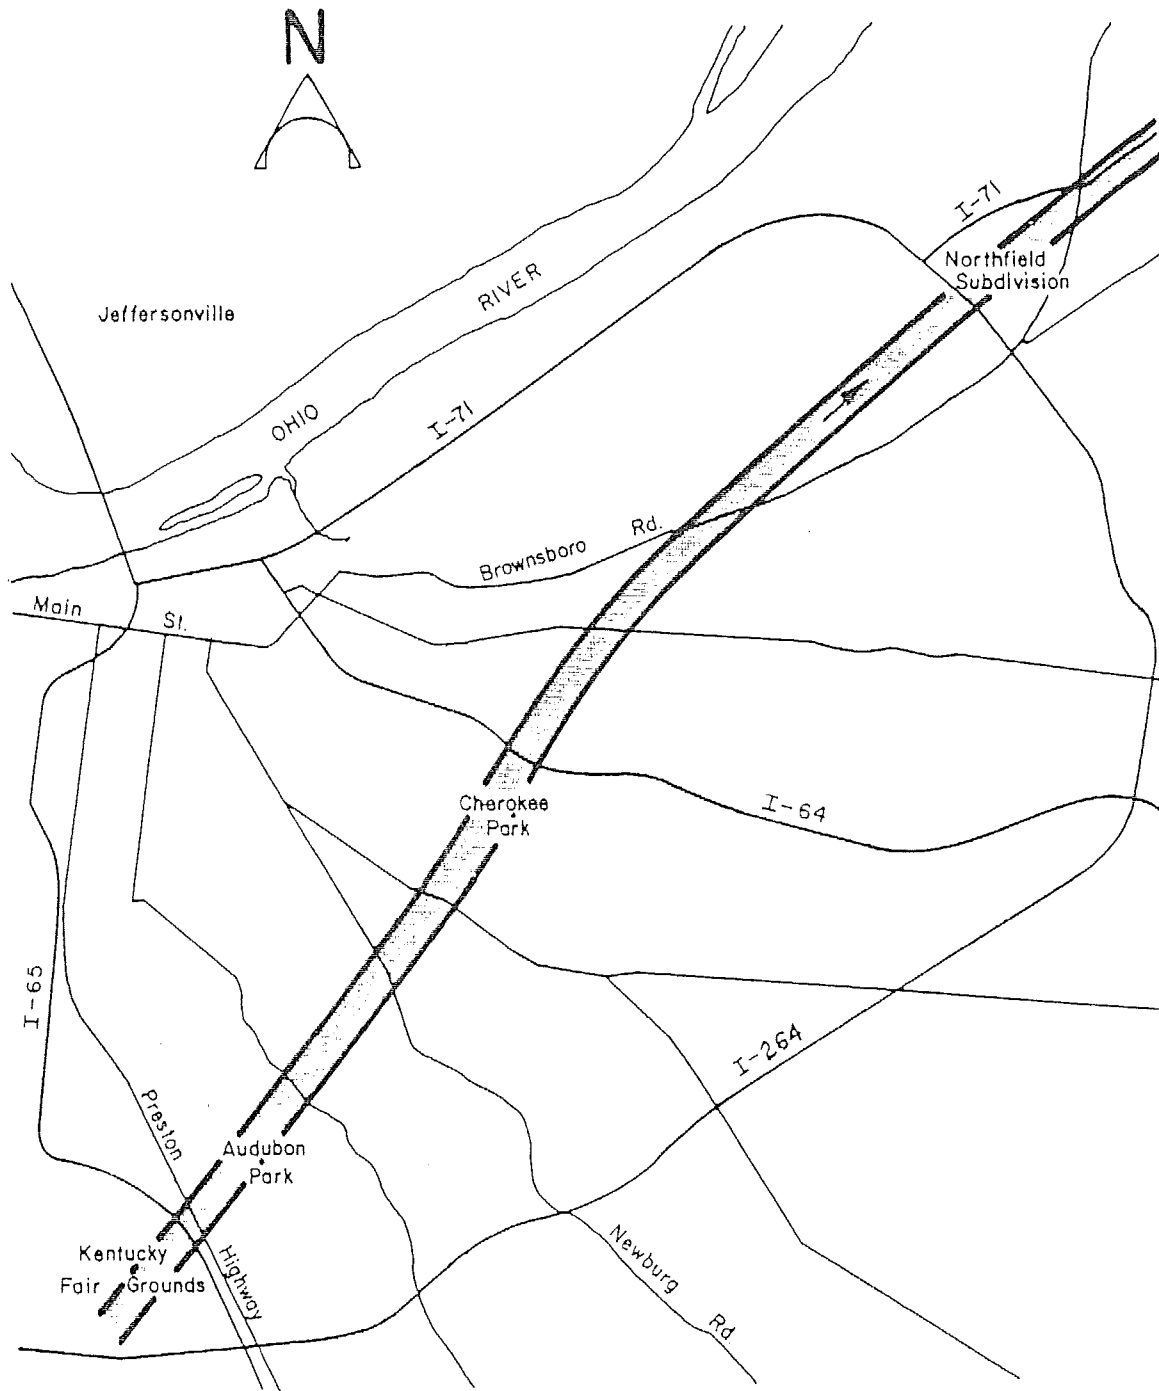
The damage path through the city is shown in a map reproduced from the Louisville *Courier-Journal* (see Figure 70). The damage south and west of Interstate 64 was not as intense as that toward the upper end of the path. Based on the extent of damage to houses and trees, windspeeds along the first half of the path were estimated at 150 mph. Trees in the forest in Cherokee Park were leveled, while in the Indian Hills section, Northfield, and beyond, well-constructed frame houses had roofs and some walls torn off. From these and other observations the windspeeds were estimated to be 175-200 mph.

FIGURE 70. LOUISVILLE STORM PATH. The storm path averaged 660 ft wide and was 10 mi long. Most of the damage was to residences. (Copyright (C) 1974, The Louisville Courier-Journal)

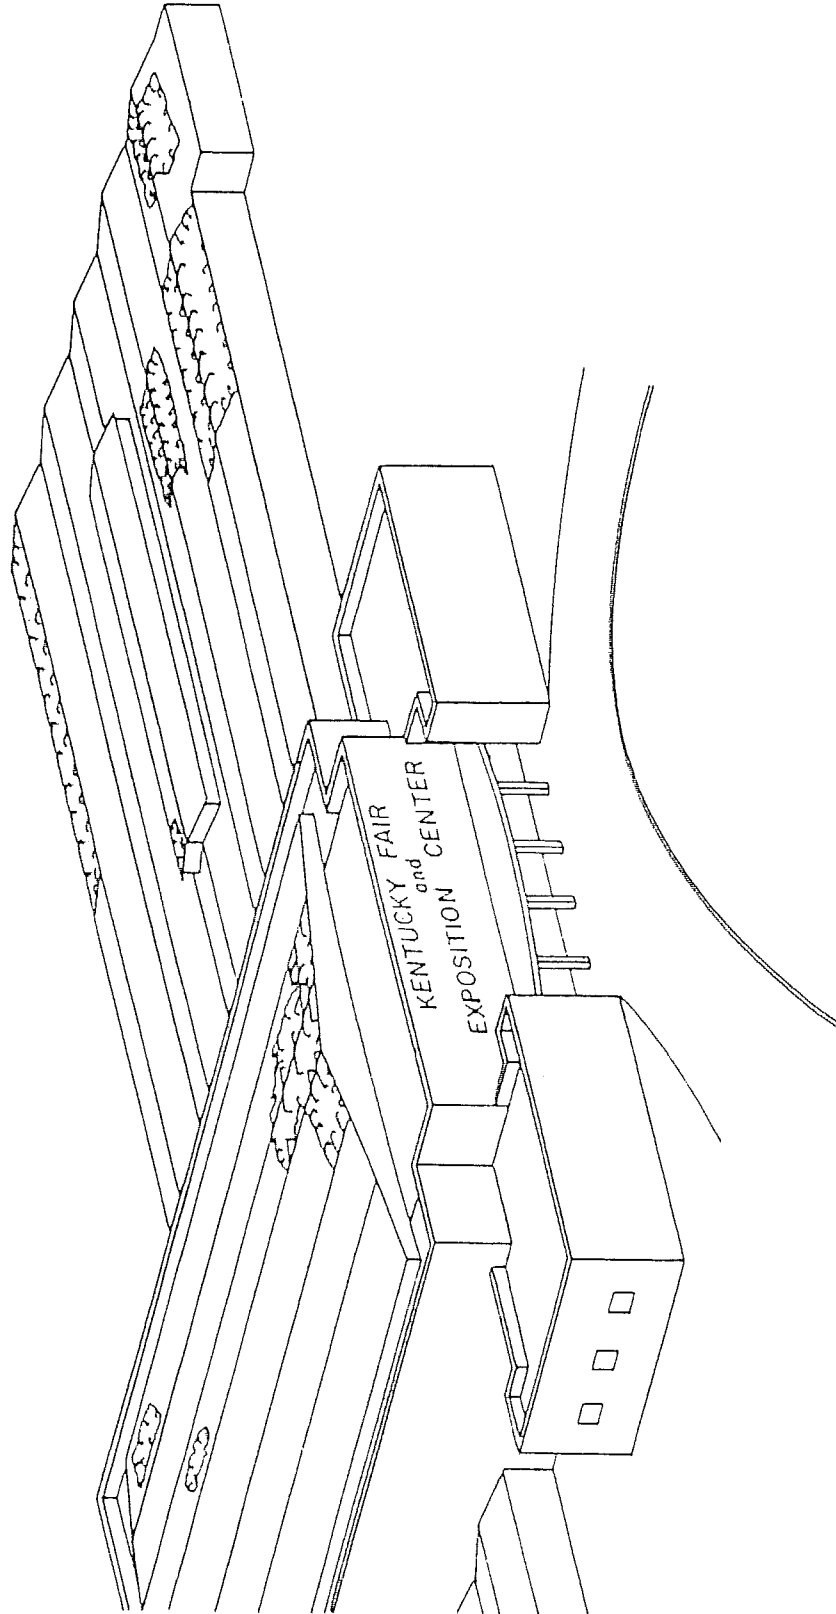
Freedom Hall
Kentucky Fair and Exposition Center

exhibition wings extending to the east and west sides of Freedom Hall (see Figure 71). The west wing was out of the tornado path and received no damage. There was no structural damage to Freedom Hall but two large holes were ripped in the roof and caused postponement of the American Basketball Association playoffs underway at the time.

FIGURE 71. KENTUCKY FAIR AND EXPOSITION CENTER. The shaded areas show locations of roof damage to Freedom Hall and the East Wing.

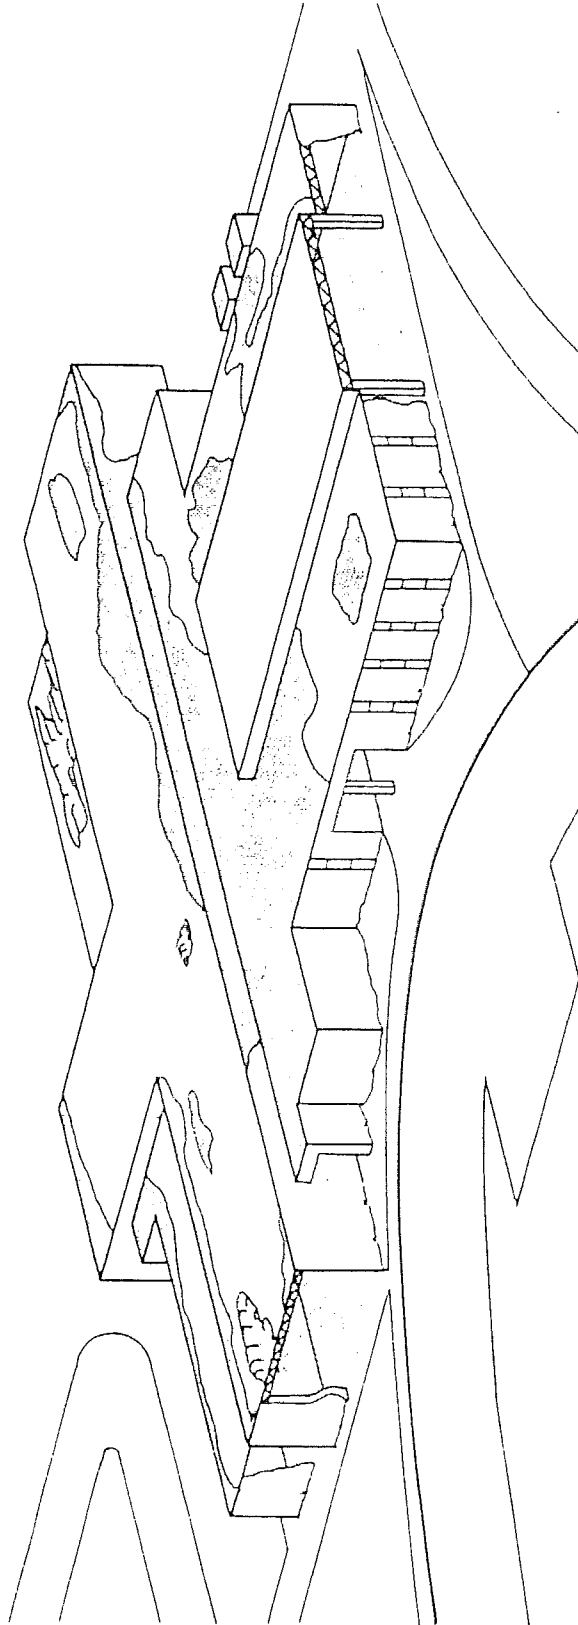
Dunn Elementary School
4799 Brownsboro Road

Dunn Elementary School, located just west of Interstate 71 near the Northfield Subdivision (see Figure 70), is a modern elementary school constructed at a cost of \$1,400,000. Figure 72 is a schematic drawing of the building with the damaged areas shaded. The principal damage was due to collapse of exterior walls which were constructed of 8 in. concrete blocks and 4 in. face bricks and were unreinforced and unanchored at the roof level. Vertical control joints in the masonry had no horizontal reinforcement to tie the wall to the rest of the structure, leaving it a free standing wall, which would be susceptible to damage from winds of considerably less magnitude than observed (see Figure 74). Damage caused by this type of construction detail has been observed in other storms which should be called to the attention of industry.

Interior hallways again would have provided adequate protection to occupants of this building. The light fixtures in the building, installed in the suspended accoustical ceiling framework, were relatively large (36 x 18 in.). Air pressure between the ceiling and roof caused some to drop out of their supports and fall to the floor. A fixture of the size found in this building could cause injury to someone inside the building. A better anchoring system should be explored.

FIGURE 72. SCHEMATIC DRAWING OF DUNN ELEMENTARY SCHOOL. The view is looking southwest. The shaded areas indicate damage.

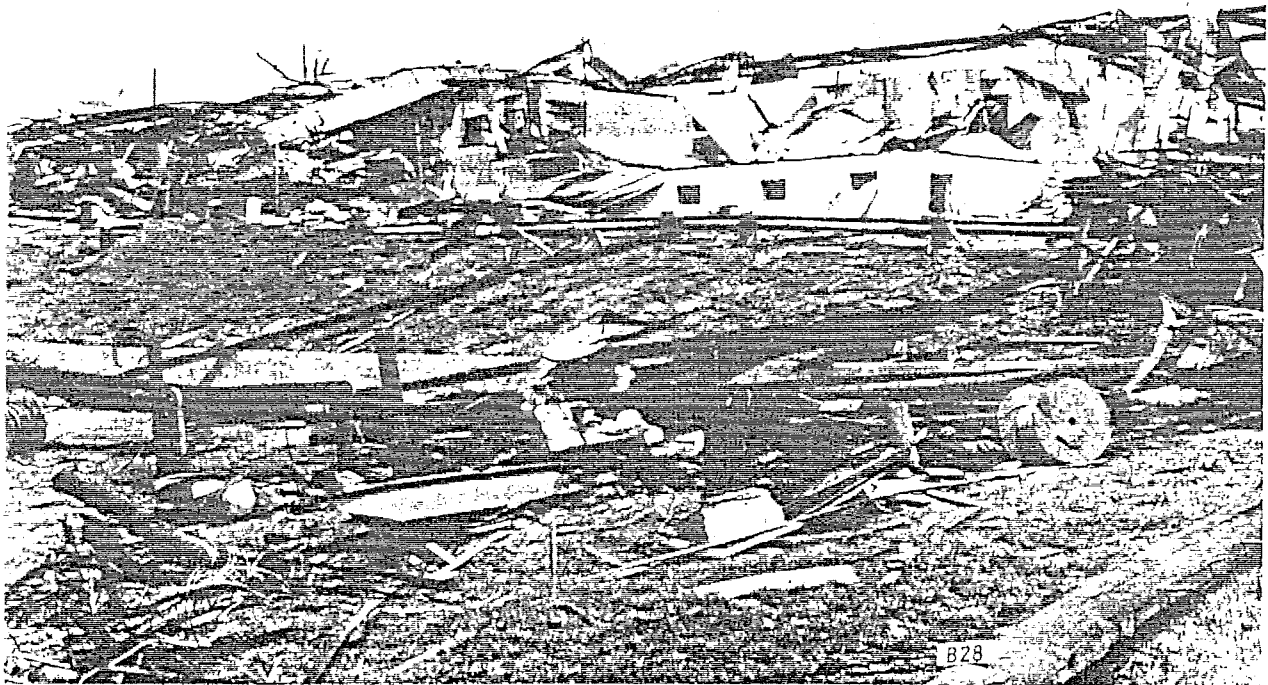
FIGURE 78. REC HEADQUARTERS. The utility poles were stored on the rack in the foreground. Although in an ideal position to become airborne, the poles did not move beyond what is shown in the photo.
