## **Squall Line Produces Two Tornadoes** April 24<sup>th</sup>, 2010

## **Overview**

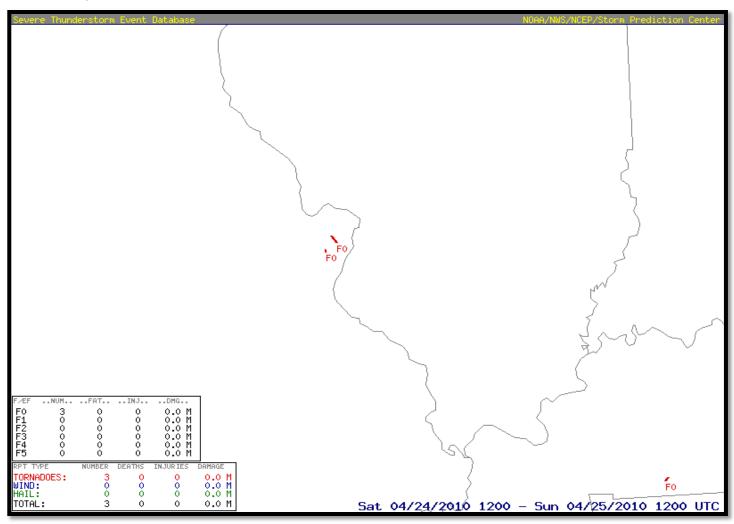
A line of severe thunderstorms moved northeast across the St. Louis area during the early evening hours of April 24<sup>th</sup>. Two small circulations developed within a distinct notch that was visible on the radar reflectivity. Interestingly, the circulations moved southeast to northwest, producing two weak tornadoes across St. Louis County. The first tornado occurred in Des Peres and the second was centered in Overland.
